**FIGURE 19** Ned Prather Spring Area Hydrocarbon Results

Phase I Prather Spring Site Investigation

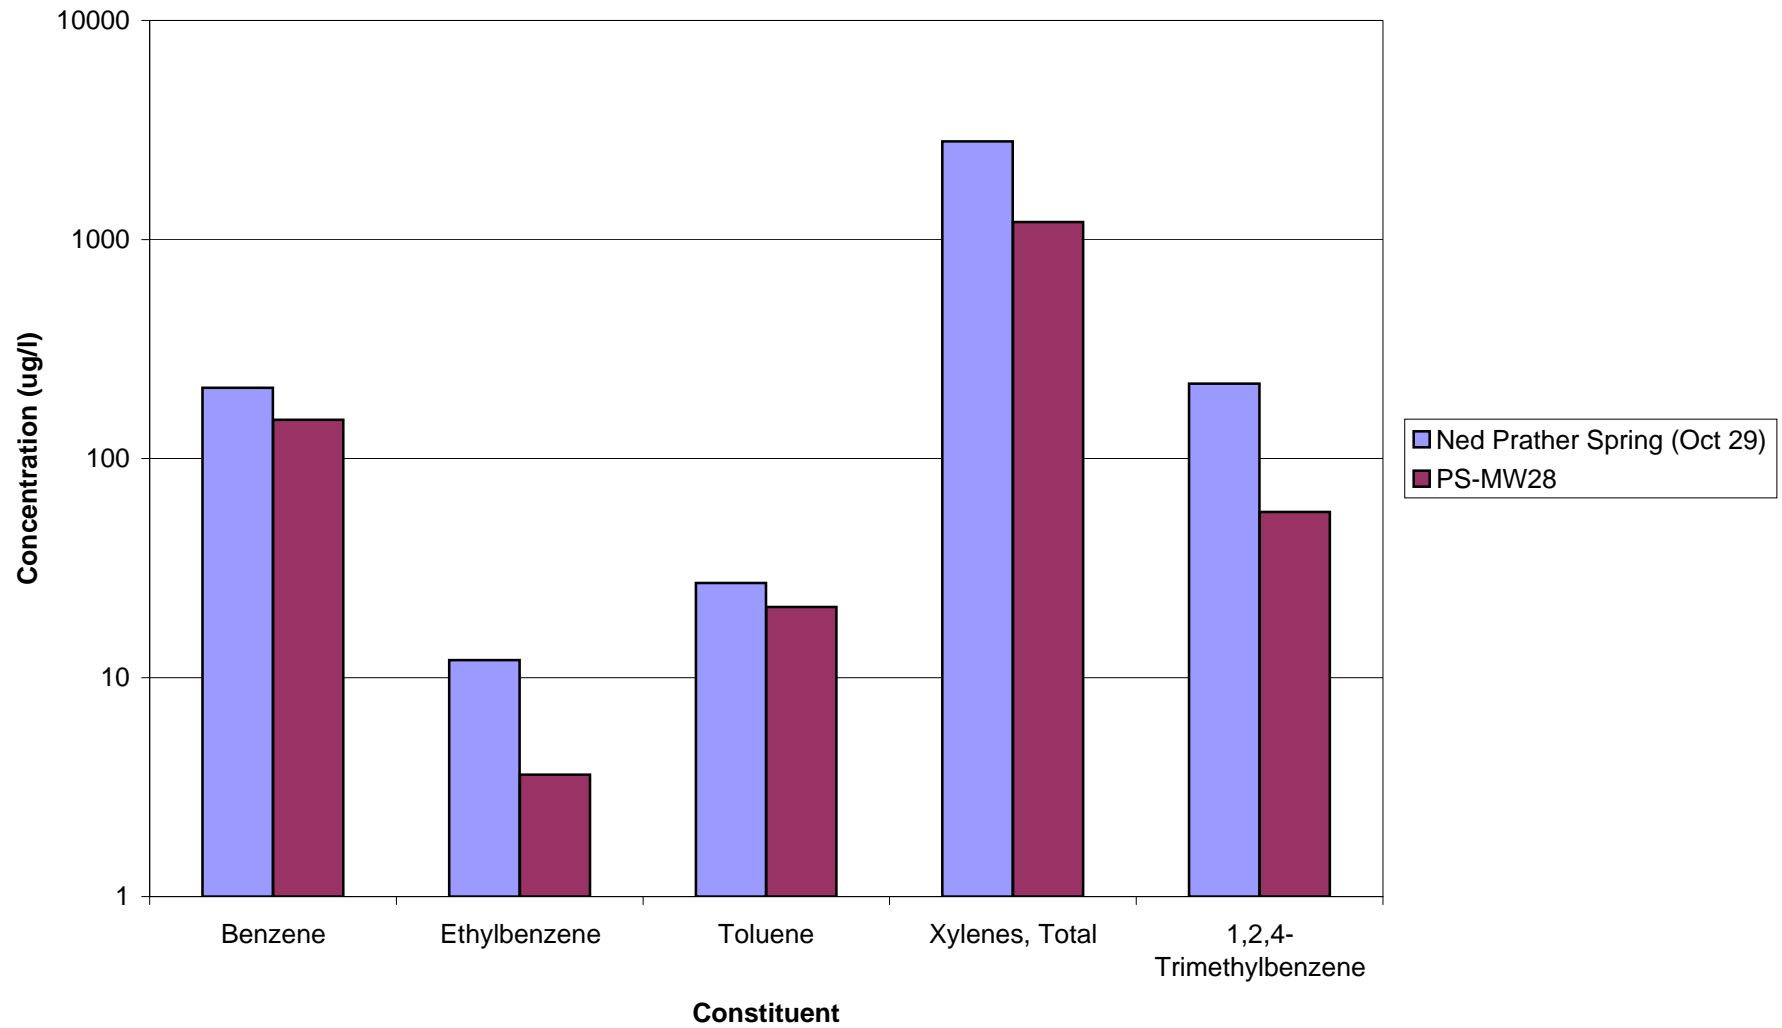
**Figure 20**  
**Concentration Comparison - Ned Prather Spring and PSMW-28**
