**Soil Sampling and Analytical Results Summary  
McPherson A Well Pad Incident**

**February 24, 2009**

**Antero Resources Piceance Corporation**

**HRL Compliance Solutions, Inc.  
744 Horizon Ct., Suite 140  
Grand Junction, CO 81506**

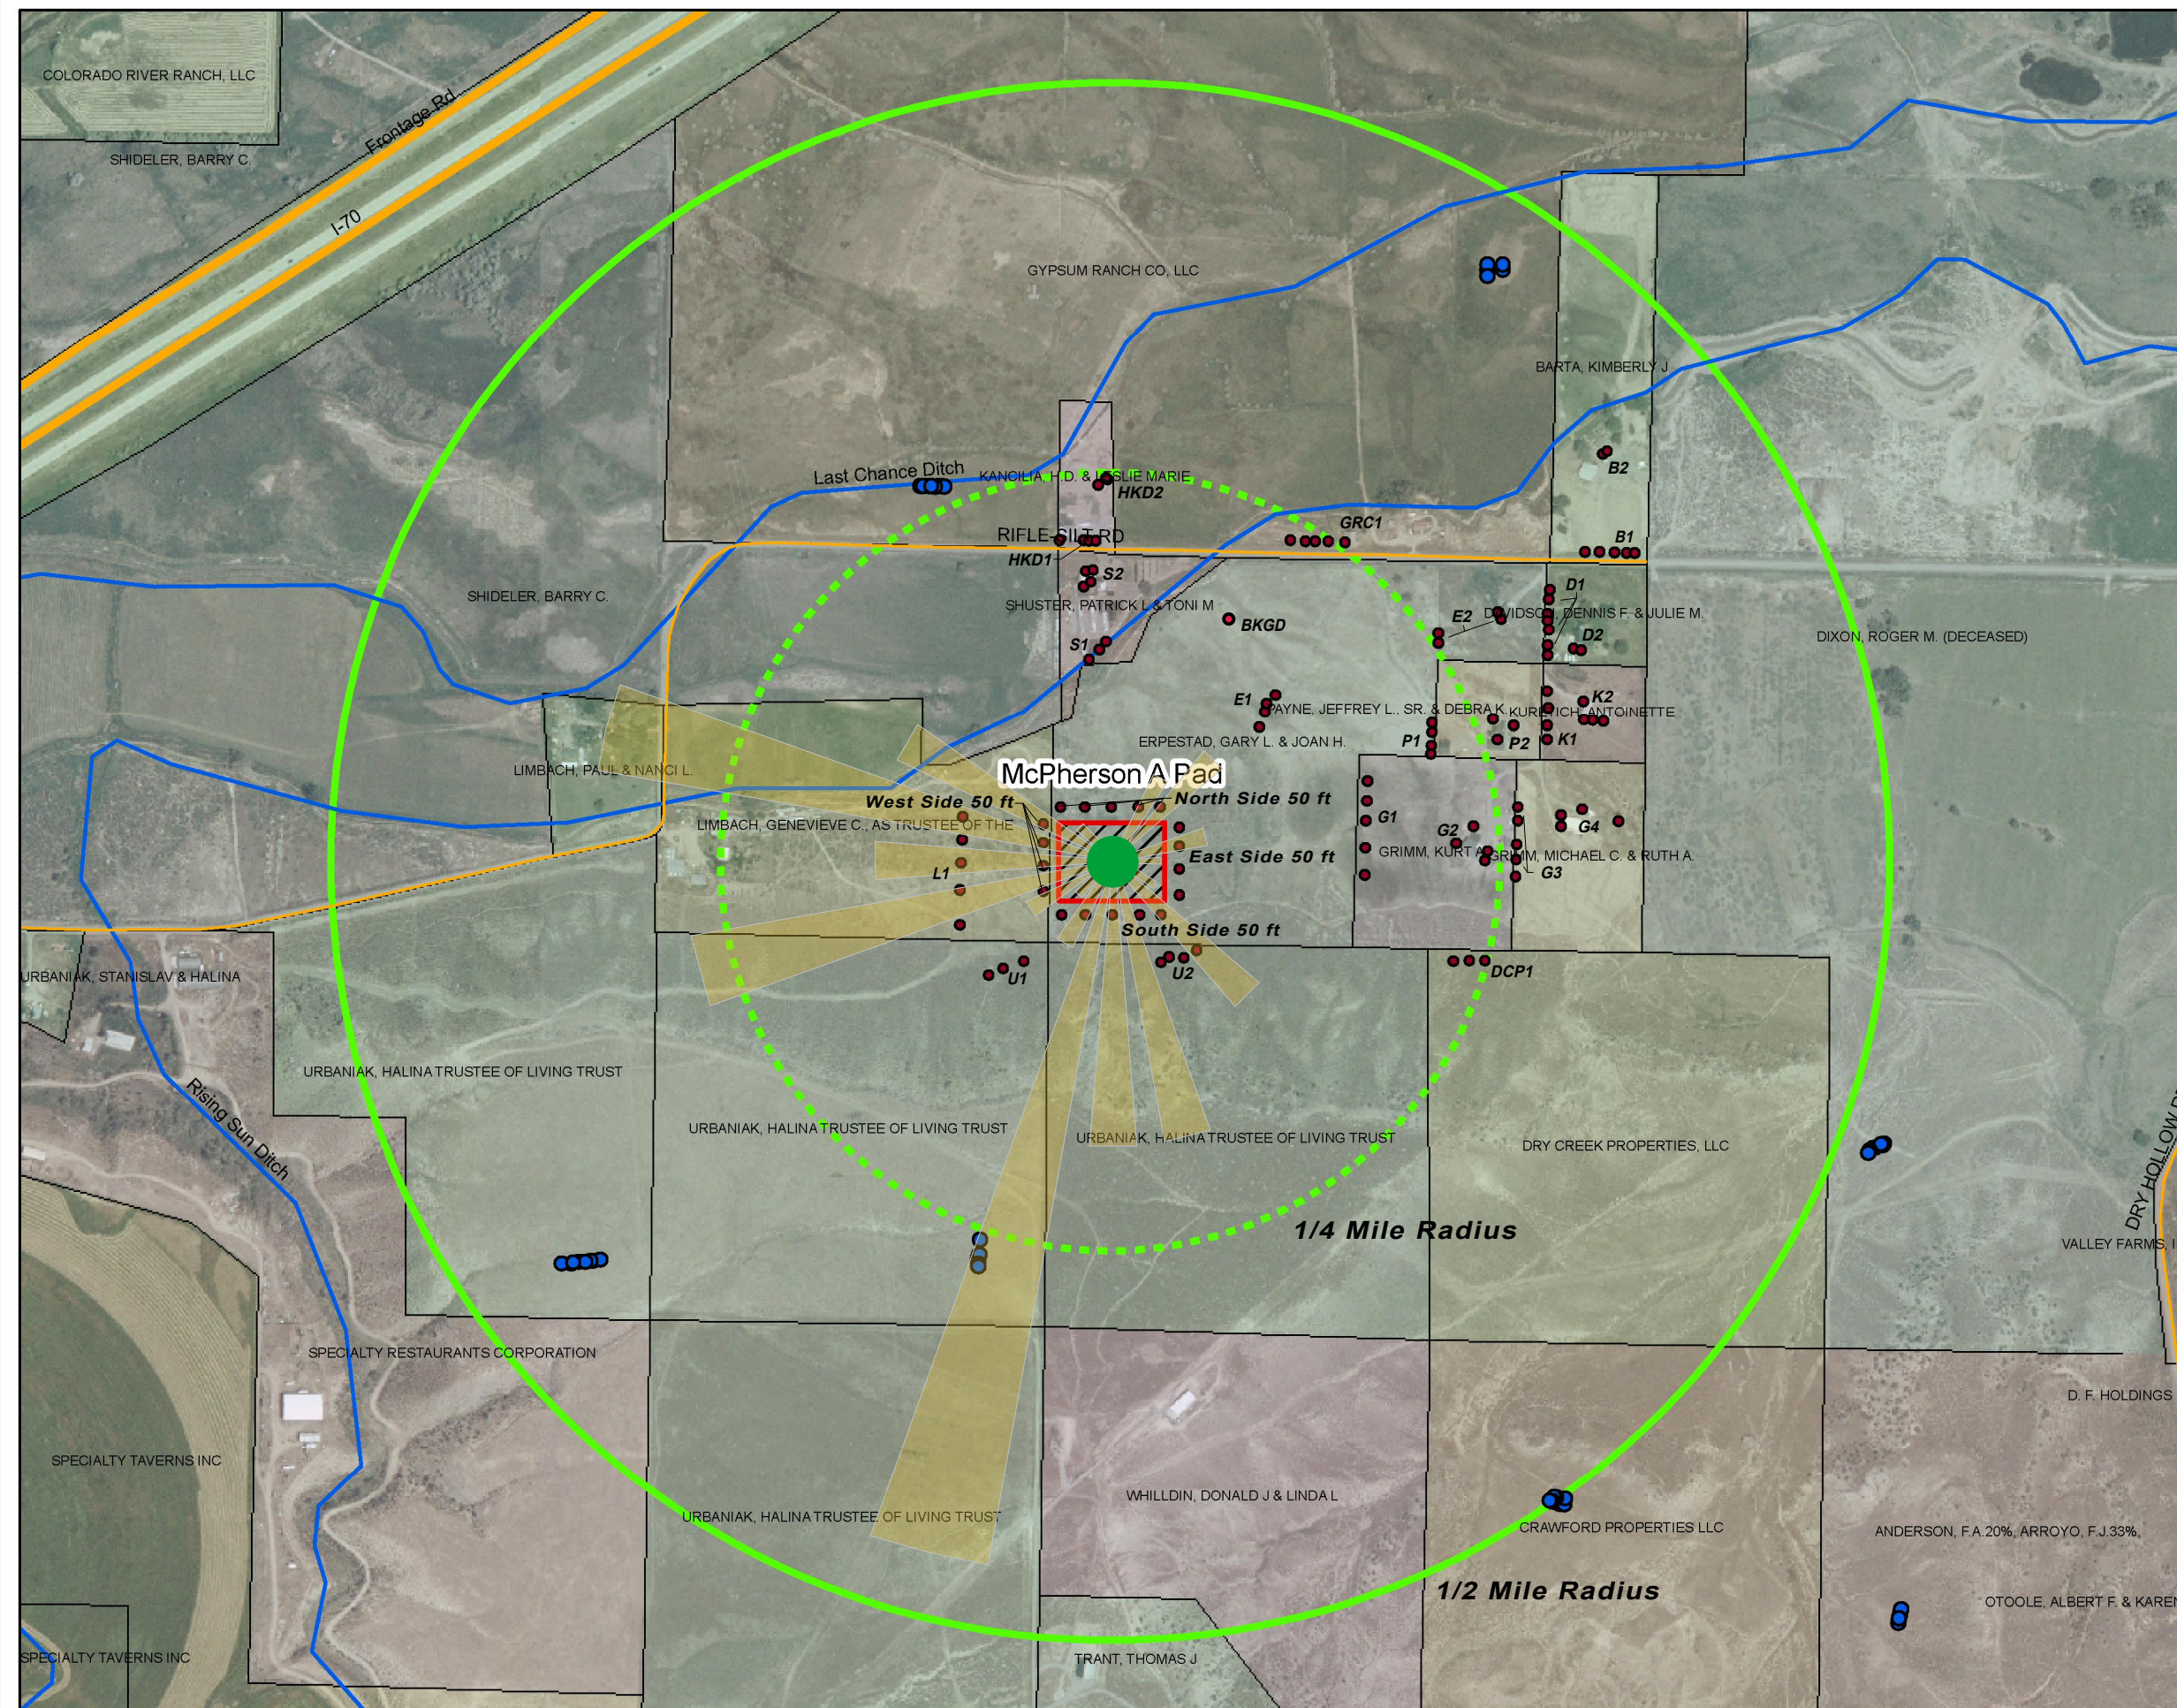
**Figure 1. Composite soil sample locations within a ½ mile radius of the McPherson A well pad.**

Surface soil sampling from the potentially affected property owners was conducted on January 13 and 14, 2009. The Composite samples were collected as close to the original proposed locations and as shown in Figure 1 of the previously submitted Sampling and Analysis Plan. The actual composite sample locations are depicted in Figure 1. Composite soil sample locations within a ½ mile radius of the McPherson A well pad. Analytical results from this sampling event are attached as Table 2. Soil sampling analytical results. Adjacent property owners within a ½ mile radius of the McPherson A well pad.

Figure 1. Composite soil sample locations within a 1/2 mile radius of the McPherson A well pad
