## EnCana Stormwater Management Inspection Form

Well Name: Shaffer Newman 0-6-13, 1-8-13, 24-13

AGW Project Number: E09192.EC

Date & Time: 10/2/09 @ 1:45 pm

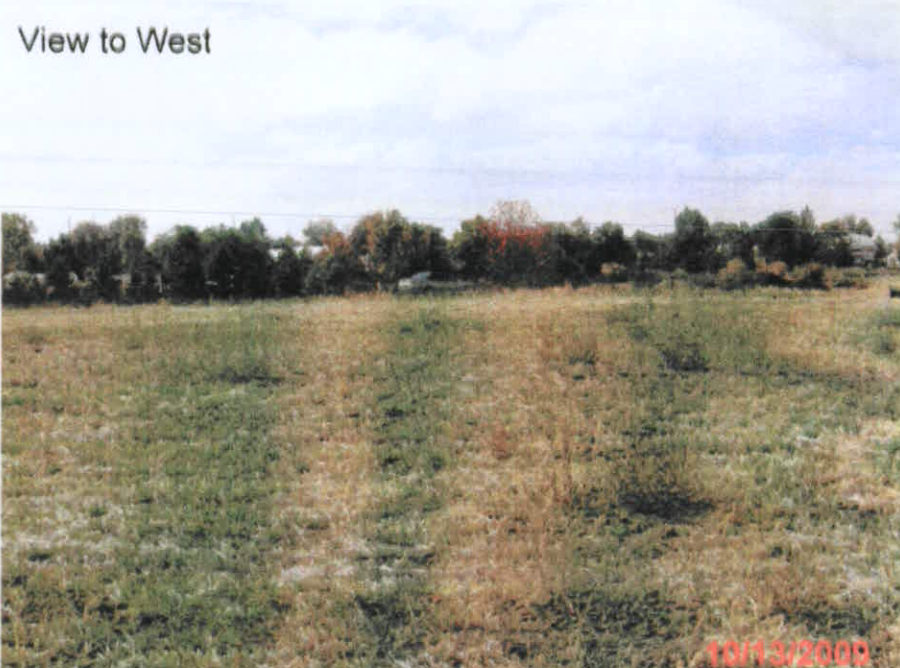
View to West

Notes: All ground surface disturbing activities at the site have been completed, and all disturbed areas have  
achieved a vegetative cover of greater than 80% of the undisturbed reference area plant coverage. Interim  
reclamation of all disturbed areas is complete and bi-weekly stormwater management inspections are no longer  
required at the site. AGW will coordinate removal of the remaining silt fence with Roberts Excavation Corporation.

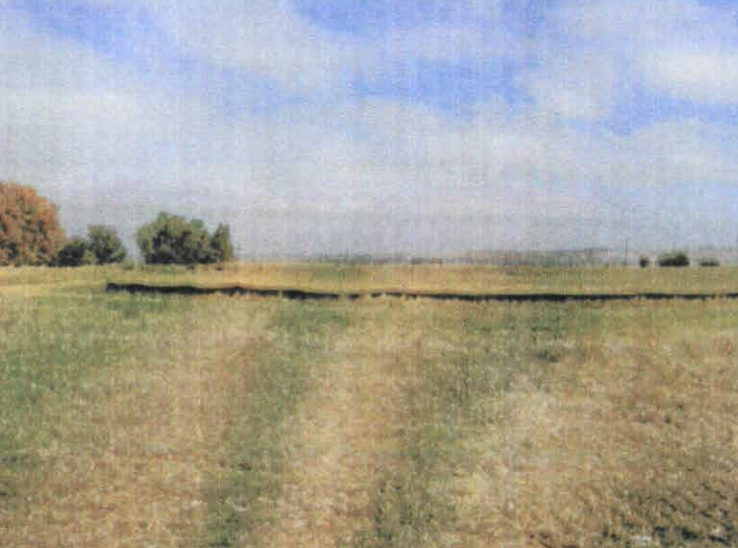
A photograph showing a wide, flat landscape under a blue sky with scattered white clouds. The foreground is covered in dry, yellowish-brown grass. In the middle ground, there is a line of green trees and shrubs. The horizon is flat and distant. The text "View to East" is printed in the top left corner, and the date "10/13/2009" is printed in red in the bottom right corner.
