PROJECT DATA BOOK

WILLIAMS FIELD SERVICES COMPANY

**WILLIAMS IGNACIO PLANT
NORTH EVAPORATION POND
3746 COUNTY ROAD 307
DURANGO, CO 81303**

3.0 LINER QA/QC DATA

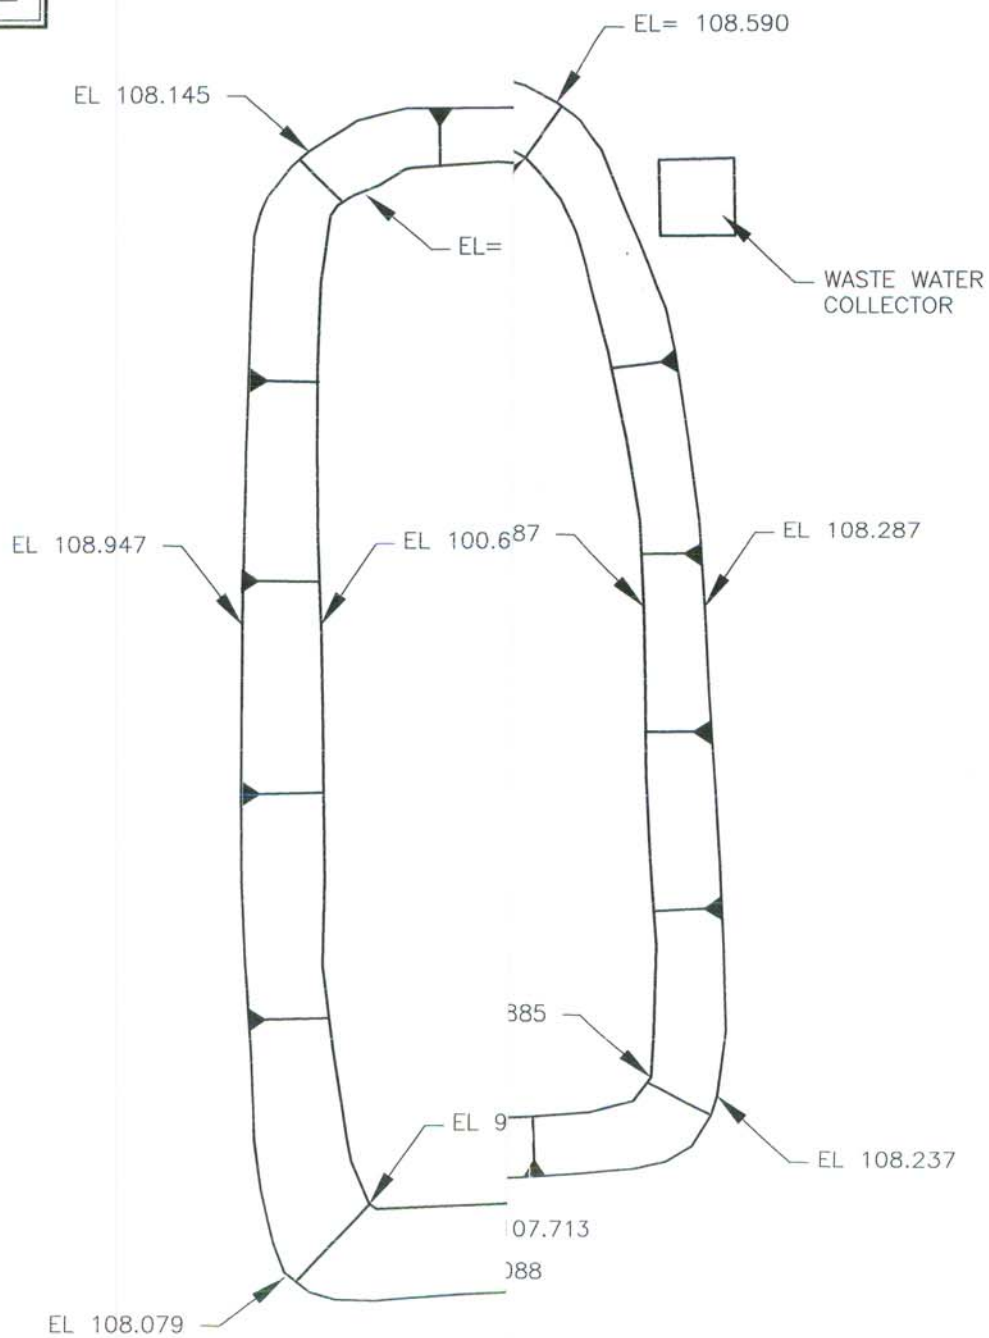
FIGURE
1

TOTAL CONTAINMENT:
154,240.83 bbls

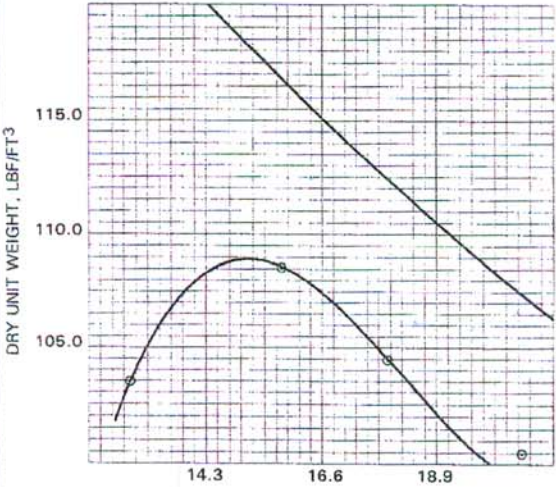
SIEVE ANALYSIS : FINER THAN NO. 200 :			LABORATORY COMPACTION CHARACTERISTICS : ASTM D698 METHOD A				
SIEVE	ACCUMULATIVE % PASSING	SPECIFICATION
