Re: Notification of Completion of Pit Closure
FRU 297-20B, API #05-103-11128
Remediation Number 6821/Document # 2222681

XTO FRU 297-20B
Piceance Basin, CO

Site Photographs

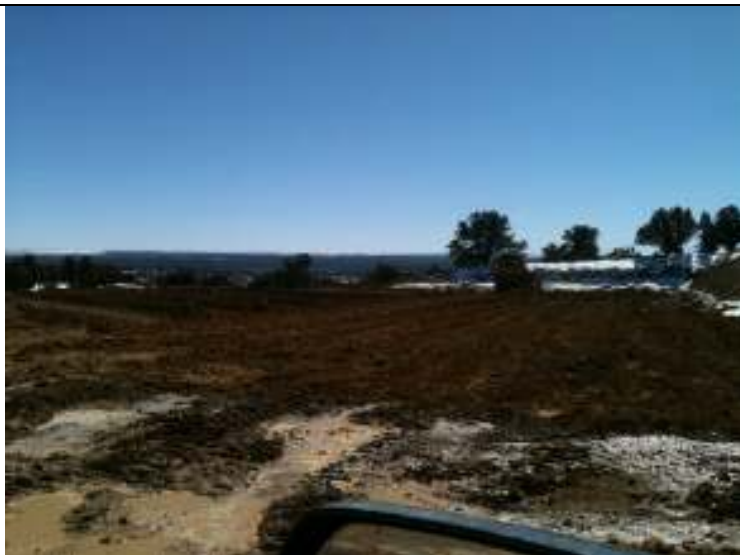
Photograph 1 – View of completed pit closure, Freshwater and Reserve Pits, , photo taken 3/5/2012, N side facing S

The pits will be closed and backfilled with native on-site material or material transported to the site. Material used to fill the top three feet of each pit will be obtained from on-site native material. The closed pits will be regraded per the approved pad reclamation design to provide positive drainage to the perimeter of the closed pit. Following grading activities, stockpiled topsoil will be spread across re-graded pits and seeded with a BLM approved seed mixture and application rate. Additional soil stabilization practices, such as mulching, crimping, or erosion control blankets may be employed as necessary.

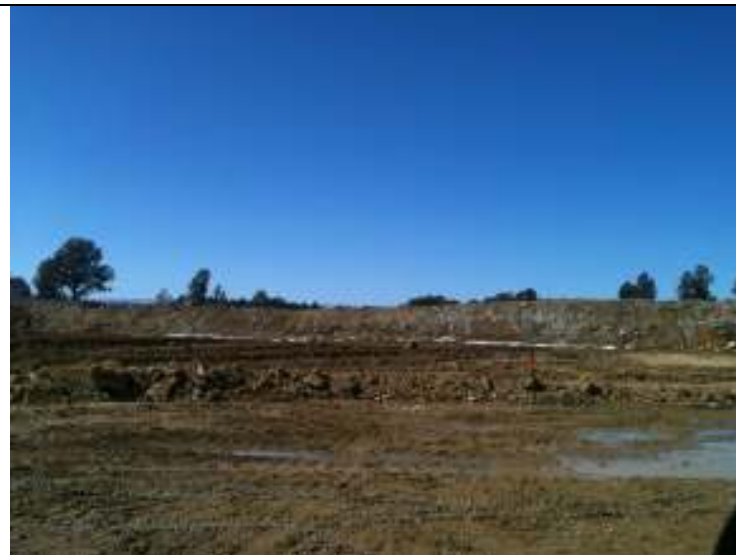
Photograph 2 – View of completed pit closure, Freshwater and Reserve Pits, , photo taken 3/5/2012, NE side facing SW
