**From:** Edith Savage  
**Company:** Savage and Savage, Inc.  
**Project:** Betz PC G09-22D, Wetland Delineation  
and Corps Concurrence  
**Phone:** 970-674-8080  
**Fax:** 970-674-8088  
**Date:** August 6, 2011

**RE: Concurrence Request for Noble Energy Production, Inc.'s  
Betz PC G09-22D Well Site, Weld County, Colorado  
Corps File No. NWO-2010-1405-DEN**

**NOBLE ENERGY PRODUCTION, INC.  
BETZ PC G09-22D DRILL SITE  
WATERS OF THE UNITED STATES IDENTIFICATION  
AND WETLAND DELINEATION  
WELD COUNTY, COLORADO**

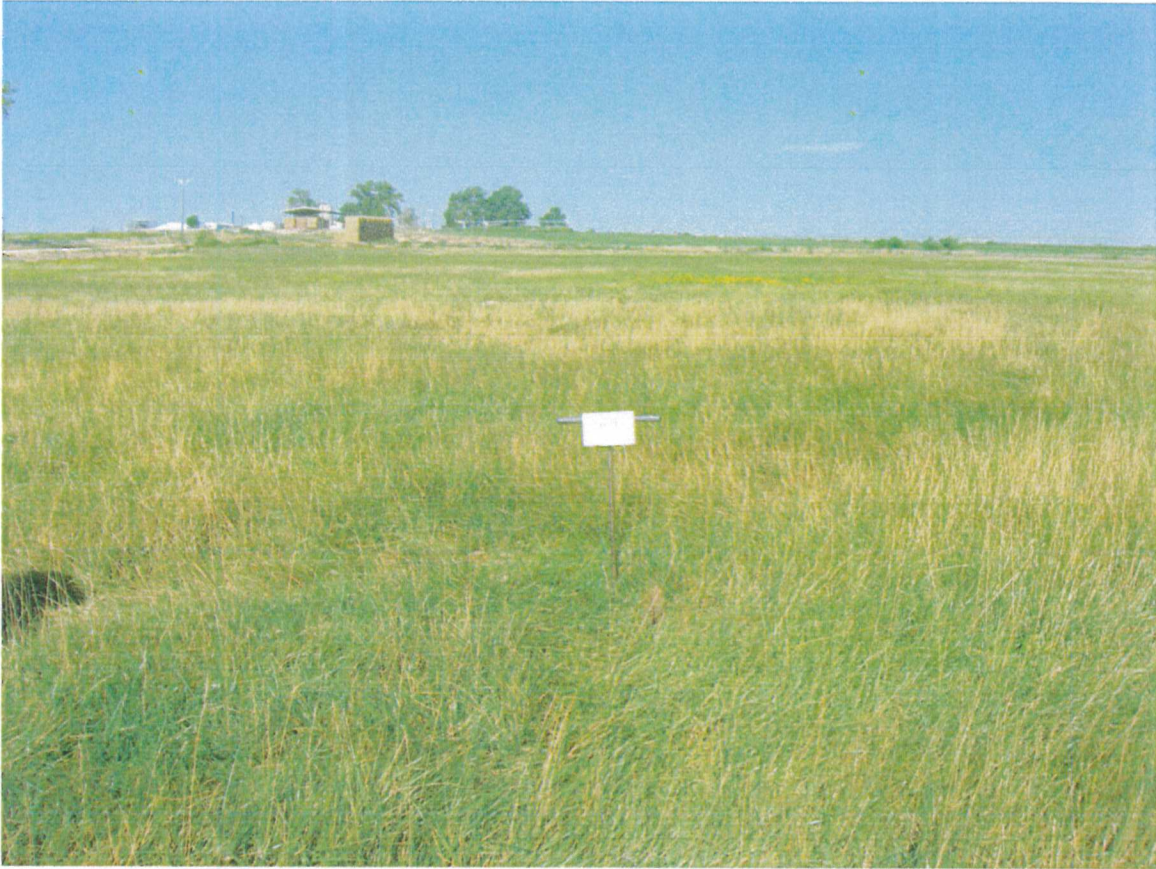
**Figure 2. Betz PC G09-22D Sample Point 1. Facing West**

Irophytic Vegetation Present?      Yes _____ No <u>X</u> Iric Soil Present?                      Yes _____ No <u>X</u> Land Hydrology Present?            Yes _____ No <u>X</u>	Is the Sampled Area within a Wetland?                      Yes _____ No <u>X</u>
marks: 30' W OF TANK FARM FENCE 75' S OF TANK FARM N BOUNDARY TANK FARM 30' WIDE FROM RD ADDITIONAL VEGETATION & SOIL PRESENCE DUE TO ADJACENT IRRIGATION ONLY

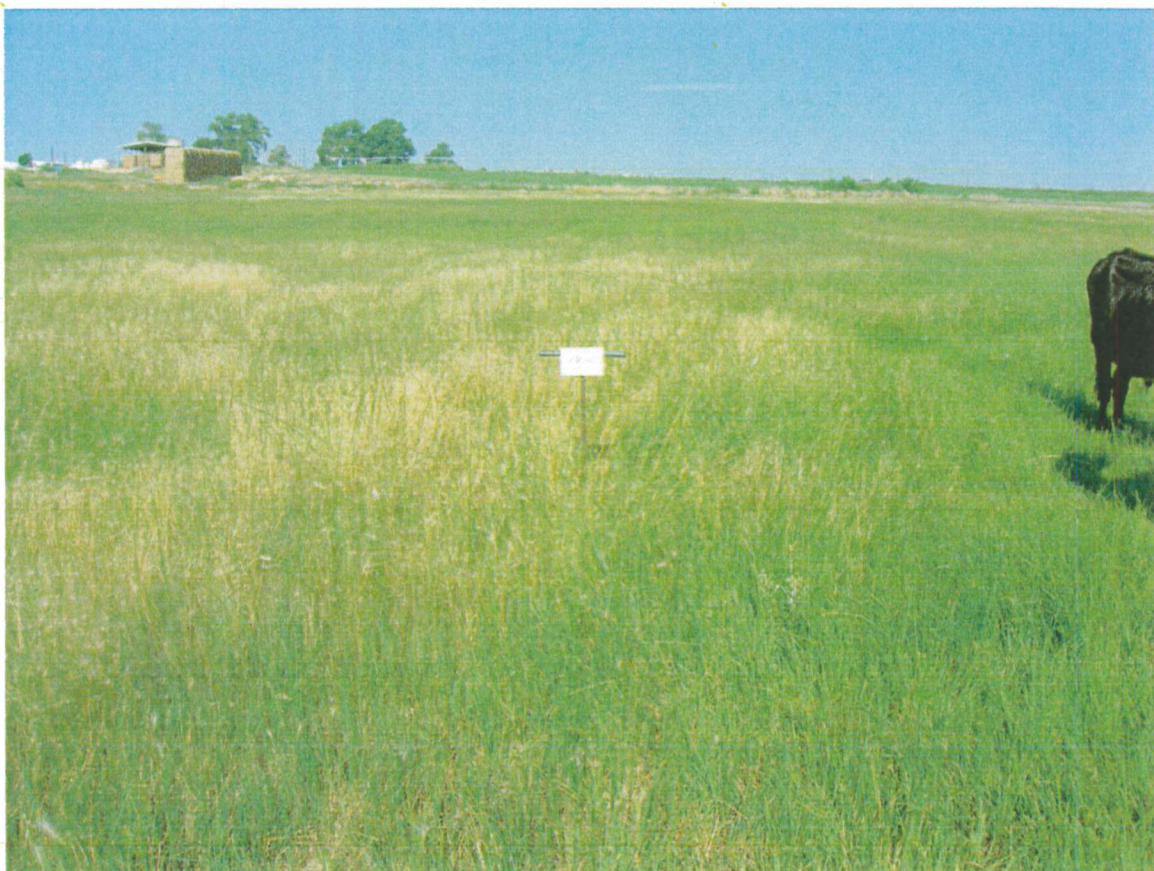
**Figure 3. Betz PC G09-22D Sample Point 2. Facing West**

Hydrophytic Vegetation Present?	Yes <u>X</u> No _____	Is the Sampled Area within a Wetland? Yes <u>X</u> No _____
Hydric Soil Present?	Yes <u>X</u> No _____	
Wetland Hydrology Present?	Yes <u>X</u> No _____	
Remarks: <u>200' E OF TANK FARM FENCE, 75' SOUTH OF TANK FARM N BOUNDARY</u>

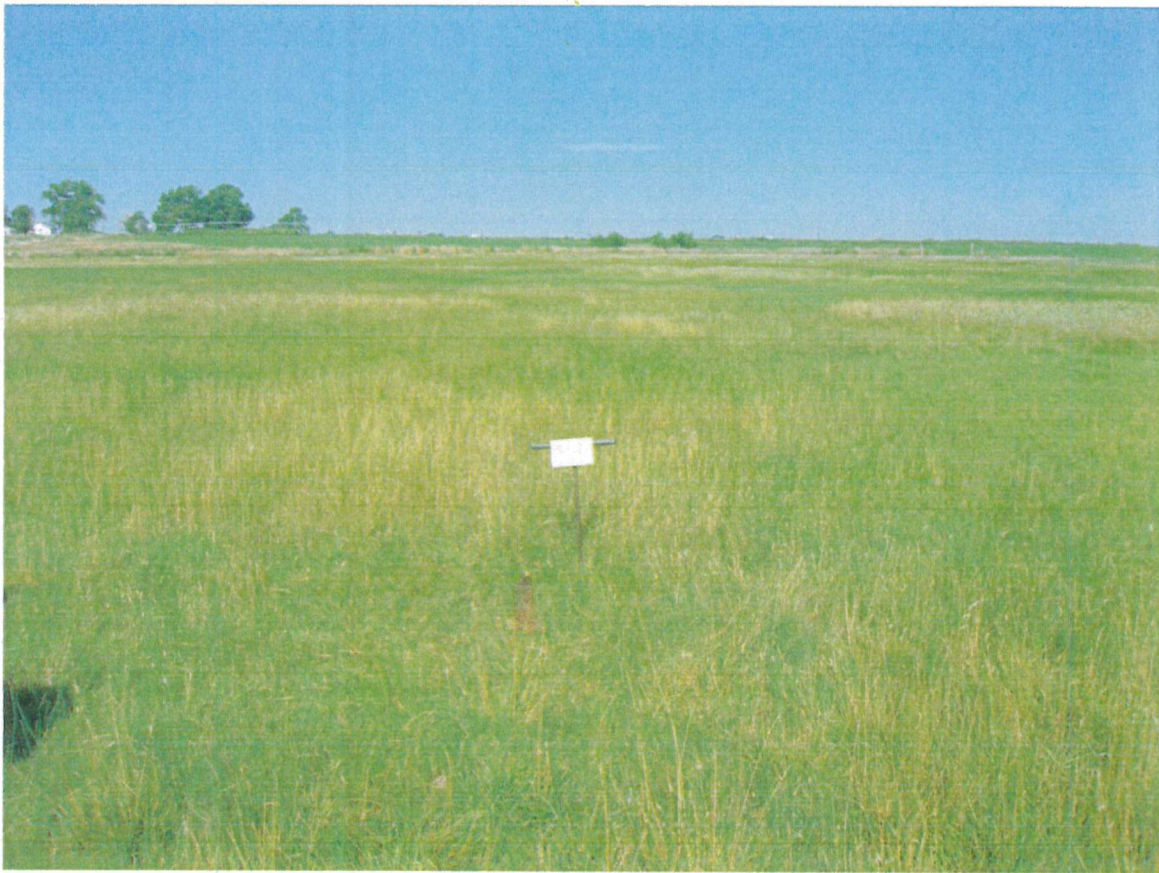
**Figure 4. Betz PC G09-22D Sample Point 3. Facing West**

Hydrophytic Vegetation Present?	Yes <u>X</u> No _____	Is the Sampled Area within a Wetland? Yes _____ No <u>X</u>
Hydric Soil Present?	Yes _____ No <u>X</u>	
Wetland Hydrology Present?	Yes _____ No <u>X</u>	
Remarks: <u>50' WEST OF PROPOSED DRILL SITE FENCE (SW CORNER)</u> <u>PROPOSED DRILL SITE 165' WIDE FROM ROAD</u>

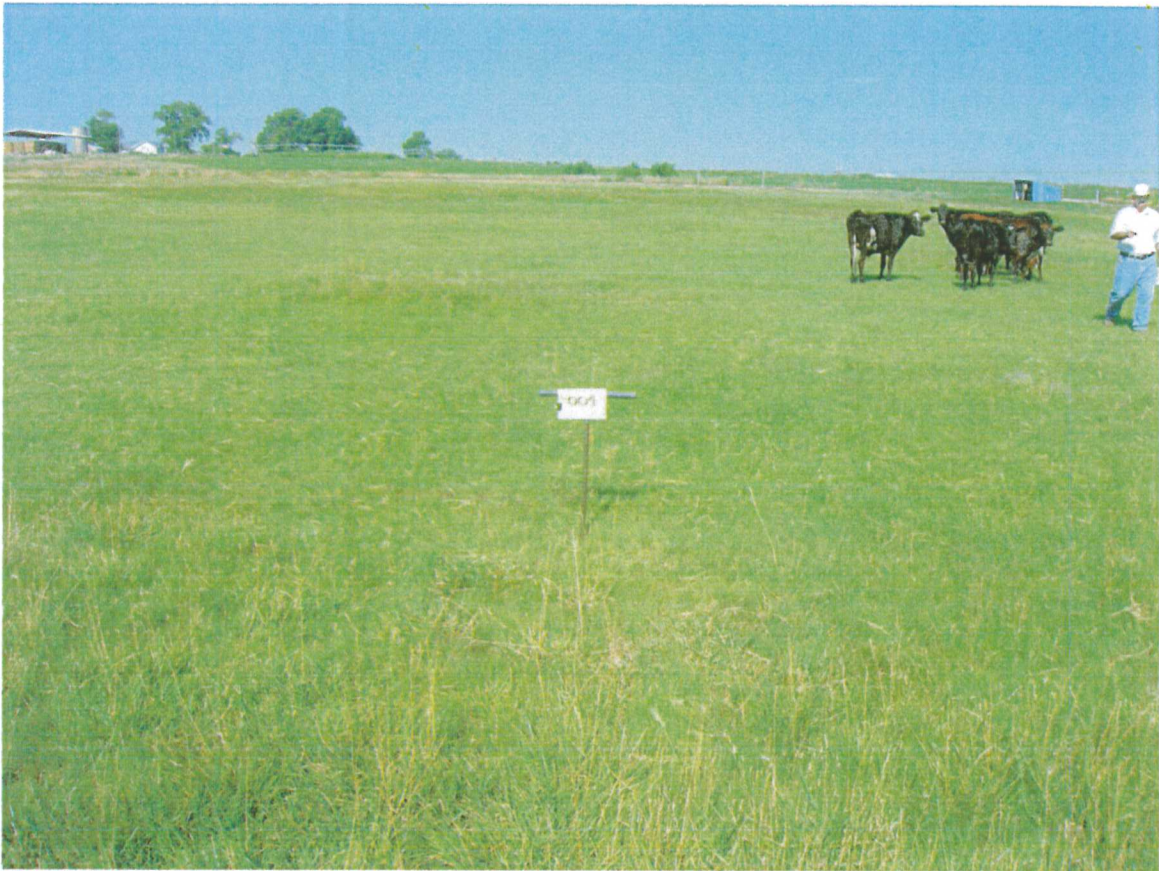
**Figure 5. Betz PC G09-22D Sample Point 4. Facing West**

Hydrophytic Vegetation Present? Yes _____ No <u>X</u>	Is the Sampled Area within a Wetland? Yes _____ No <u>X</u>
Hydric Soil Present? Yes _____ No <u>X</u>	
Wetland Hydrology Present? Yes _____ No <u>X</u>	
Remarks: <u>300' SOUTH OF PASTURE FENCE, 50' WEST OF PROPOSED DRILL PAD BOUNDARY FENCE; ~ 100' WEST OF EXISTING DRILL HEAD (290' SOUTH OF PASTURE FENCE) PROPOSED DRILL PAD 420' (N-S),</u>

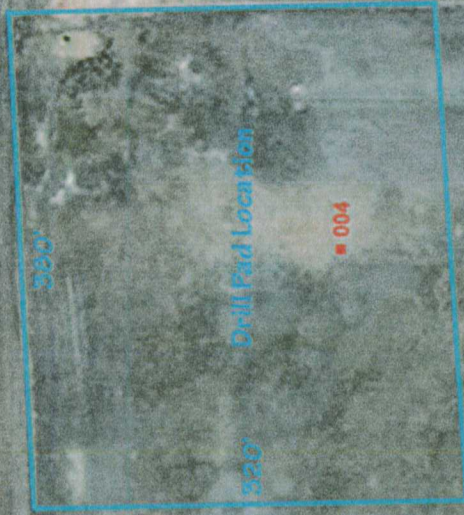
Noble Energy Betz PC G09-22 D Wetland Delineation (South Area)

The Betz PC G09-22D drill pad will be approximately 2.8 acres and will be located outside the wetland depicted on the wetland delineation aerial photograph. We request the Corps concur with our conclusion that there are no wetlands located within the proposed Betz PC G09-22D drill pad. If you have any questions or require further information about this site please contact me.

Savage and Savage conducted a wetland delineation at the proposed Noble Energy Production Betz PC G09-22D well site on August 9, 2011. This delineation was conducted in order to determine the presence and extent of wetlands within the proposed drill site. Hydrophytic vegetation was identified within three of the sample locations, however hydric soil and wetland hydrology were not identified within these sample sites (Sample Points 001, 003, 004). Hydrophytic vegetation, hydric soil, and wetland hydrology were identified within Sample Point 002. Wetlands are present along the south end of the field. (Figure 6).
