**RE: Concurrence Request for Noble Energy Production, Inc.'s
Olson USX 029-20D and Nanda USX 029-18D and 21D Well Pad,
Weld County, Colorado**

**NOBLE ENERGY, INC.
OLSON USX 029-20D AND NANDA USX 029-18D AND 21D WELL PAD
WATERS OF THE UNITED STATES IDENTIFICATION
AND WETLAND DELINEATION
WELD COUNTY, COLORADO**

Prepared by: Savage and Savage, Inc.
4610 Haystack Drive
Windsor, CO 80550
970 674 8080

February 2012

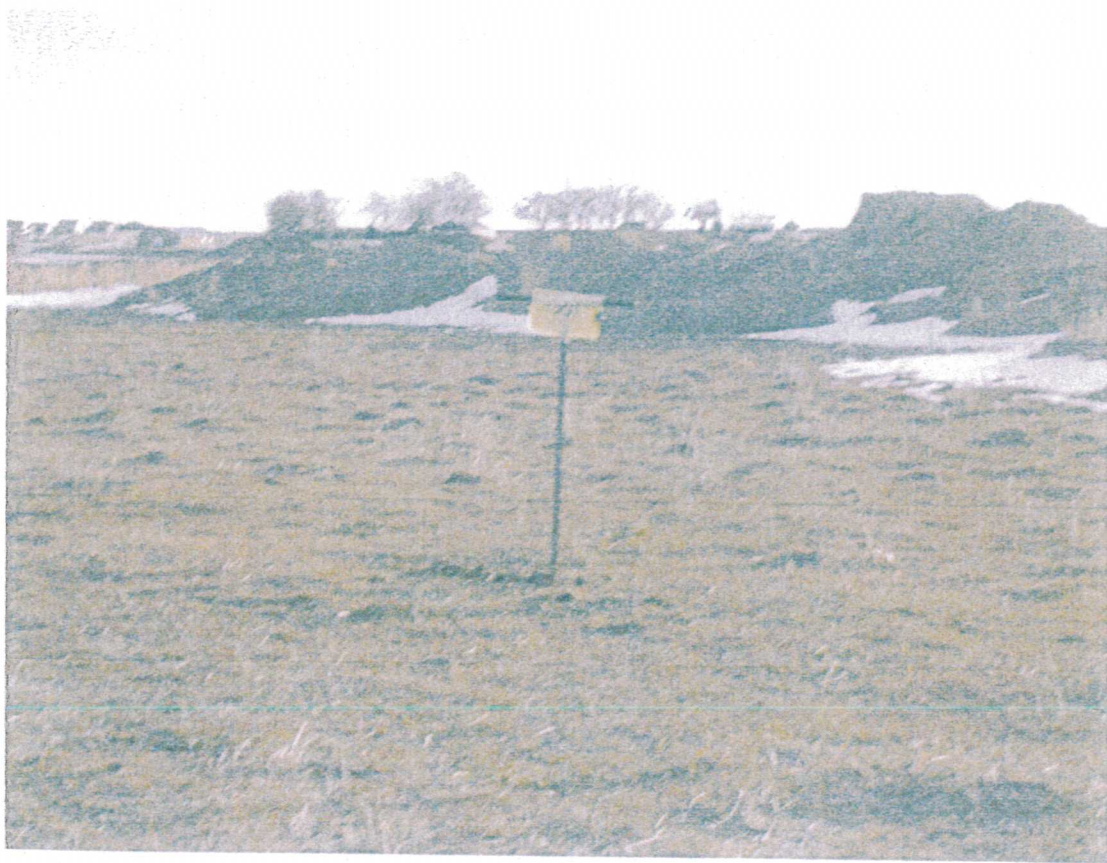
Figure 2. Sample Point 001 – Facing East

During our site visit the vegetation on the northwest half of the drill pad was identified as agricultural field. Vegetation on the southeast half of the drill pad, located above and along the unnamed ditch, consists of tall wheatgrass (*Agropyron elongatum*), orchardgrass (*Dactylis glomerata*), and Kentucky bluegrass (*Poa pratensis*). These grasses were likely seeded in the area for pasture and range purposes. (Figures 2 and 3.)

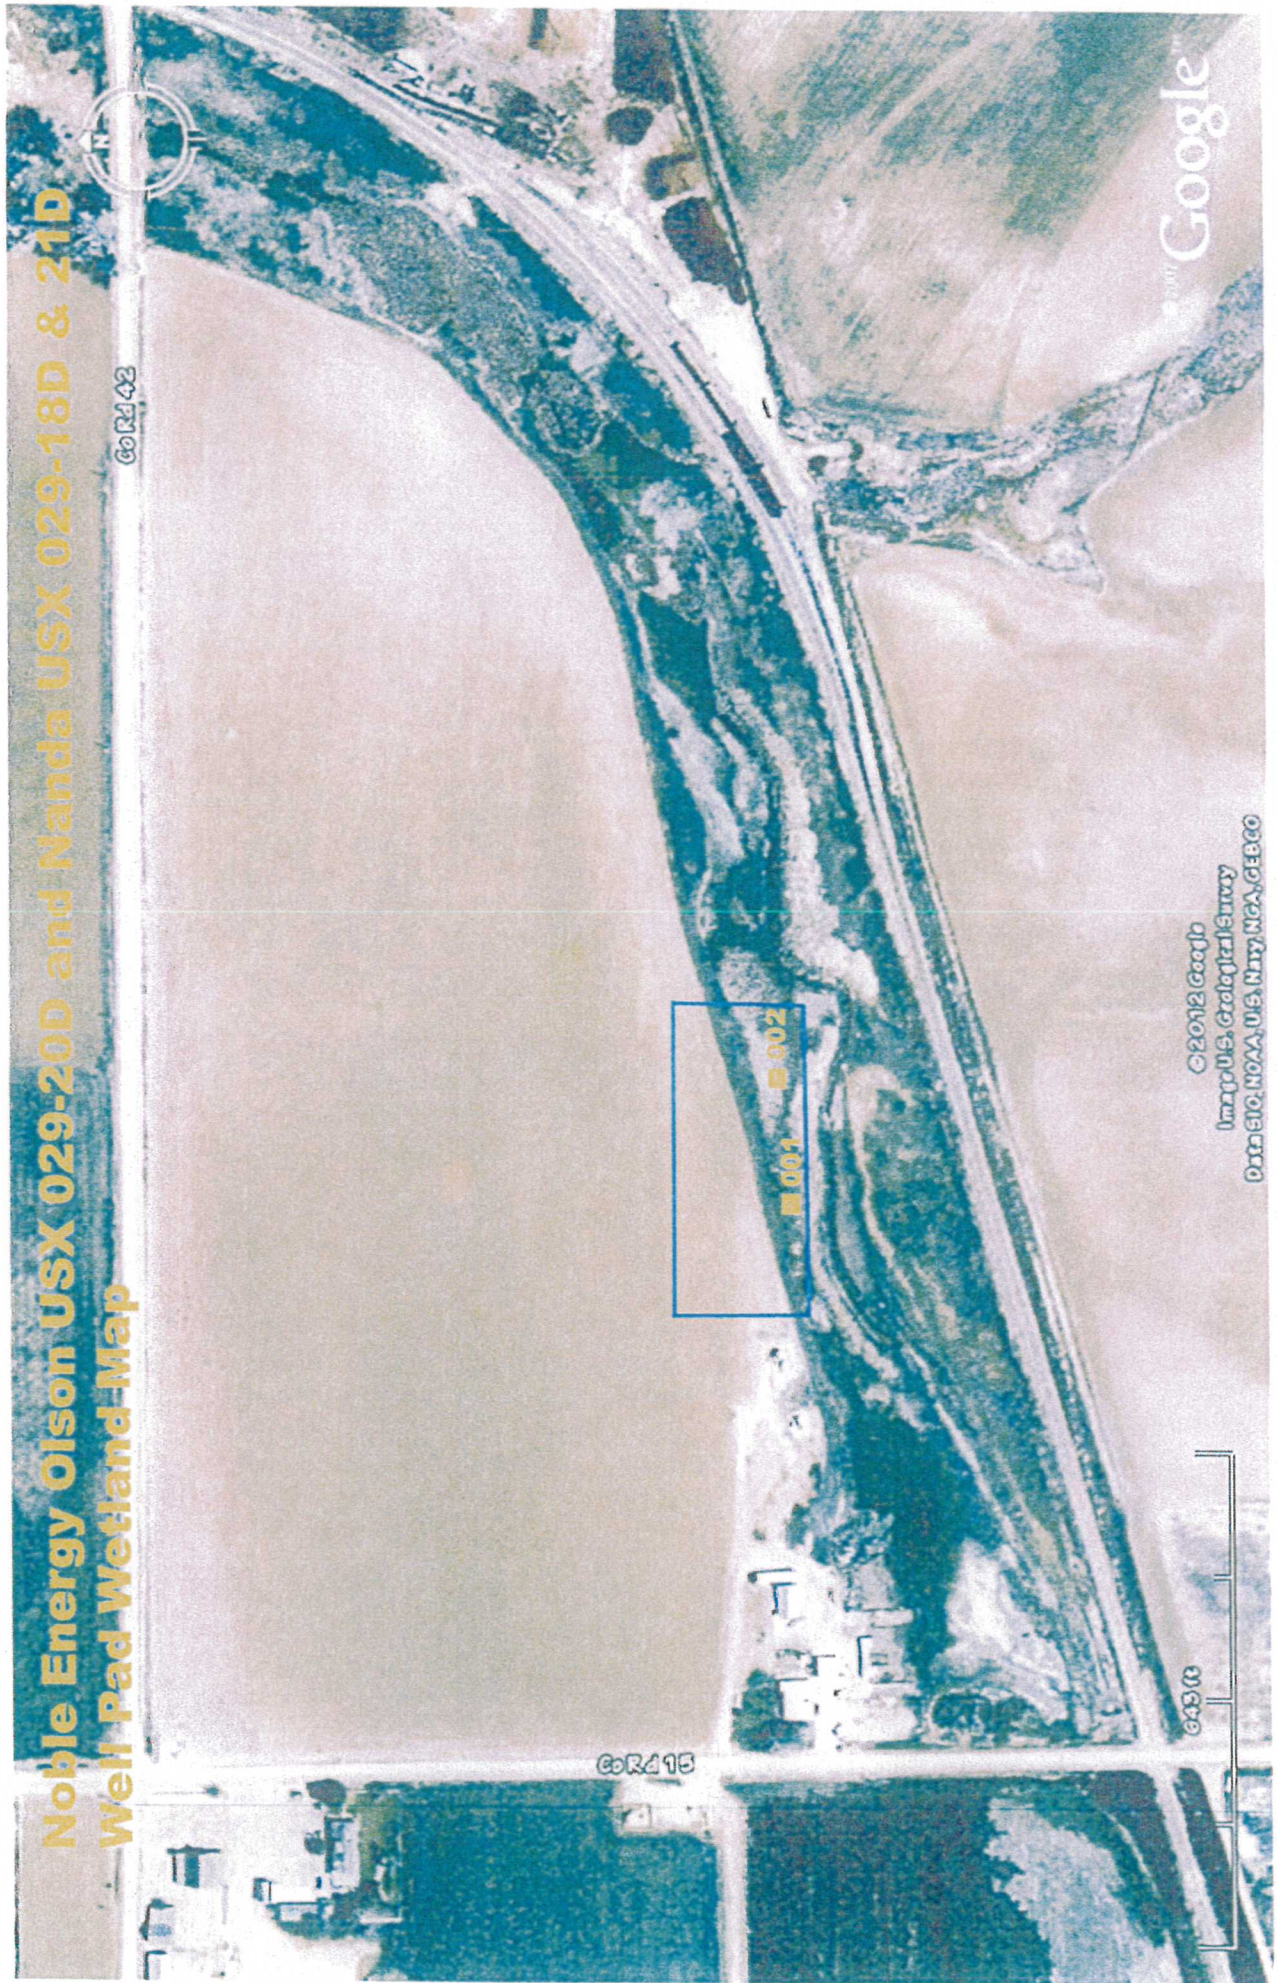
**Noble Energy Olson USX 029-20D and Nanda USX 029-18D & 21D
Well Pad Wetland Map**

Savage and Savage conducted a wetland delineation at the proposed Noble Energy, Inc. Olson USX 029-20D and Nanda USX 029-18D and 21D well pad on February 22, 2012. This delineation was conducted in order to determine the presence and extent of wetlands at the well pad. Uplands are present in the hayfield and along the unnamed ditch. There are no wetlands present within the proposed well pad site. (Figure 4.).
