Subject: **Produced Water Pit Replacement Closure Report**
UPRC 1-12L, Hibbs #1, Plutt P1-1 SWSW Sec 1, T3N, R67W
API # 05-123-16557, 05-123-07996, 05-123-22155
Platteville, Colorado
Fremont Project No. C013-025

PRODUCED WATER PIT REPLACEMENT

UPRC 1-12L, HIBBS #1 and PLUTT P1-13

FREMONT PROJECT NO. C013-025

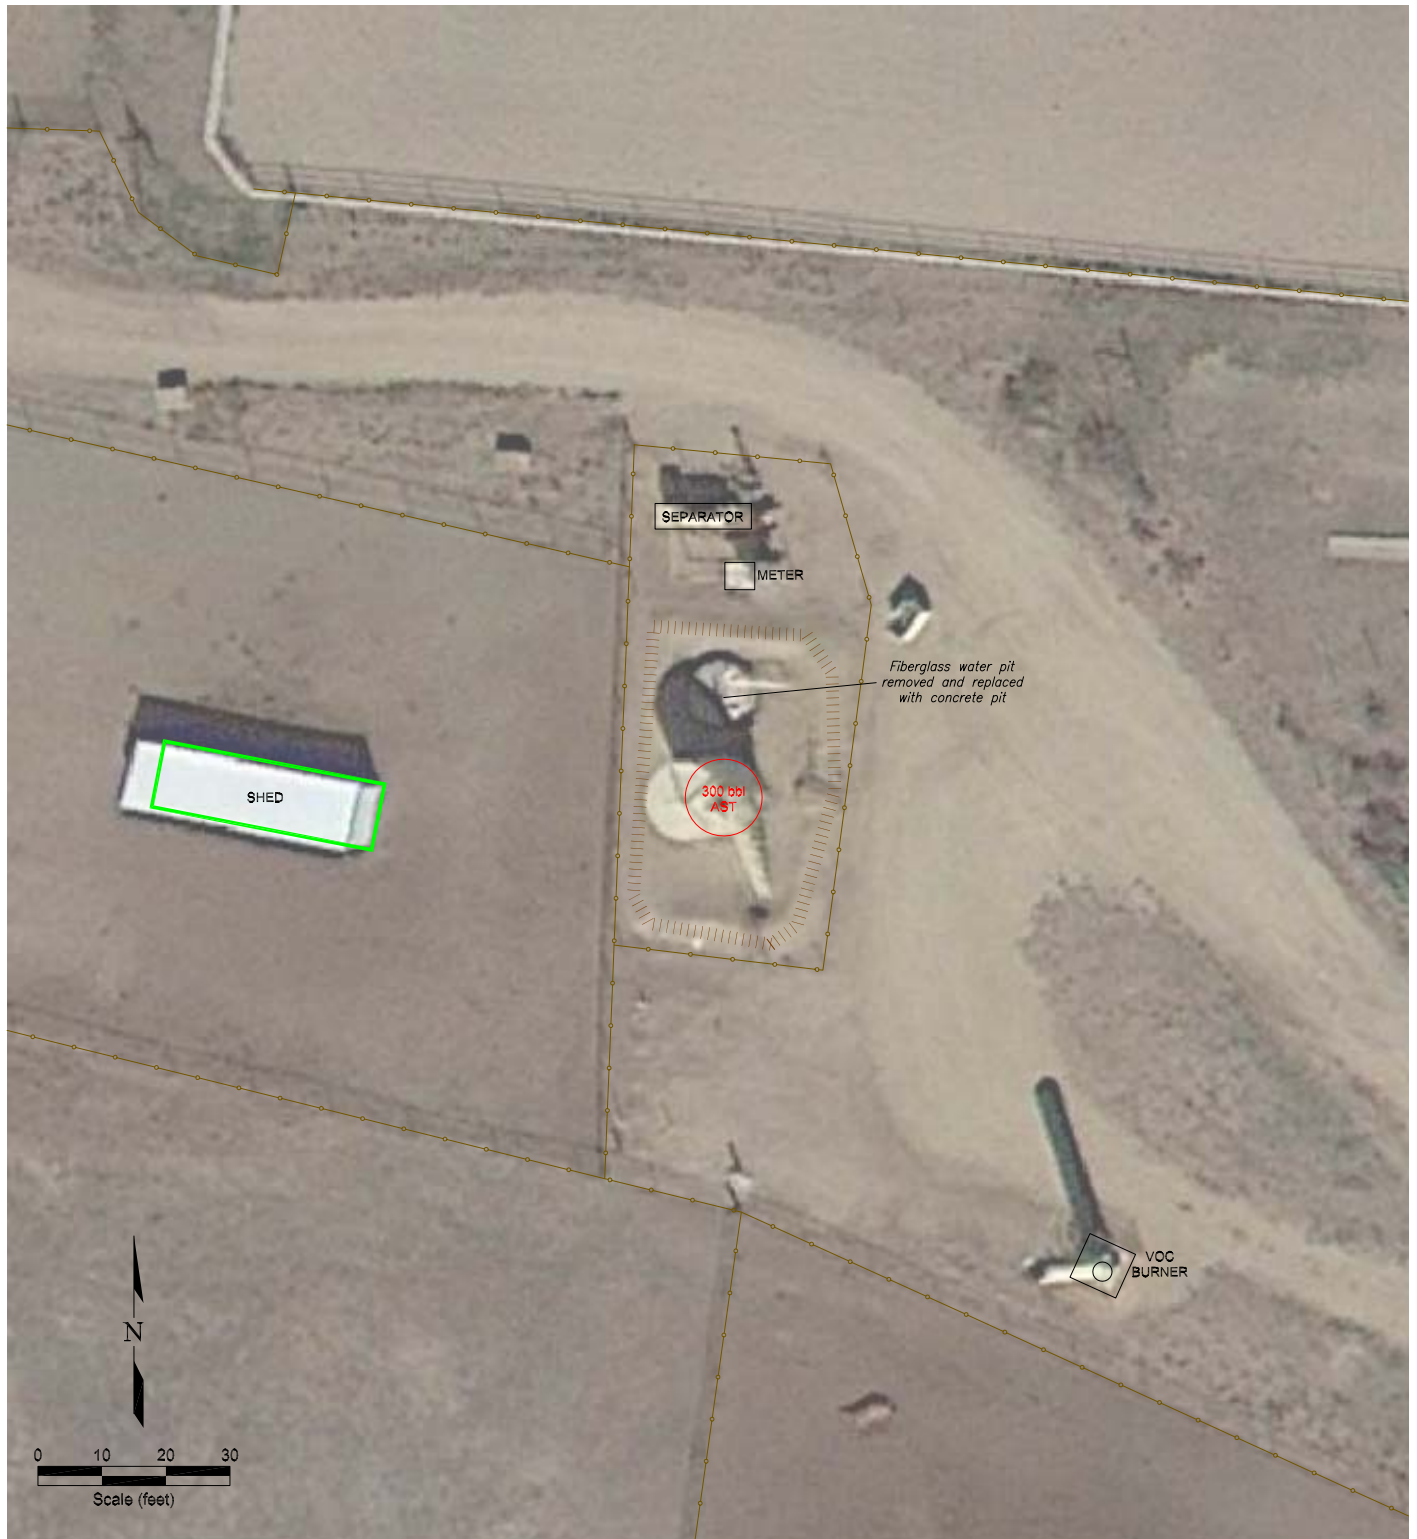
Figure 2

The site is a natural gas production and oil storage facility for the UPRC 1-12L, Hibbs #1 and Plutt P1-13 wells as shown on Figure 2, Site Map. These wells were drilled in 1992, 1974, and 2004, respectively. In July 2013, it was determined that the produced water concrete pit was unable to maintain its water level indicating a potential problem with the pit.

SITE MAP

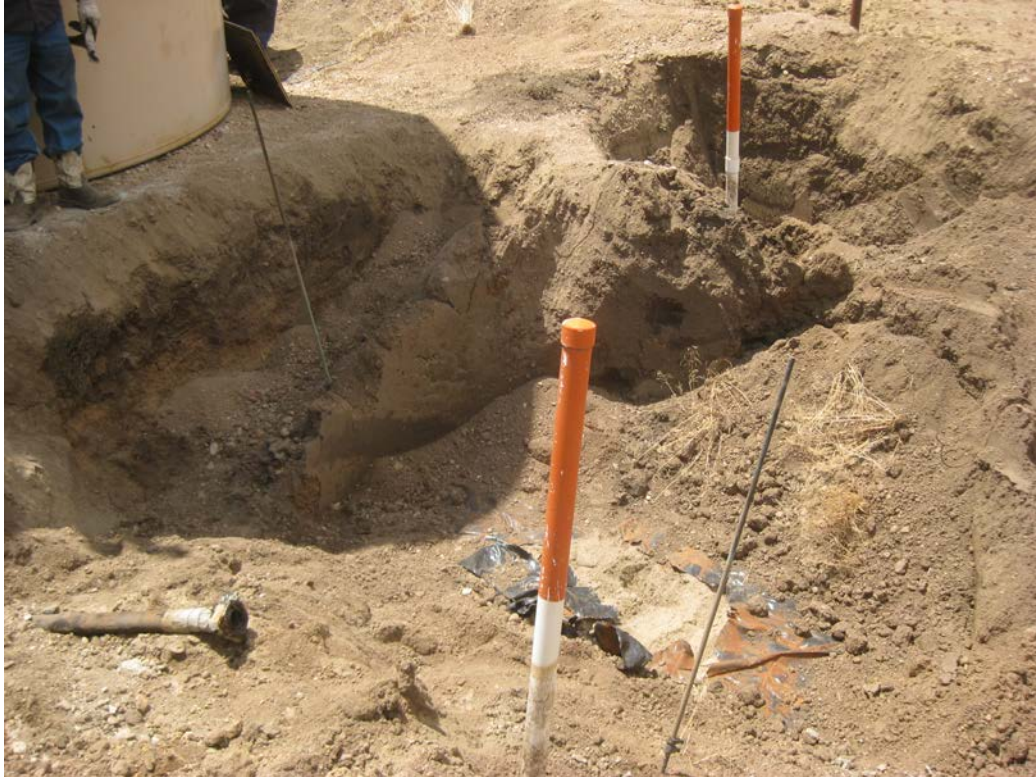
On July 31, 2013, a crew from Ramirez Trucking Services excavated the produced water pit immediately north of the oil storage tank at the site. The fiberglass water pit was removed and inspected for damage. No obvious indication of failure was observed. Regardless, the fiberglass pit was replaced with a new, concrete water pit. Photos of the pit excavation are provided.

Looking northwest at produced water pit excavation

The concrete pit was replaced by a new concrete pit at this same location and the facility was placed back in operation. Fremont personnel did not oversee that portion of the project.

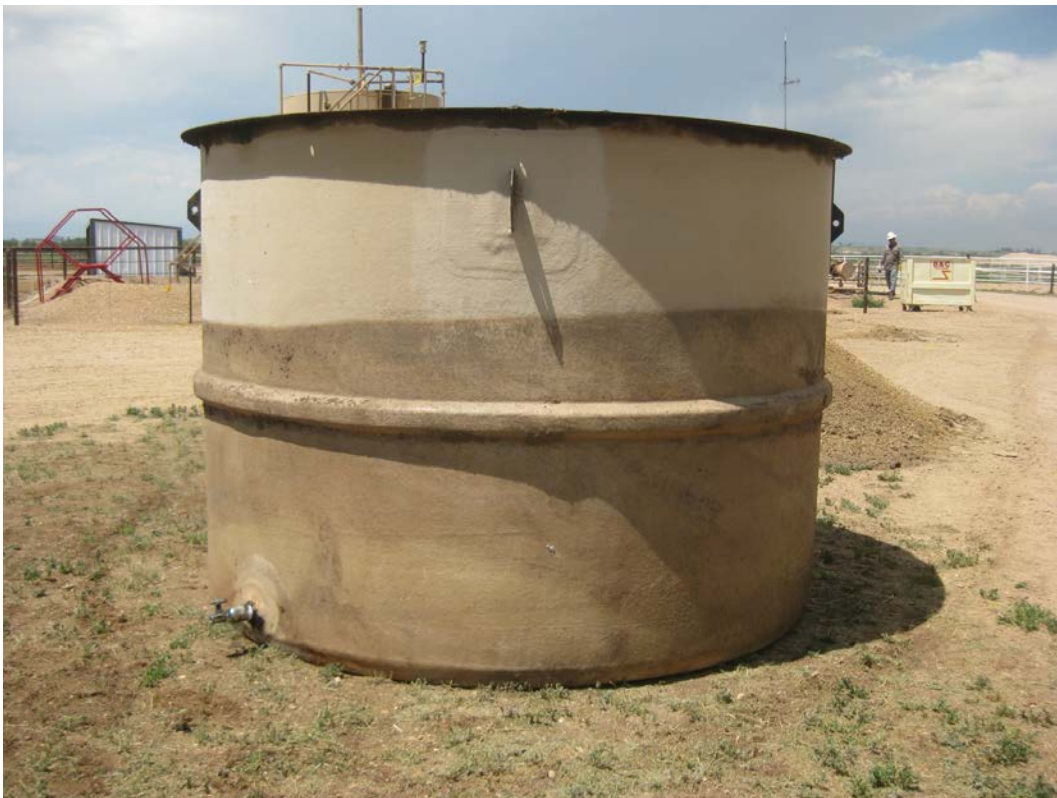
Fiberglass water pit after removal. No obvious indication of failure was noted.
