STATE OF
COLORADO

Re: Fw: Facility ID 334104 1K Pit Closure

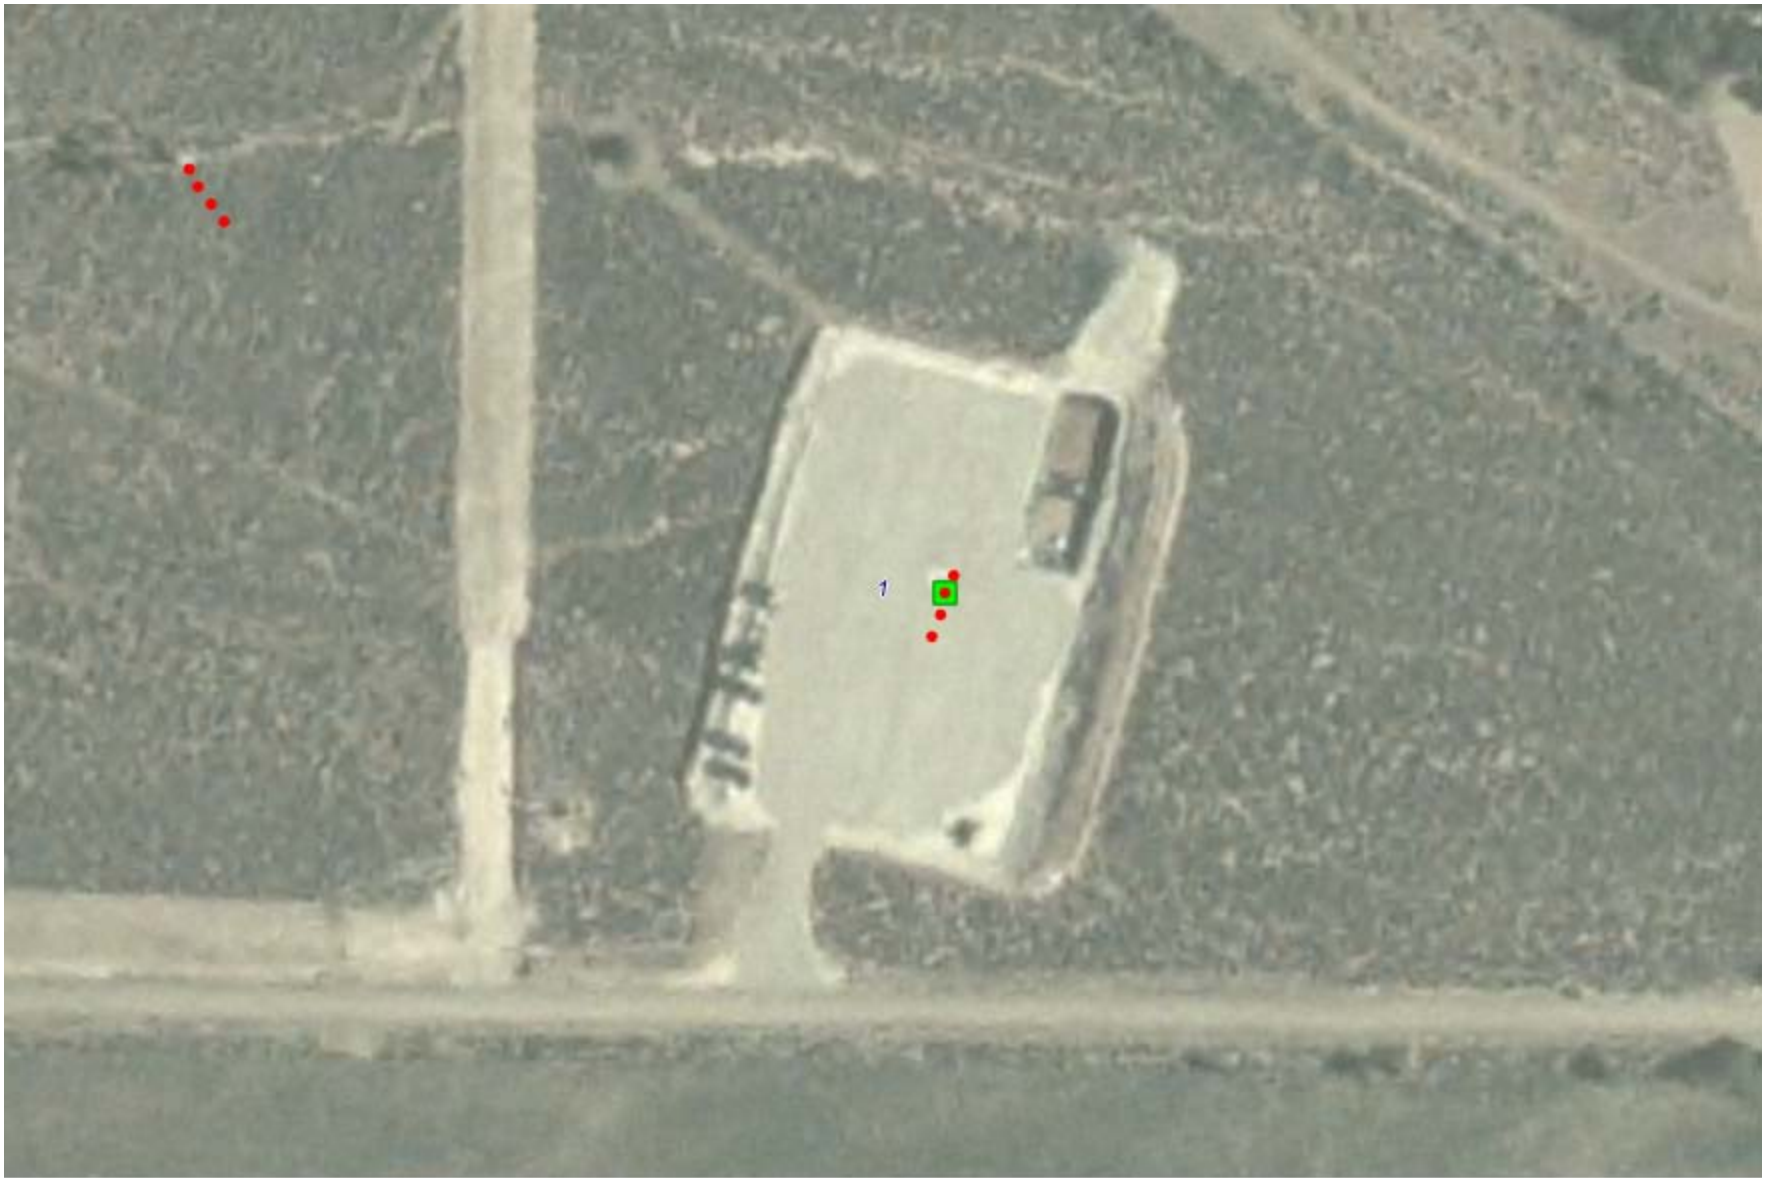
Noble 1K Pad. Location Facility ID # 334104.
Aerial photo 2005. Reserve Pit???

- There was originally a drilling pit (that did not required permit). This pit located on the northeast corner of the pad was backfilled sometime between 2005 and 2009, probably in 2009 before the aerial photo was taken (See attached Powerpoint presentation). Noble must have sampled the bottom of the reserve pit before backfilling it. If no impact was found, there was no need to notify COGCC, just keep investigation report on file. If impact had been found, Noble would have had to submit a Form 19, notifying COGCC of a release discovered during pit closure. I don't know if Noble did that investigation but I will concentrate on the production pit closure which, I believe, is the one you are submitting the form 27 for.

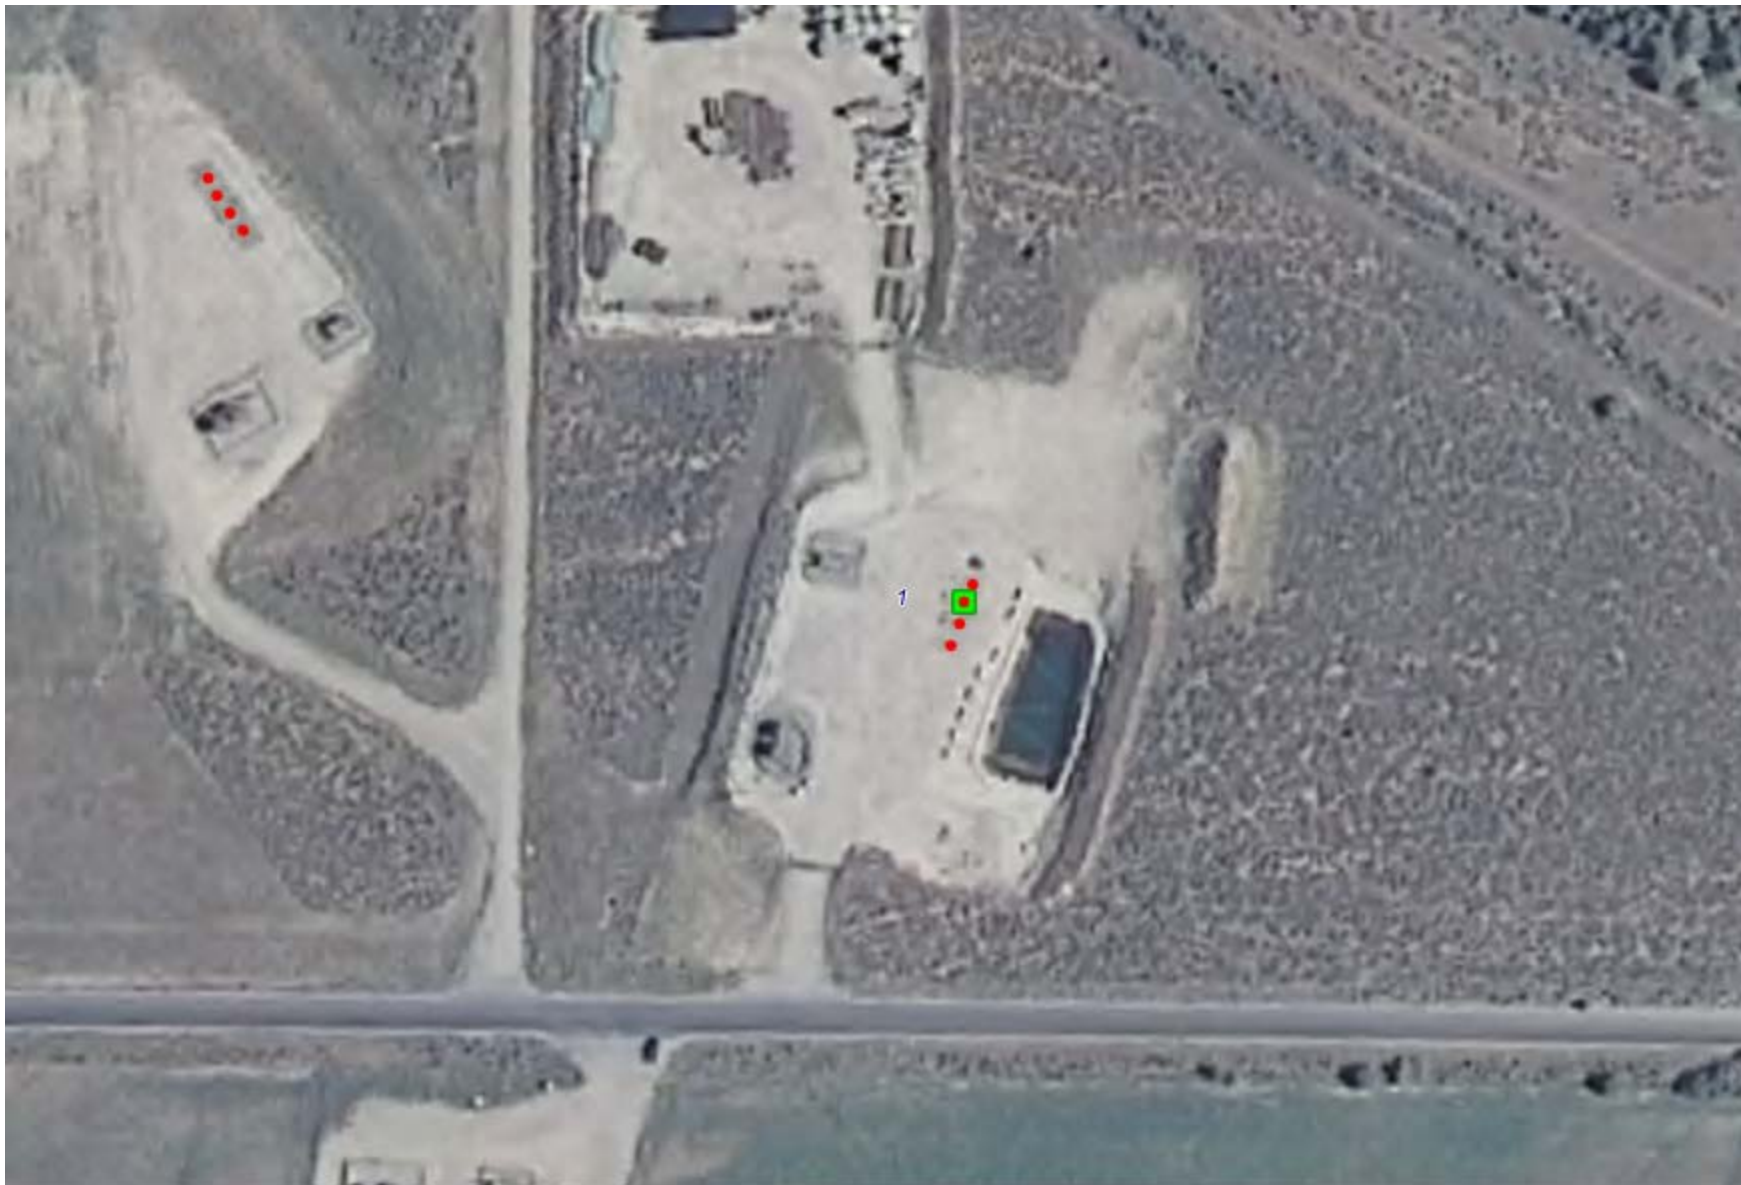
Noble 1K Pad. Location Facility ID # 334104.
Aerial photo 2009. Production Pit.

Please confirm that the pit you are closing is the production pit (southeast corner of pad). Please let me know if liner has been removed as one of the form 27 (the one attached to Olson's letter) says that the pit liner and the leak detection system were removed. Please clarify which pit has been backfilled. The same form 27 says that the water pit was backfilled in late 2009. Aerial photos from 2009 and 2011 show the drilling/reserve pit backfilled and the production pit active.

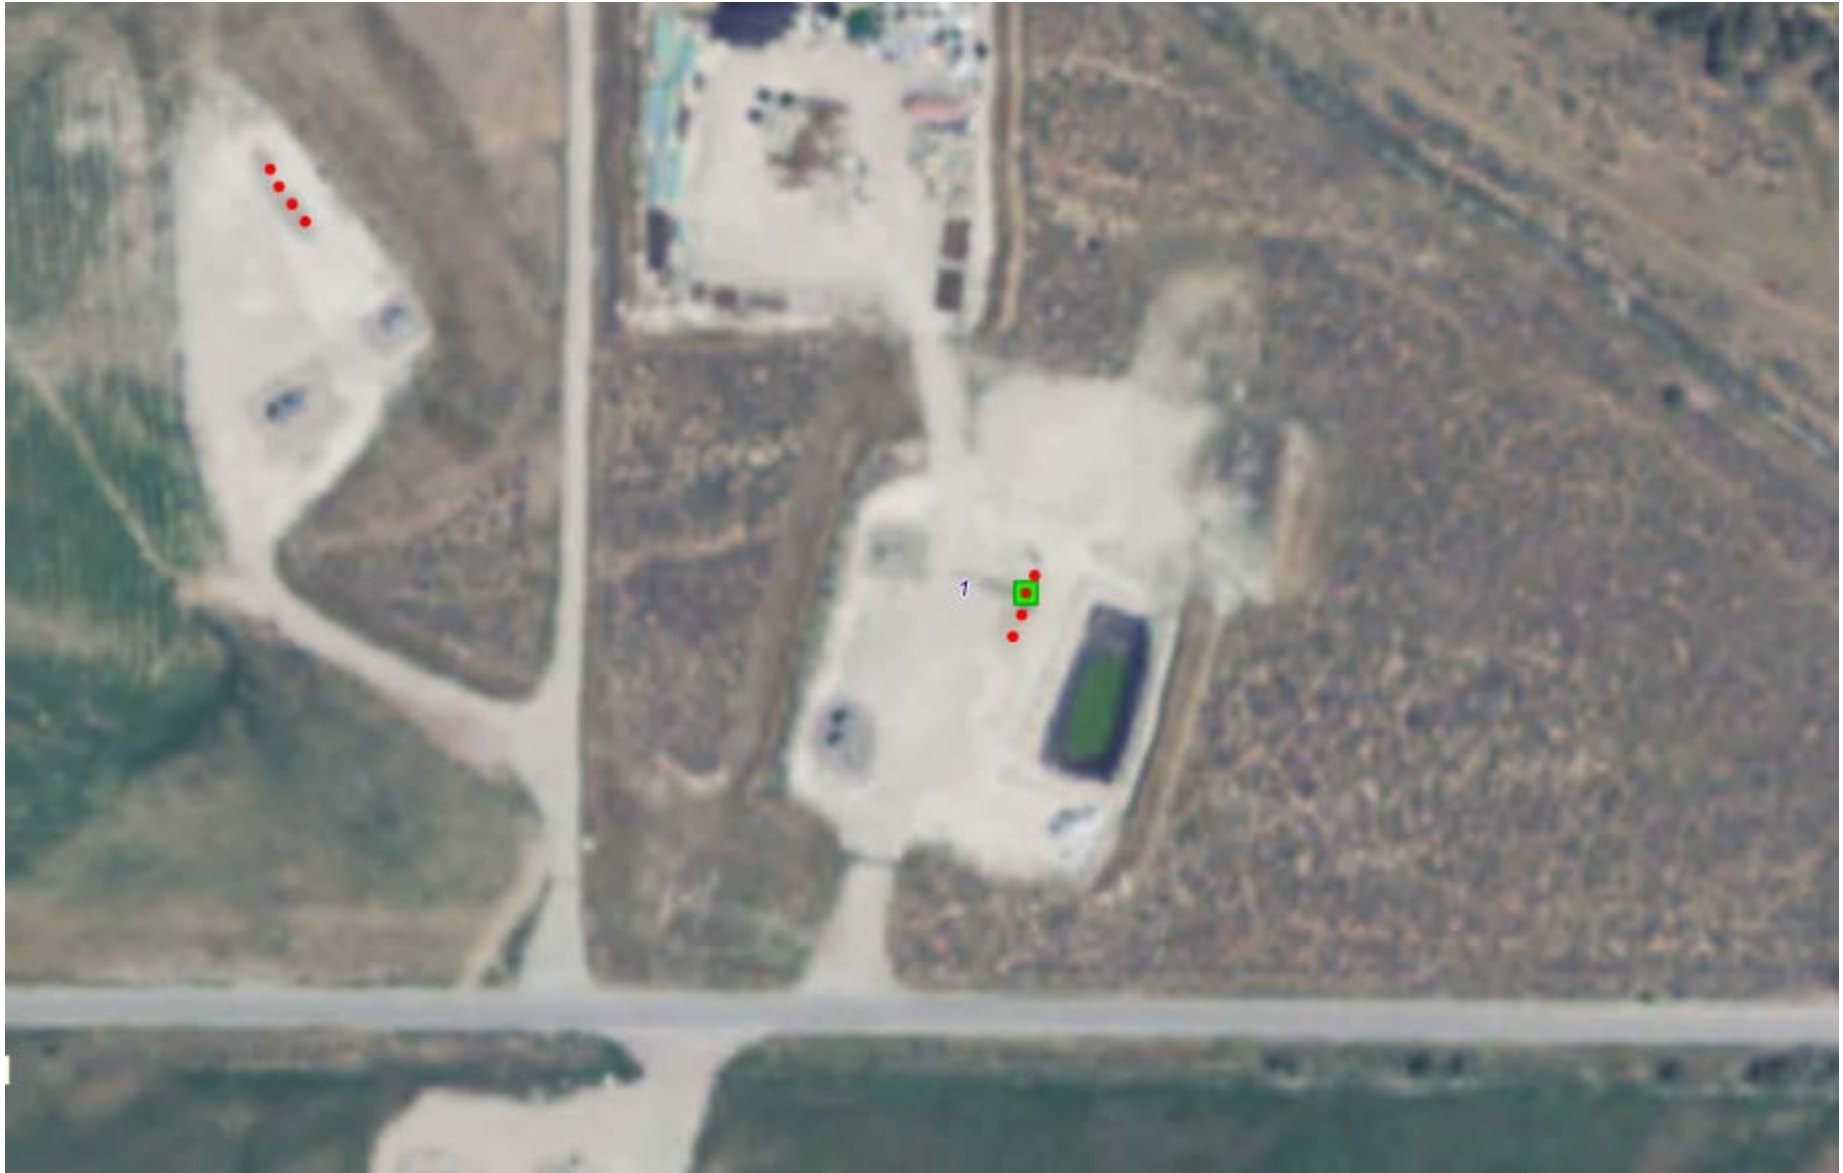
Noble 1K Pad. Location Facility ID # 334104.
Aerial photo 2011. Production Pit
