Reference Area Photographs

Site Assessment and Remediation Work Plan

Maralex

Roan Creek Evaporation Pit

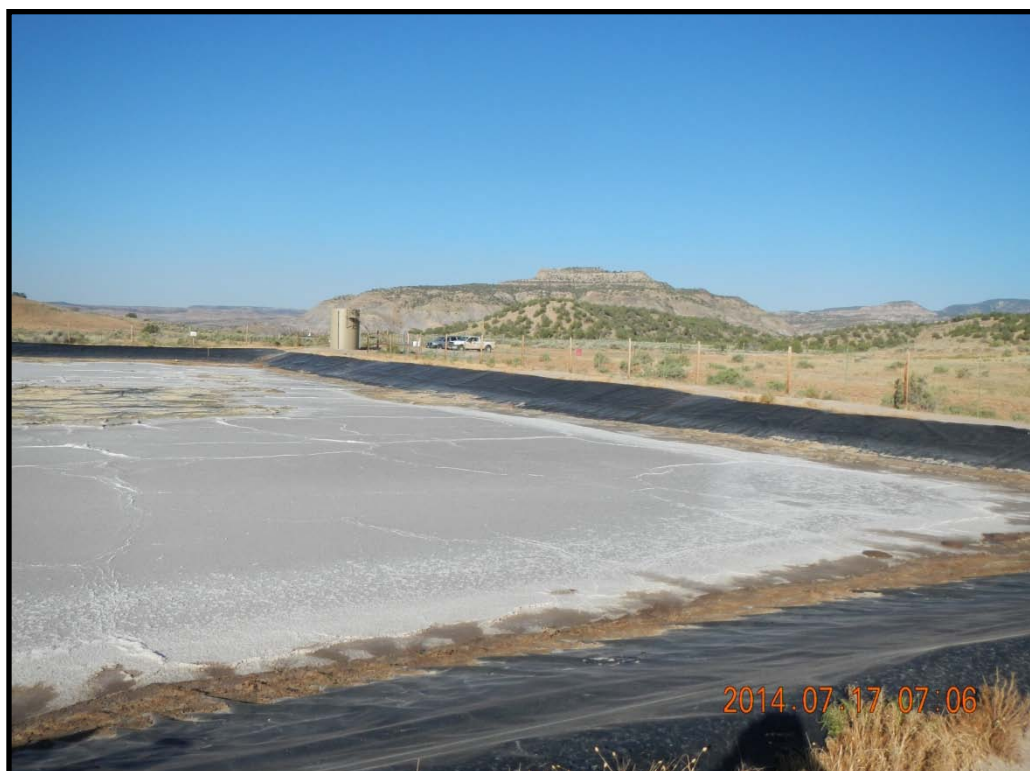
Dry pit. Sediments and salt cover most of the bottom of the pit. Bushes have been removed from around the pit but there is still some vegetation growing right on the border of the pit.

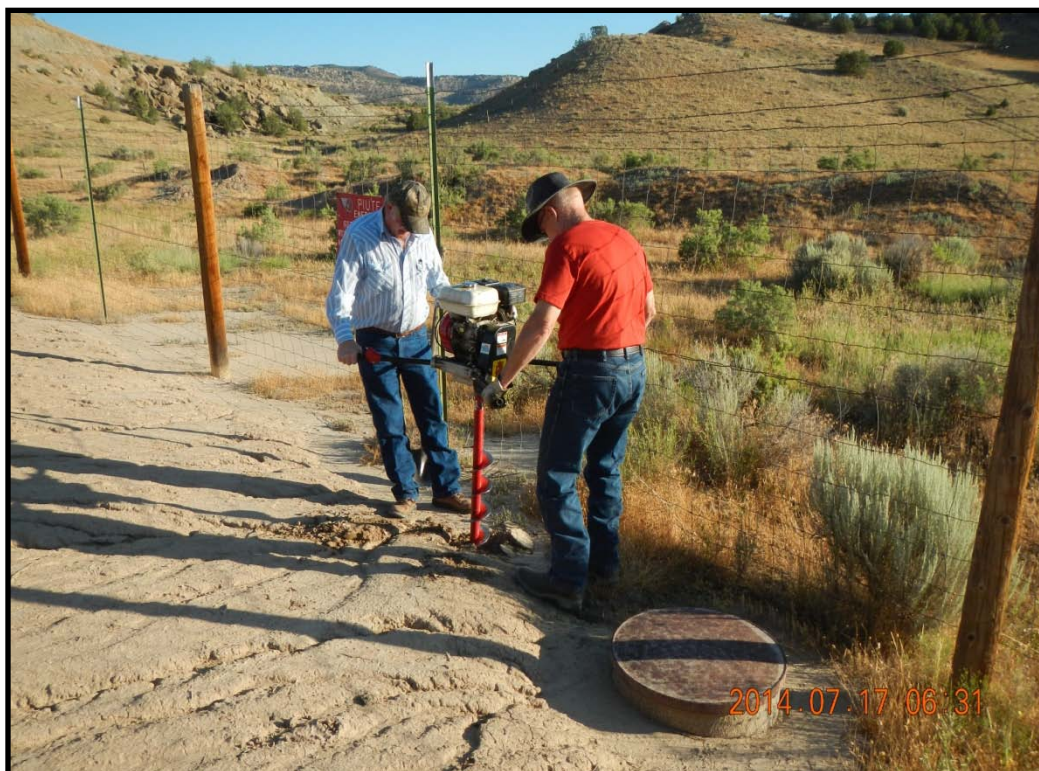
Drilling to take a sample near the sump

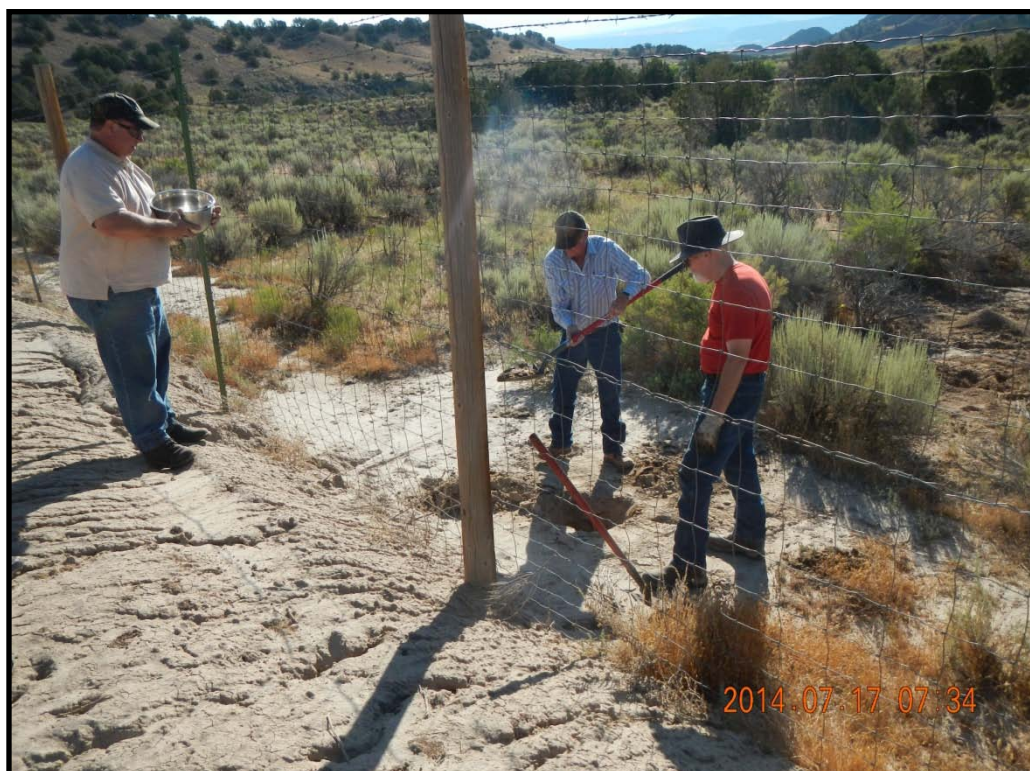
Sampling outside of the fence on the Southeast area. Sampling was done where sediment from the pit perimeter was observed.

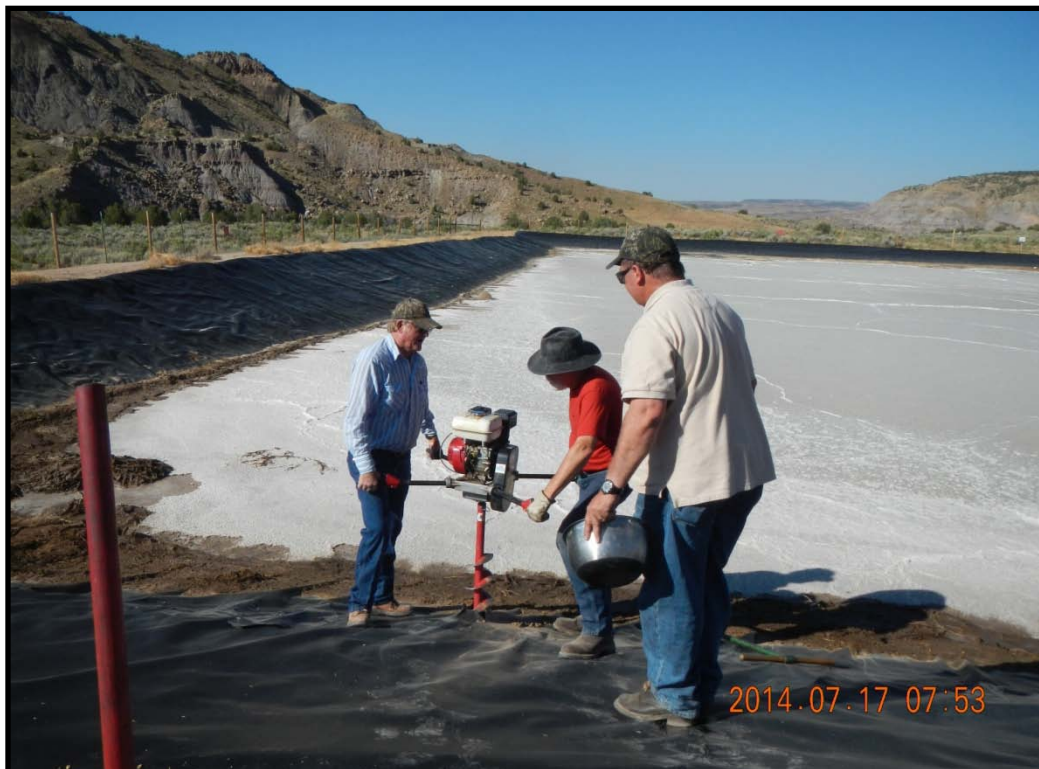
Drilling on the East side of the pit. Sampling was done at selected patch locations, near the bottom of the pit. Samples from 5 locations were collected along the East side of the pit.

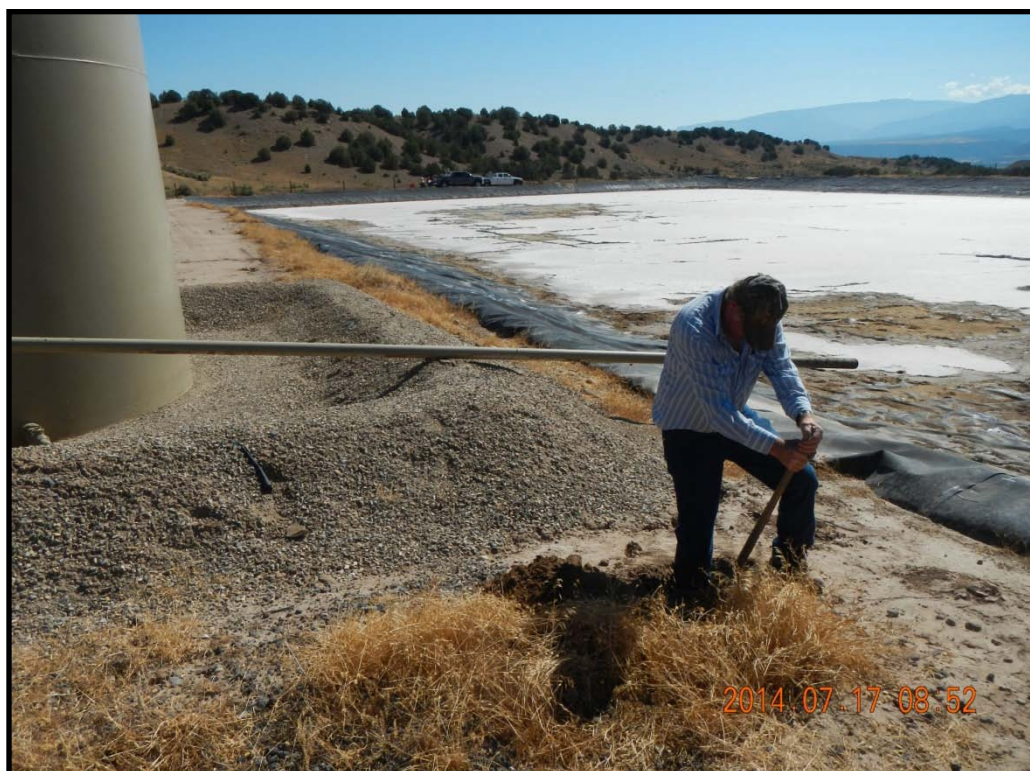
Last sample was collected from a point between the tank and the pit (Northwest corner of the pit).
