CM PRODUCTION, LLC
RICE LEASE ENVIRONMENTAL ASSESSMENT REPORT

COGCC REMEDIATION PROJECT NUMBERS
8444, 8461, AND 8517
CLIFF UNIT, LOGAN COUNTY, COLORADO

September 2014

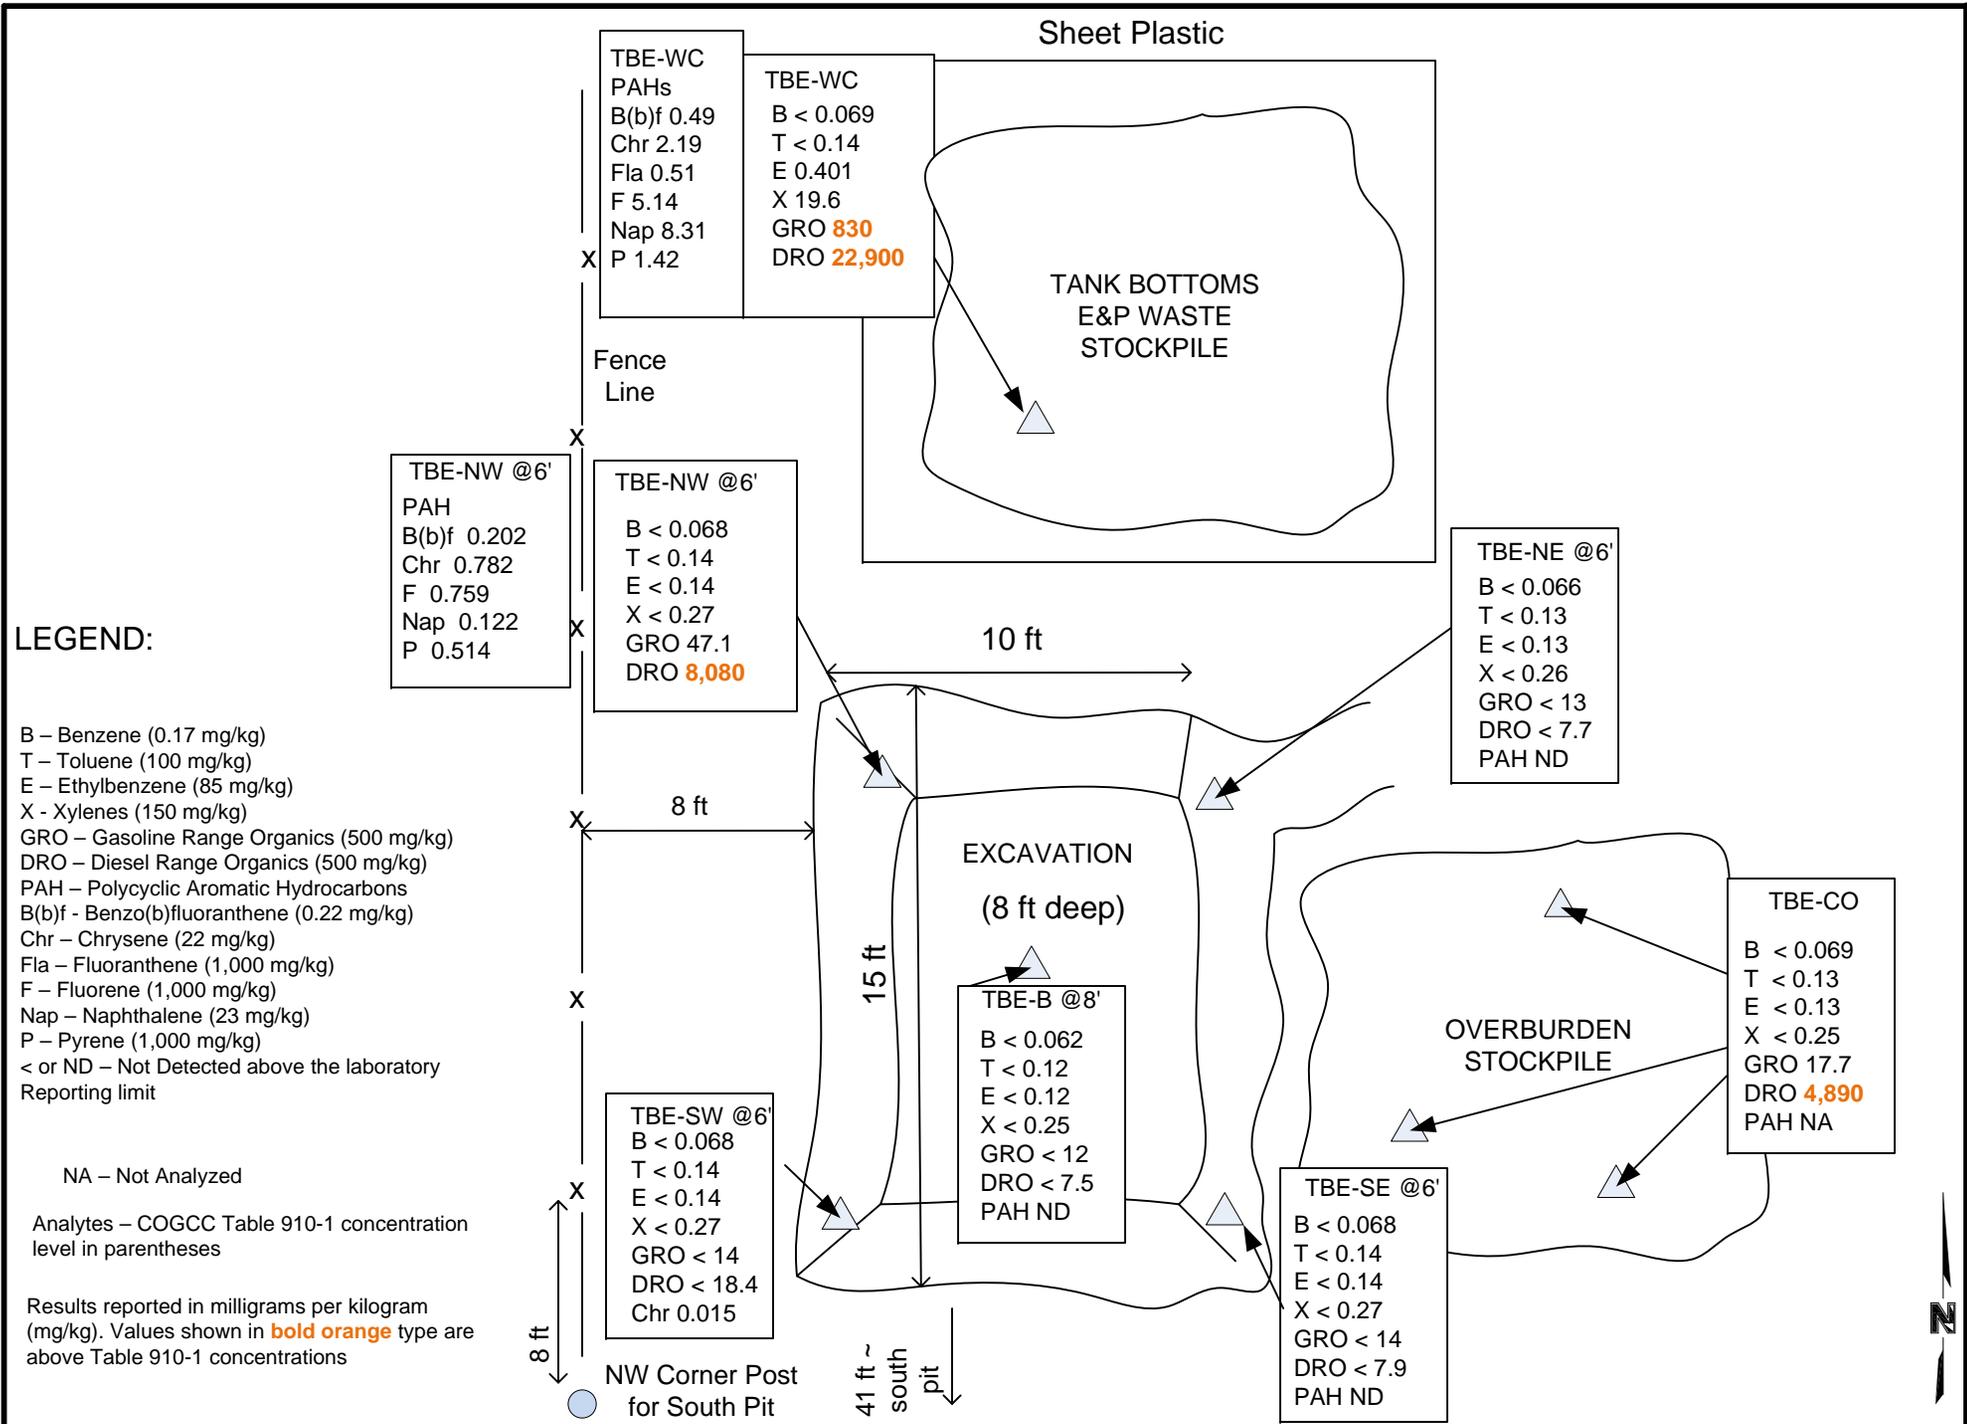
CM Production, LLC
 Organic Compounds in Soil
 Cliff Unit – Rice Lease Tank Bottoms Excavation
 Logan County, Colorado

Analytes – COGCC Table 910-1 concentration level in parentheses

Results reported in milligrams per kilogram (mg/kg). Values shown in **orange** type are above COGCC Table 910-1 concentrations

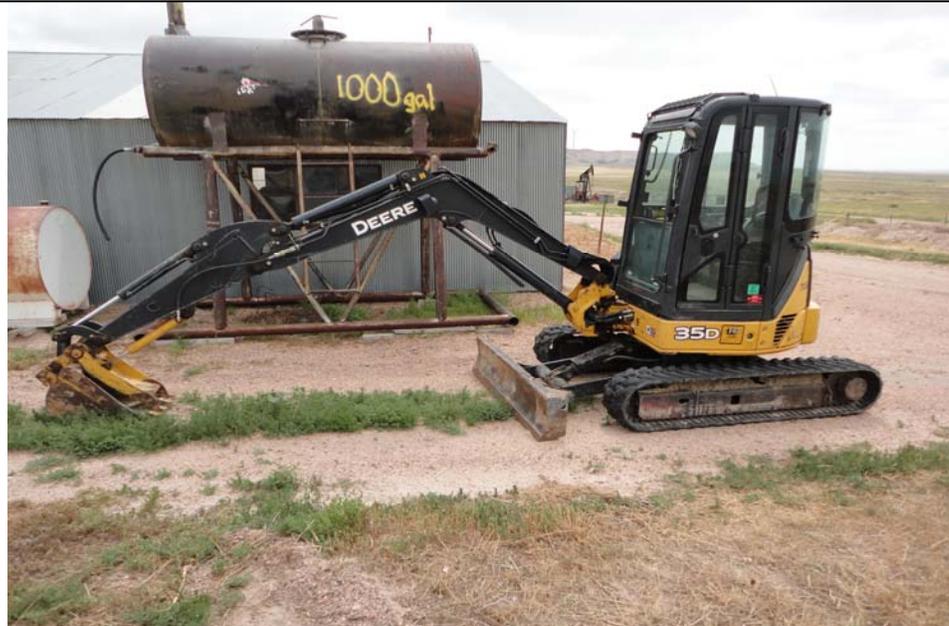
Subject: A John Deere 35D Was used to excavate the tank bottoms oily waste from an area northwest of the south produced water pit.

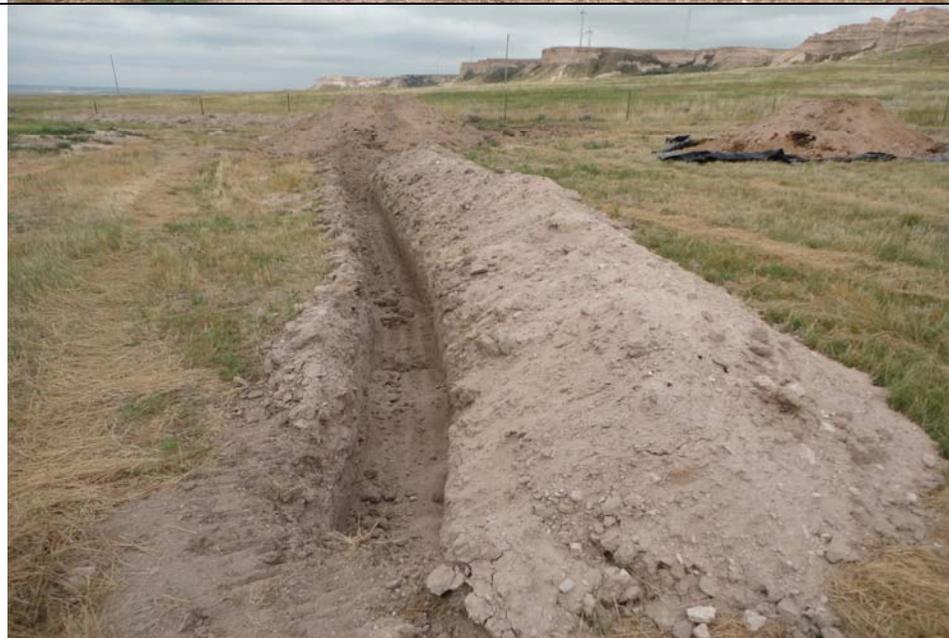
Subject: A trench was excavated around the perimeter of the south produced water pit, oily waste excavation. Impacted soils and E&P waste removed from the excavation were placed on plastic.

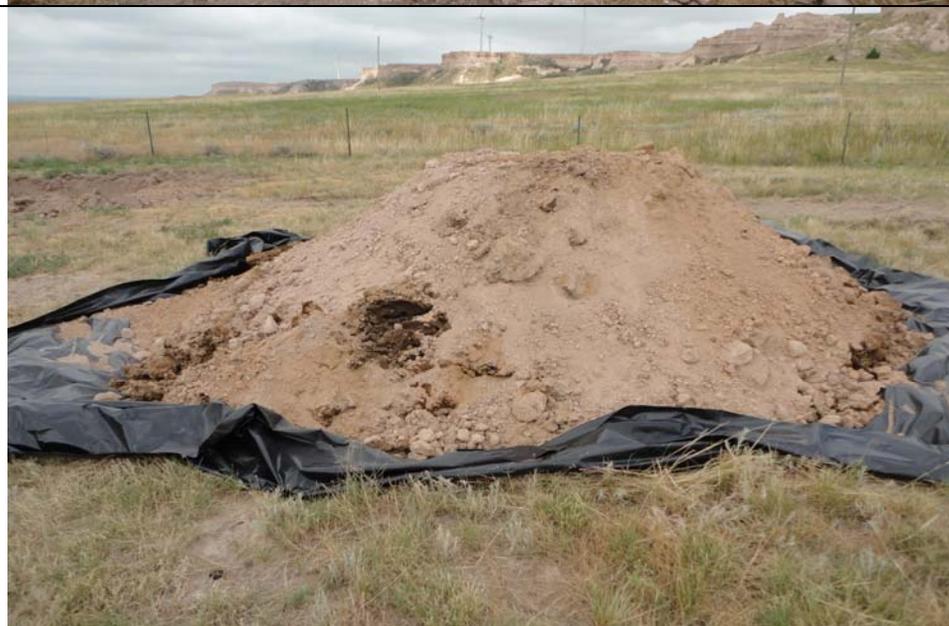
Subject: Impacted soils and E&P oily wastes/tank bottoms were placed on plastic.

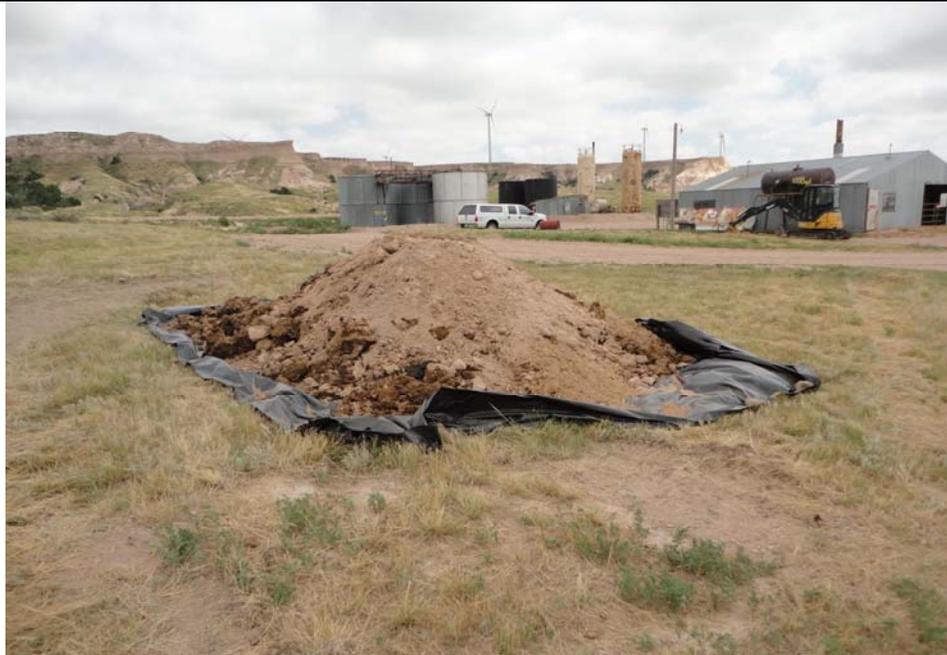
Subject: Impacted soils and E&P tank bottoms oily wastes were stockpiled on plastic. Approximately 10 cubic yards of impacted materials were estimated to have been removed.

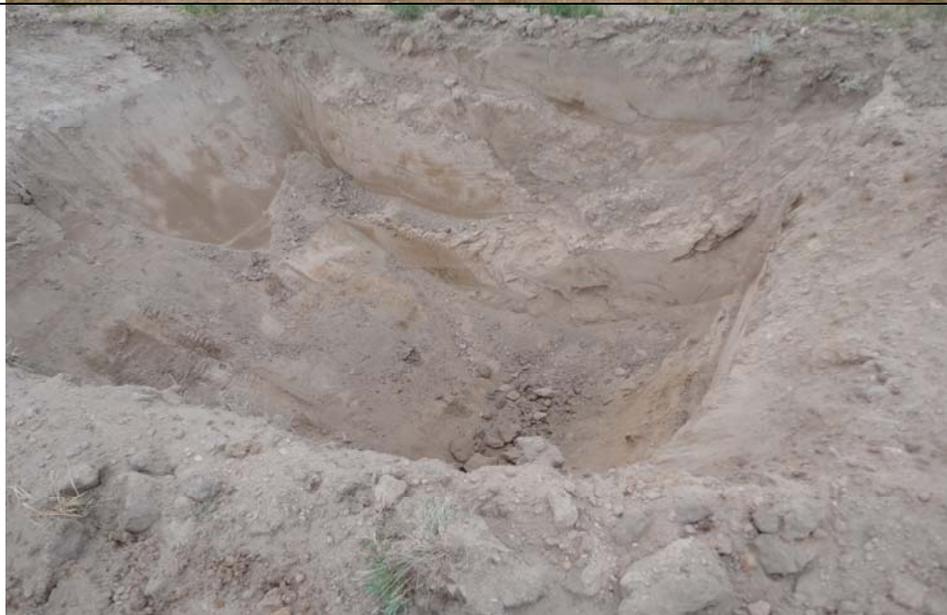
Subject: Photograph shows the excavation for the tank bottom wastes. The excavation measured approximately 10 feet wide by 15 feet in length and was approximately 8 feet deep.

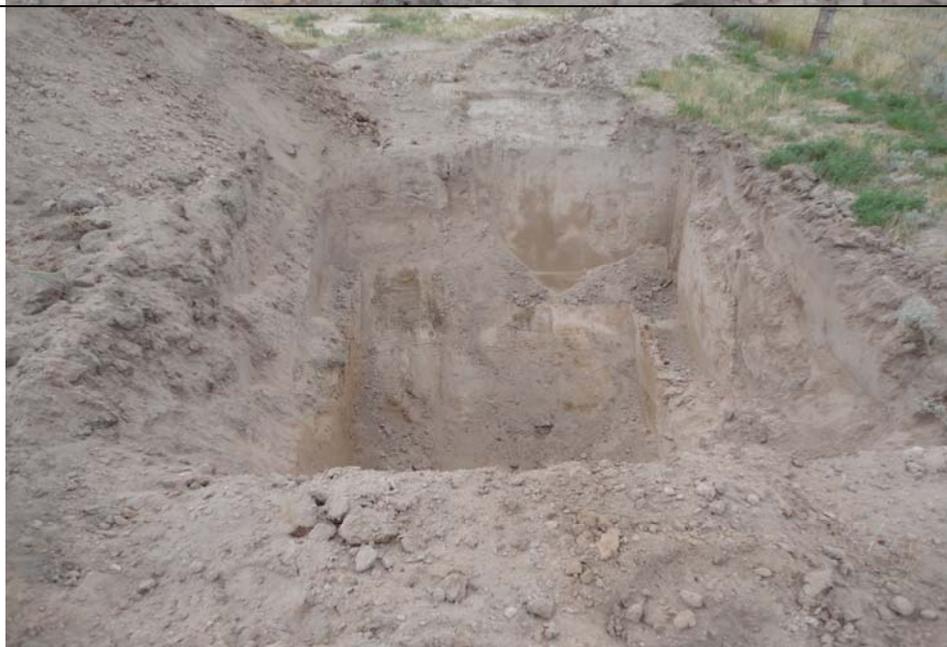
Subject: The excavation for the tank bottom wastes did not exhibit any apparent staining.

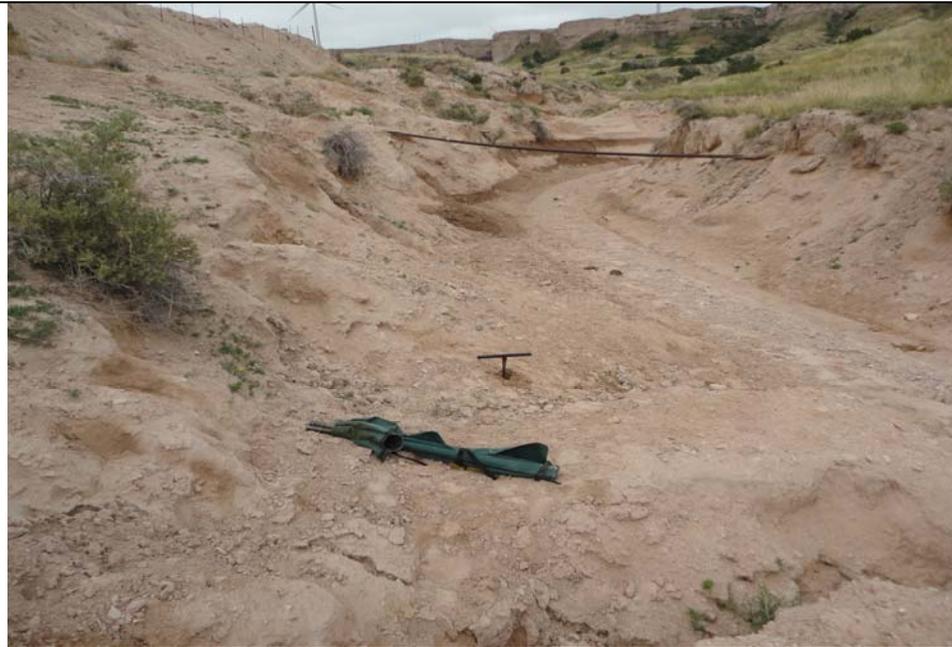
Moisture was observed as “seepage” on both the east and west banks of the drainage. The location of PZ-1 was selected at a point south of the gathering pipeline crossing where moisture was observed in the soil and rock outcrop. According to CM Production personnel, there had been a lot of rain prior to the field assessment, and the grasses around the site were green, when normally at this time in July they would have dried out and browned.

Subject: Photograph shows the location of hand auger hole for piezometer, PZ-1, looking up the main drainage from the southeast corner of the southeast pit. Moisture was observed along both banks of the drainage.

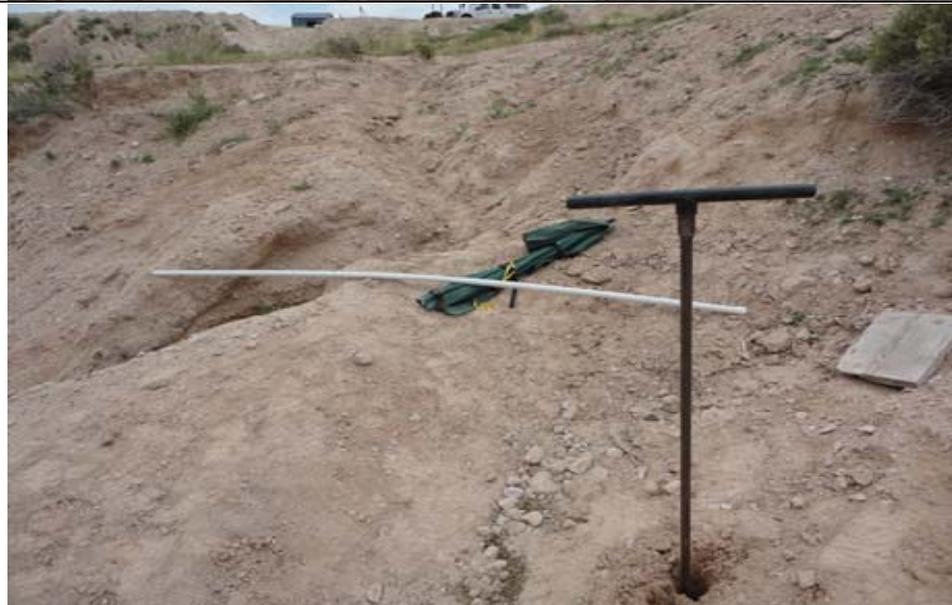
Subject: Photograph shows the location of the hand auger hole and 1" diameter by ten feet PVC casing for piezometer, PZ-1.

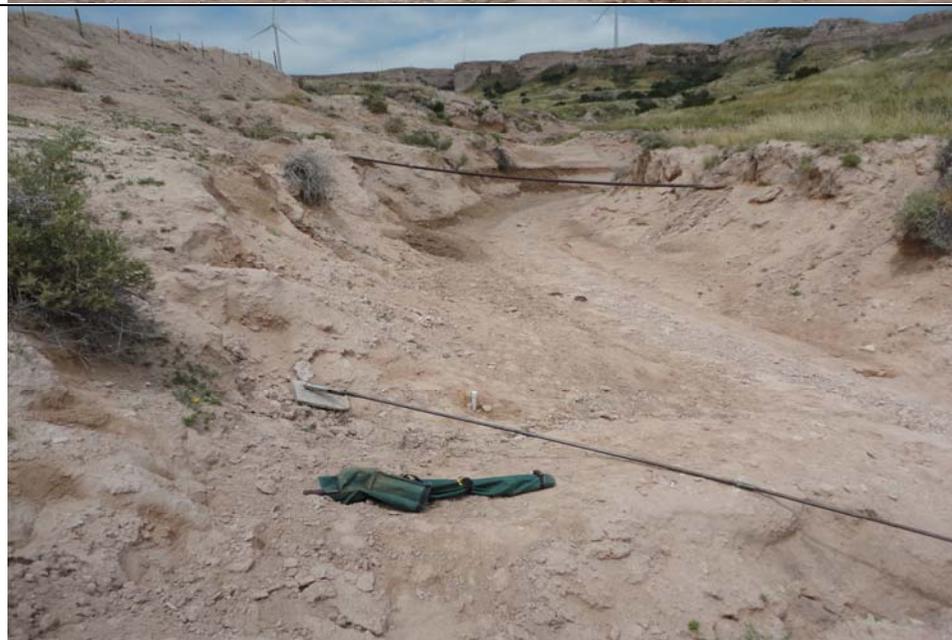
Subject: Photograph shows the piezometer, PZ-1, and hand auger after being set and the elevation above the base of the drainage. The piezometer remained dry during the site visit.

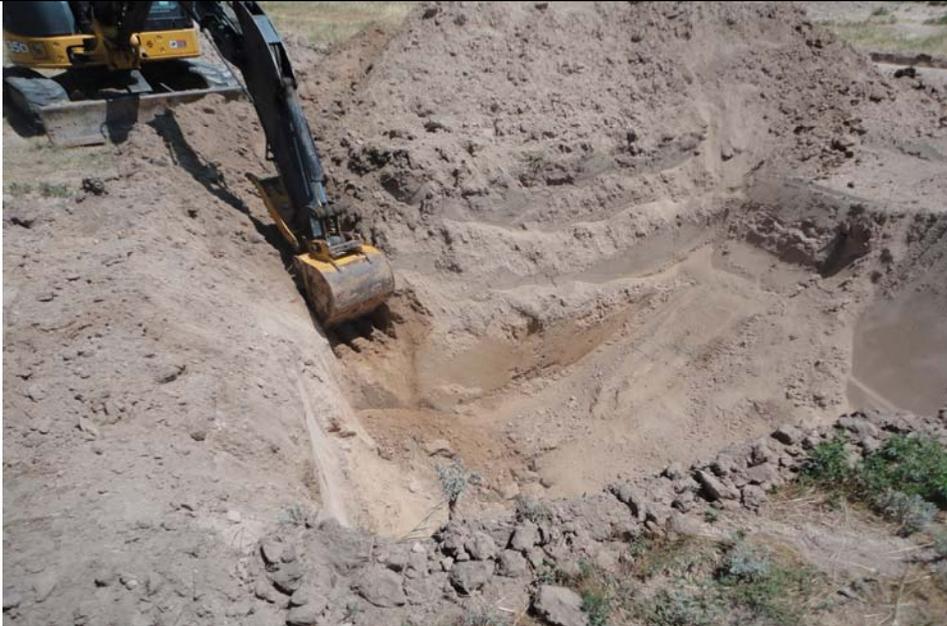
Subject: The excavator was used to collect soil samples from the side walls and base of the tank bottom waste excavation.

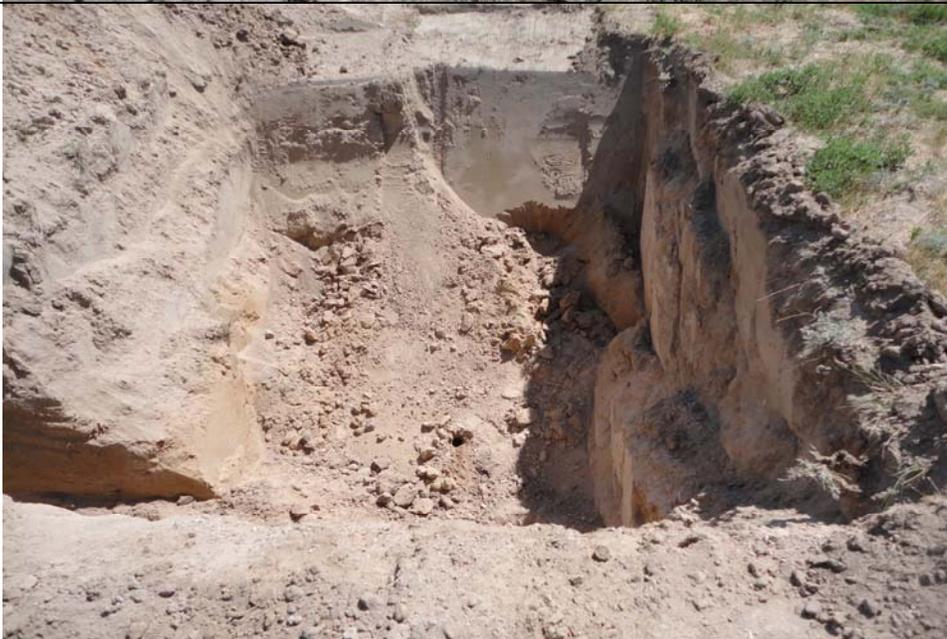
Subject: Photograph shows the location of the sampling points in the tank bottom oily waste excavation.

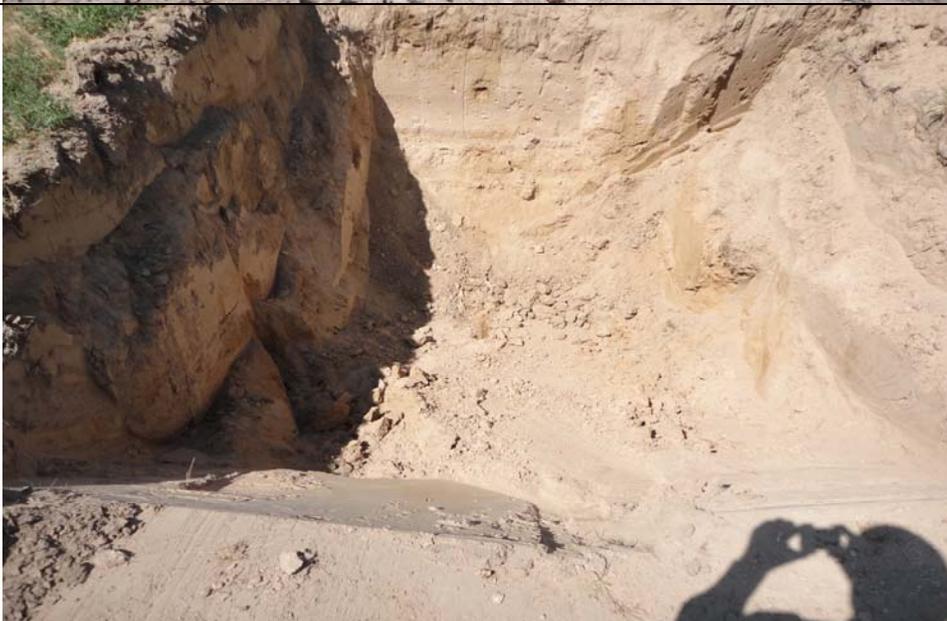
Subject: Photograph shows the location of the sampling points in the tank bottom oily waste excavation. No apparent staining was observed in the sidewalls or the base of the excavation and excavated soils did not exhibit any odor.

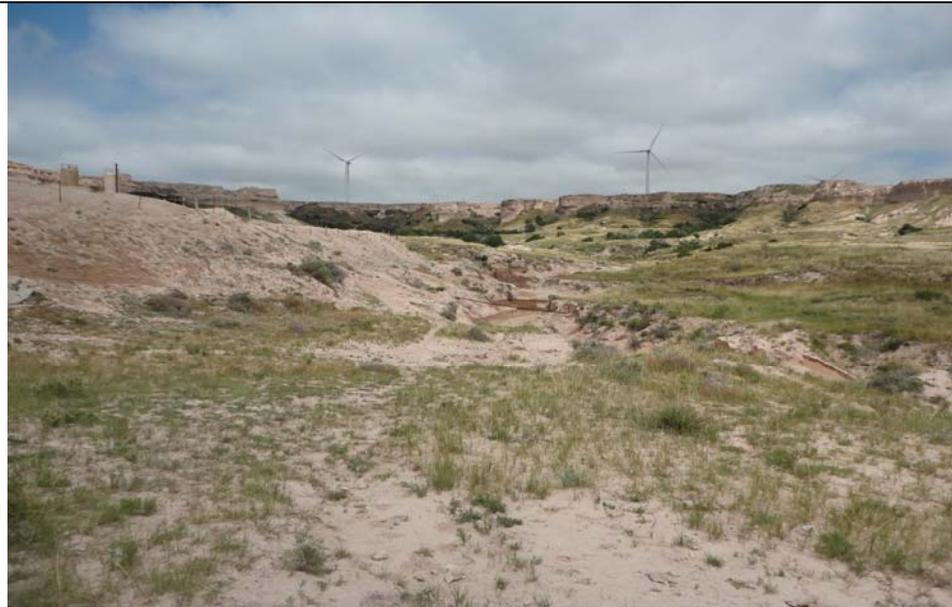
Subject: Photograph shows the main drainage from the bench near the Rice #2 well and the southeast pit.

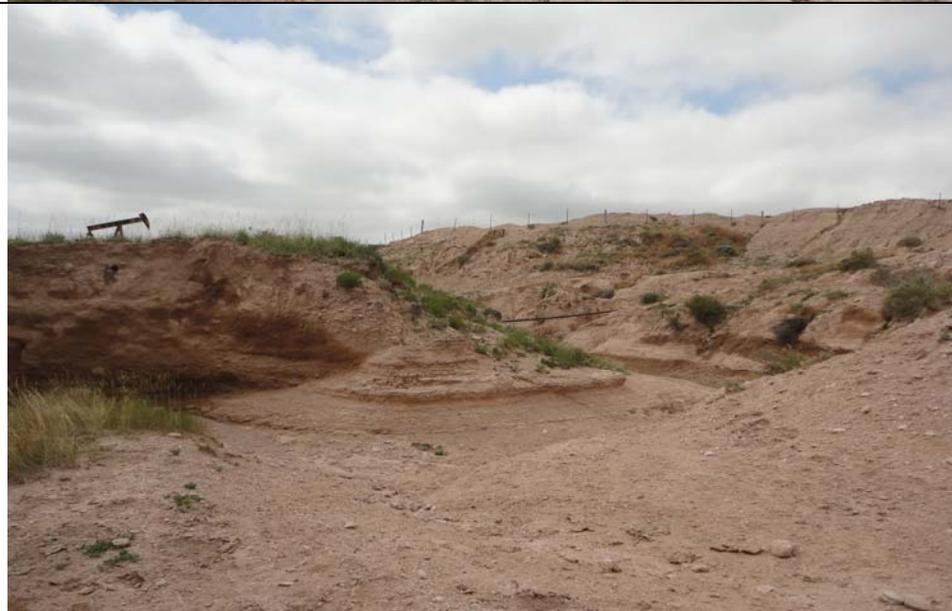
The elevated TDS and chloride impacts to soils and water in the drainage may be the result of historic produced water discharge to the drainage. Moisture seeping through the bedrock and soils was observed on both sides of the drainage as shown in the middle photograph on page B5 of Appendix B. This appears to be the result of recent rainfall and not seepage from the pits. The same wet soil and bedrock were observed in the ephemeral drainage to the north of the north pit indicating that the ephemeral drainage was wet due to recent precipitation runoff.

Subject: Moisture was observed in the banks on both sides of the drainage. The pits are shown on the right side of the photograph. Moisture is shown seeping on the east side of the drainage on the left side of the photograph. The Rice #2 oil well is shown at the center left.

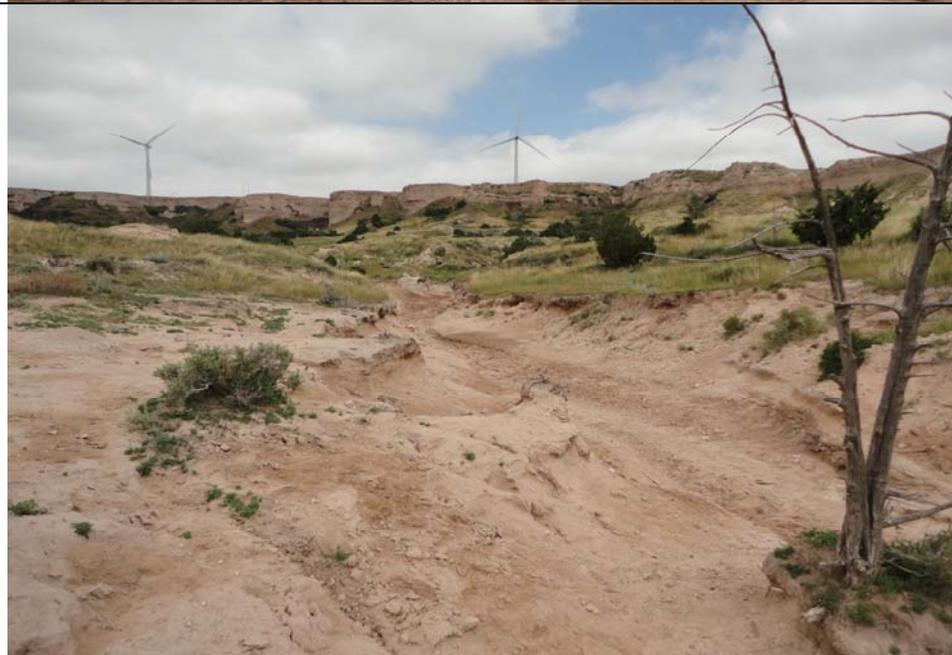
Subject: Photograph shows vegetation along the drainage near the north pit.

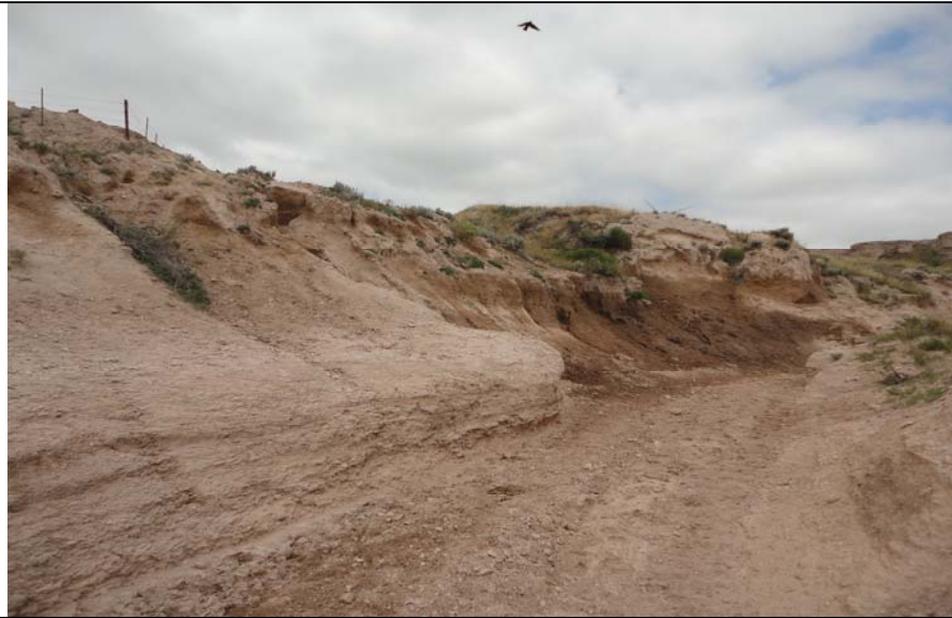
Subject: Moisture was observed in the banks along both sides of the main drainage near the north end of the southeast pit.

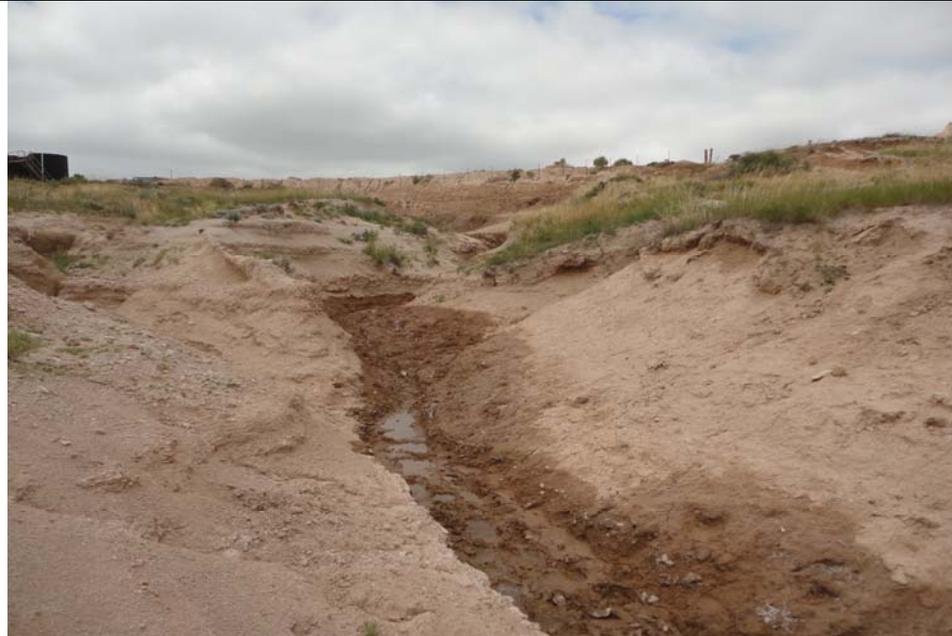
Olsson observed the presence of standing water in the side drainage down from the northeast corner of the north pit where the side drainage joined the main drainage. A grab sample of the surface water was collected (water sample NPD-SW) and submitted for laboratory analysis of the COGCC Table 910-1 inorganic water quality parameters and included:

Subject: Moisture and standing water was observed in a side drainage down from the north pit.

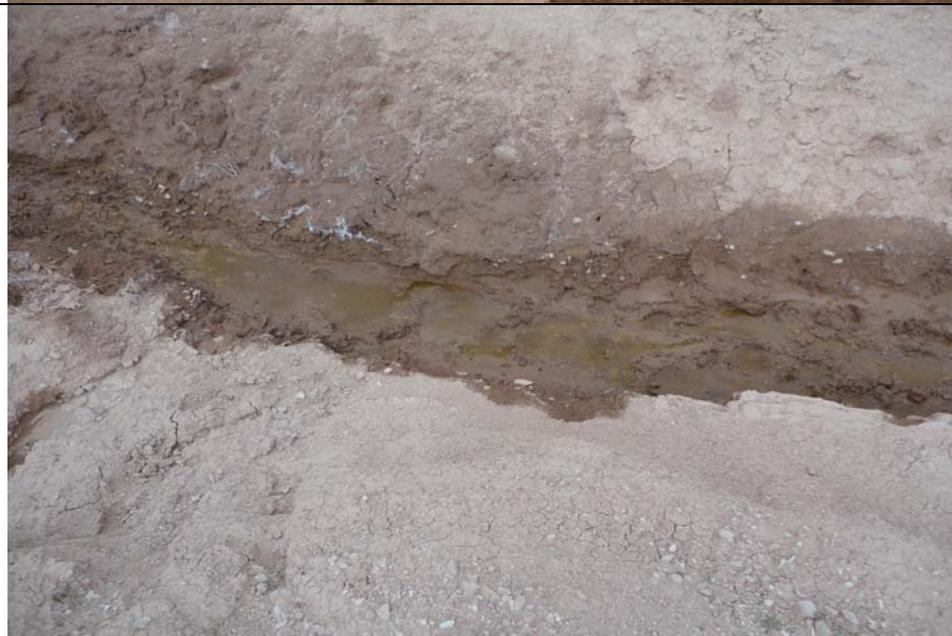
Subject: A grab water sample was collected from the water in the side drainage down from the north pit near where it met the main drainage. There was no apparent sheen on the water or odor.

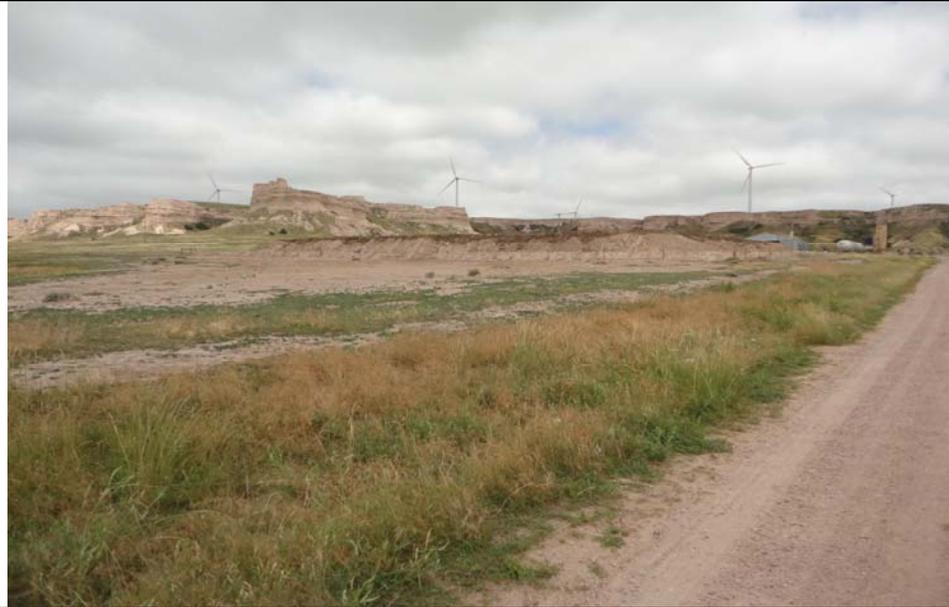
An area that was observed to be lacking vegetation, as compared to the surrounding areas, is located on the south side of the south pit. The COGCC collected a soil sample from this area that had a SAR result of 130 during the January 14, 2014 inspection.

Subject: An area lacking vegetation was observed on the south side of the south pit.

Once the area has been prepared as a seed bed, the area should be resampled to show that the SAR levels are less than 12, and then the area should be seeded using a mixture of blue grama, western wheatgrass, buffalo grass, sand drop seed, winterfat (white sage), and fourwing saltbush as described in the Logan County Colorado Soil Survey. Addition of a bulking agent such as crimping straw or hay may also help with retention of moisture and drainage.

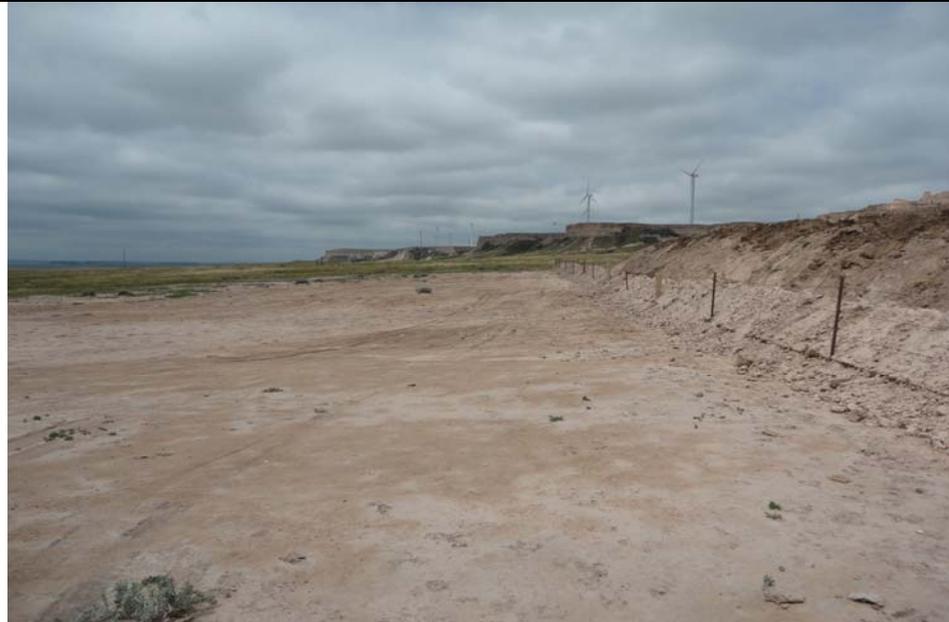
Subject: Photograph shows the area south of the south pit that lacks vegetation. Four surface soil samples were collected from this area and submitted for analysis of sodium adsorption ratio (SAR) to assess historical produced water impacts.

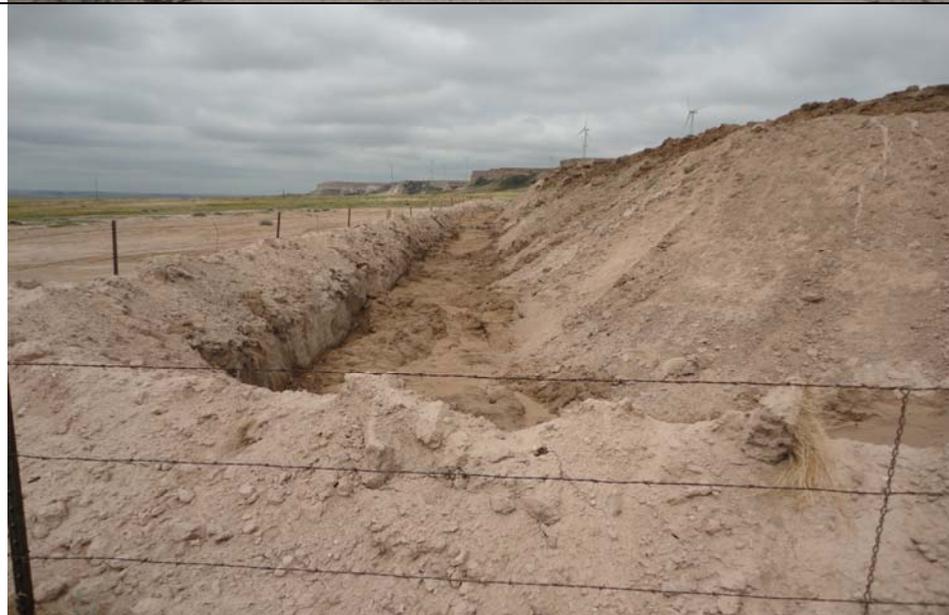
Subject: A trench and berm were constructed along the perimeter of the south pit to contain produced water during the repairs to the south berm.

CM Production has since re-constructed the south berm and constructed a perimeter containment ditch to capture any produced water that might be released during the repairs to the inside of the south pit berm.
