Subject: Lynch 34-6-18 #1 Well Pad Wetland Investigation

Catamount Energy Partners
Lynch 34-6-18 #1
Wetland Investigation

Lynch 34-6-18 #1
La Plata County, CO

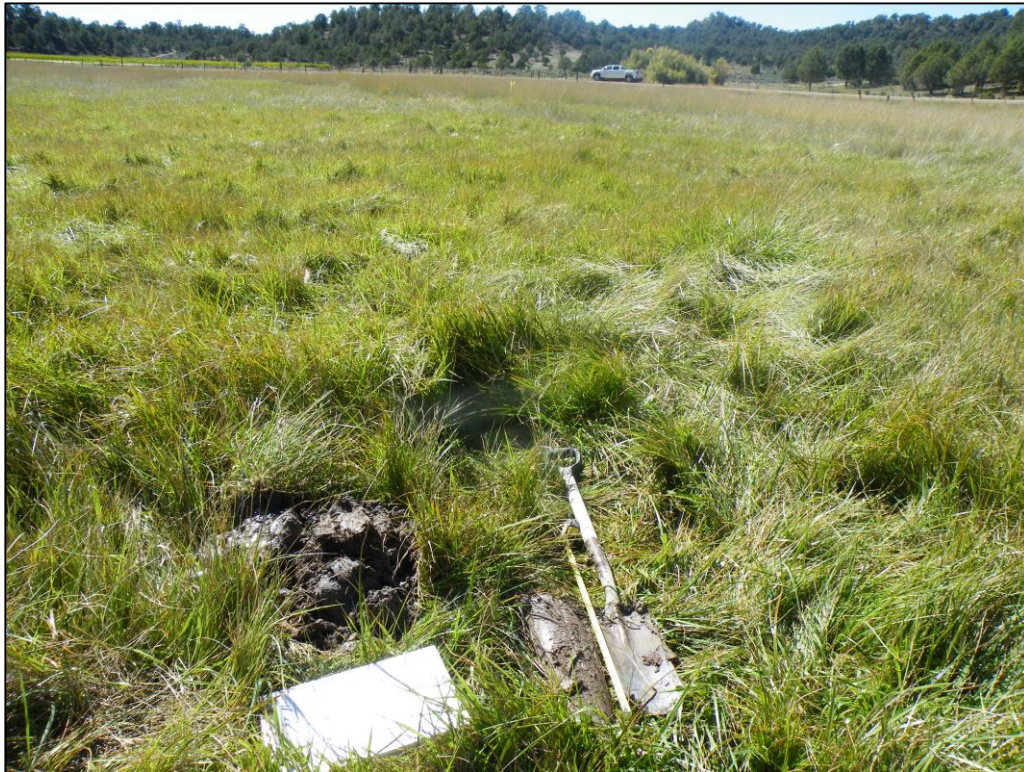
I investigated the well pad for establishing stormwater controls on 2 October 2014. At that time I noted small areas of hydric vegetative species along the eastern edge of the well pad boundary, near to a drainage ditch outward of that boundary. Also within these areas are small and scattered sand-bar willow (*Salix exigua*). I chose a location of relatively dense wetland type-vegetation (within the well-pad boundary) and employed wetland delineation methods as established by the United States Army Corps of Engineers Version 2 of the Arid West Regional Supplement to the 1987 Wetland Delineation Manual. Despite the visual nature of these areas all indicators for wetlands were not identified. This letter presents my findings.

East Edge of Well Pad Looking West to Access Road Entry

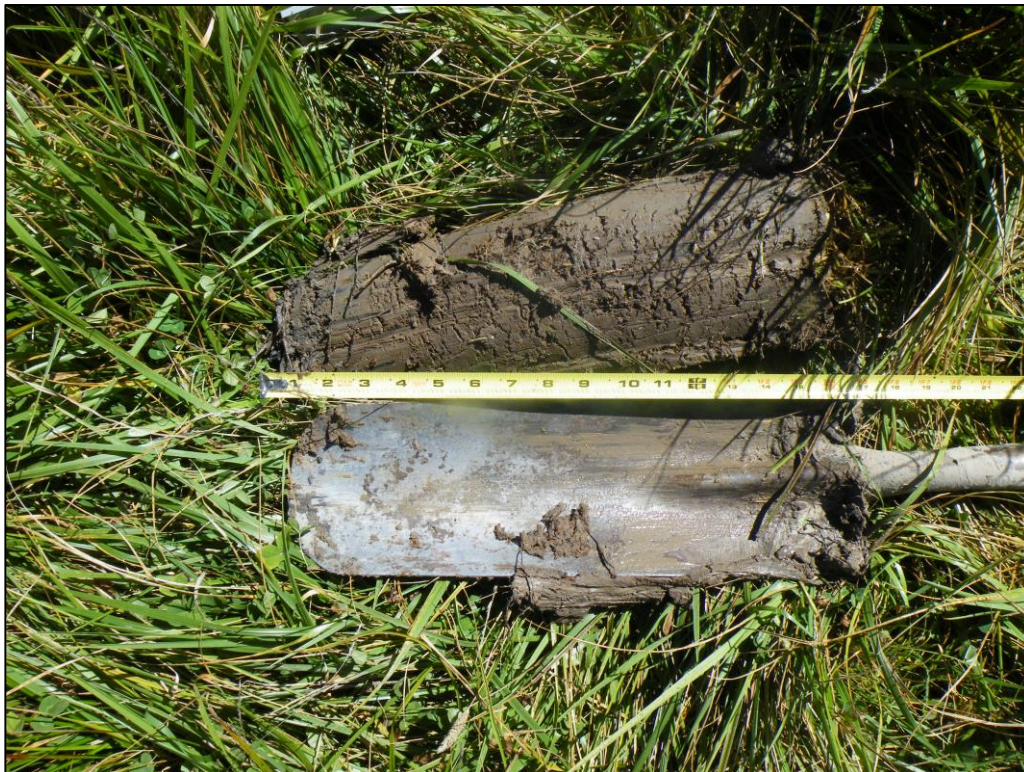
Despite the visual vegetation transition, upon employing field methods for wetland determination, vegetation did not meet wetland parameters. Regardless, a pit was dug in accordance with the delineation procedures. Soils and hydrology are within the area, but primary and secondary indicators for hydrology were not positive for wetland criteria based on the investigation.

Investigation Point Soil Profile

Depth (inches)	Matrix		Redox Features		Type ¹	Loc ²	Texture	Remarks
	Color (moist)	%	Color (moist)	%				
0-14.5	10YR 3/2	100	2.5YR 3/6	5	C	M/P	clayey	clayey - moist - not sat
14.5-23"	10YR 4/3	100	—	—	—	—	sandy

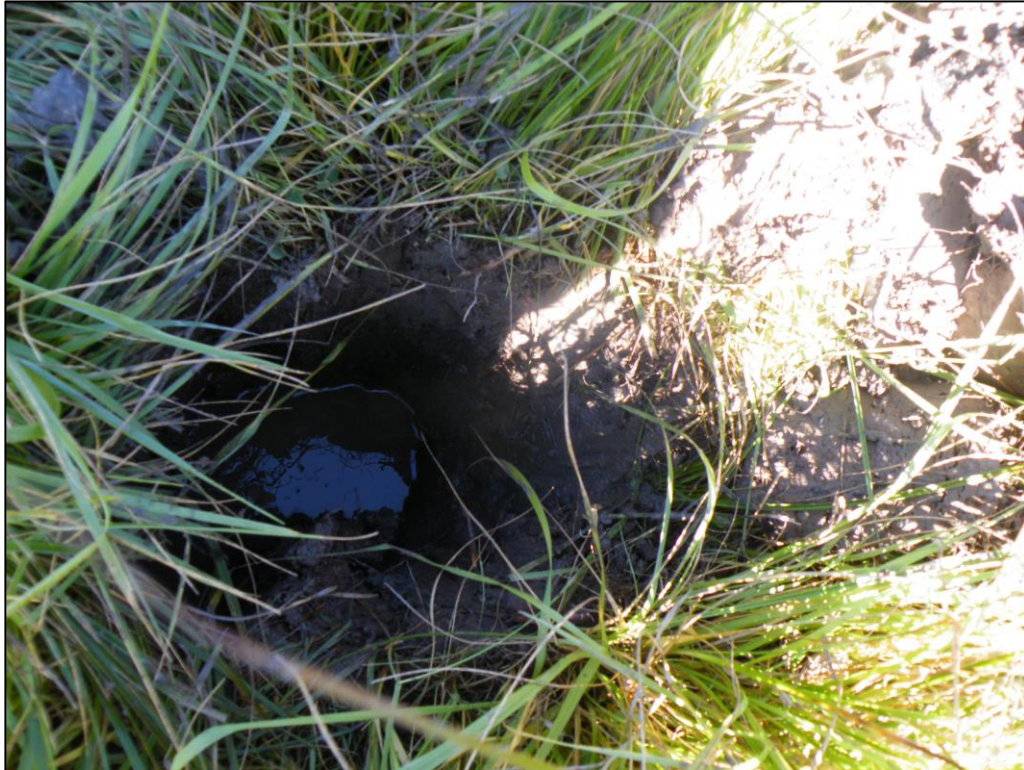
Investigation Point Ground Water at Weathered Sandstone Layer (16 inches)

Water Table Present? Yes ☒ No ☐ Depth (inches): 16"

Water allowed to stabilize w/in hole for >10 min.
no sign of recent filling in area.

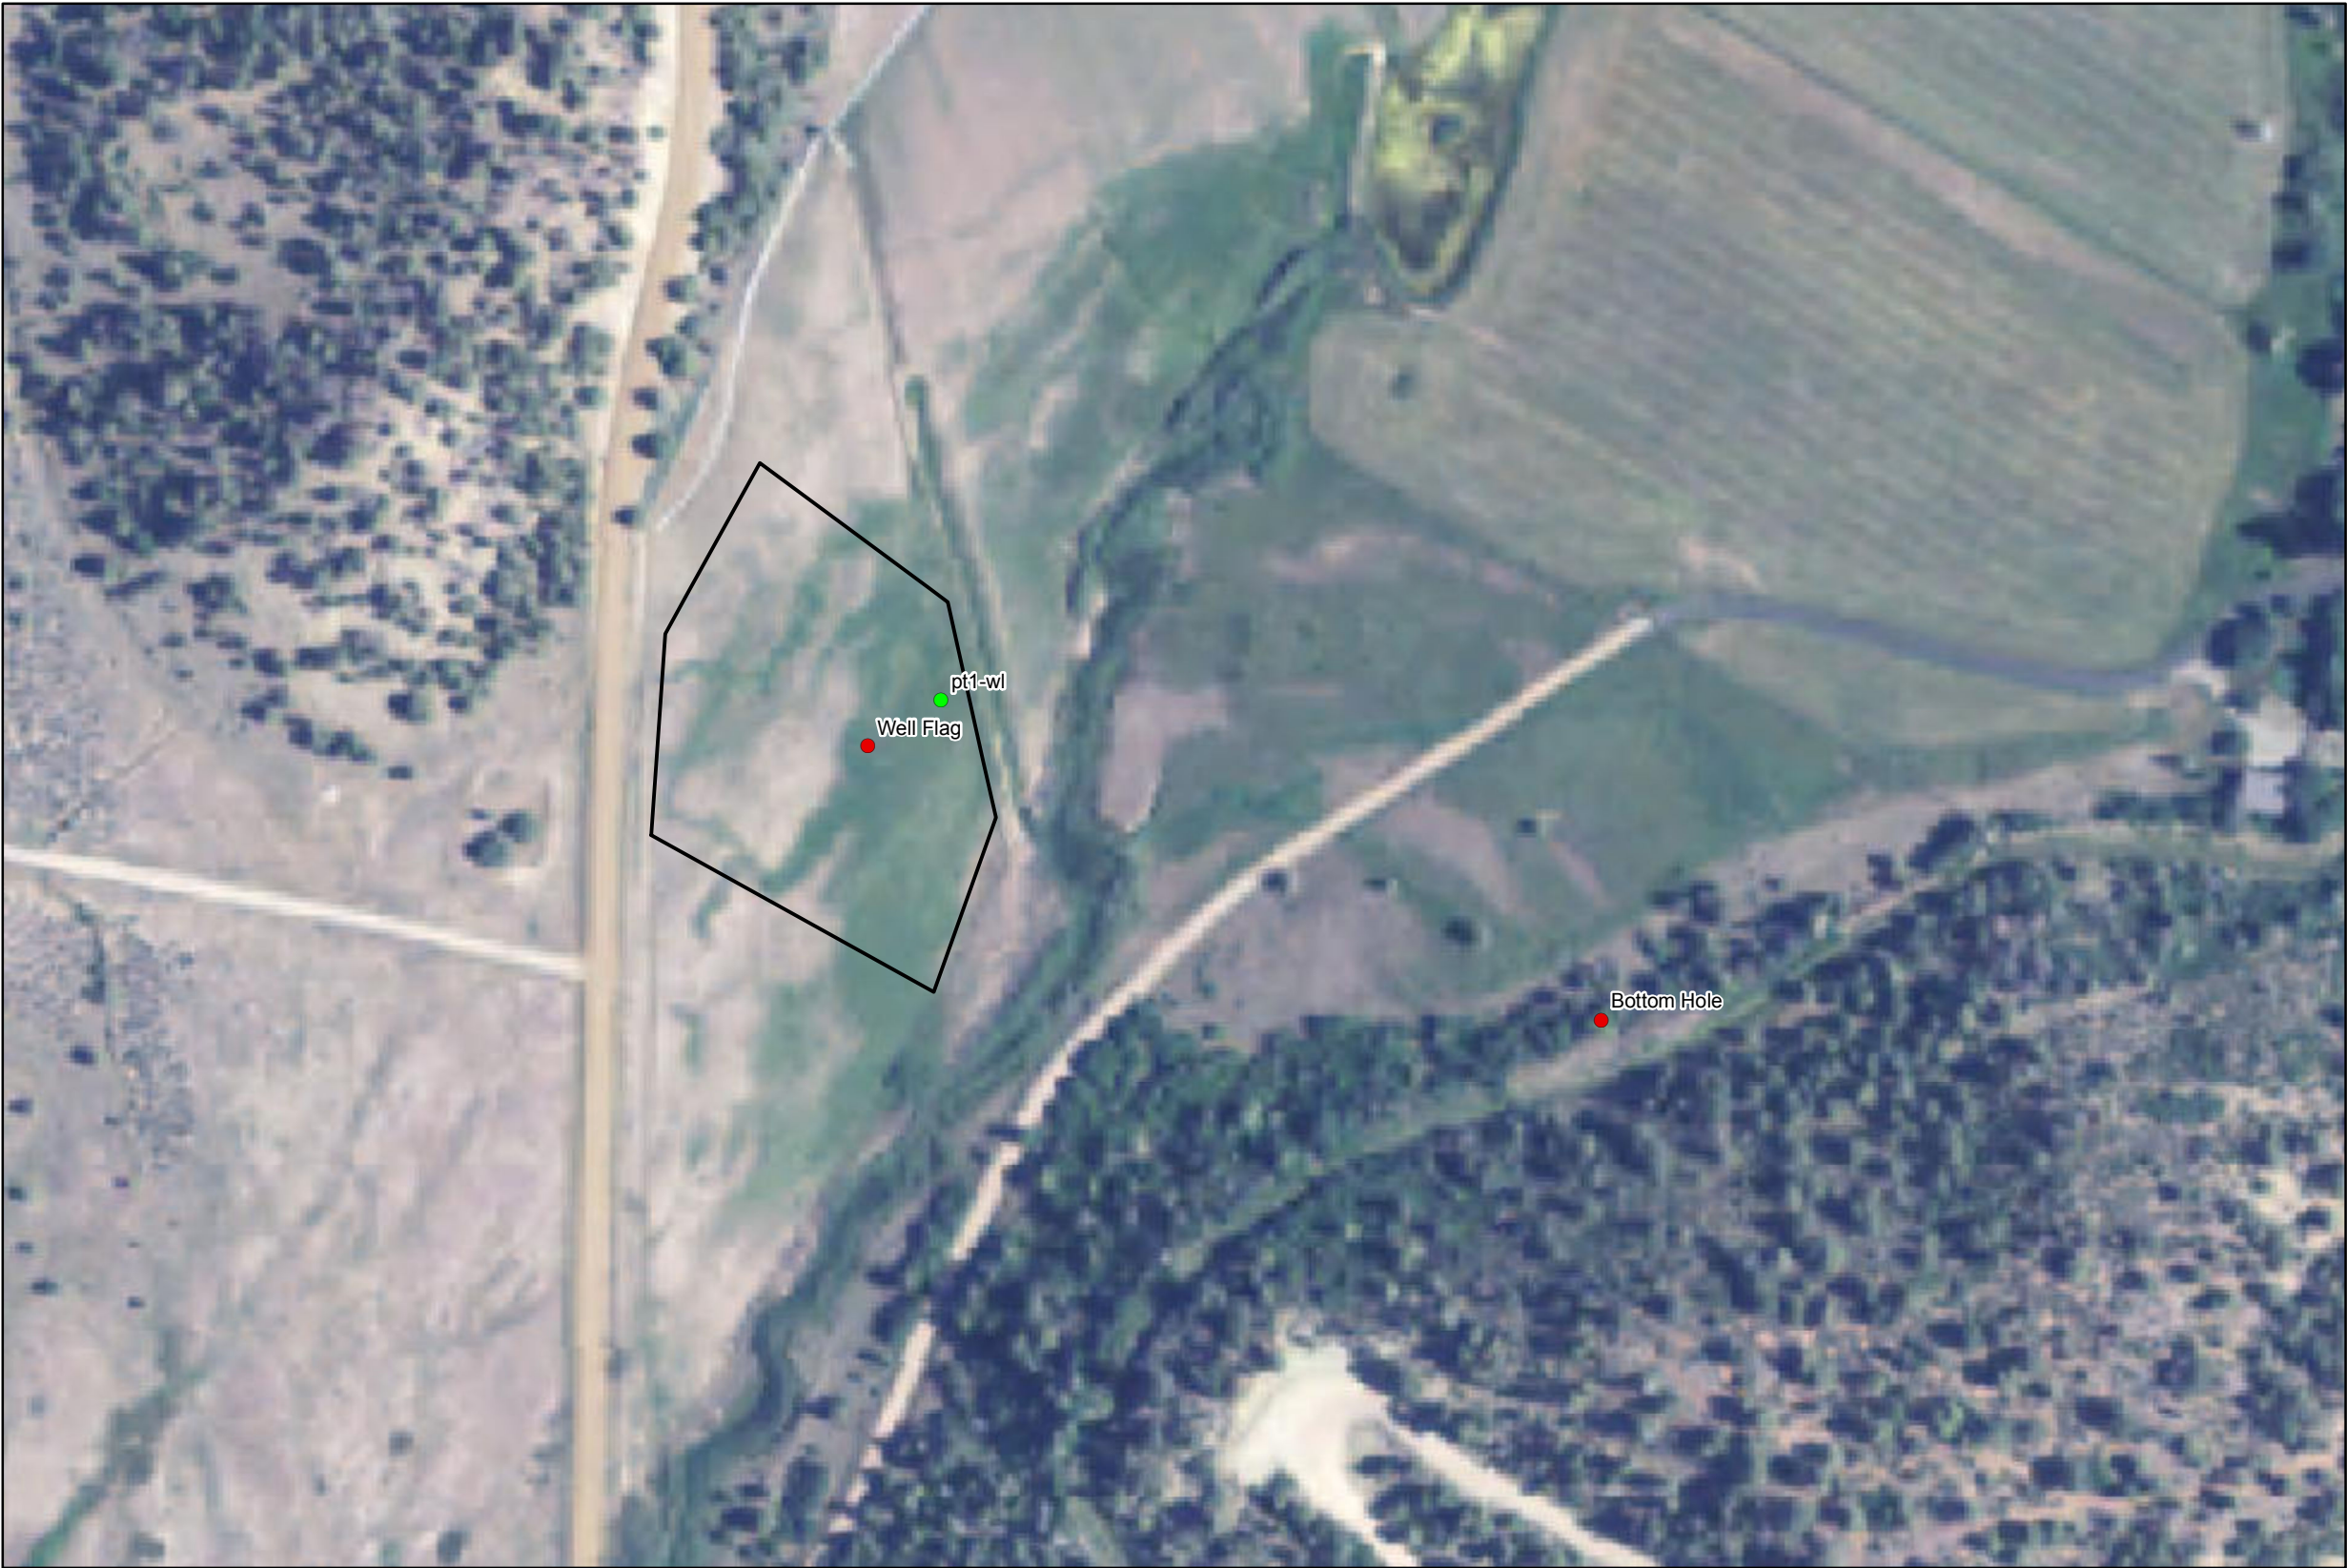
-- Figure 3 --

Attached are photographs of the investigation site, the soil profile analyzed, and the height of groundwater identified. Also attached is the Corps of Engineers Wetland Determination Data Form and a map showing the juxtaposition of the investigation site to the surveyed well-pad boundary.

LA PLATA COUNTY 2007 DIGITAL ORTHOPHOTO
