Reference Area Photographs

Inspection Conducted on December 16, 2014

Marathon Oil

697-21A Pad

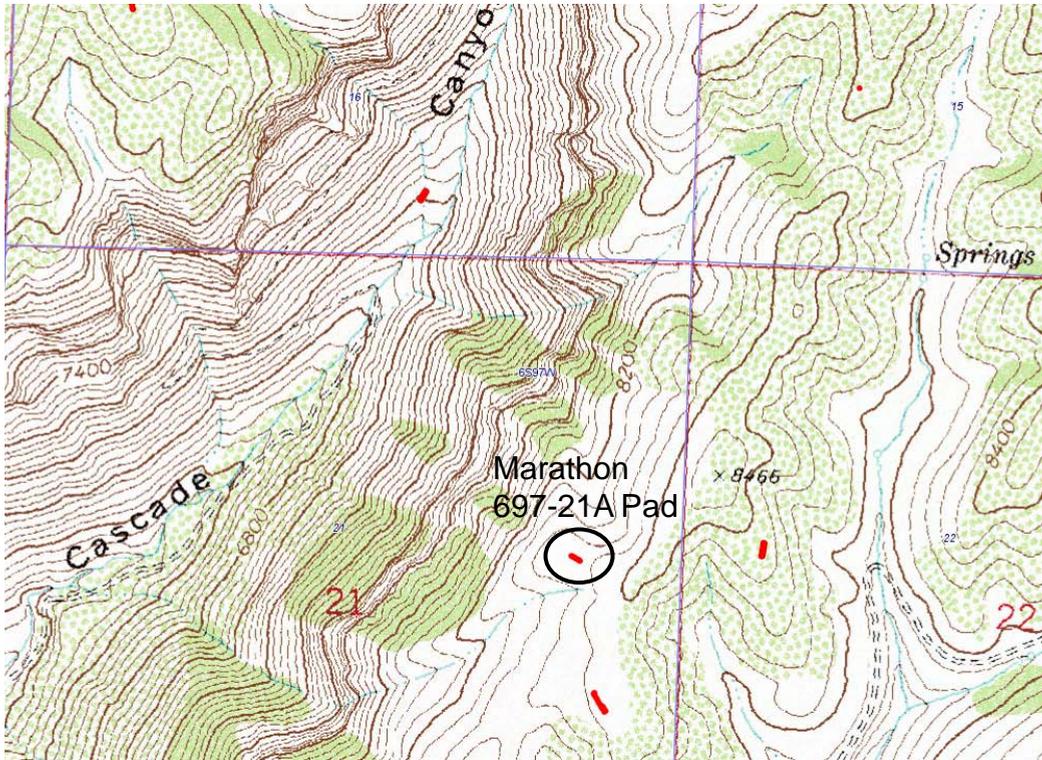
Pad is located on a ridge with natural drainages to the South, North, and to the East. To the West, steep slope. Vertical distance to Canyon Creek is about 1,400 feet.

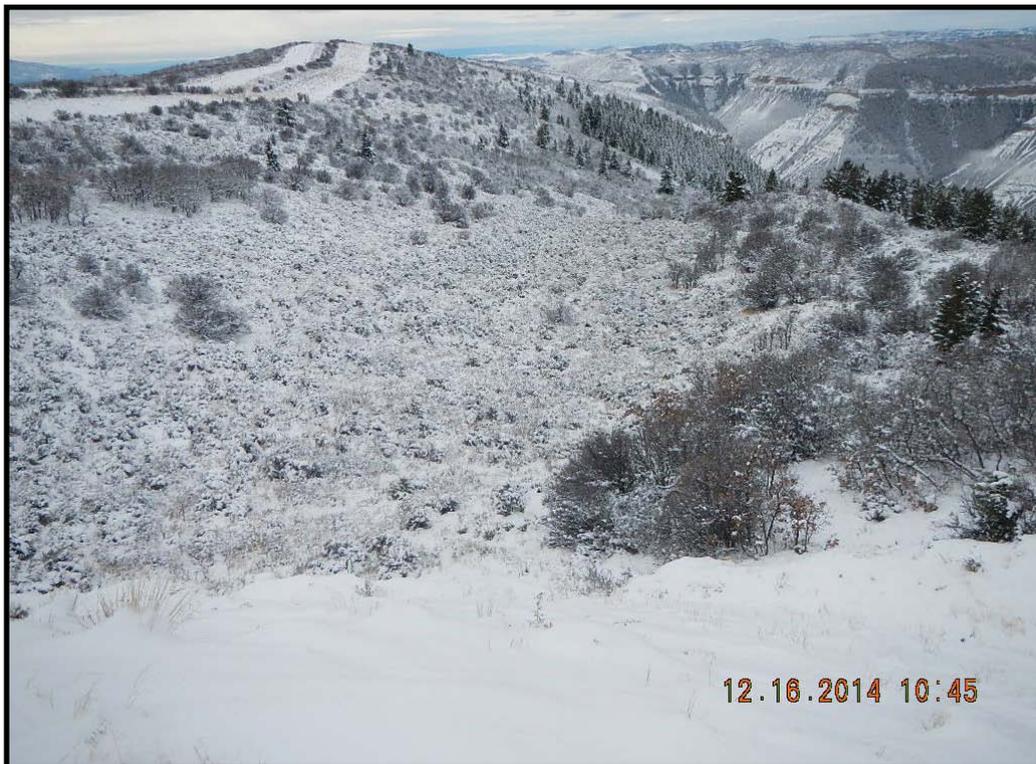
From the pad, looking South. Natural drainage. Steep slope to the west (right side of the photo).

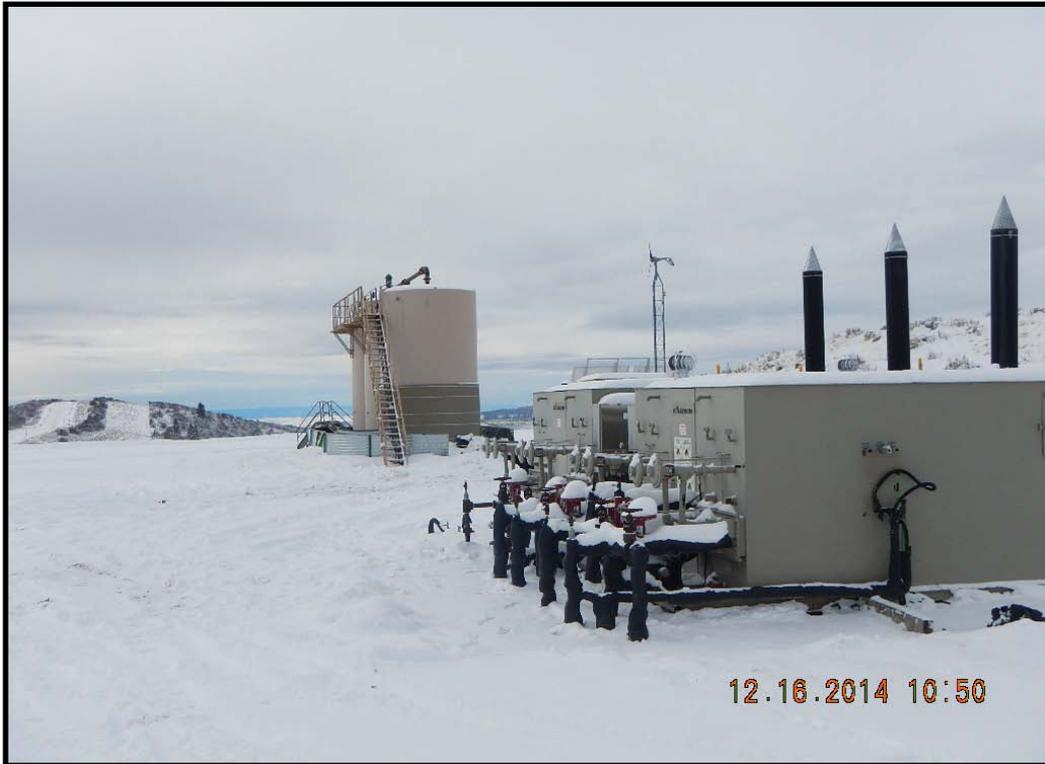
From the Northwest corner of the pad, looking South. Separators and tanks.

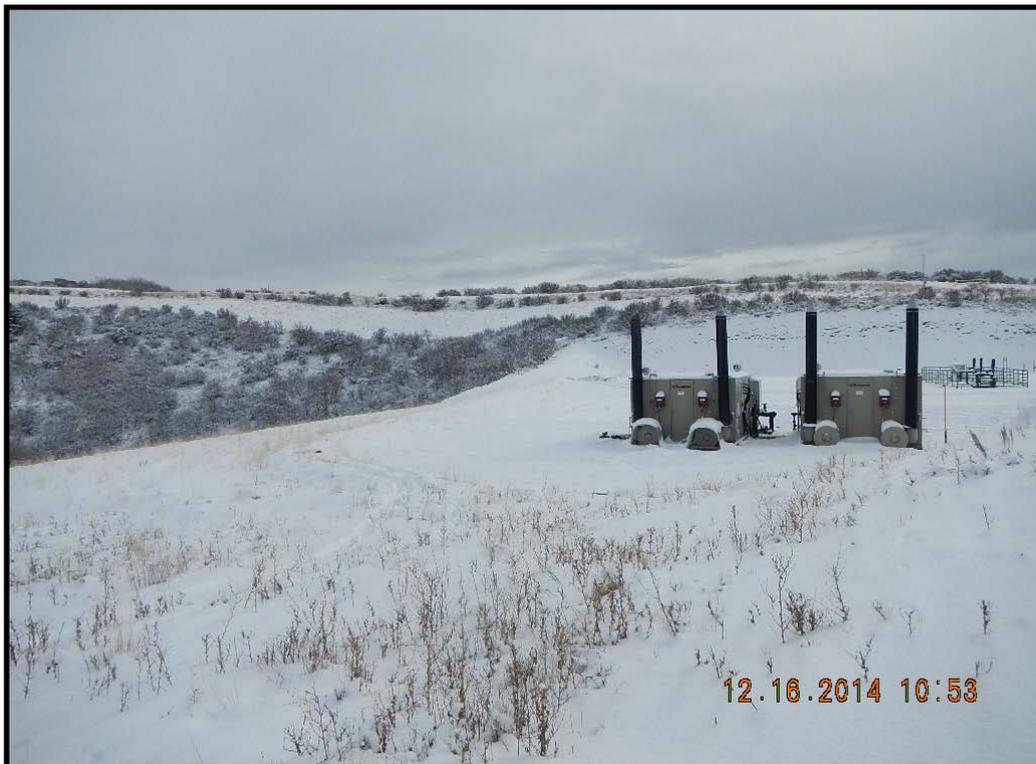
From the Northwest corner of the pad, looking East. Separators and fenced wells (behind the separators, to the right). See natural drainage to the North (left).

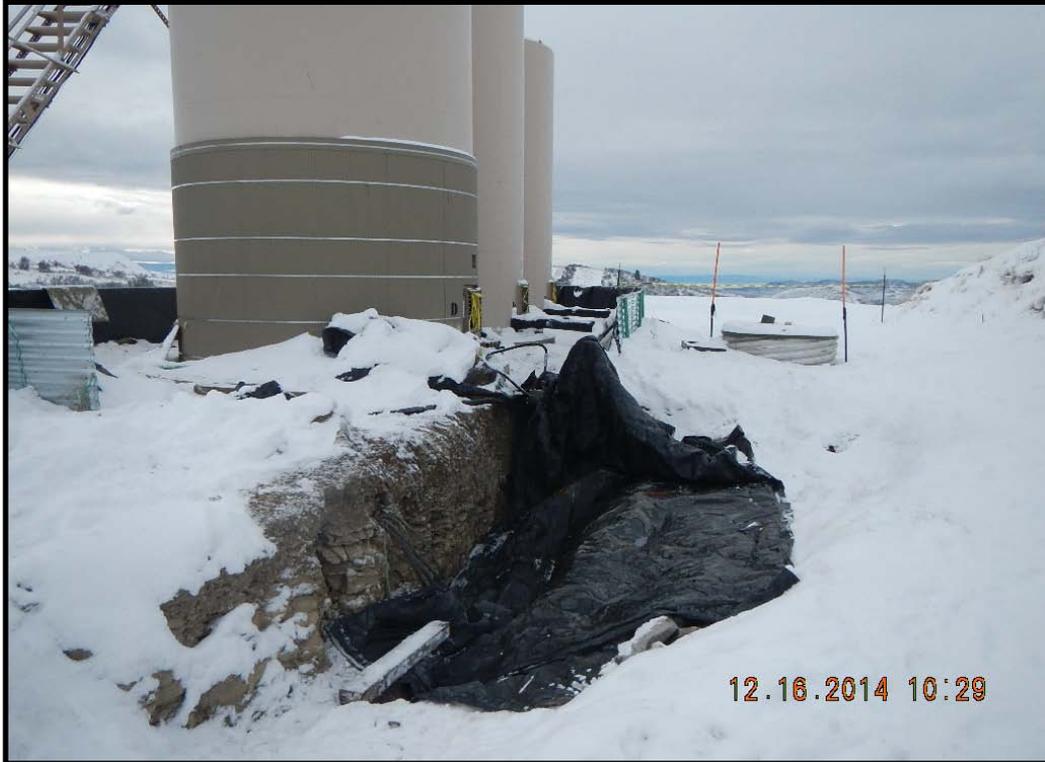
Looking South. Location of the release. A buried dump line leaked . Wells have been shut-in, tanks are empty now, all lines pressure tested (last pressure test was performed few months ago, in compliance).

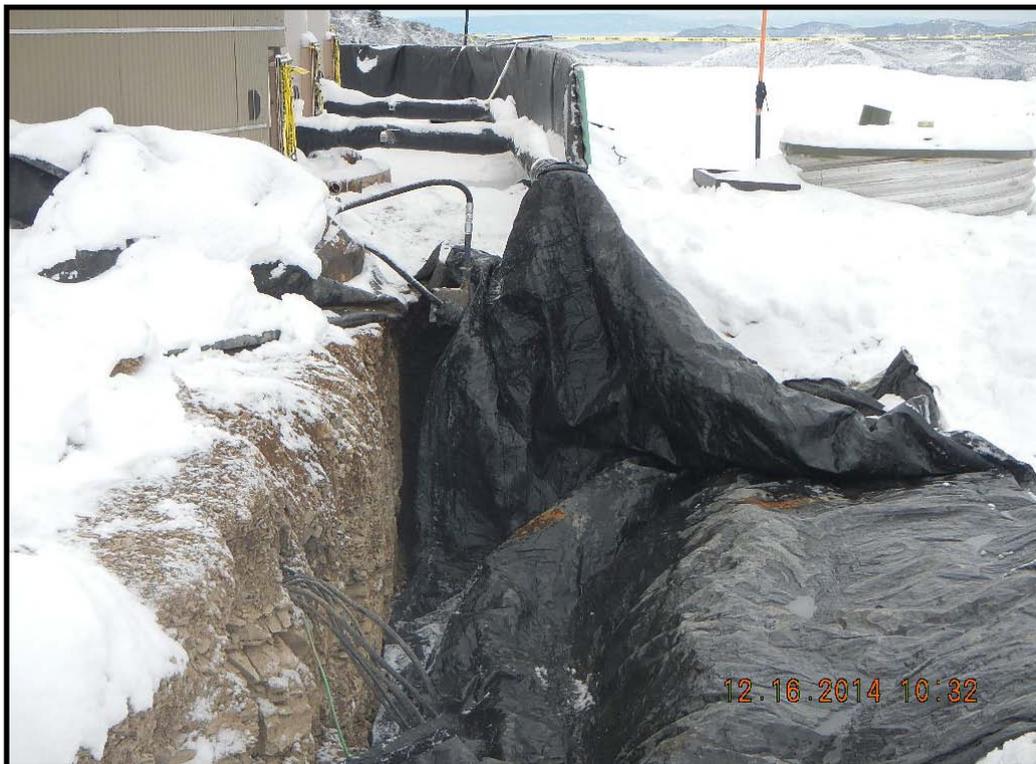
Excavation and PID readings indicate that the impacted area was limited to the extent of the trench. No surface leak; all fluid infiltrated to the sub-soil/fractured rock. Maralex did some potholing around the excavation and found no indication of impact.
