RE: Status Report: Drill Pads KP 24-17, KP 23-17 & KP 34-18 COGCC Rule 317B Post DCPS Operations Water Quality Sampling, November/December 2014

Figure 1: November/December 2014 DCPS Operations Rule 317B Sampling Evaluation S 17 & 18, T6S, R91W, 6 PM

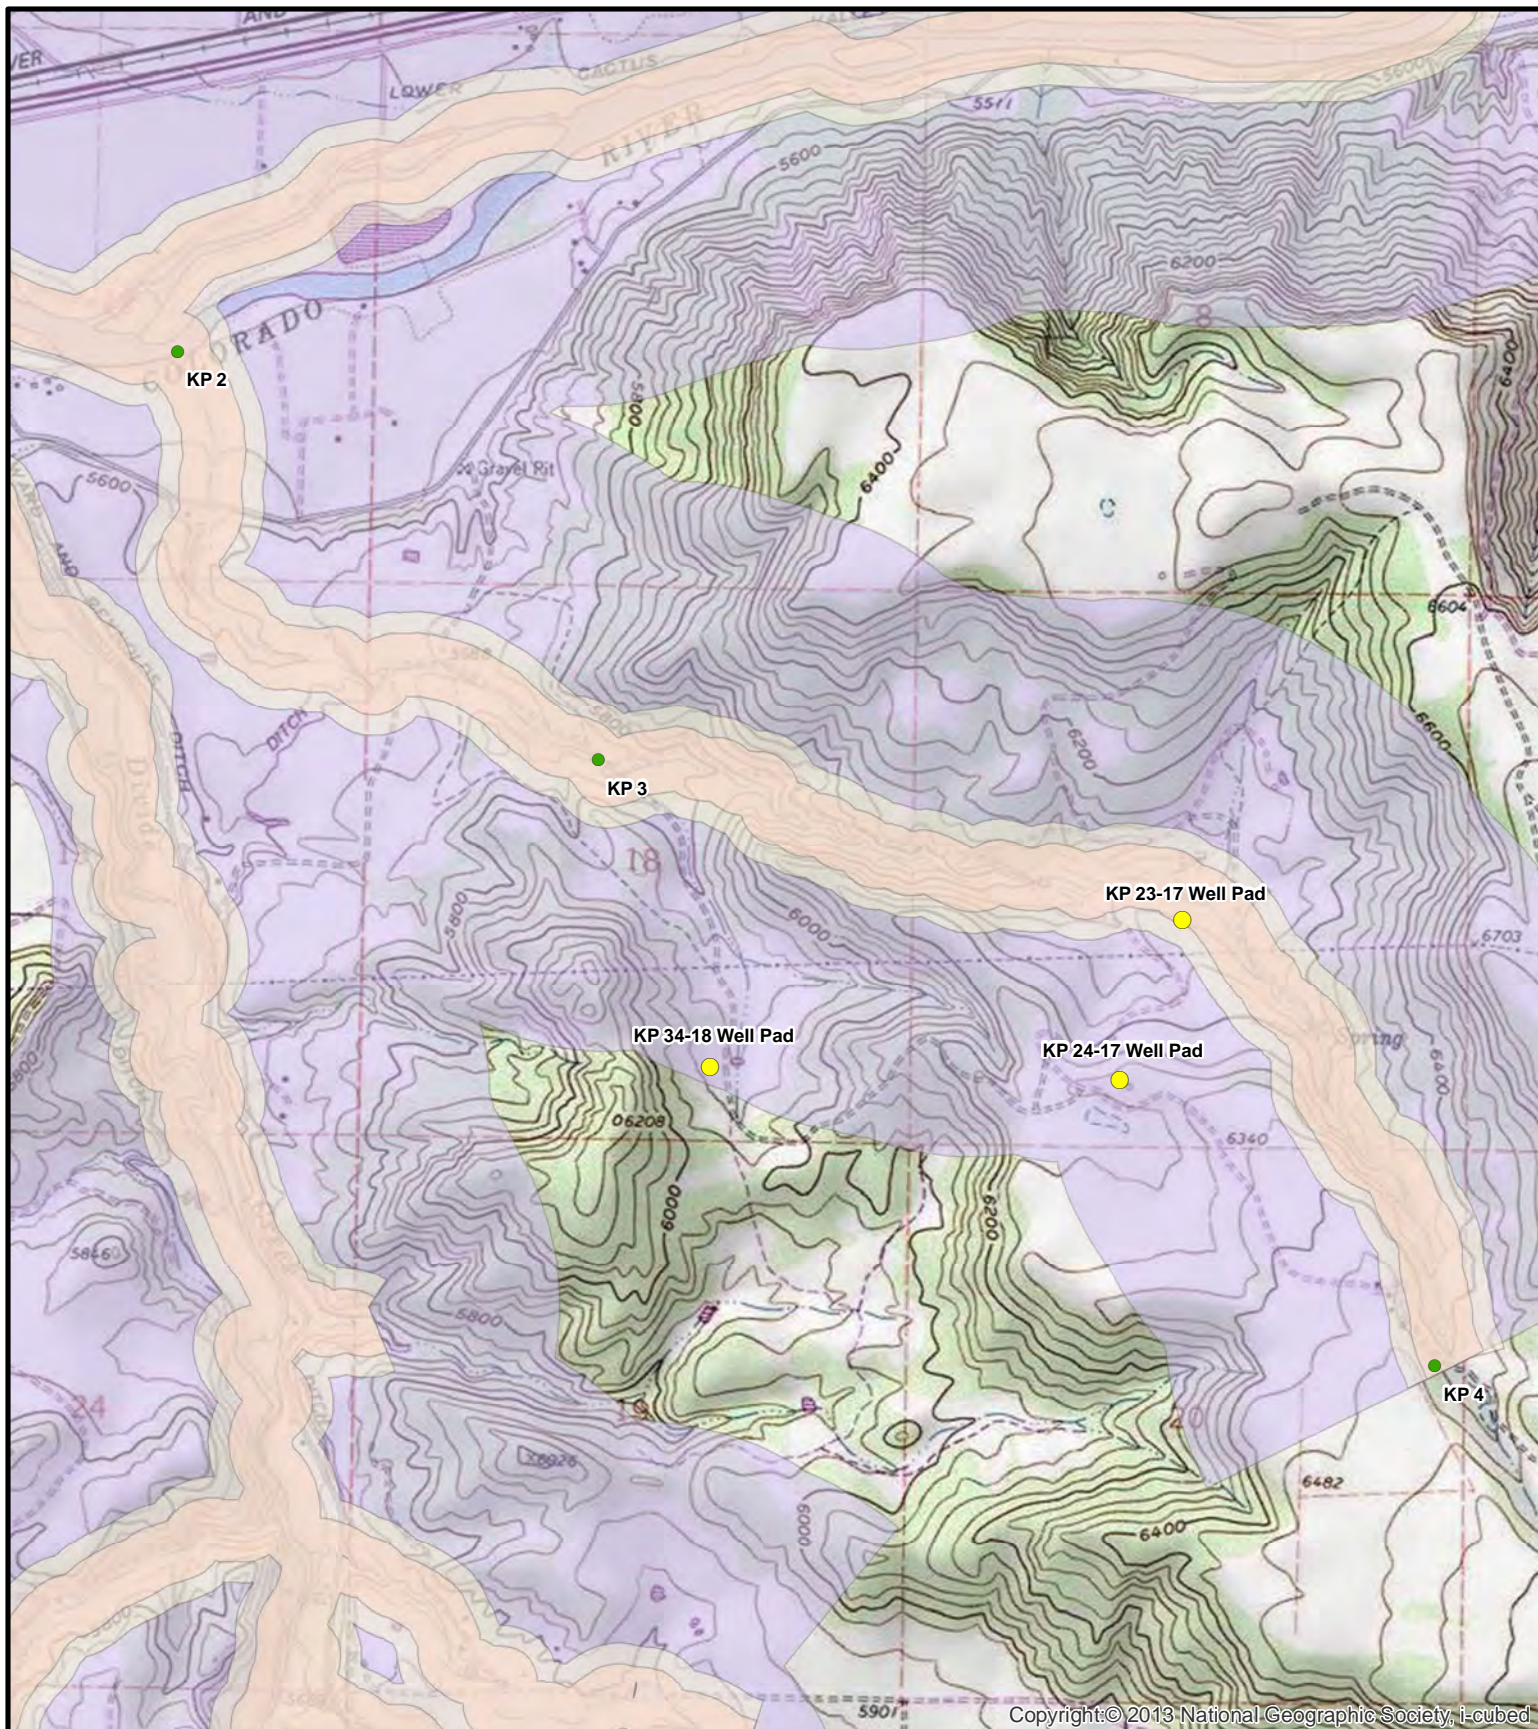
Previously established sampling locations for the SSWSA were provided to WWL by WPX. The sampling locations were established by HRL Compliance Solutions, Inc. (HCSI). Sampling locations downgradient of the referenced WPX DCPS Operations locations are shown in Figure 1. Sampling location KP 3 (COGCC Facility ID 752549) is the nearest downgradient sampling location to the referenced WPX DCPS Operations locations and was therefore identified as the preferred sampling location.

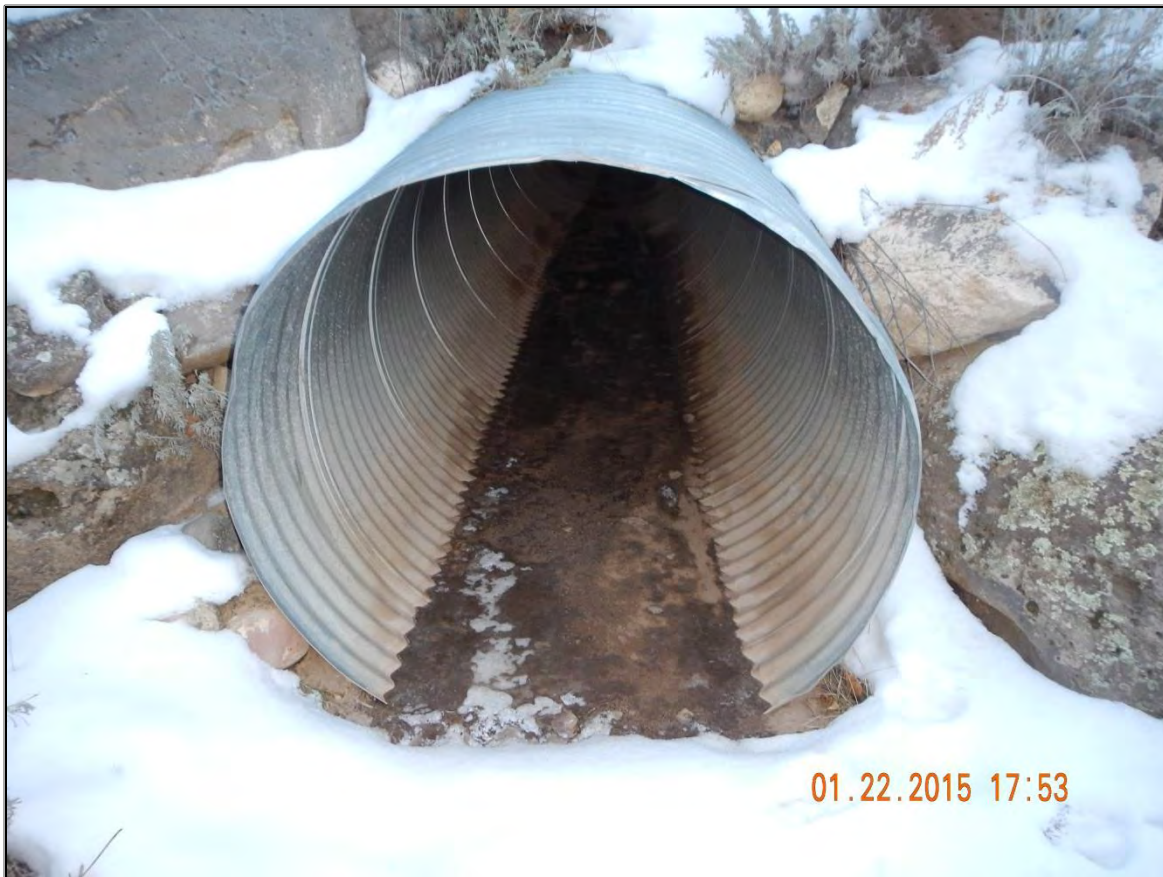
Sampling location KP 3 was visited by WPX personnel on January 22, 2015. This sampling location resides in an ephemeral drainage immediately downgradient of a culvert under the access road. No water, flowing or standing, was observed in the drainage although there was ice present in the culvert. The next downgradient sampling location, KP 2 (COGCC Facility ID 752548), was not visited because WPX does not have property owner consent to access this location. Photographs from the field activities are included in Attachment A. As a result of these events, no samples were collected during the November/December 2014 DCPS Operations sampling event.

Photo 1. Sampling location KP 3. (January 22, 2015)

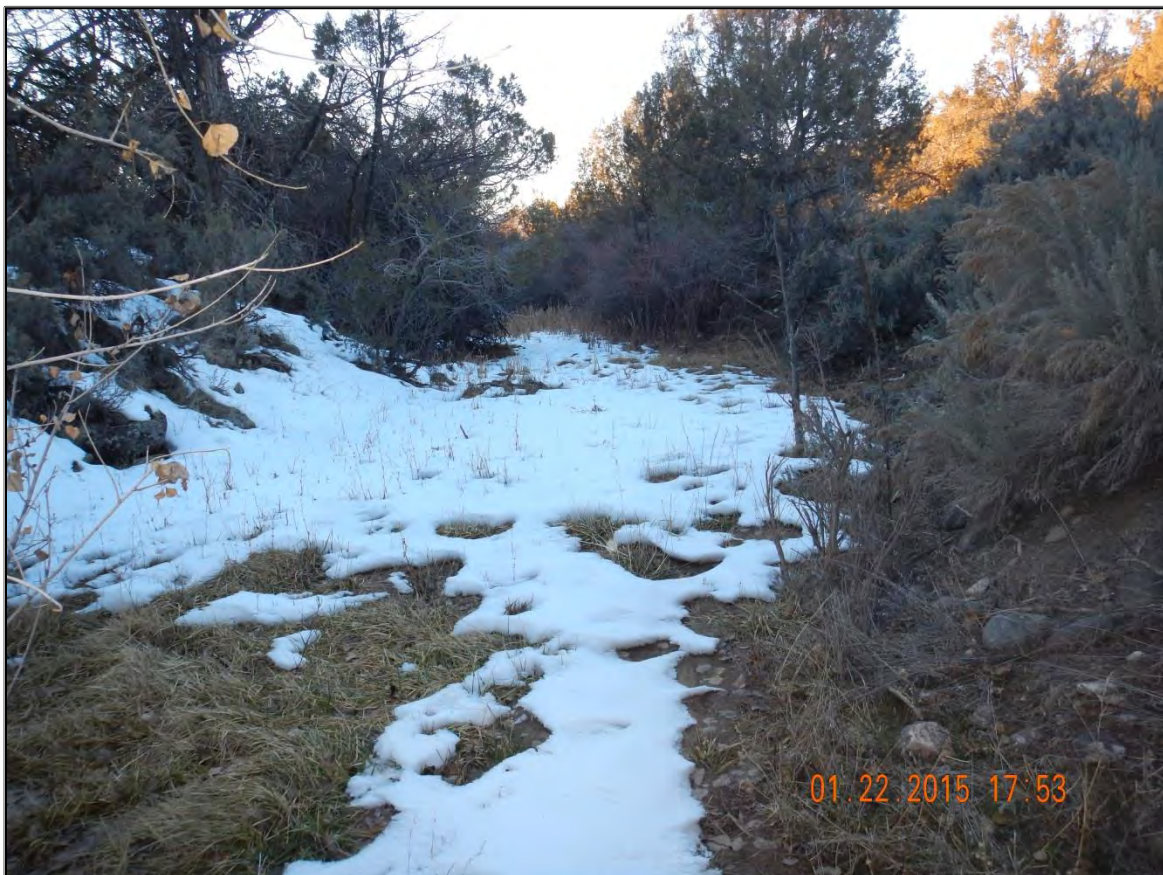
Photo 2. Drainage downstream of sampling location KP 3. (January 22, 2015)
