SPILL/RELEASE REPORT

Date of Incident: <u>4/10/2014</u> Facility Name & No: <u>Hanks Pooling Unit 1</u>	County: <u>Weld</u>
Type of Facility (well, tank battery, flow line, pit): <u>Production facility</u>	QtrQtr: <u>SWSW</u> Section: <u>34</u>
Well Name and Number: <u>Hanks Pooling Unit 1</u>	Township: <u>2N</u> Range: <u>67W</u>
API Number: <u>05-123-07246</u>	Meridian: <u>6th</u>
Specify volume spilled and recovered (in bbls) for the following materials:	
Oil spilled: <u>Unknown</u> Oil recov'd: <u>0</u> Water spilled: <u>Unknown</u> Water recov'd: <u>0</u> Other spilled: <u>0</u> Other recov'd <u>0</u>	
Ground Water impacted? <input checked="" type="checkbox"/> Yes <input type="checkbox"/> No <input type="checkbox"/> Unknown	Surface Water impacted? <input type="checkbox"/> Yes <input checked="" type="checkbox"/> No
Contained within berm? <input checked="" type="checkbox"/> Yes <input type="checkbox"/> No	Area and vertical extent of spill: <u>15' N-S x 35' E-W</u> x <u>5' bgs</u>

Kerr McGee Oil and Gas Onshore, LP
 HANKS POOLING UNIT 1
 SWSW S34 T2N R67W
 Weld County, CO

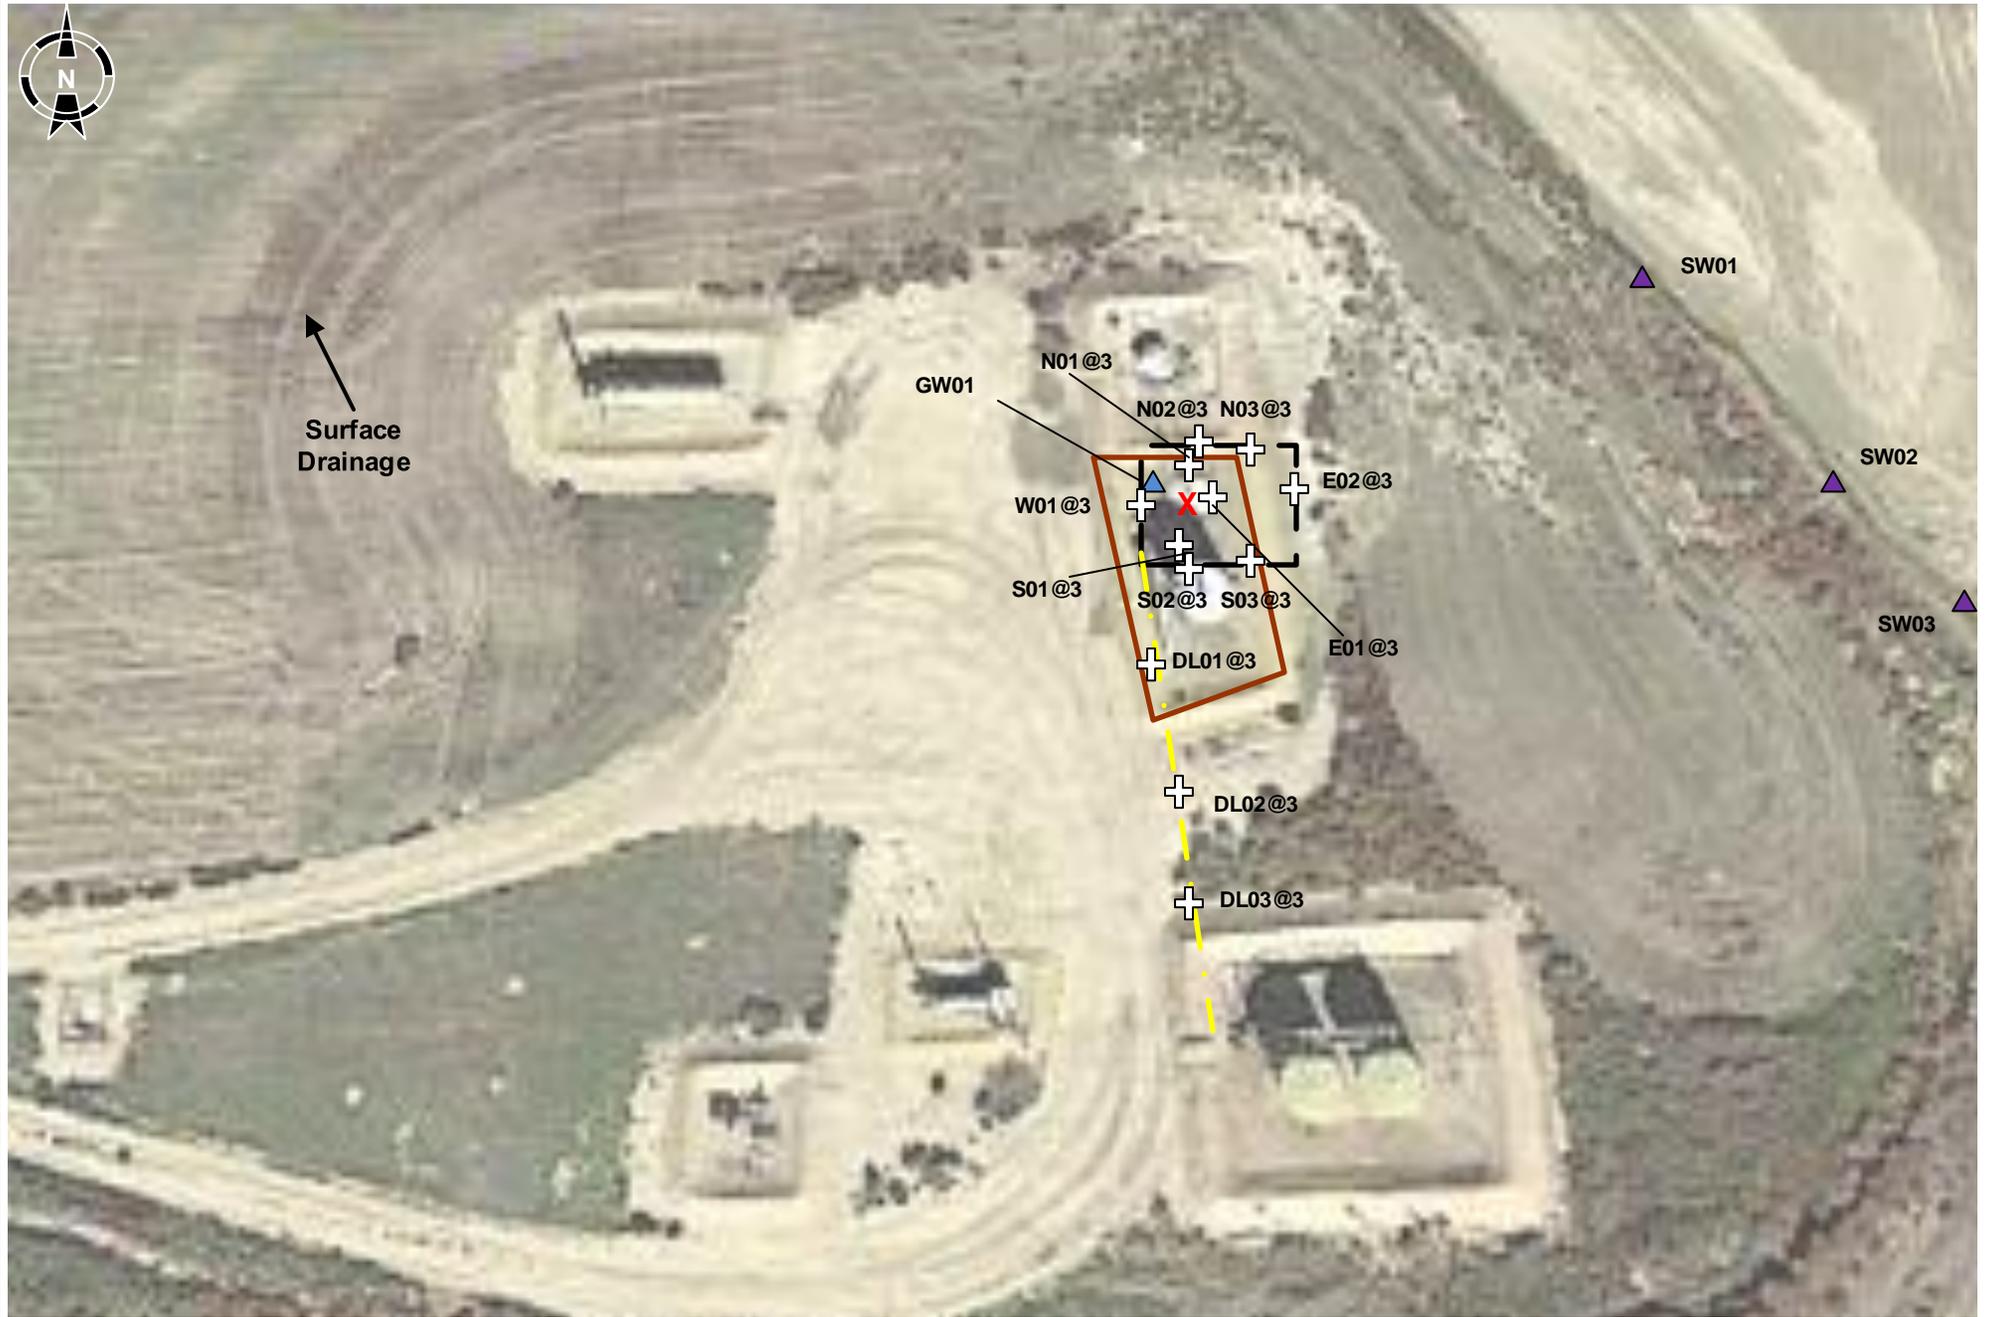
FIGURE 2
SITE AND SAMPLE
LOCATION
 Approximate Scale:
 1"=20'

Describe immediate response (how stopped, contained and recovered): The tanks and all of the associated lines were cleaned in preparation for decommissioning. Approximately 140 cubic yards of impacted soils were excavated and transported to the Front Range Regional Landfill in Erie, Colorado. The location and final extent of the excavation is illustrated on Figure 2.

How was the extent of contamination determined? Soil samples were collected from the sidewalls of the excavation at approximately 3 feet below ground surface (bgs) and submitted to eAnalytics Laboratory in Loveland, Colorado for laboratory analysis of BTEX and TPH. Laboratory results from the confirmation sidewall samples indicate concentrations above the applicable COGCC Table 910-1 standards on the north, south and east sidewalls. Additional hydrovacating and excavation activities will help to further identify the extent and magnitude of soil contamination. Three soil samples (DL01@3' - DL03@3') were also collected from beneath an exposed dump line and submitted for analysis of BTEX and TPH. DL01@3' - DL03@3' exhibited concentrations of BTEX and TPH below the applicable COGCC Table 910 standards. Groundwater was encountered in the excavation at approximately 4 feet bgs. A groundwater sample (GW01) was collected on April 10, 2014 for laboratory analysis of BTEX. Analytical results for sample GW01, received on April 11, 2014, indicated concentrations of benzene at 1,745 ug/L and total xylenes at 1,851 ug/L, exceeding the Colorado Groundwater Quality Standards (CGWQS). Three surface water samples, upstream (SW01), midstream (SW02) and downstream (SW03) of the excavation, were collected from a drainage area approximately 130 feet to the east of the existing excavation. Samples SW01 - SW03 were submitted for analysis of BTEX and exhibited concentrations below the applicable Colorado Basic Standards for Surface Water (CBSSW). A summary of soil sample analytical data is presented in Table 1, groundwater sample analytical data is presented in Table 2 and surface water analytical data is presented in Table 3. Soil, groundwater, and surface water sample locations and the final excavation extent are depicted on Figure 2.

Further remediation activities proposed (attach separate sheet if needed): A subsurface assessment will be completed to define the extent and magnitude of the soil and groundwater impacts. Data from the assessment will be provided in a Form 27.
