**RE: Supplemental Indoor Air Quality Sampling Results – July 1 and 2, 2015
DCP Midstream, L.P. – 940 E. 3rd St., Eaton CO 80615**

Tasman Geosciences (Tasman), on behalf of DCP Midstream, L.P. (DCP) conducted an indoor air quality (IAQ) survey on June 4th and 5th, 2015, in the interior of a private residence located at 940 E. 3rd St., Eaton, CO 80615, as described in the June 24, 2015, *Indoor Air Quality Sampling Results* letter (IAQ Letter) prepared by Tasman. Per the recommendations of the IAQ Letter, a supplemental IAQ sampling event was conducted on July 1 and 2, 2015, to evaluate IAQ at the residence subsequent to completion of impacted soil excavation activities that were occurring near the residence during the initial June 2015 vapor sampling event. The residence is located adjacent to a DCP Pipeline located approximately 0.25 miles north of the intersection of County Road 39 and County Road 74 near the town of Eaton, CO (Site [Figure 1]).

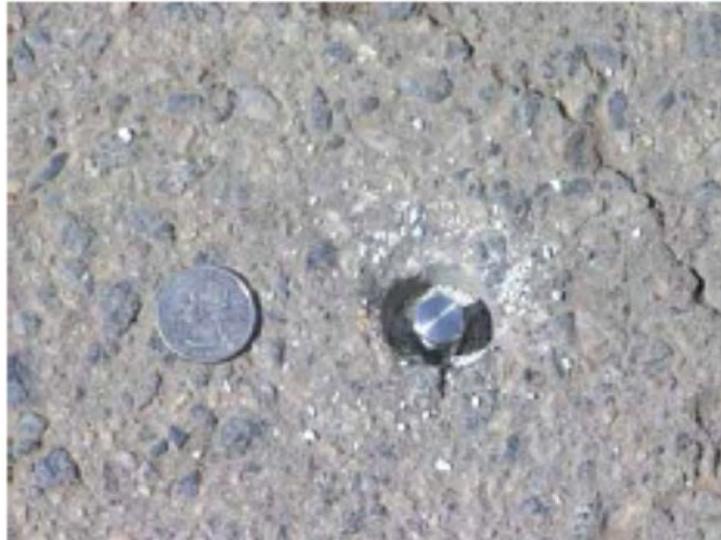
Example of flush mounted vapor sampling point

Due to the findings of the ISABS and the vapor sampling activities presented herein, at the homeowner's request and/or approval, Tasman recommends to install sub-slab vapor sampling points in accordance with CDPHE regulations to evaluate petroleum hydrocarbon vapor concentrations below the building foundation, if any. Typical sub-slab vapor sampling points consist of a 1-inch outer diameter hole through the concrete foundation slab located in the basement. A sub-slab vapor sampling probe will then be grouted in place, flush with the top of the concrete slab with recessed stainless steel plugs so as not to interfere with day-to-day use. The images below illustrate examples of how the sampling point will be completed and how the sampling canister will be used during sub-slab sampling activities.

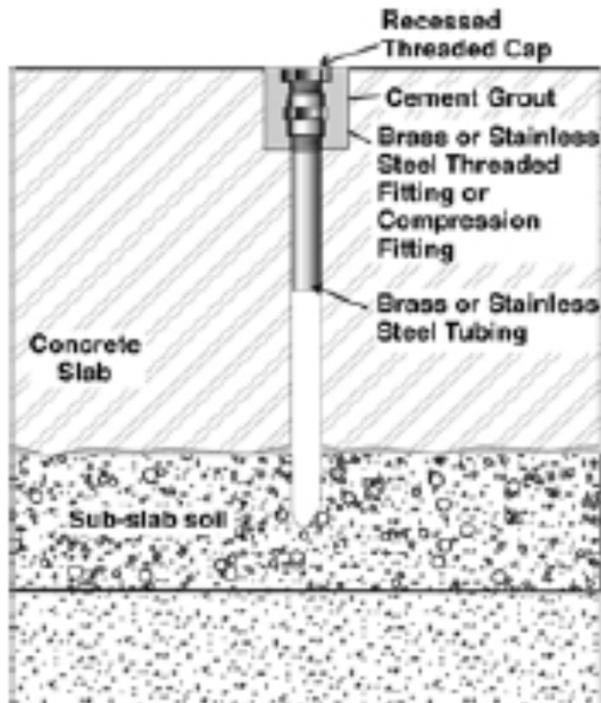
Schematic of a sub-slab vapor sampling point

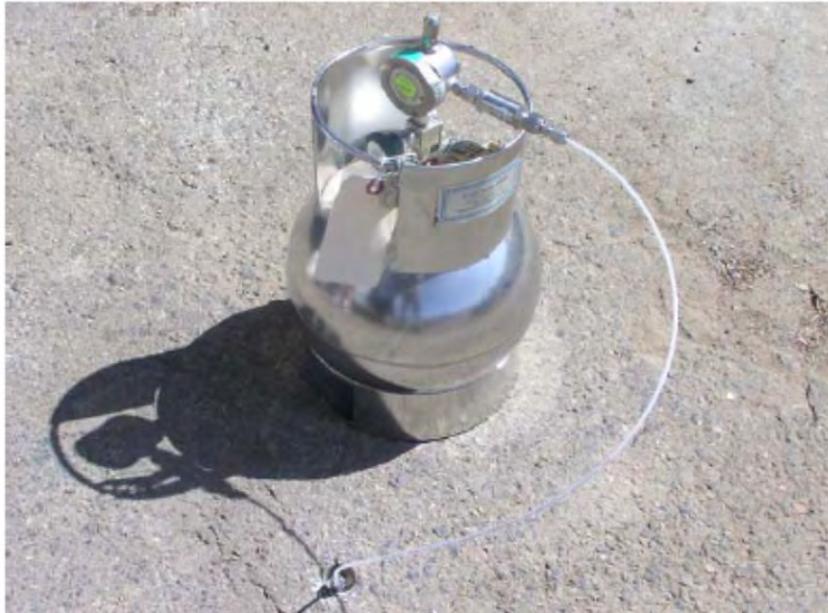
Example of the flush mounted vapor sampling point

Upon request and/or approval by the homeowner of the sub-slab vapor sampling activities, the desired location will be in the northeast corner of the basement. This may require temporarily removing any floor coverings including but not limited to carpet and carpet pad, if present, in order to access the concrete slab directly. Subsequent to conducting the vapor sampling activities, the sub-slab vapor sampling point will be sealed with grout flush to grade with the existing concrete surface and the floor coverings will be returned to their original position.

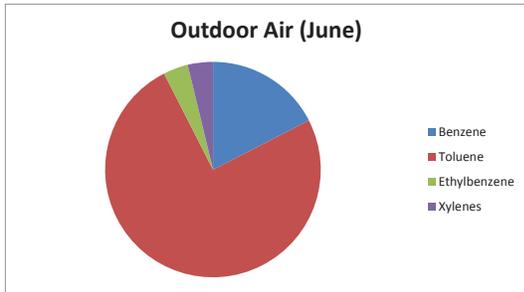
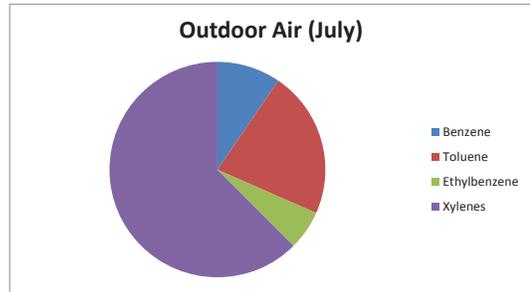
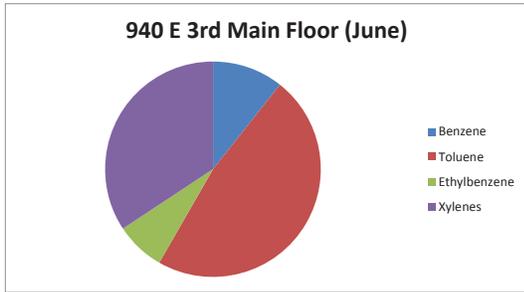
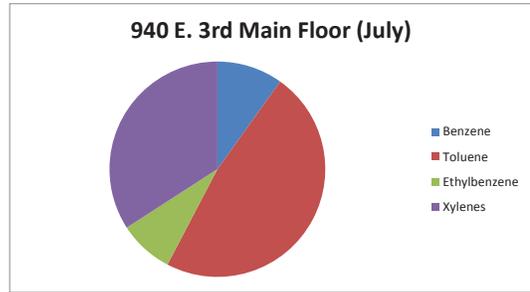
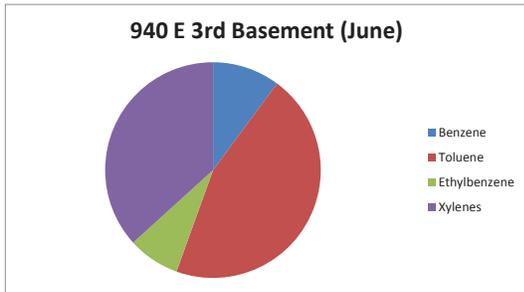
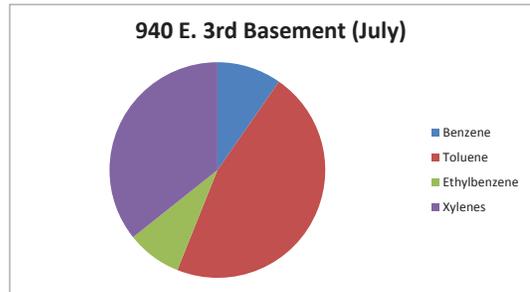
Figure 2 - BTEX Ratio Plots
940 E. 3rd St., Eaton, CO

- The relative concentrations or ratios of each of the BTEX compounds in outdoor air, indoor air, and soil vapor³ are illustrated by pie diagrams on Figure 2. BTEX ratios in the basement and on the main floor of the house are distinctly different from the BTEX ratios expected in soil vapor. This is a strong indicator that vapor intrusion is not the source of the BTEX concentrations observed in the indoor air.

- The basement and main level BTEX ratios on Figure 2 are very similar to the BTEX ratios in the garage. This, combined with the higher concentration levels in the garage discussed above, strongly indicates that air in the garage is the source of BTEX concentrations in the house.

The information evaluated, above, particularly the BTEX ratios shown in Figure 2 and the high BTEX concentrations in the garage, strongly suggest that the multiple VOC emission sources located in the garage (or in equipment in the garage) is likely the source of the BTEX that was measured in the indoor air vapor samples. This is consistent with the likelihood that petroleum constituents in the groundwater near or below the building would rapidly biodegrade in the soil below the building, so would not be present from soil vapor in the basement.
