**RE: Supplemental Indoor Air Quality Sampling Results – July 1 and 2, 2015  
DCP Midstream, L.P. – 301 Hickory St., Eaton CO 80615**

Tasman Geosciences (Tasman), on behalf of DCP Midstream, L.P. (DCP) conducted an indoor air quality (IAQ) survey on June 4<sup>th</sup> and 5<sup>th</sup>, 2015, in the interior of a private residence located at 301 Hickory St., Eaton, CO 80615, as described in the June 24, 2015, *Indoor Air Quality Sampling Results* letter (IAQ Letter) prepared by Tasman. Per the recommendations of the IAQ Letter, a supplemental IAQ sampling event was conducted on July 1 and 2, 2015, to evaluate IAQ at the residence subsequent to completion of impacted soil excavation activities that were occurring near the residence during the initial June 2015 vapor sampling event. The residence is located adjacent to a DCP Pipeline located approximately 0.25 miles north of the intersection of County Road 39 and County Road 74 near the town of Eaton, CO (Site [Figure 1]).

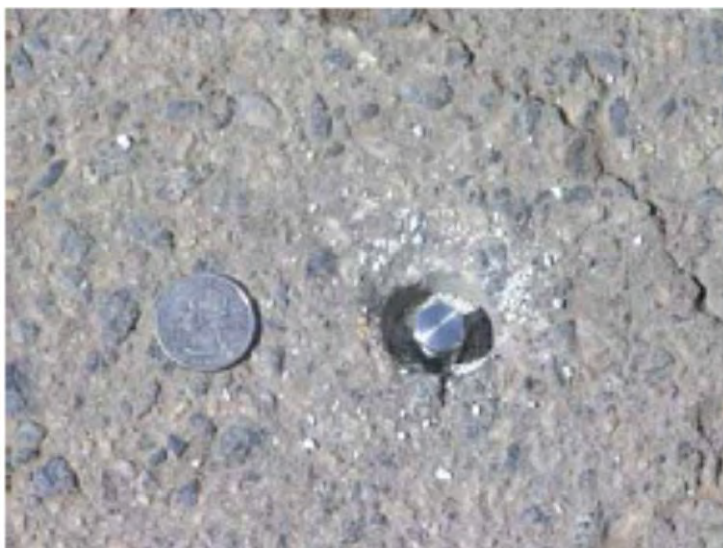
**Example of flush mounted vapor sampling point**

Due to the findings of the ISABS and the vapor sampling activities presented herein, at the homeowner's request and/or approval, Tasman recommends to install sub-slab vapor sampling points in accordance with CDPHE regulations to evaluate petroleum hydrocarbon vapor concentrations below the building foundation, if any. Typical sub-slab vapor sampling points consist of a 1-inch outer diameter hole through the concrete foundation slab located in the basement. A sub-slab vapor sampling probe will then be grouted in place, flush with the top of the concrete slab with recessed stainless steel plugs so as not to interfere with day-to-day use. The images below illustrate examples of how the sampling point will be completed and how the sampling canister will be used during sub-slab sampling activities.

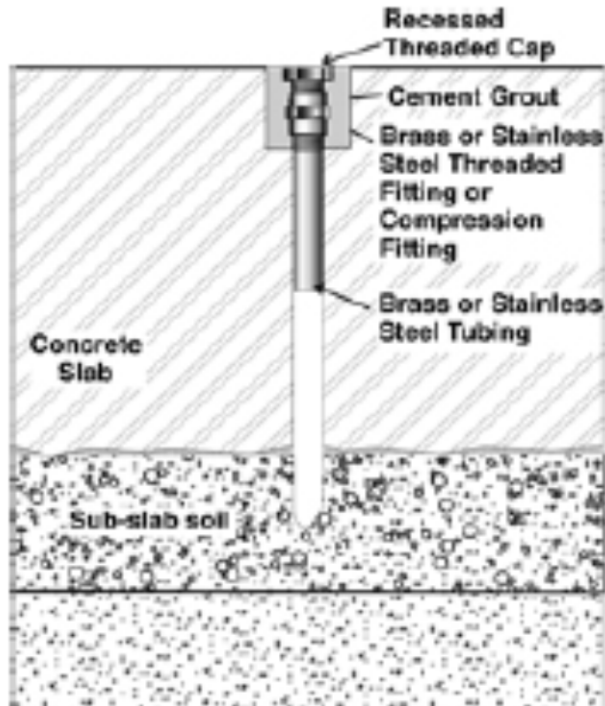
Schematic of a sub-slab vapor sampling point

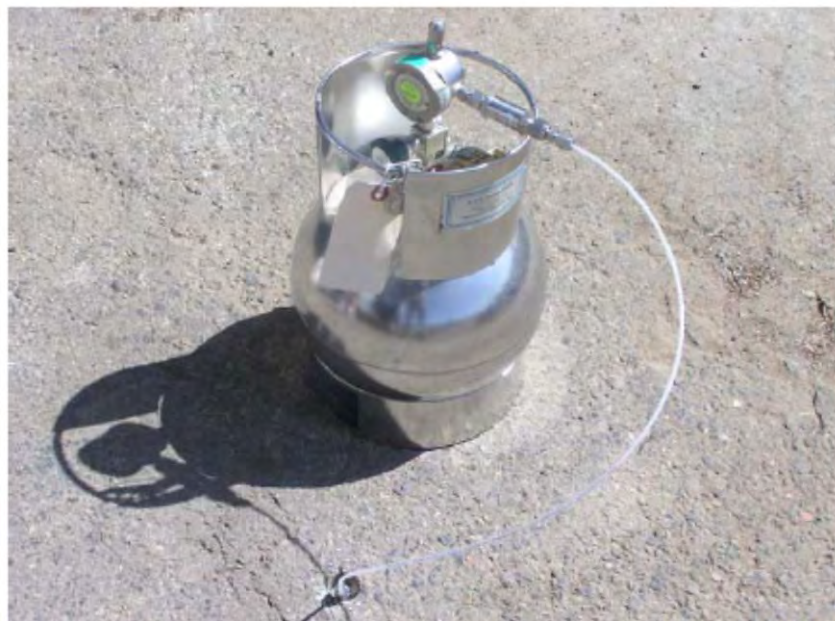
Example of the flush mounted vapor sampling point

Upon request and/or approval by the homeowner of the sub-slab vapor sampling activities, the desired location will be in the southeast corner of the basement. This may require temporarily removing any floor coverings including but not limited to carpet and carpet pad, if present, in order to access the concrete slab directly. Subsequent to conducting the vapor sampling activities, the sub-slab vapor sampling point will be sealed with grout flush to grade with the existing concrete surface and the floor coverings will be returned to their original position.
