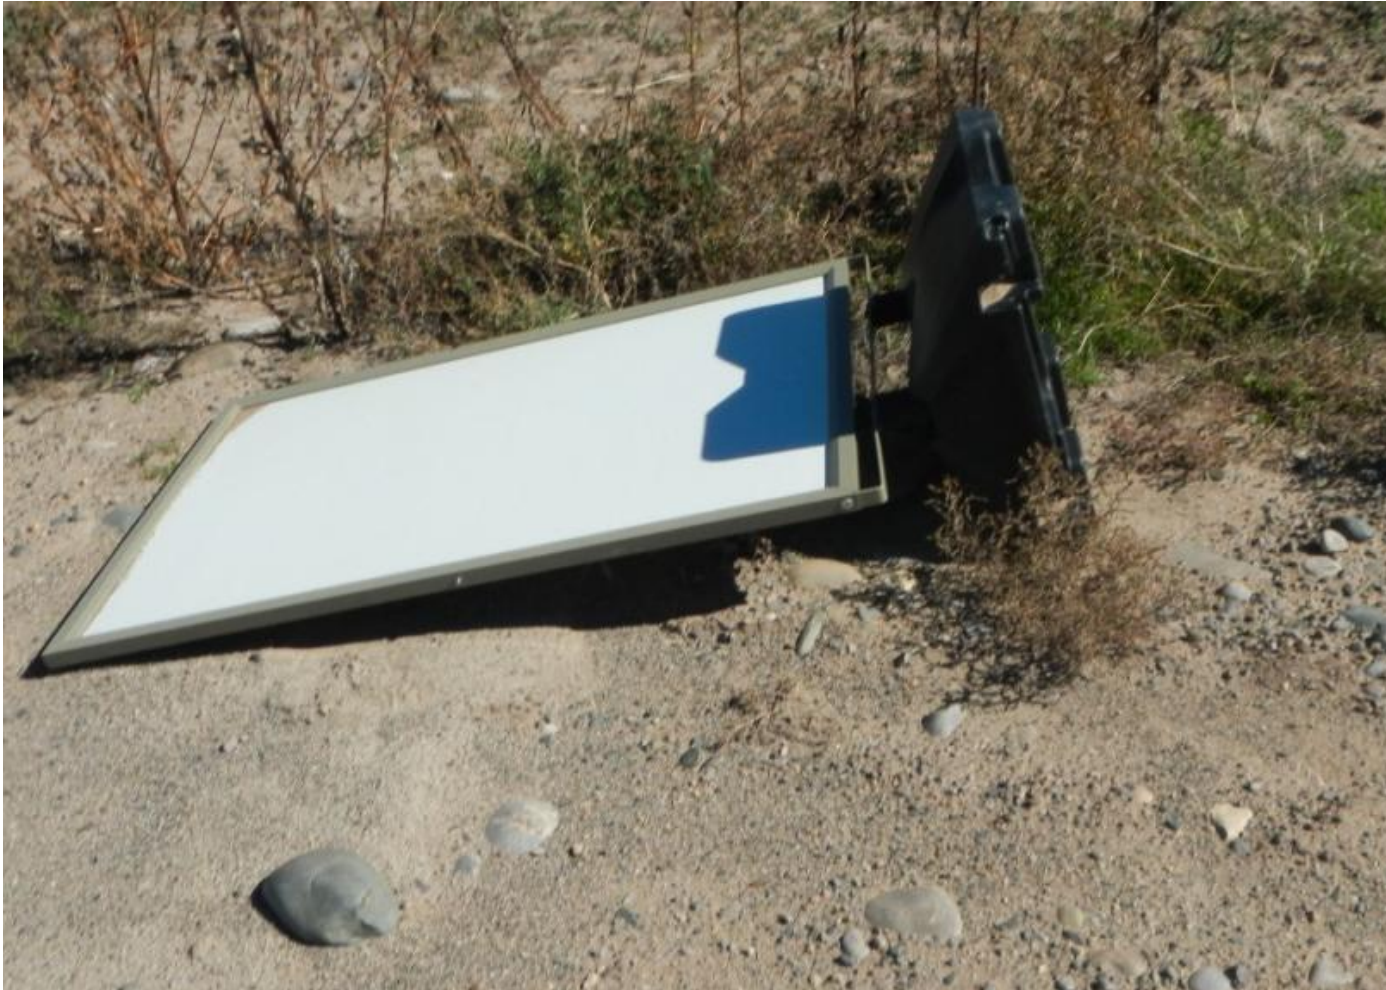
Photo 1. View of tipped sign at the entrance to the project area.

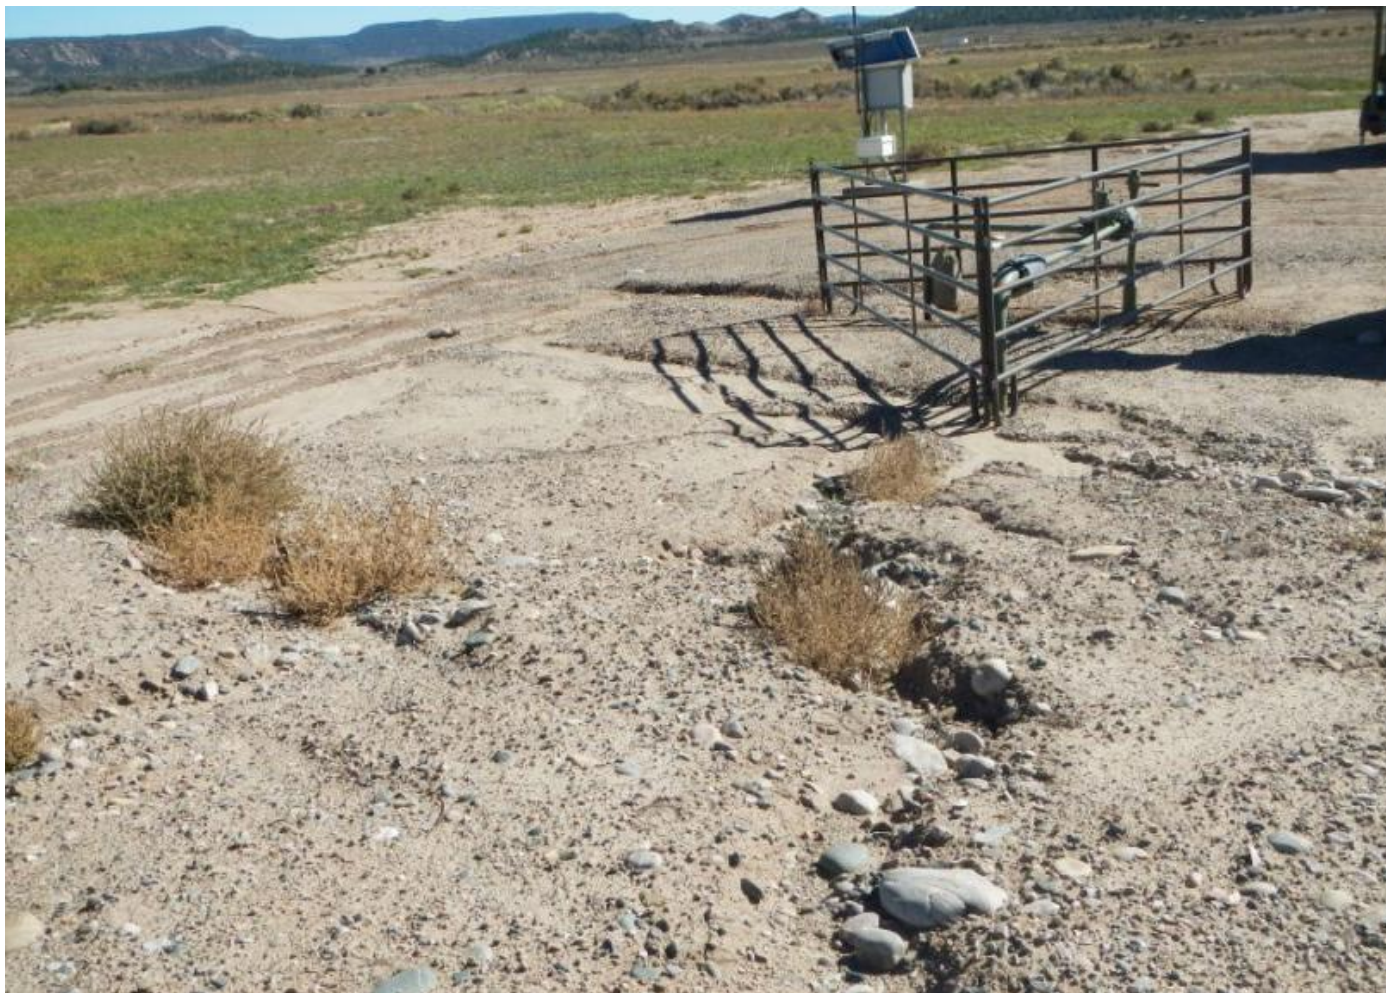
Photo 2. View of stormwater erosion in the eastern portion of the project area. Erosional channels are formed (approximately 12 inches deep and 24 inches wide) and appear to be carrying sediment outside of the project area (in background).

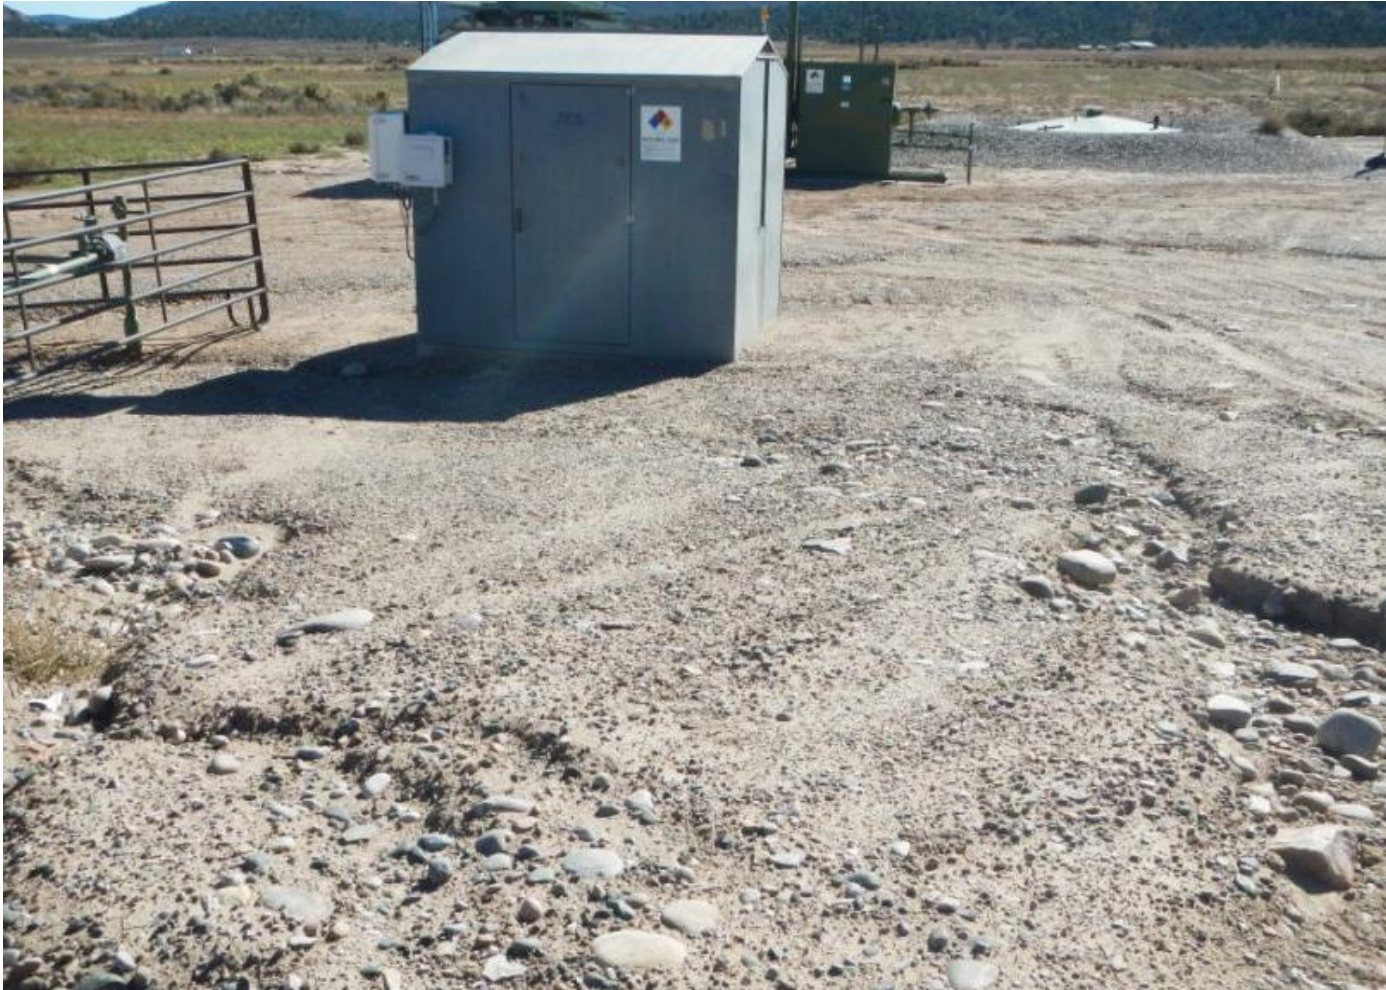
Photo 3. Another view of stormwater erosion in the eastern portion of the project area. Erosional channels are flowing beneath and through project facilities.

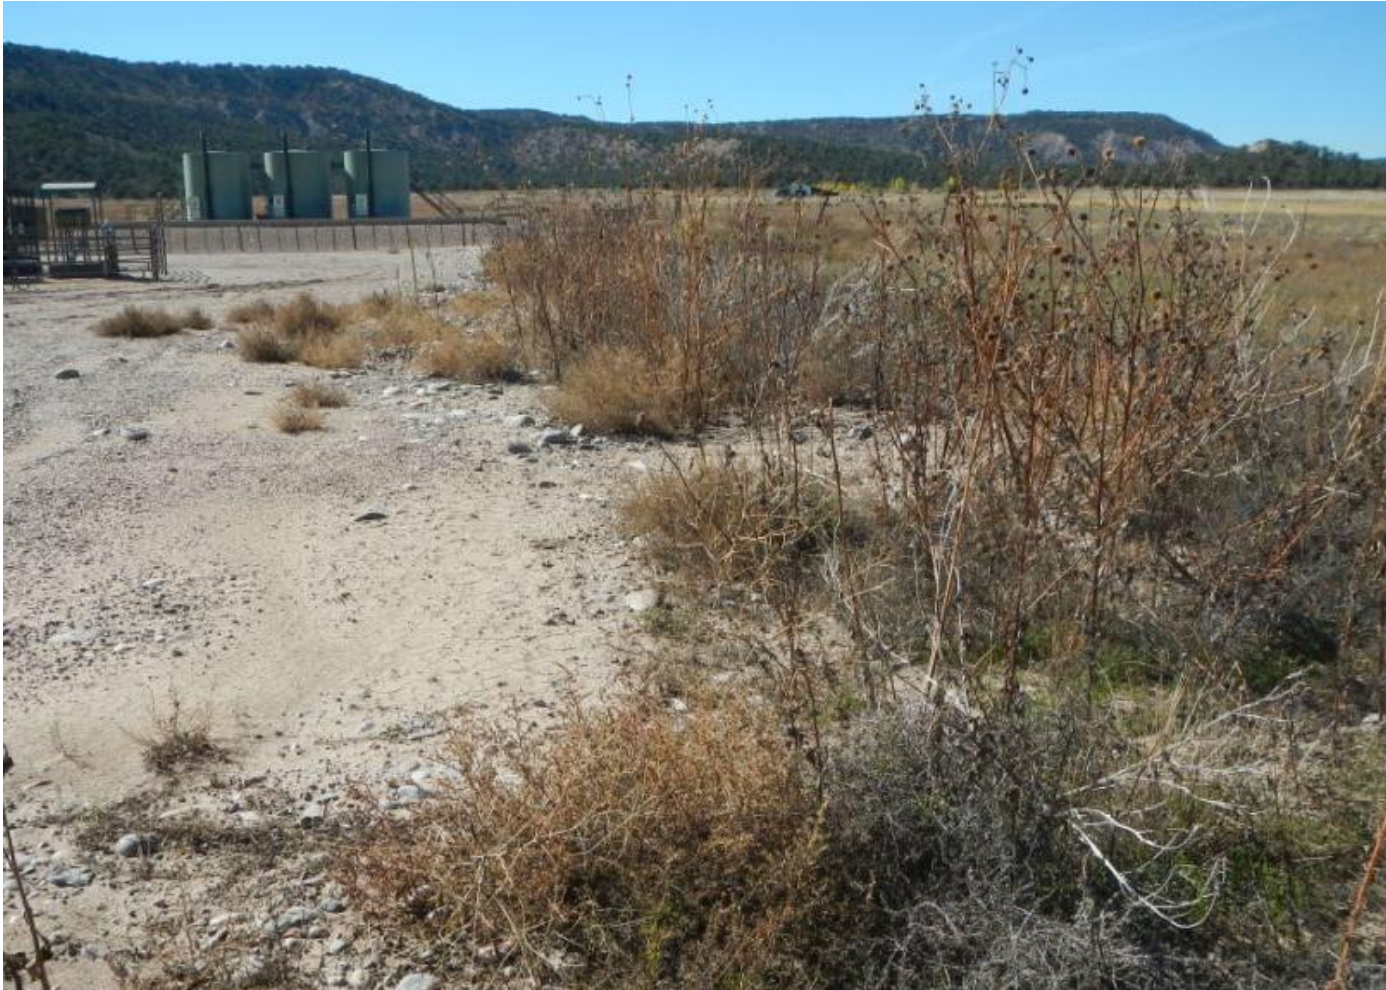
Photo 4. View of northern portion of project area from northeastern corner facing westward. Dried weeds such as annual sunflower (*Helianthus annuus*) and Russian thistle (*Salsola tragus*) are growing here.

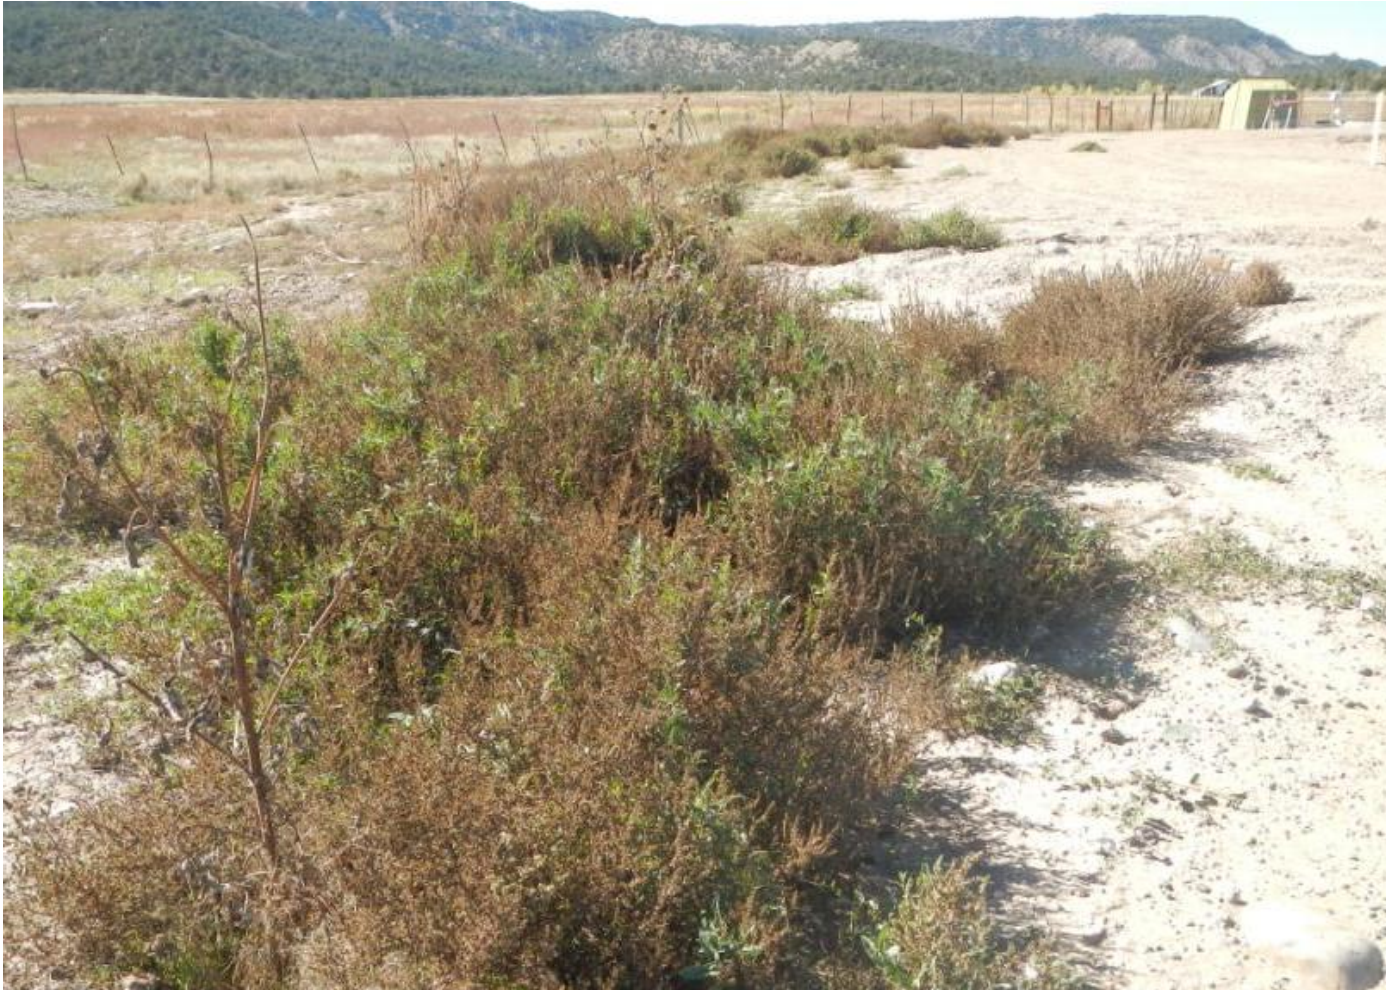
Photo 5. View southern portion of project area where Russian thistle and kochia (*Kochia scoparia*) debris is present.
