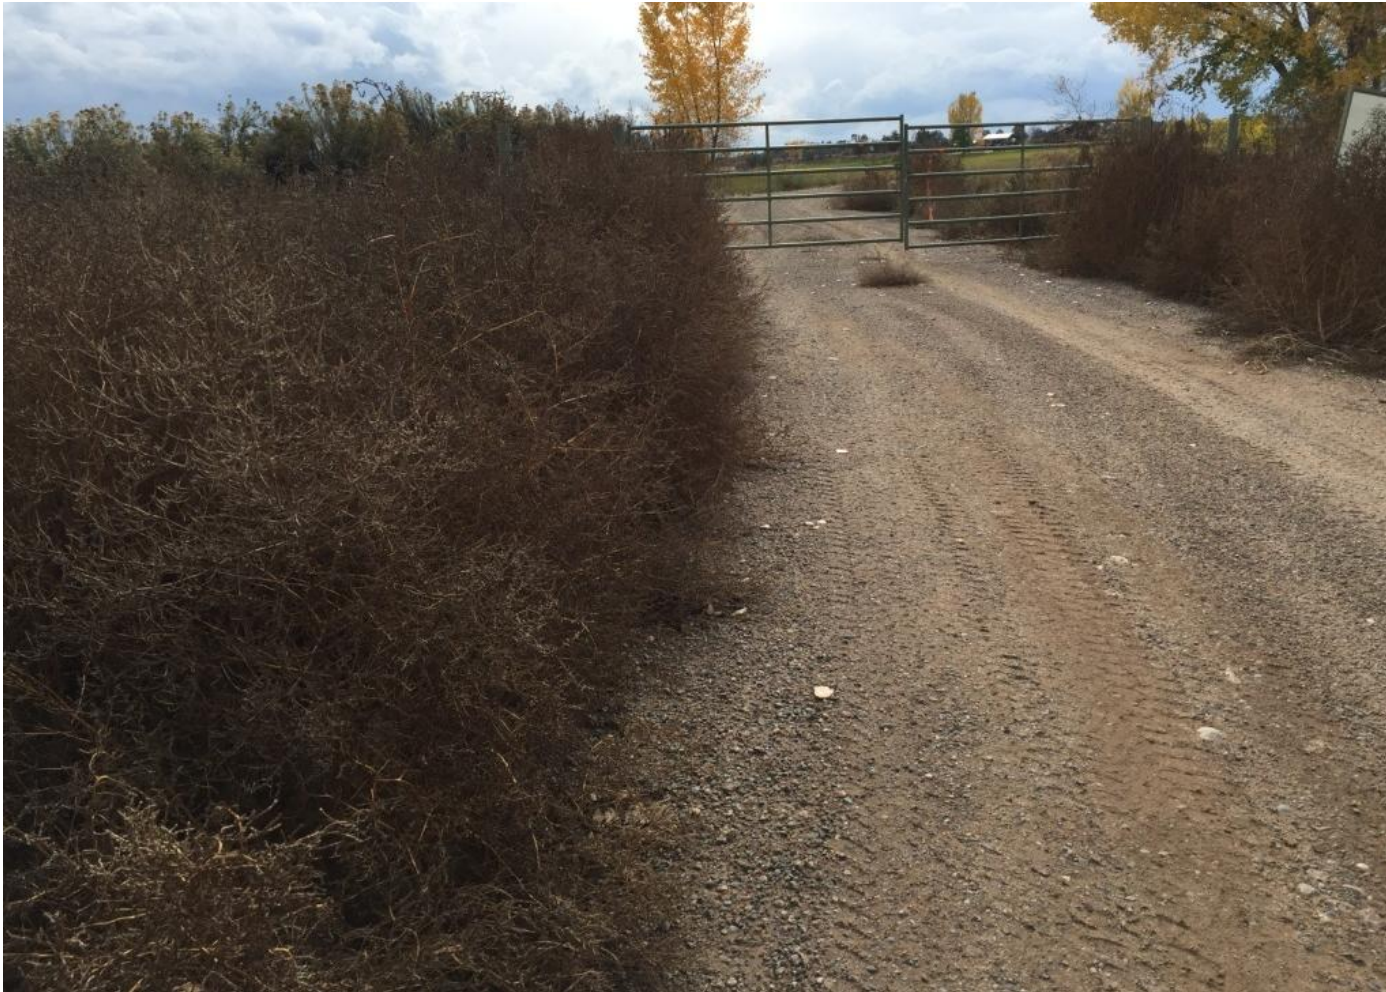
Photo 1. View of dense kochia (*Kochia scoparia*; approximately 5 to 6 feet tall) growing on both sides of the access road from the well pad entrance facing southward.

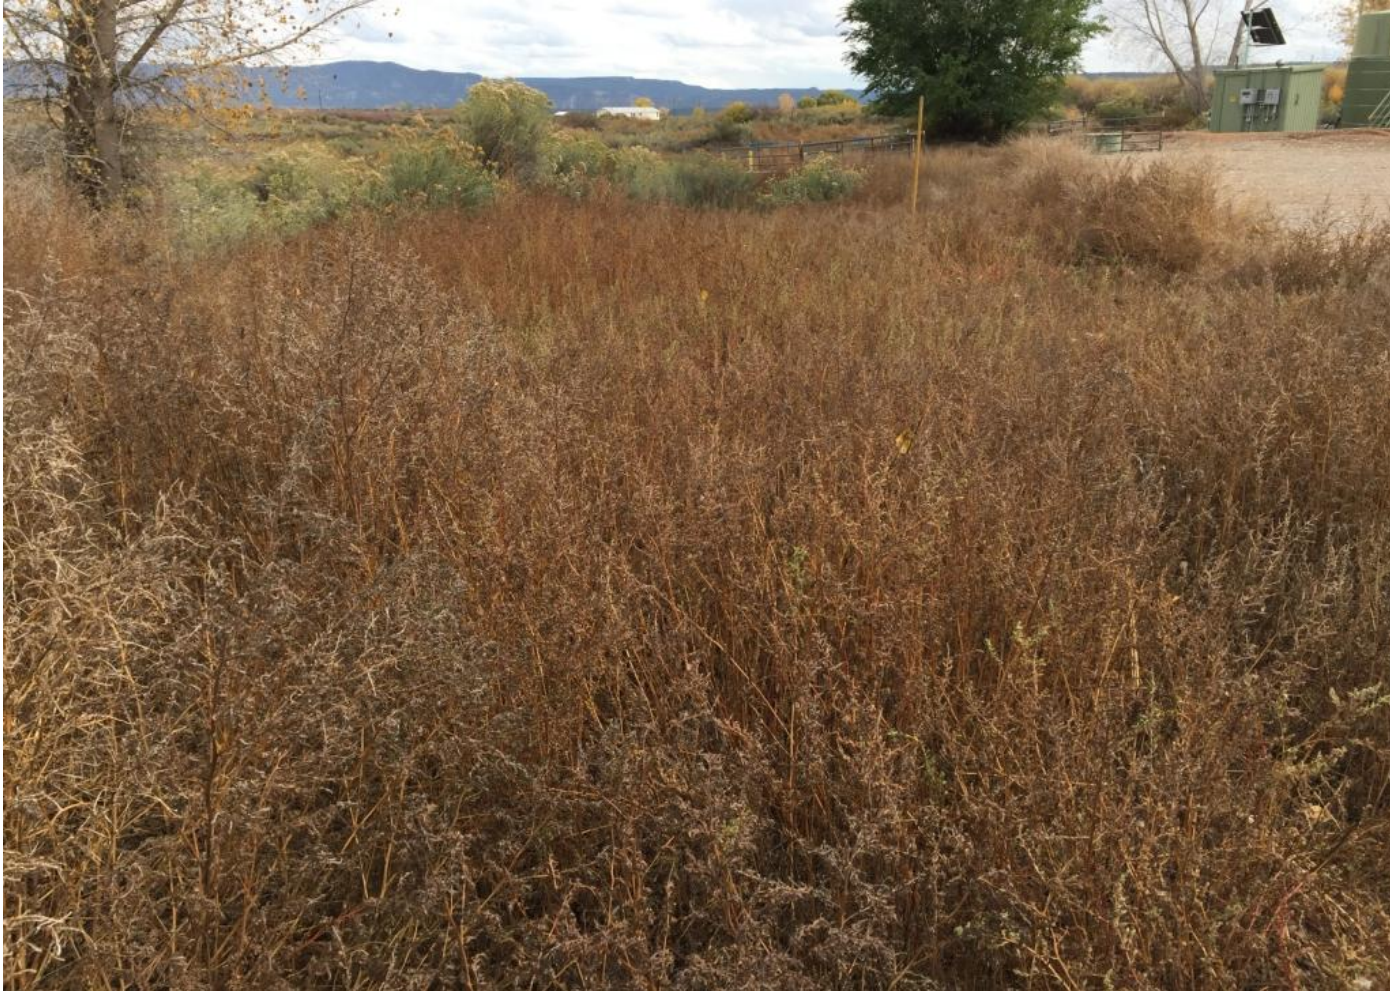
Photo 3. View of northeastern portion of project area facing southward. Dense kochia is growing here.

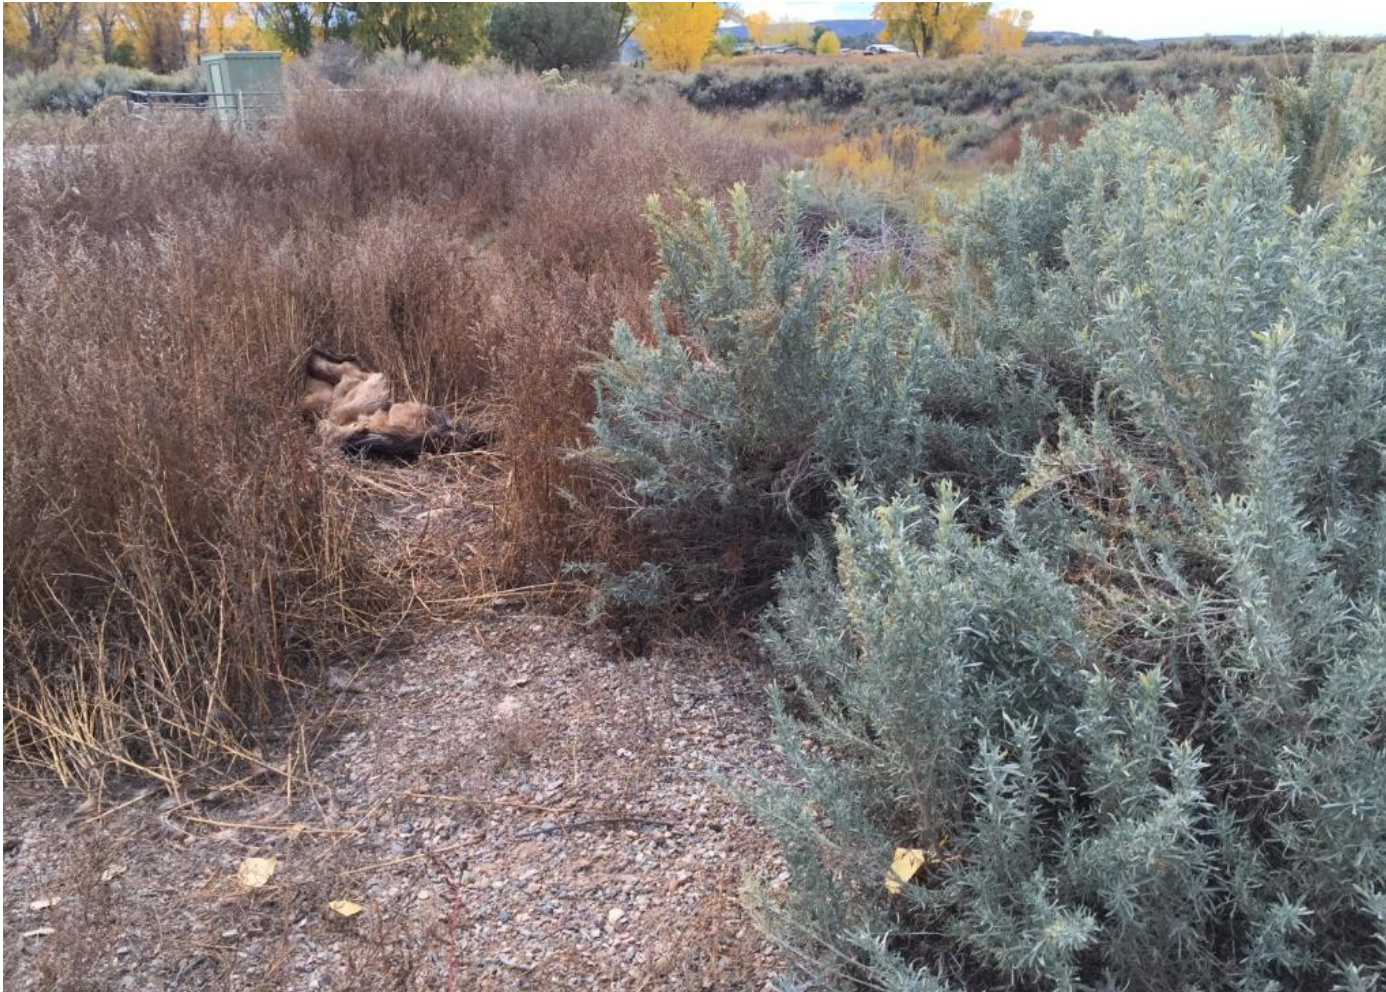
Photo 4. View of northern portion of project area from northeastern corner facing westward. Dense kochia is also growing here.

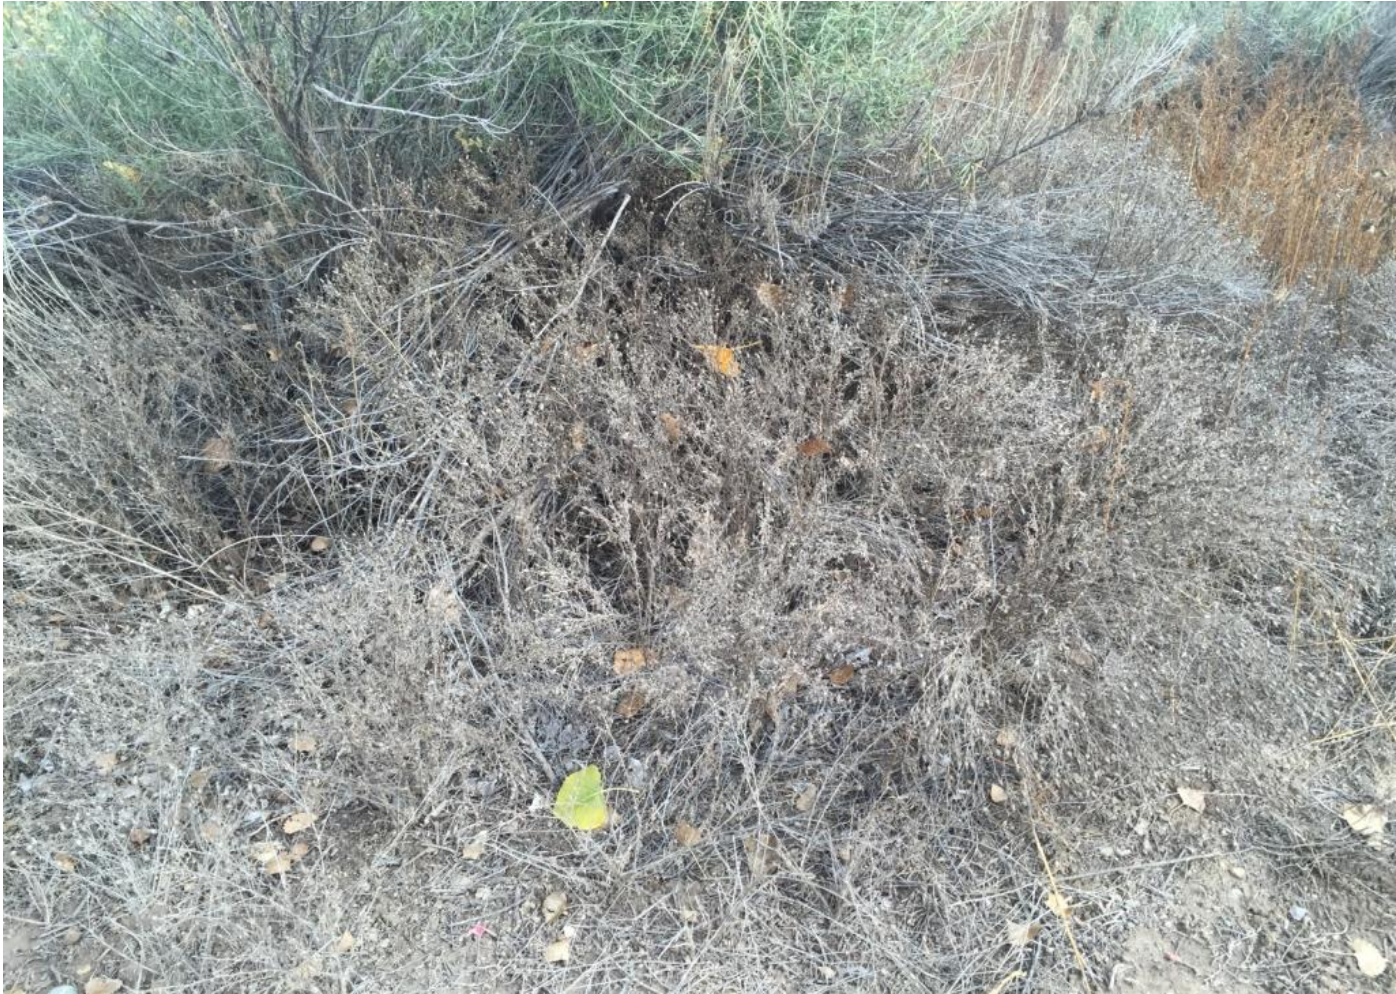
Photo 5. View of Russian knapweed plants in the eastern portion of the project area.

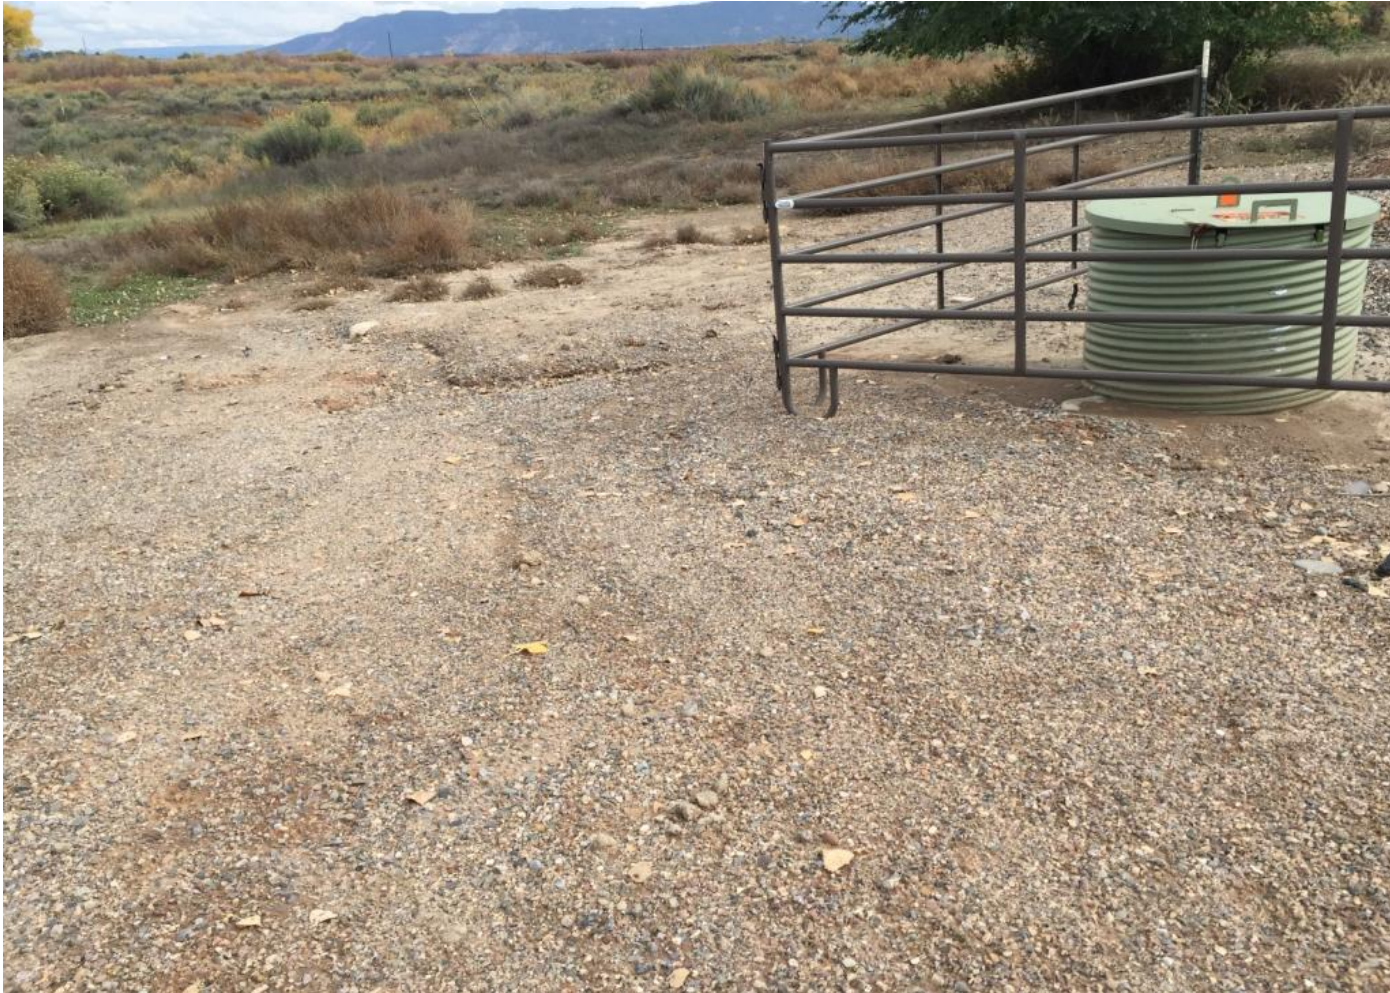
Photo 6. View of stormwater erosion occurring in the eastern portion of the project area.

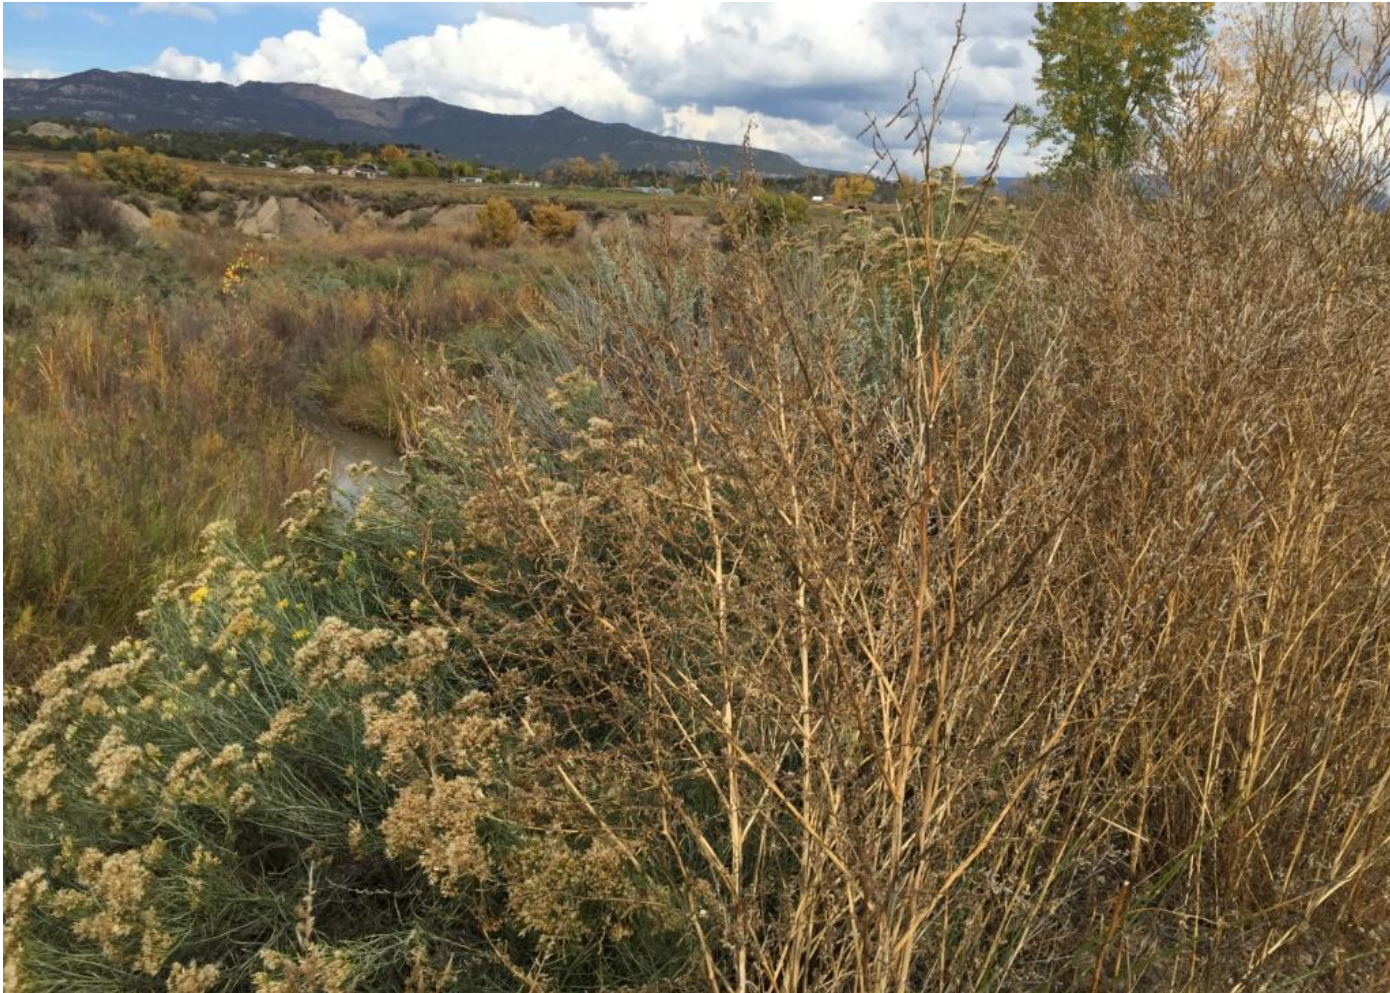
Photo 7. View of perennial stream that flows adjacent to the northern and eastern portions of the project area facing northeastward.
