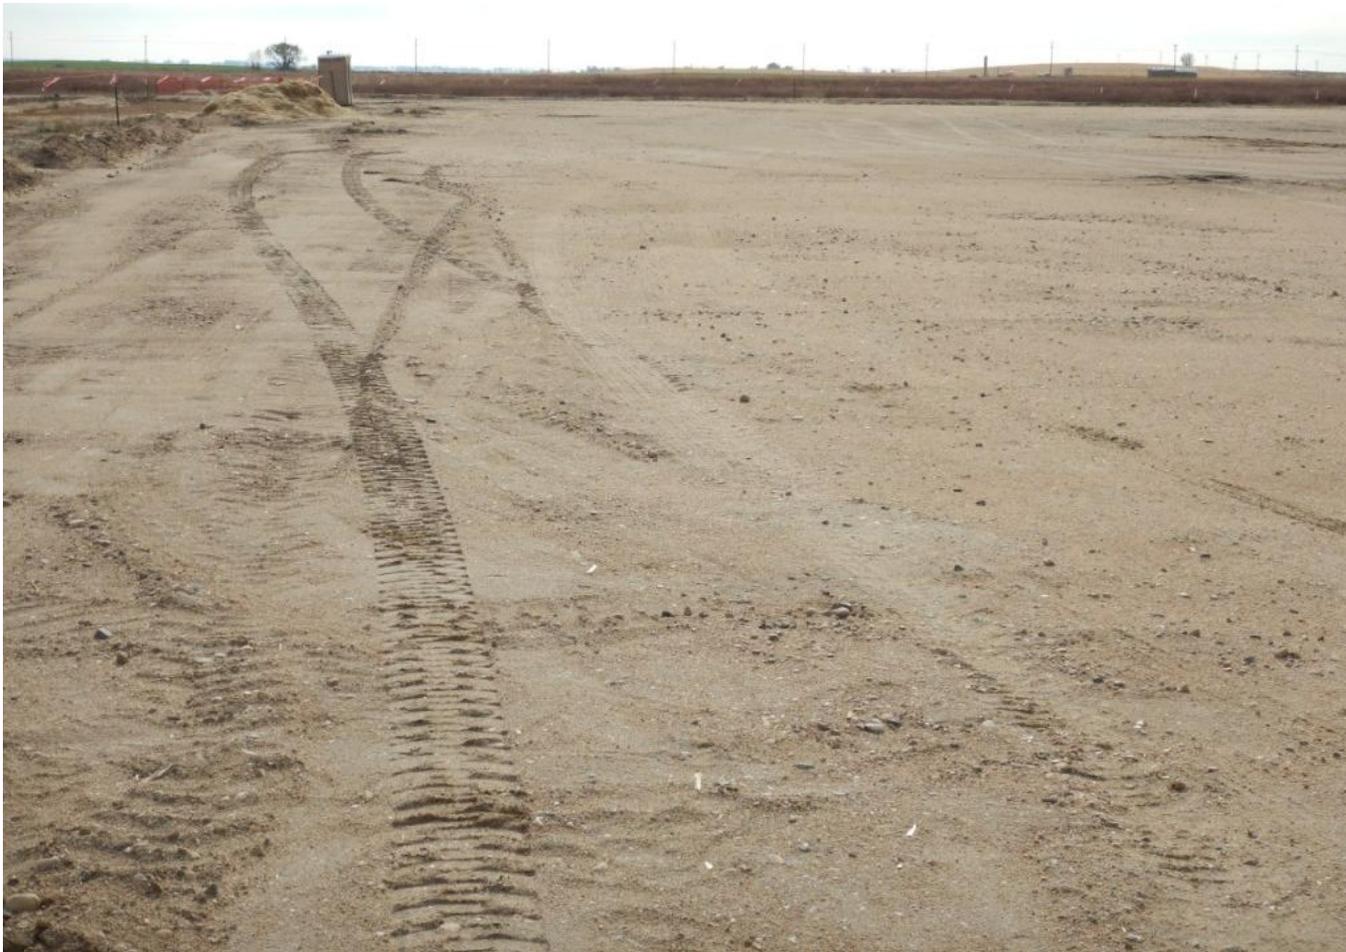
**Photo 1.** Photo taken from northeast location, facing South. When interim reclamation starts, this area shall be reclaimed and minimized where production or facilities are no longer necessary.

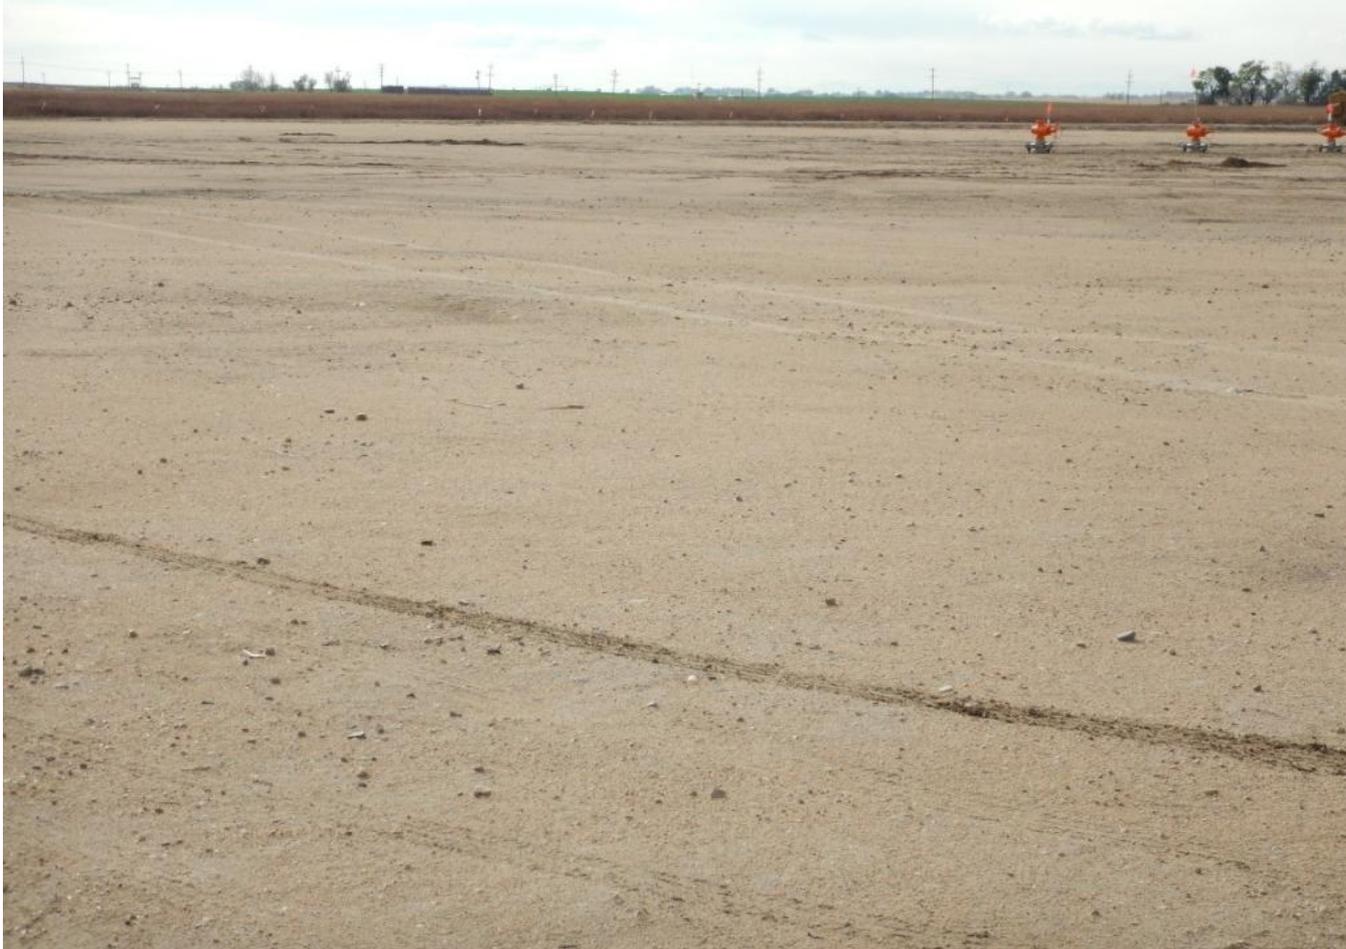
**Photo 2.** Photo taken from northeast location, facing Southwest. When interim reclamation starts, this area shall be reclaimed and minimized where production or facilities are no longer necessary.

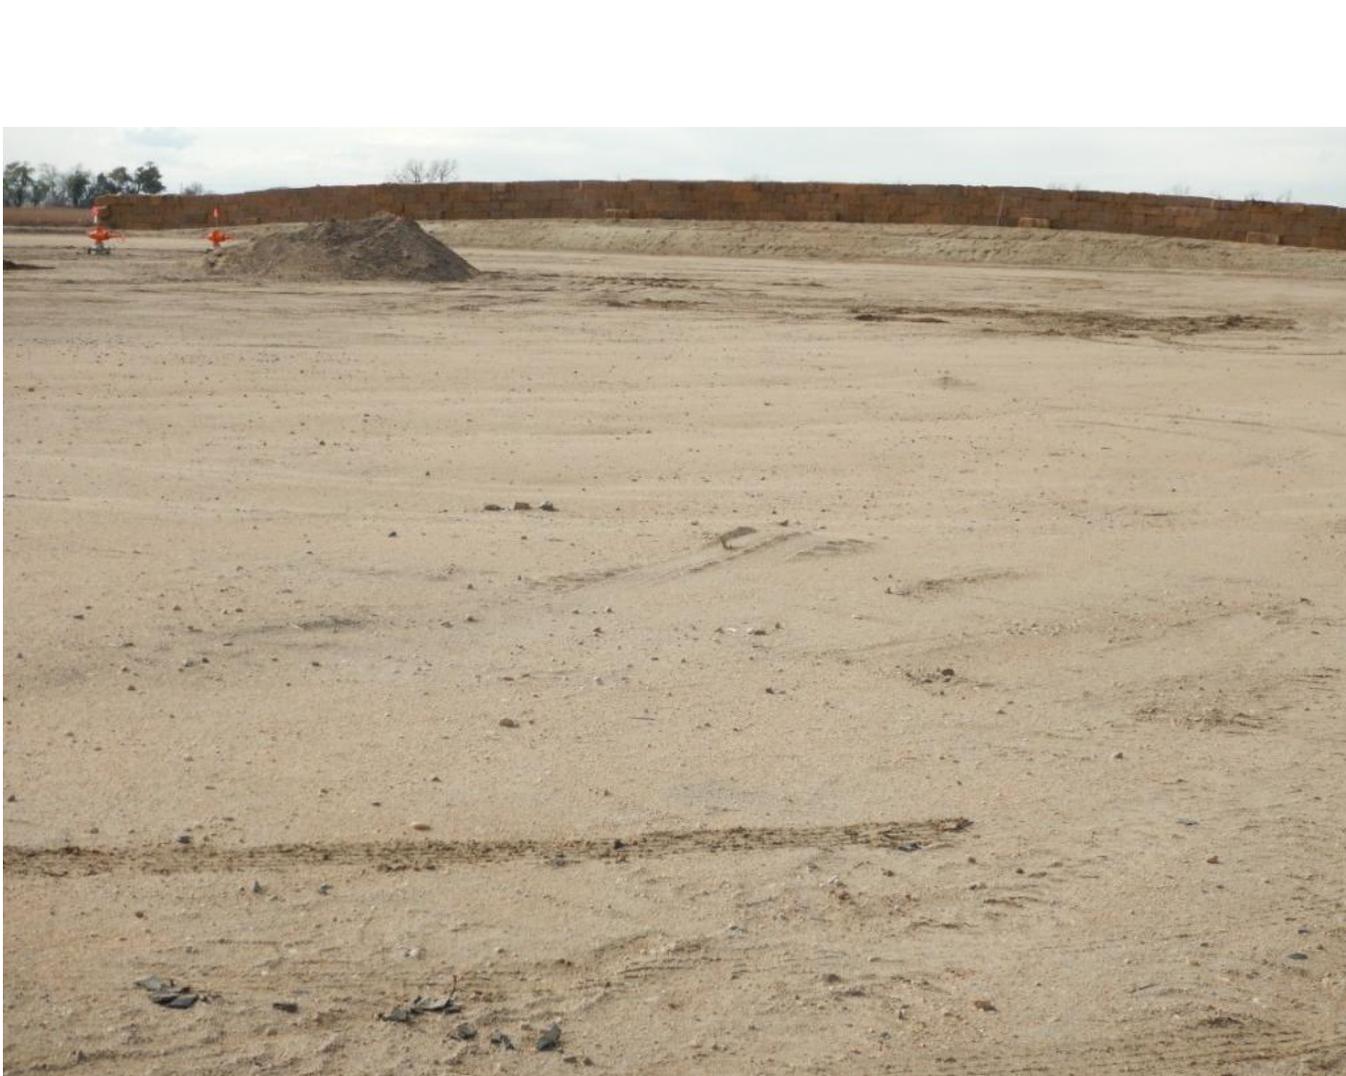
**Photo 3.** Photo taken from northeast location, facing West. When interim reclamation starts, this area shall be reclaimed and minimized where production or facilities are no longer necessary.

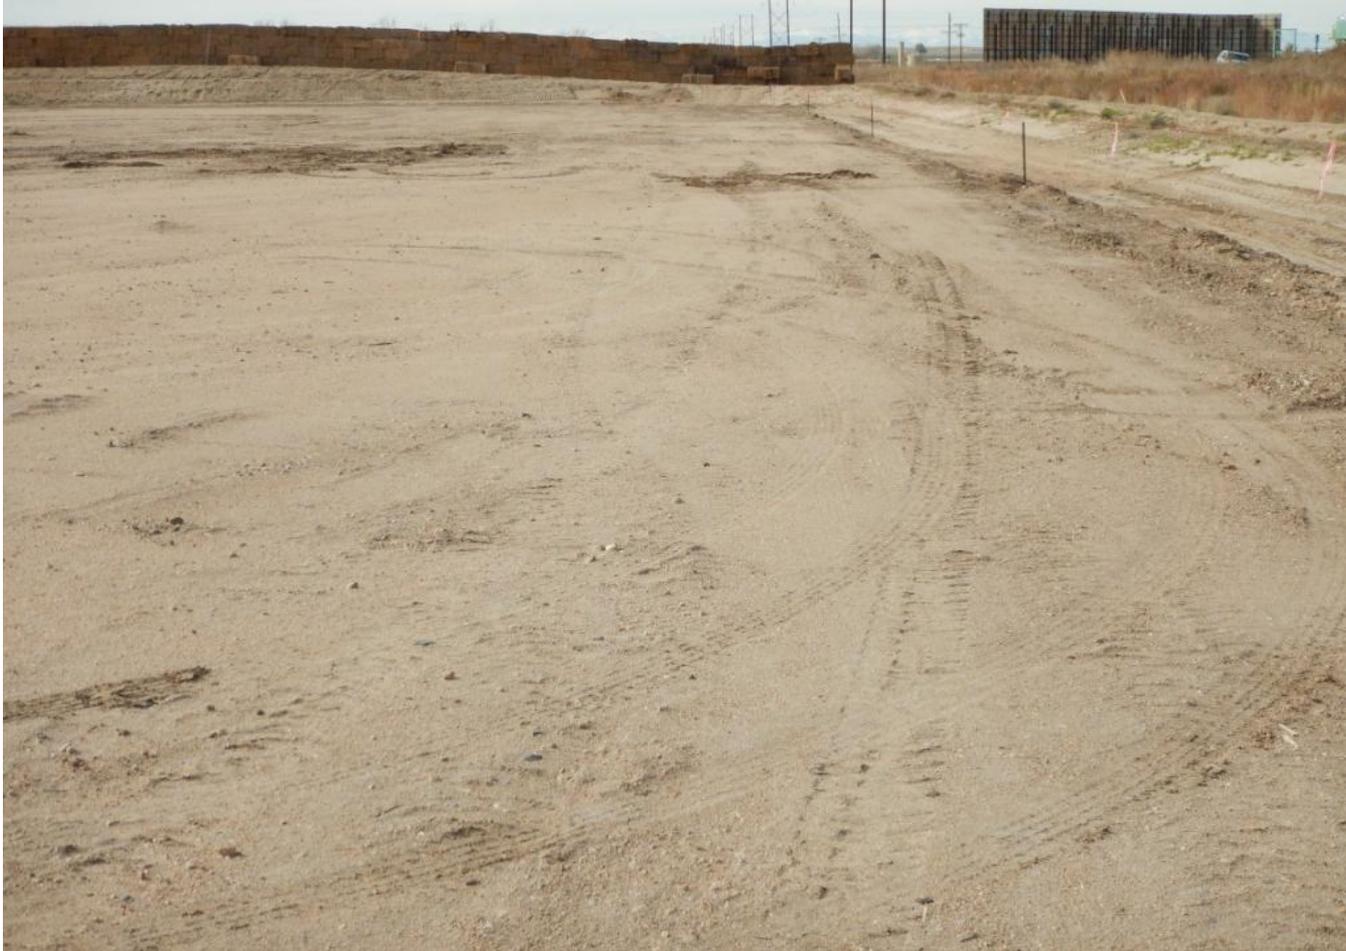
**Photo 4.** Photo taken from northeast location, facing West. When interim reclamation starts, this area shall be reclaimed and minimized where production or facilities are no longer necessary.

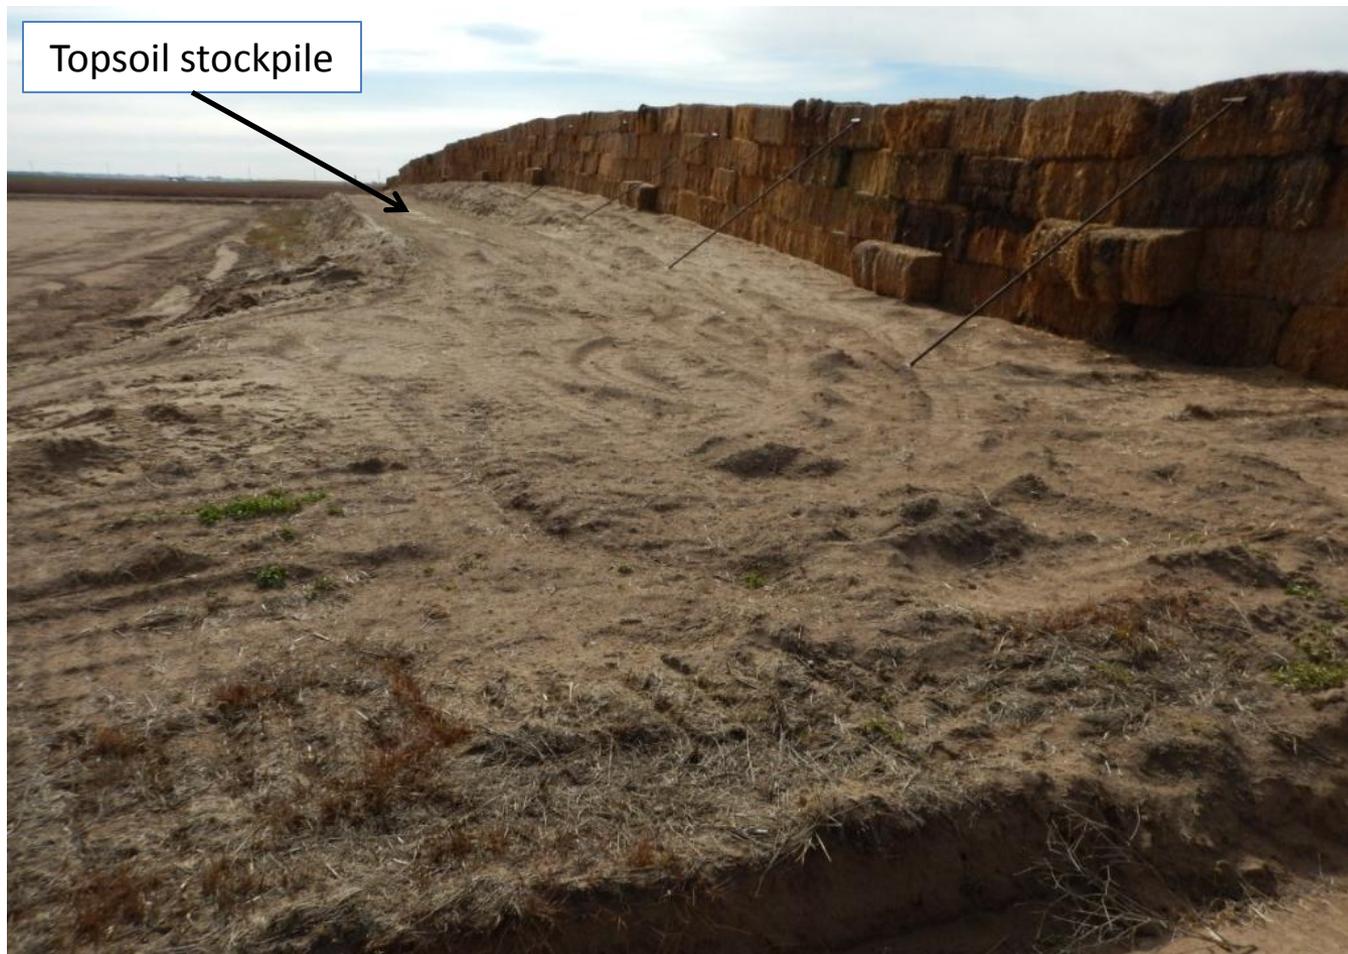
**Photo 5.** Photo taken from east-facing northwest location, facing South. Perennial vegetation is required for topsoil stabilization.

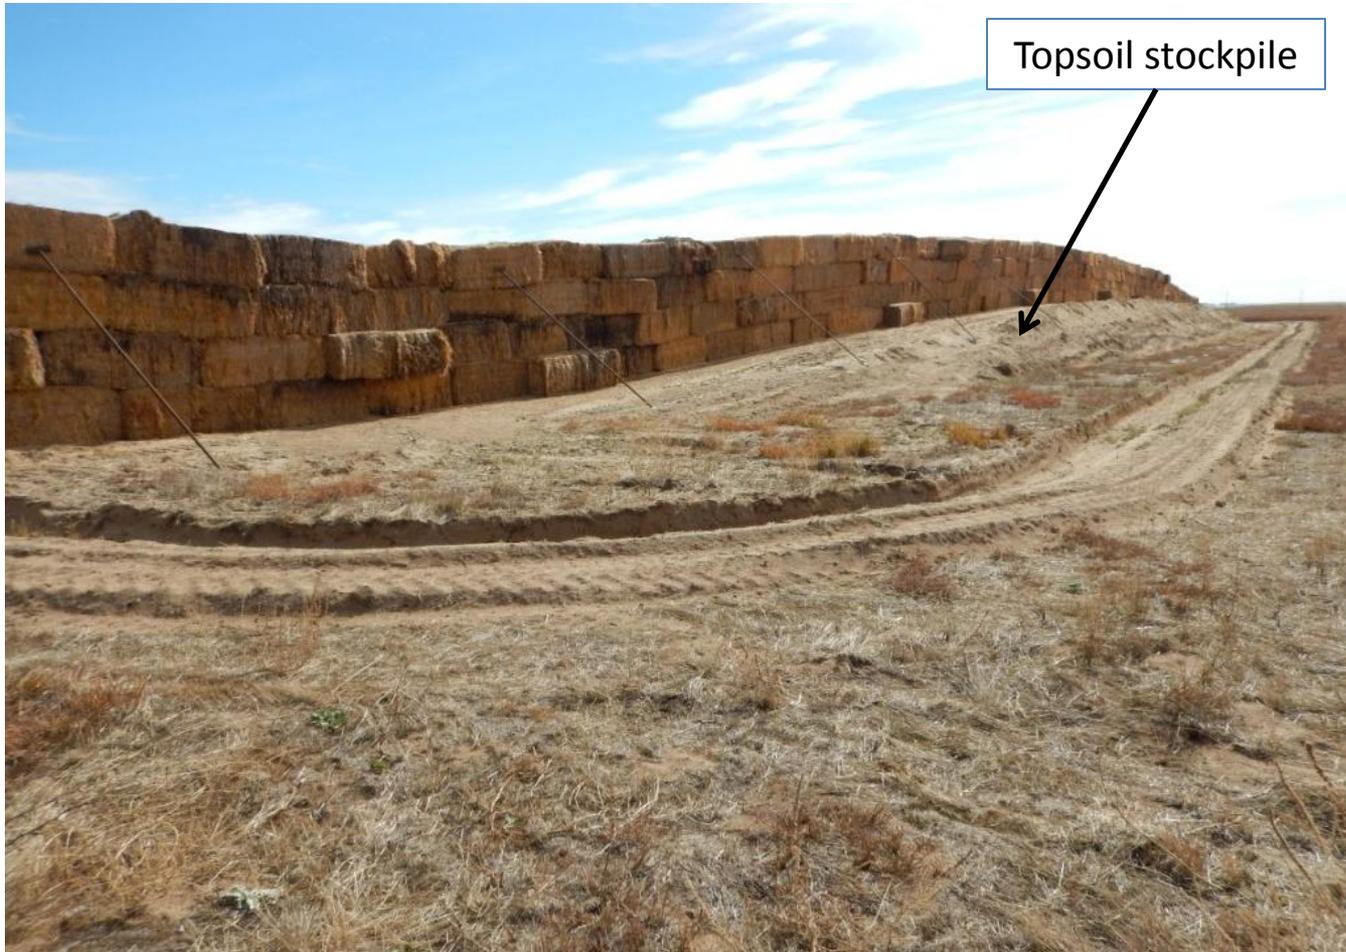
**Photo 6.** Photo taken from west-facing northwest location, facing South. Perennial vegetation is required for topsoil stabilization.

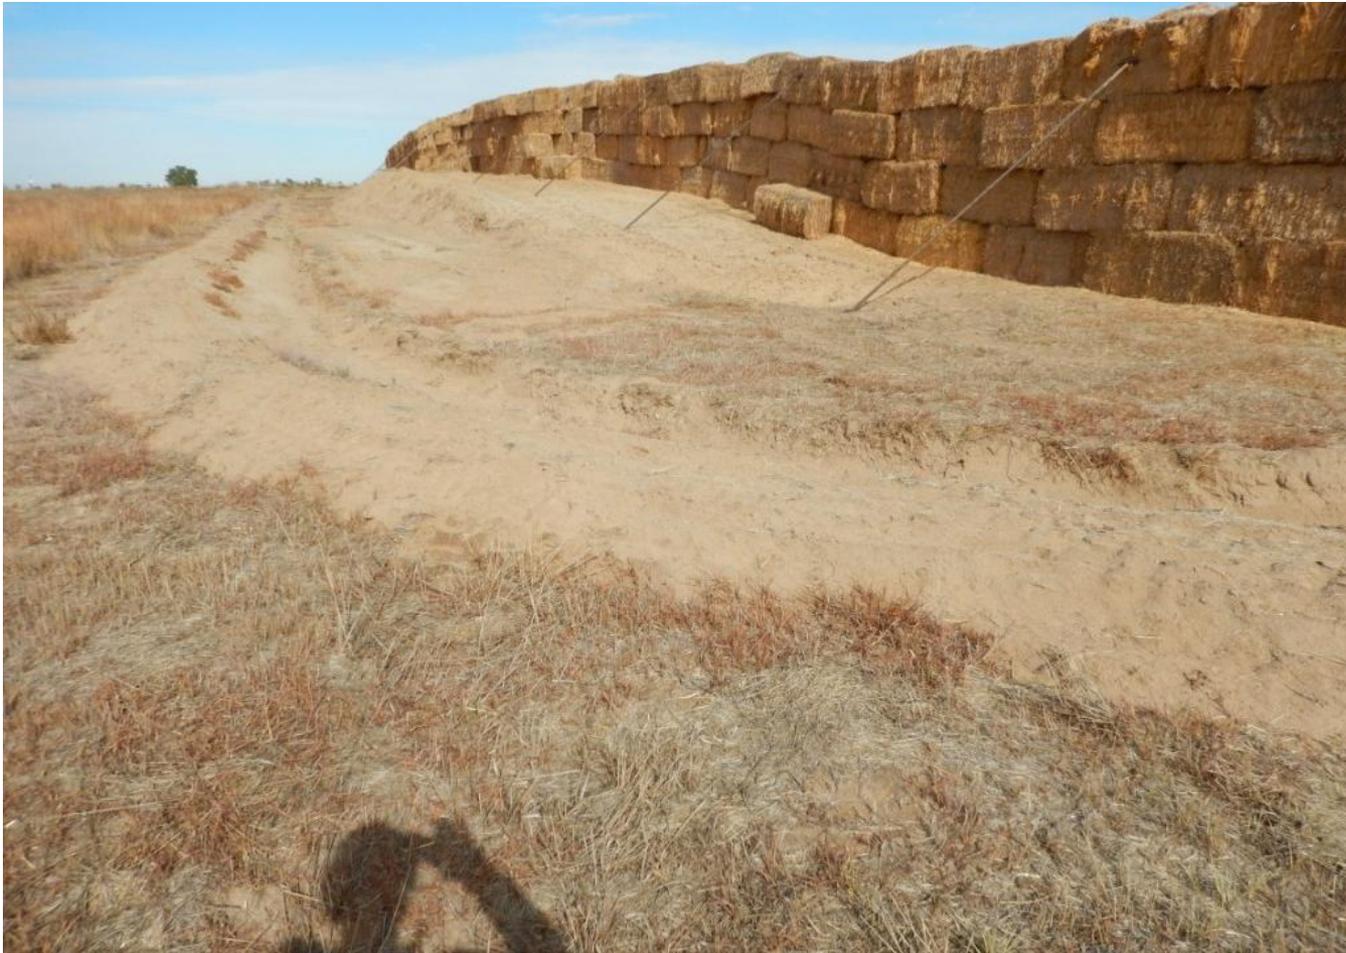
**Photo 8.** Photo taken from southwest location, facing North towards topsoil stockpile.

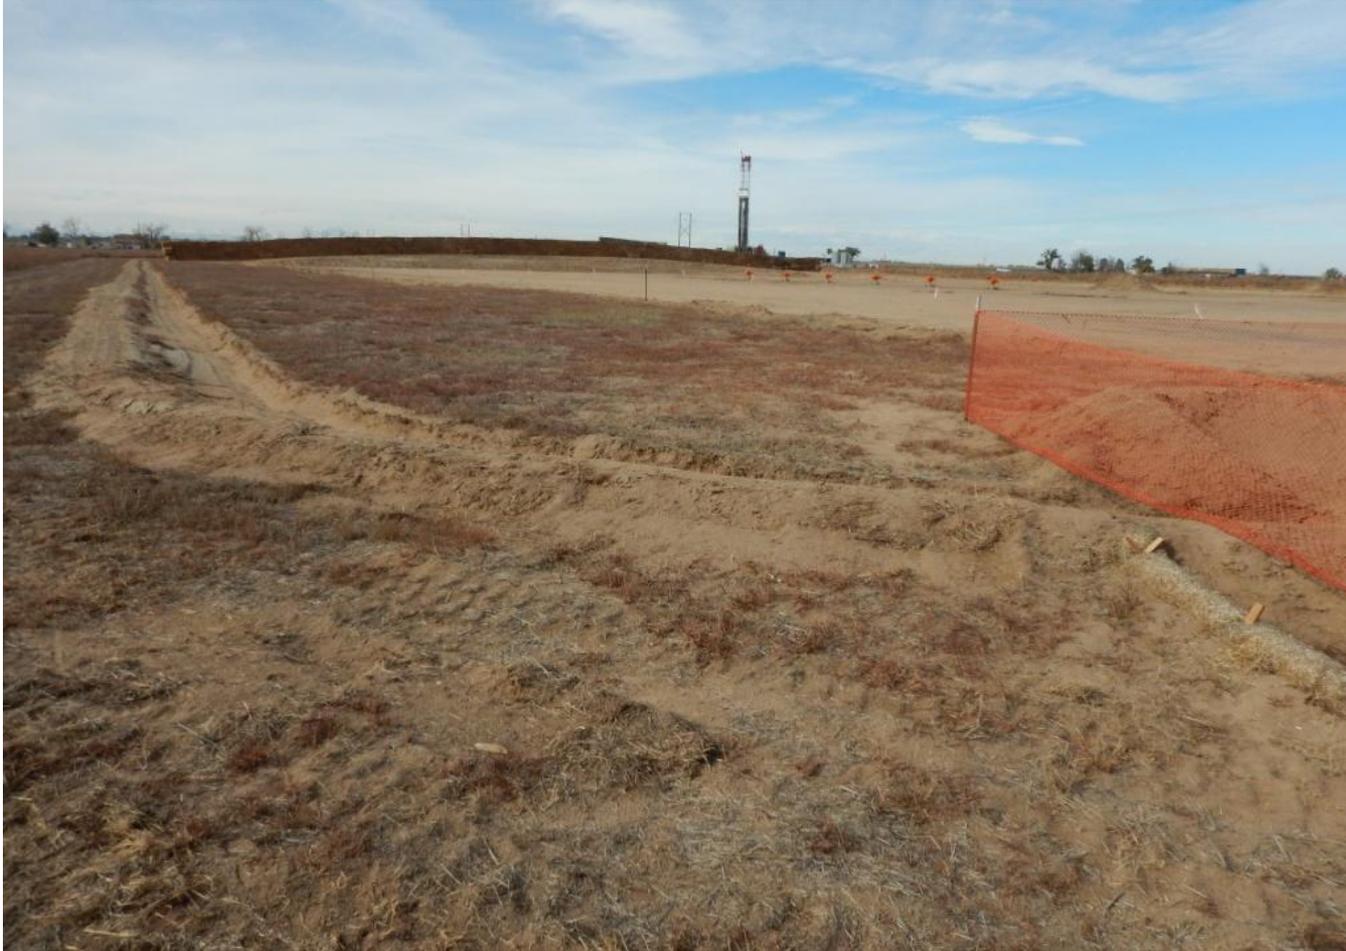
**Photo 10.** Photo taken from southeast location, facing Northwest. When interim reclamation starts, this area shall be reclaimed and minimized where production or facilities are no longer necessary.

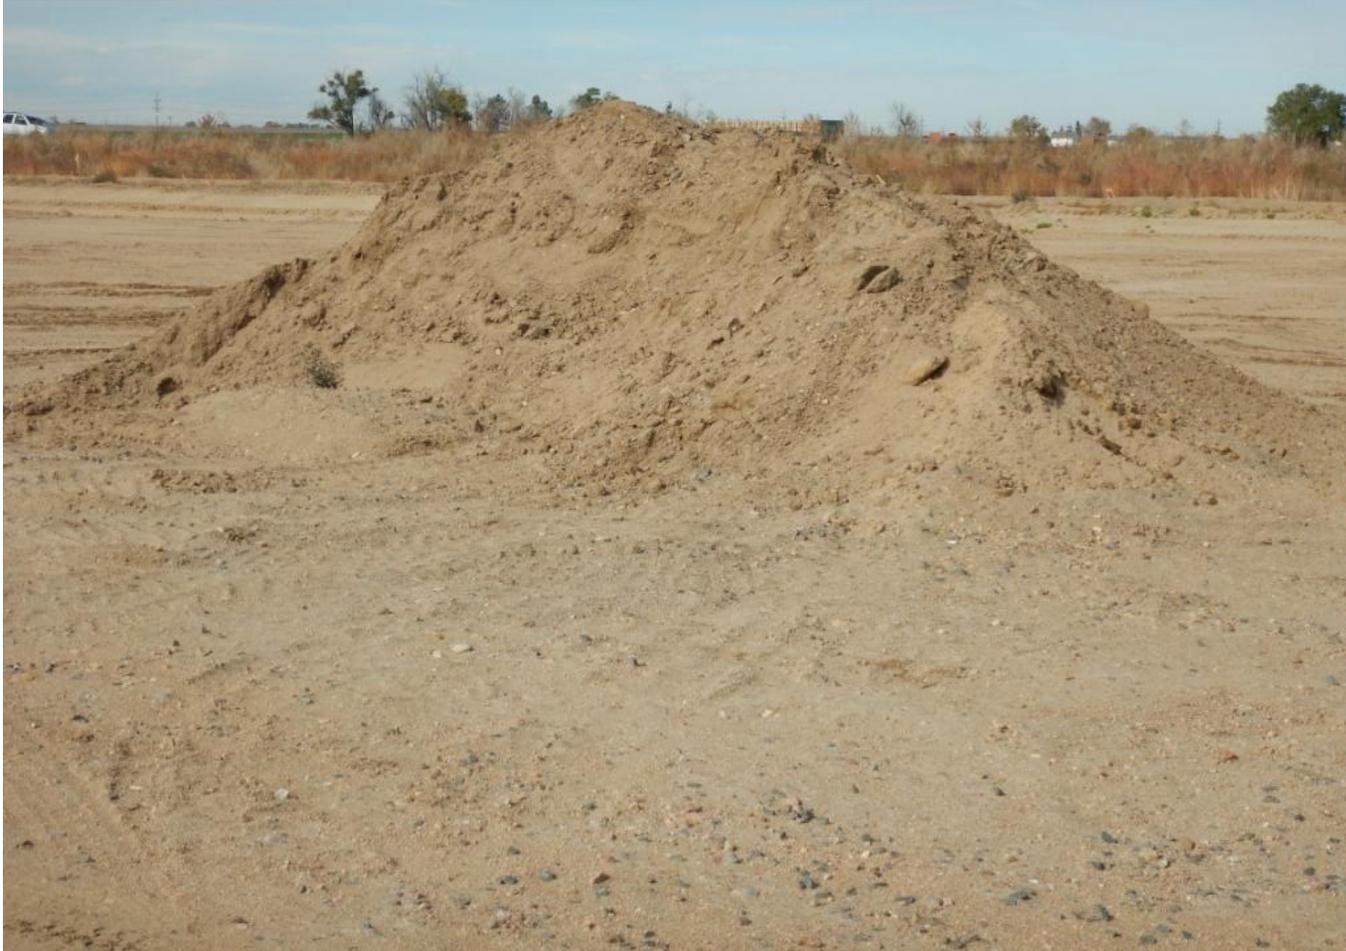
**Photo 13.** Photo taken from central location, facing North. Road base soil pile needs to be removed.

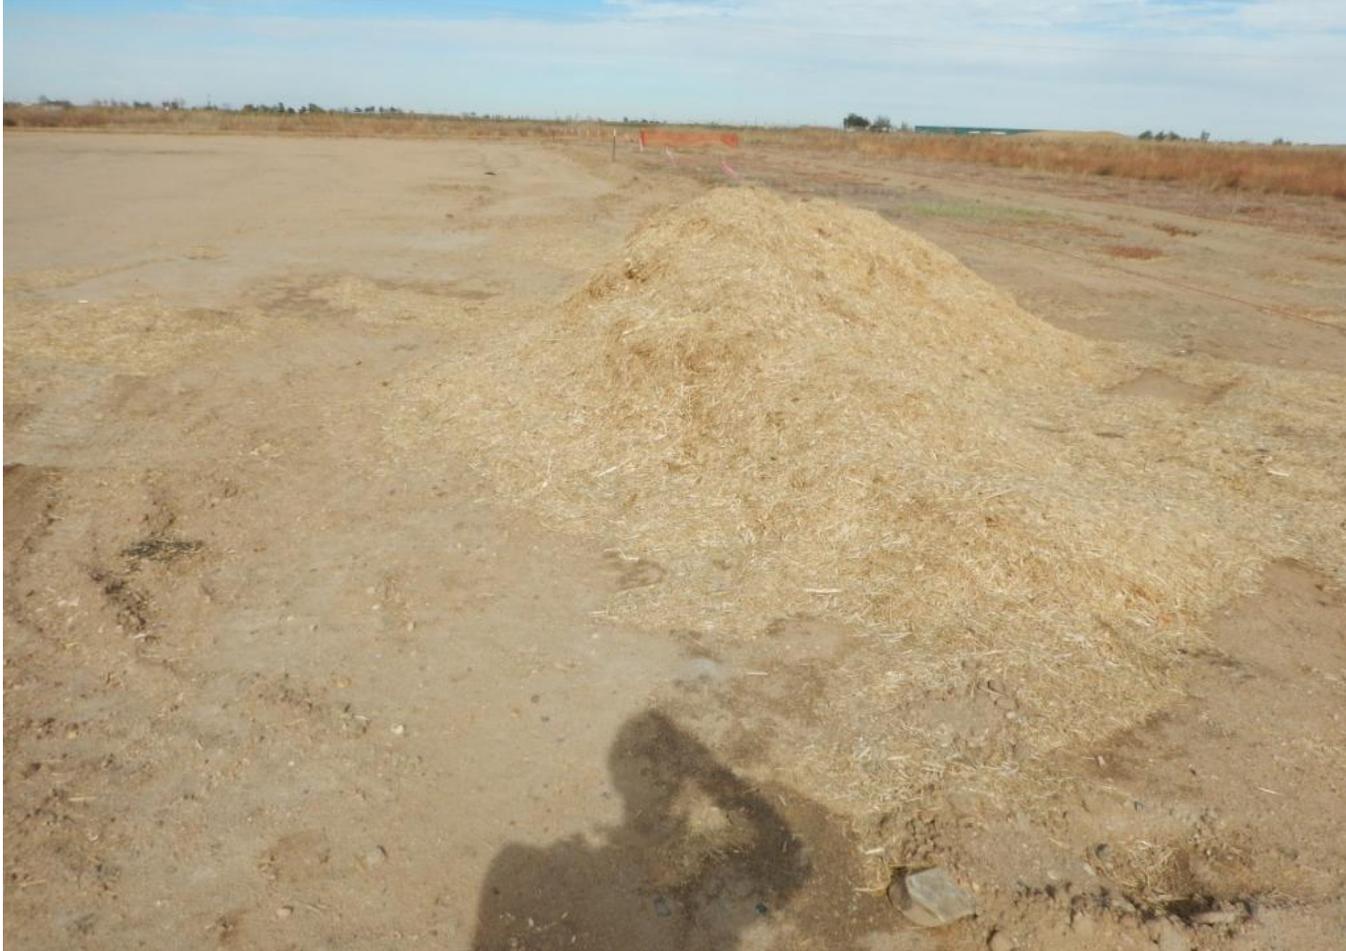
**Photo 14.** Photo taken from east location, facing North. Straw pile needs to be removed if no longer being used for operations.

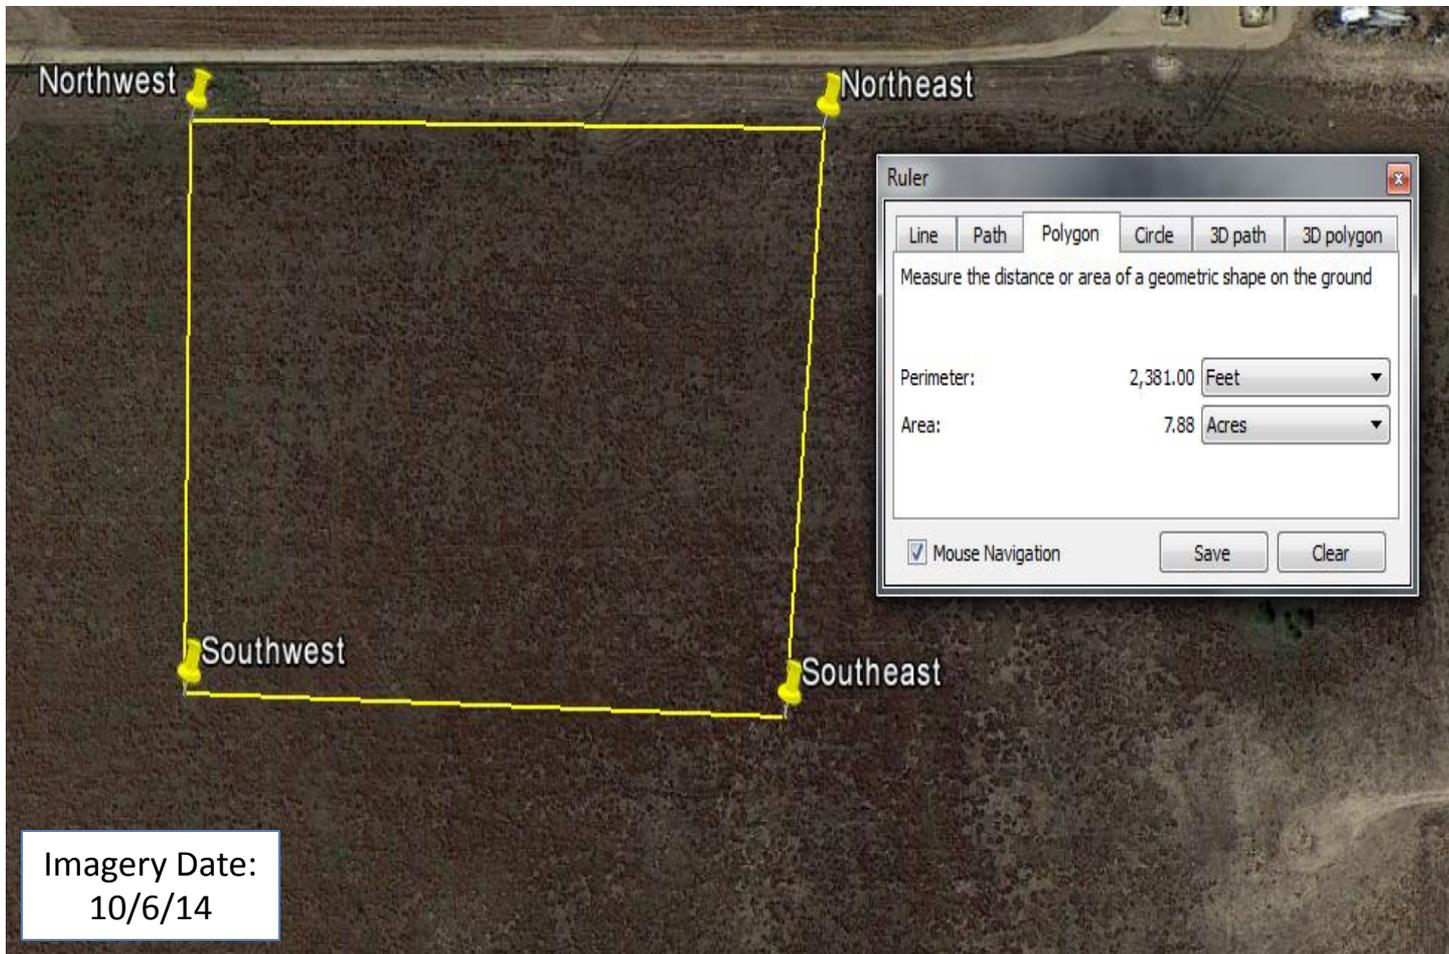
**Photo 15.** The perimeter, in yellow, illustrates the disturbance boundary as of 10/29/15. Total disturbance equals 7.9 acres which is greater than 5.7 acres stated in the 2A (Doc. #400834427) permitted area.
