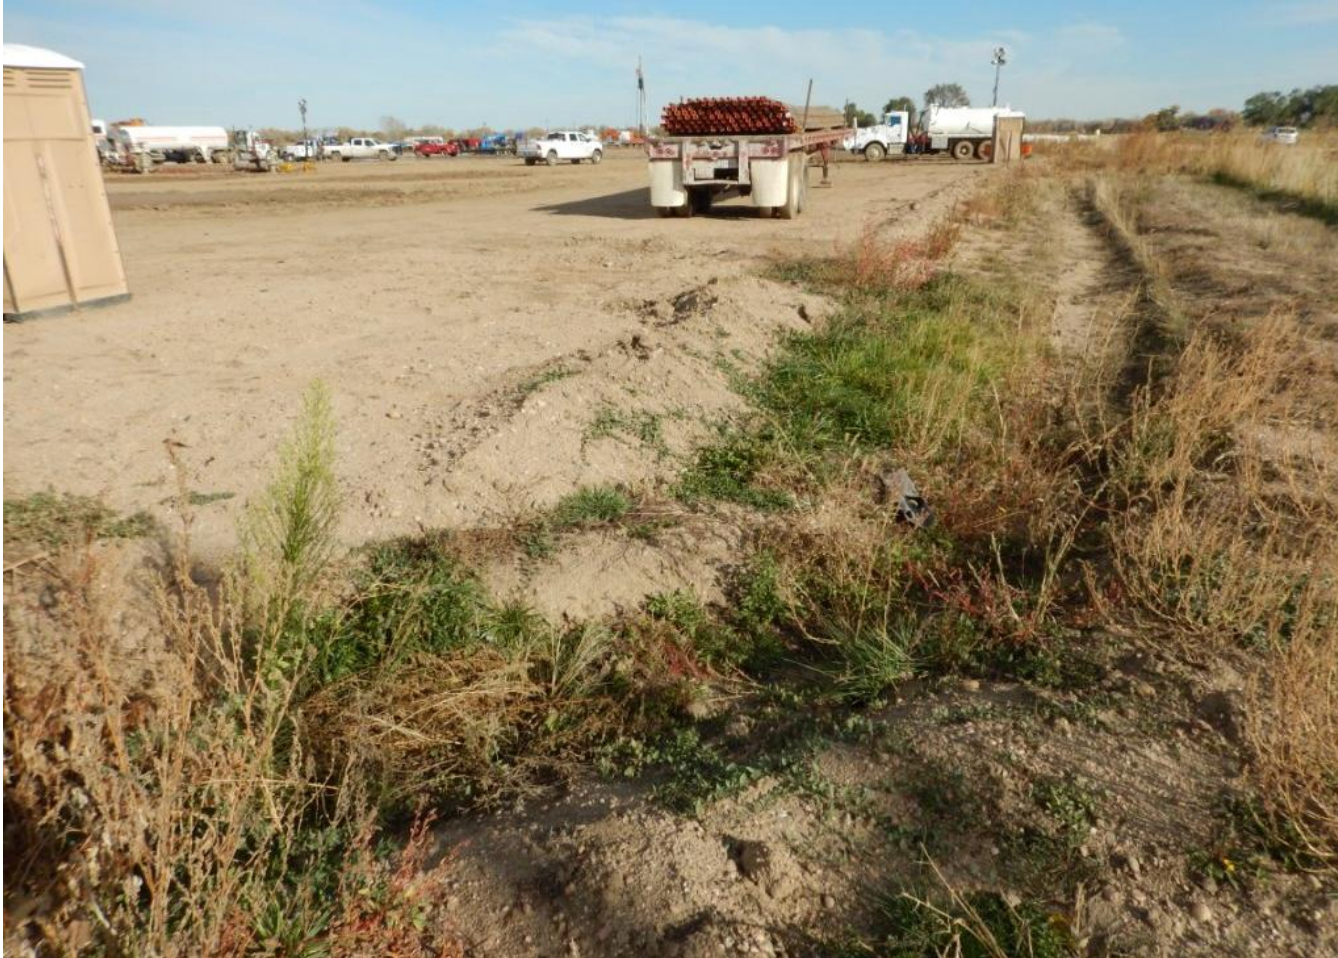
**Photo 1.** Photo taken from southwest location, facing East. Note the Kochia (*Kochia sp.*) and Russian thistle (*Salsola sp.*) in the photo. This is weed debris and will break off and encroach upon adjacent lands. When interim reclamation starts, this area shall be reclaimed and minimized where production or facilities are no longer necessary.

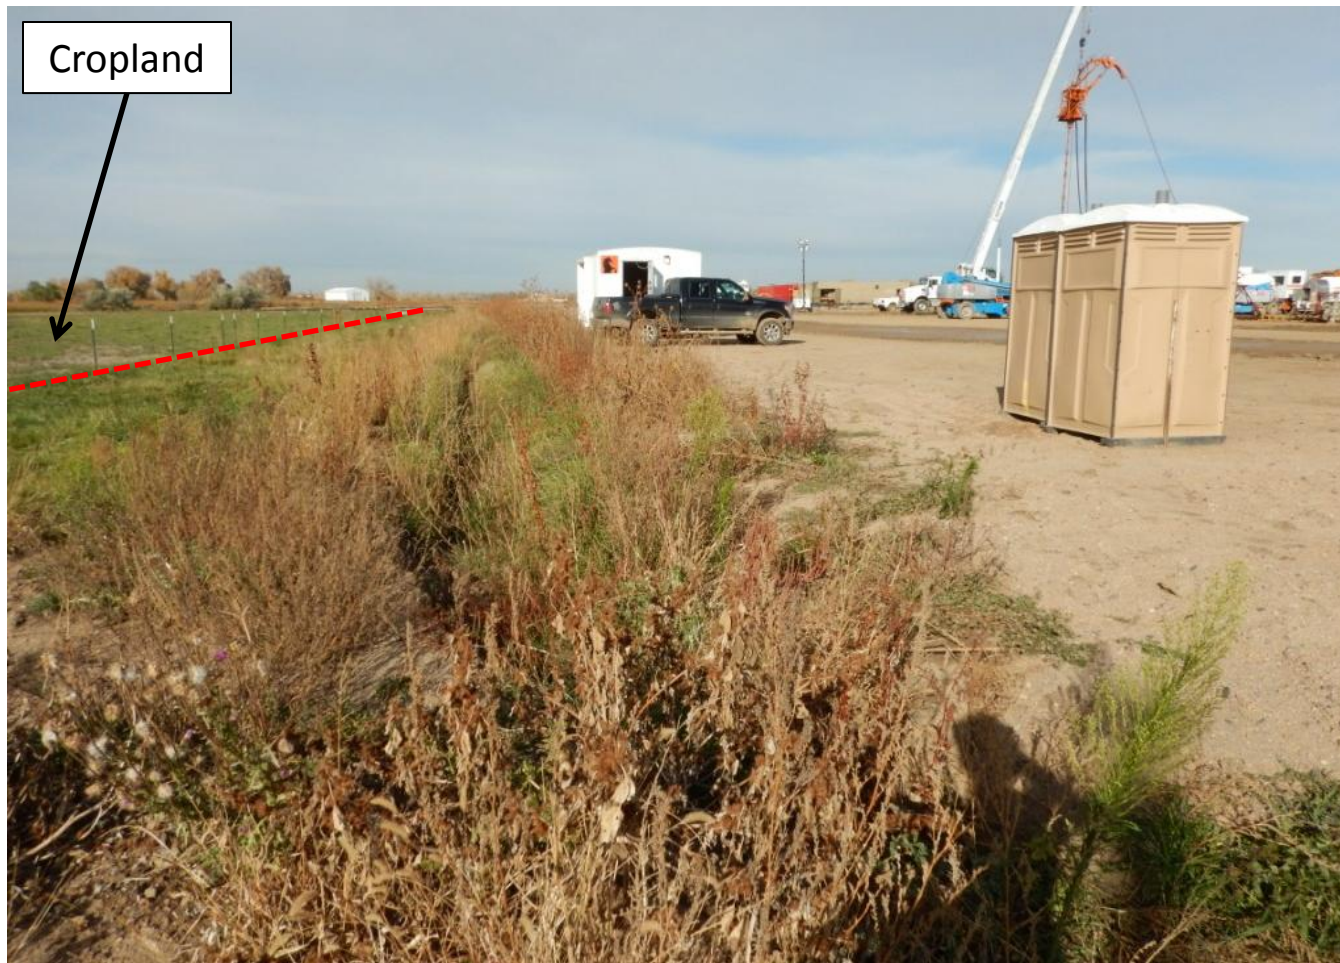
**Photo 2.** Photo taken from southwest location, facing North. Note the Kochia (*Kochia sp.*), Russian thistle (*Salsola sp.*) and Canada thistle (*Cirsium arvense*) in the photo. Weed maintenance is needed to prevent invasion of undesirable species and noxious weeds upon adjacent lands.

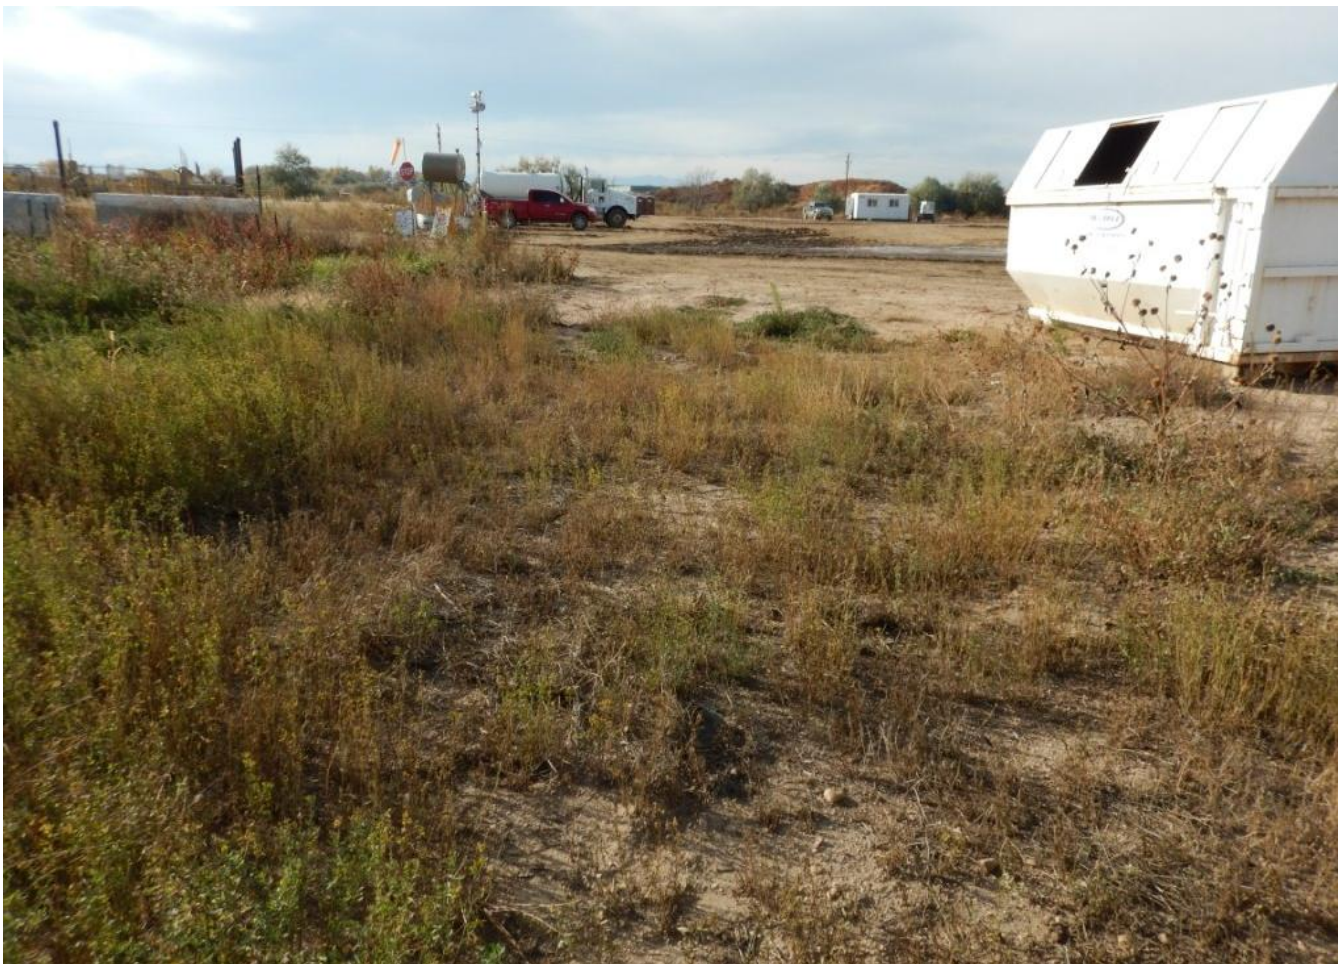
**Photo 3.** Photo taken from southeast location, facing West. Note the Kochia (*Kochia sp.*), Russian thistle (*Salsola sp.*) and Canada thistle (*Cirsium arvense*) in the photo. Weed maintenance is needed.

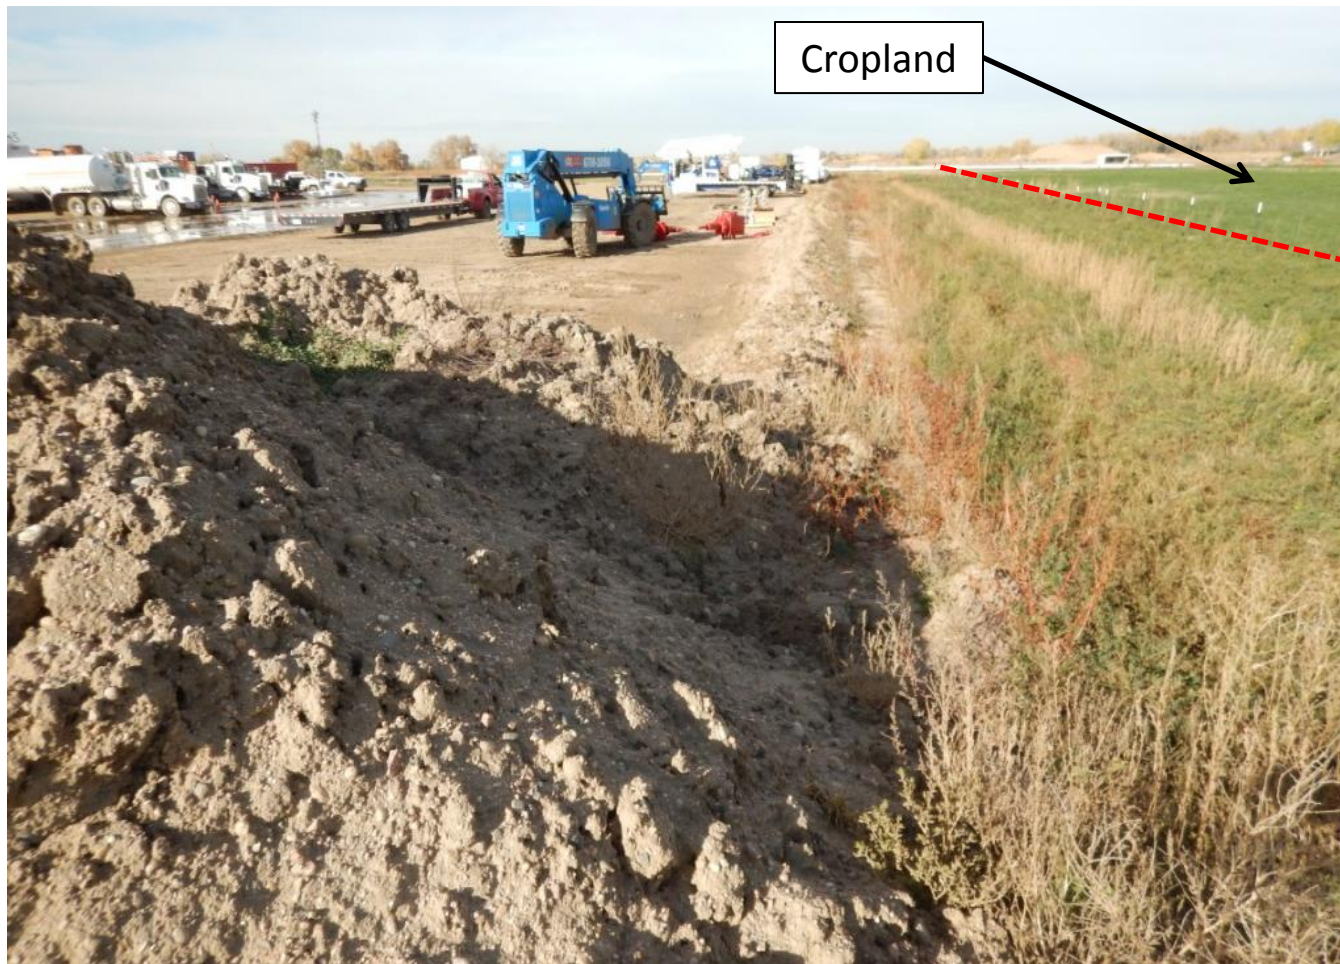
**Photo 4.** Photo taken from southeast location, facing West. Note the Kochia (*Kochia sp.*), Russian thistle (*Salsola sp.*) and Canada thistle (*Cirsium arvense*) in the photo. Weed maintenance is needed to prevent invasion of undesirable species and noxious weeds upon adjacent lands.

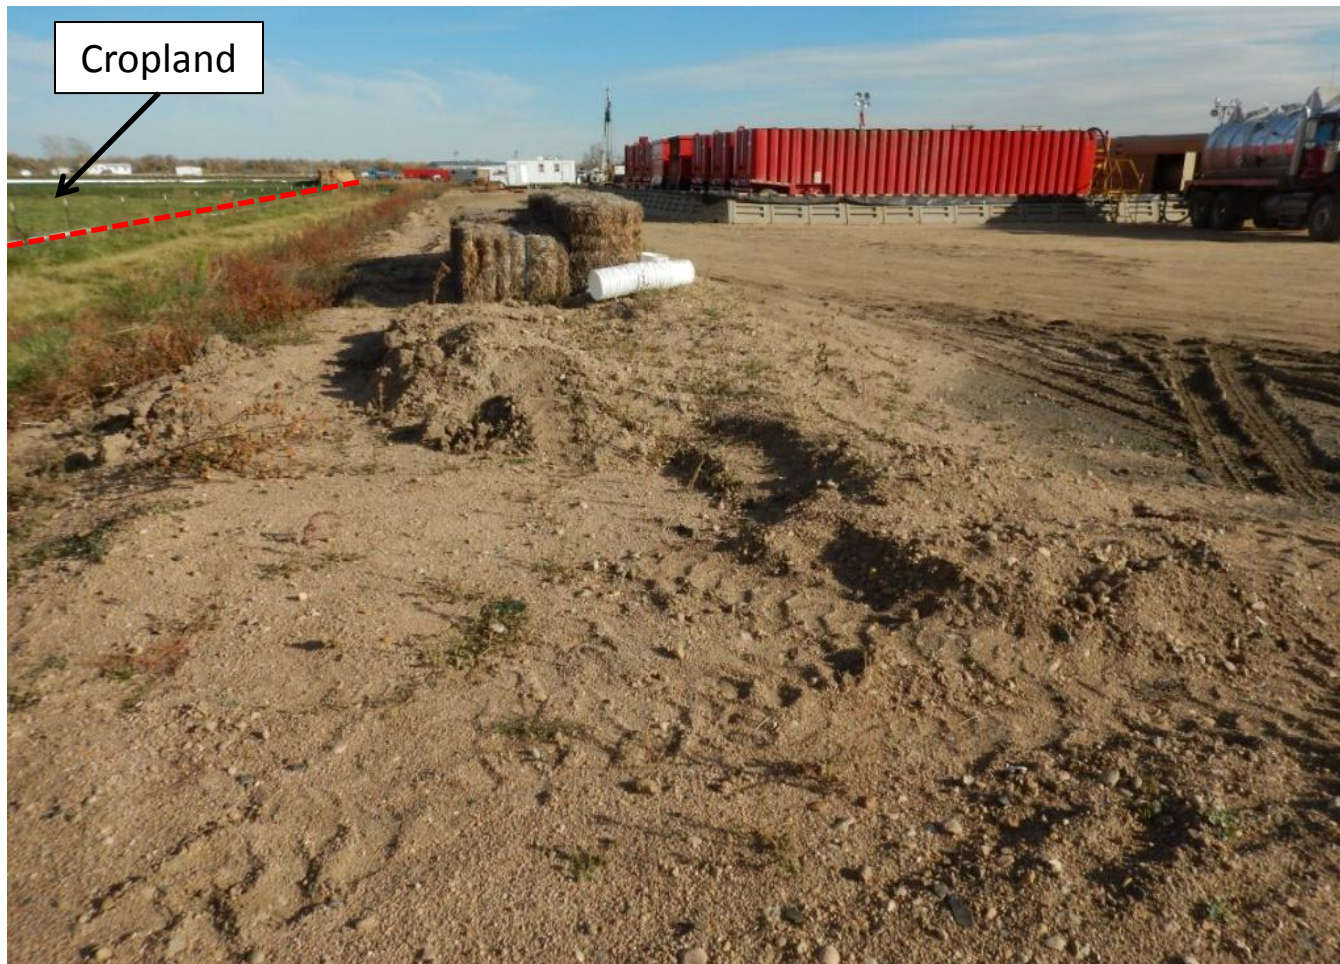
**Photo 7.** Photo taken from northeast location, facing West. Note the Kochia (*Kochia sp.*) and Russian thistle (*Salsola sp.*) in the photo. Weed maintenance is needed to prevent invasion of undesirable species and noxious weeds upon adjacent lands.

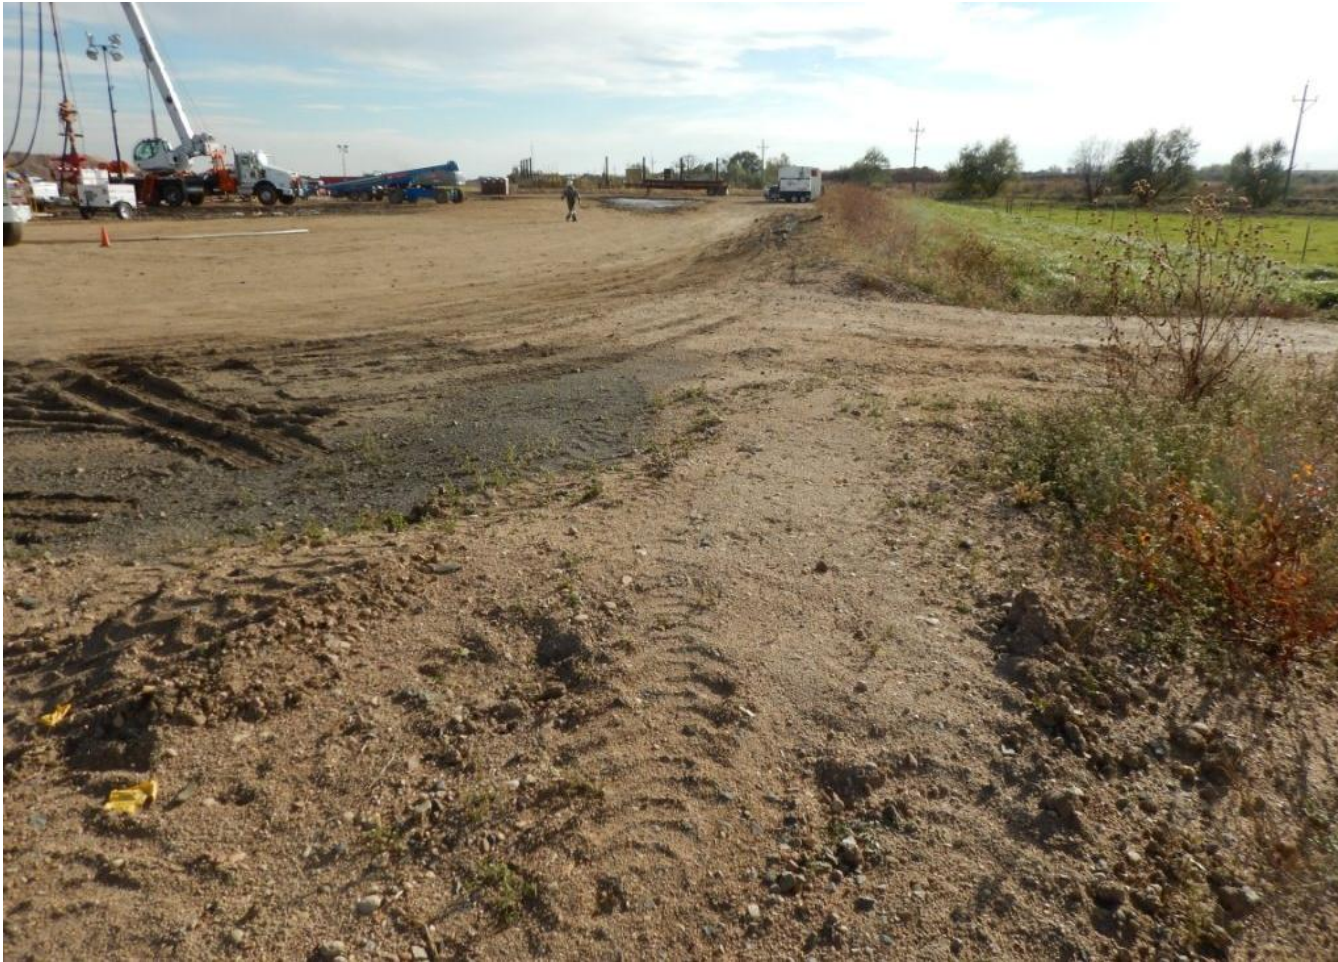
**Photo 8.** Photo taken from northeast location, facing West. Note the Kochia (*Kochia* sp.) and Russian thistle (*Salsola* sp.) in the photo. Weed maintenance is needed.

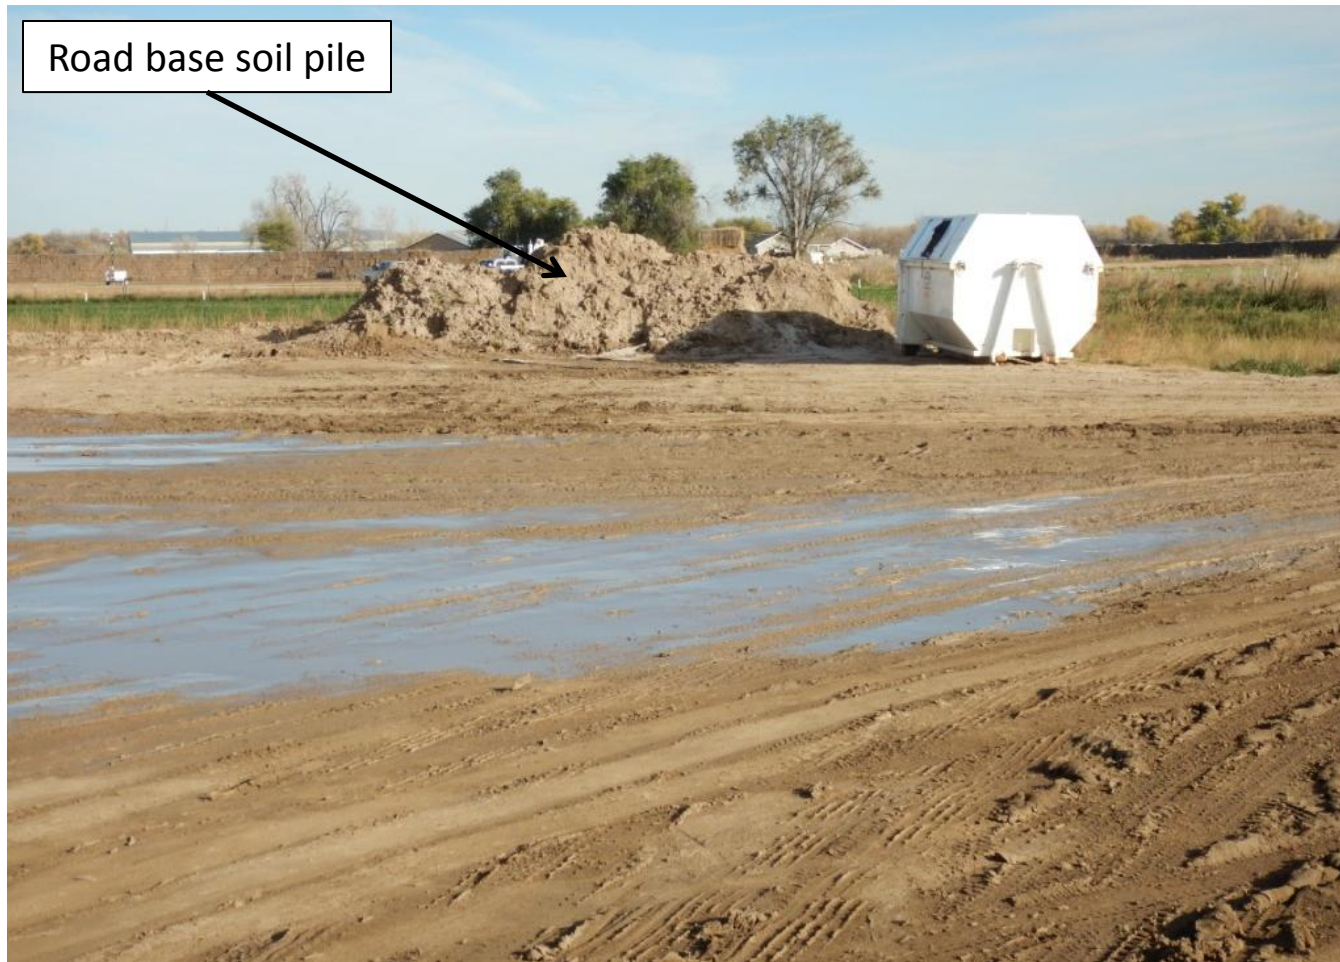
**Photo 9.** Photo taken from central location, facing Southeast. Road base soil pile needs to be removed after drilling completion.

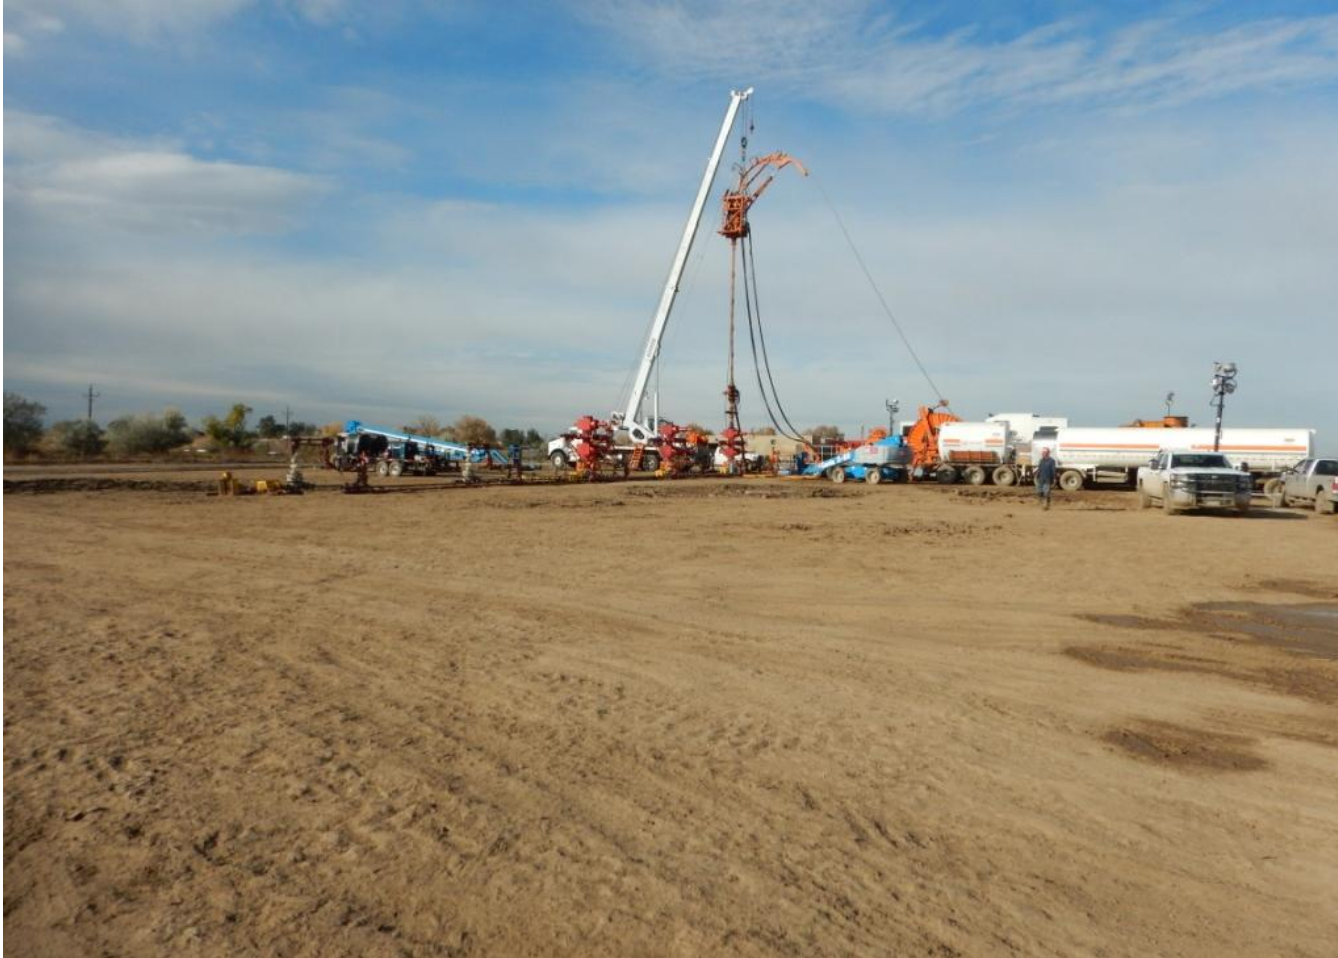
**Photo 10.** Photo taken from south entrance, facing North. When interim reclamation starts, this area shall be reclaimed and minimized where production or facilities are no longer necessary.

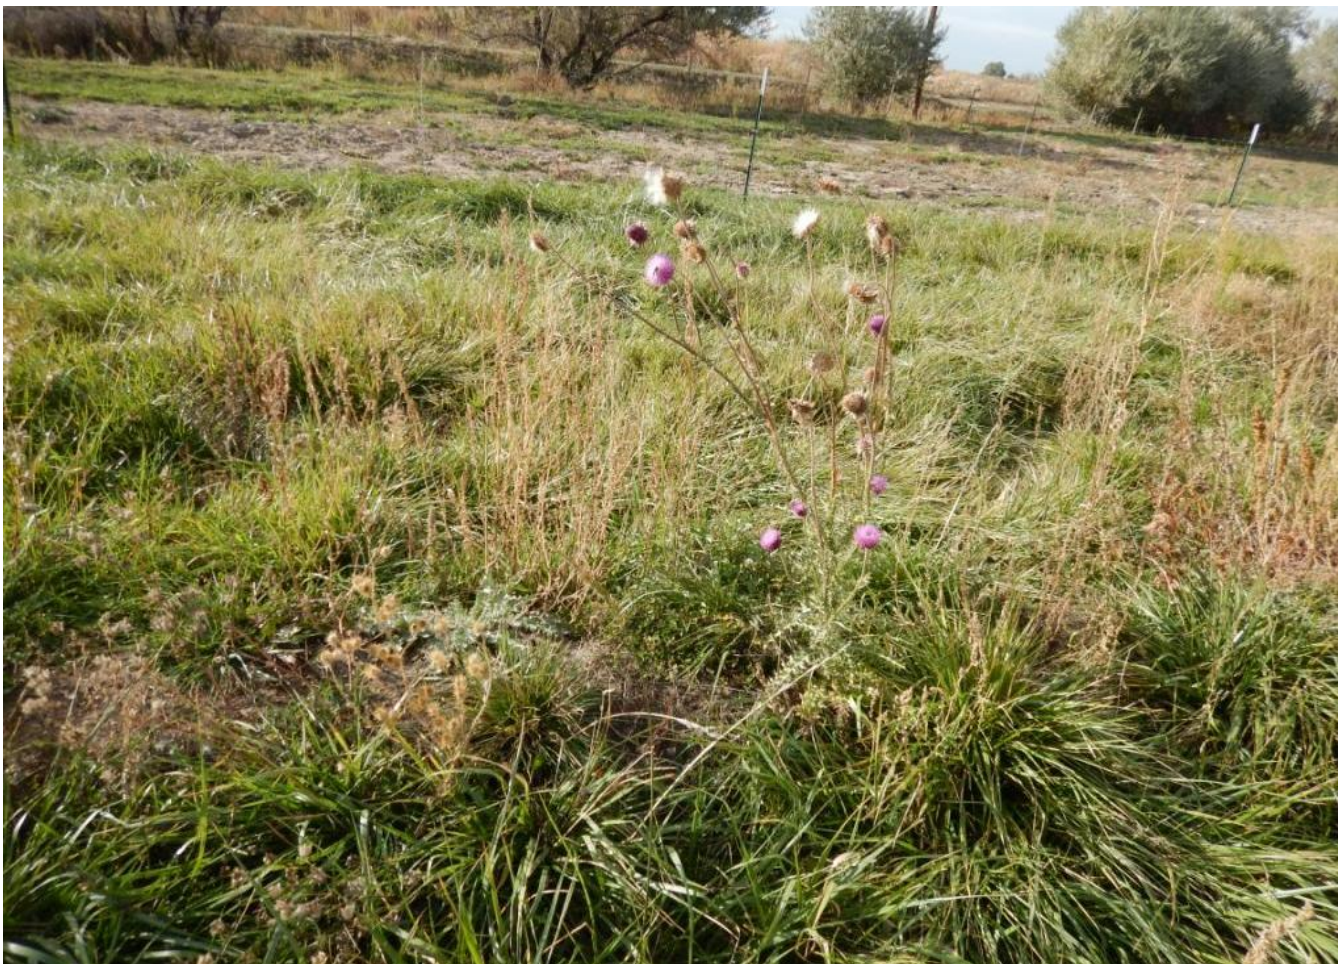
**Photo 11.** Musk thistle (*Carduus nutans*) observed throughout location. Weed maintenance is needed to prevent invasion of undesirable species and noxious weeds upon adjacent lands.
