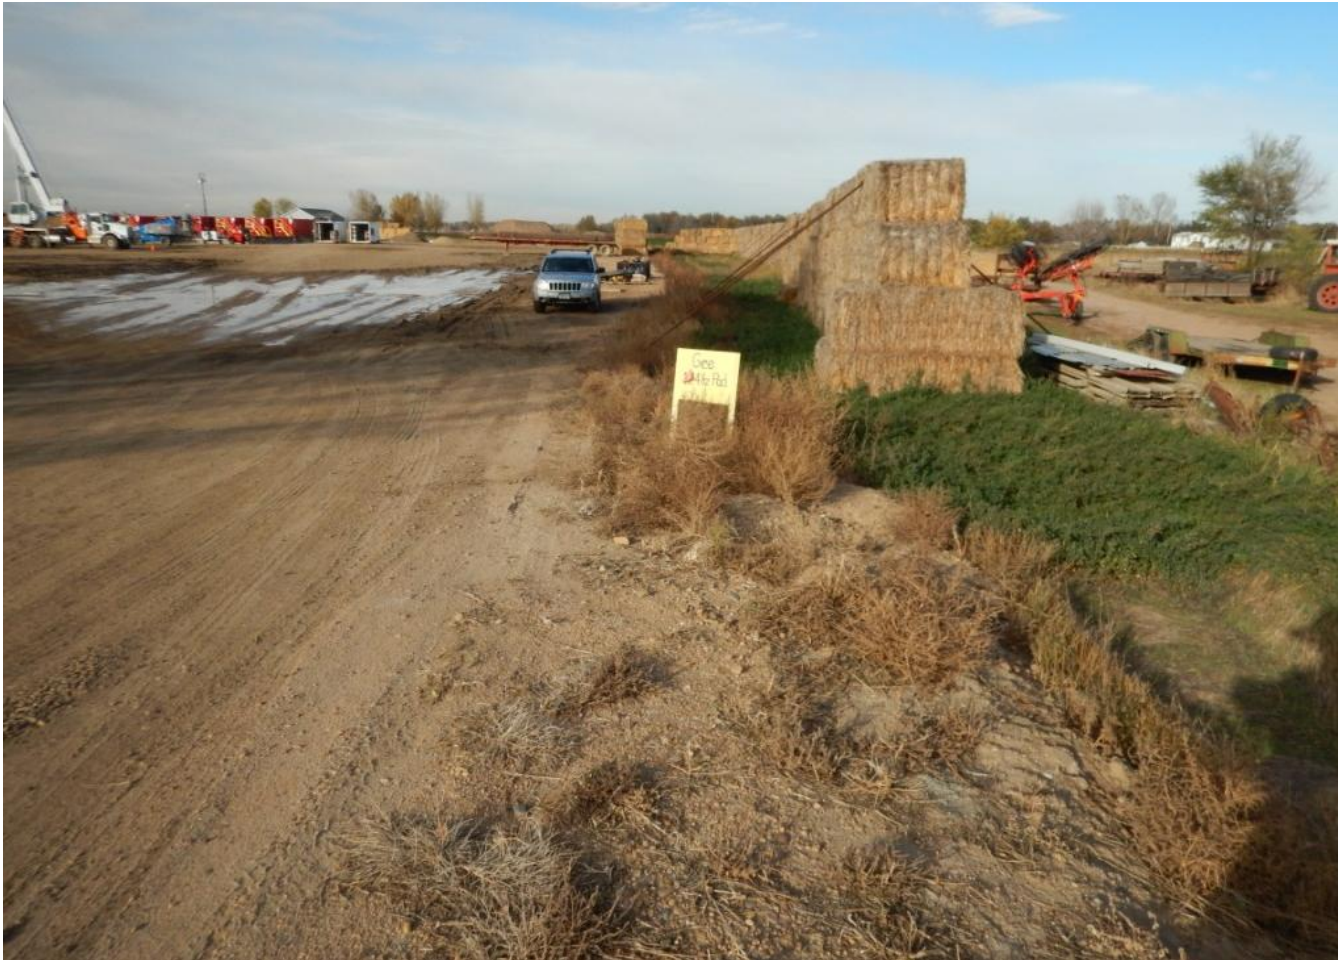
**Photo 1.** Photo taken from southeast entrance, facing North. Note the Kochia (*Kochia sp.*) and Russian thistle (*Salsola sp.*) in the photo. This is weed debris and will break off and encroach upon adjacent lands. When interim reclamation starts, this area shall be reclaimed and minimized where production or facilities are no longer necessary.

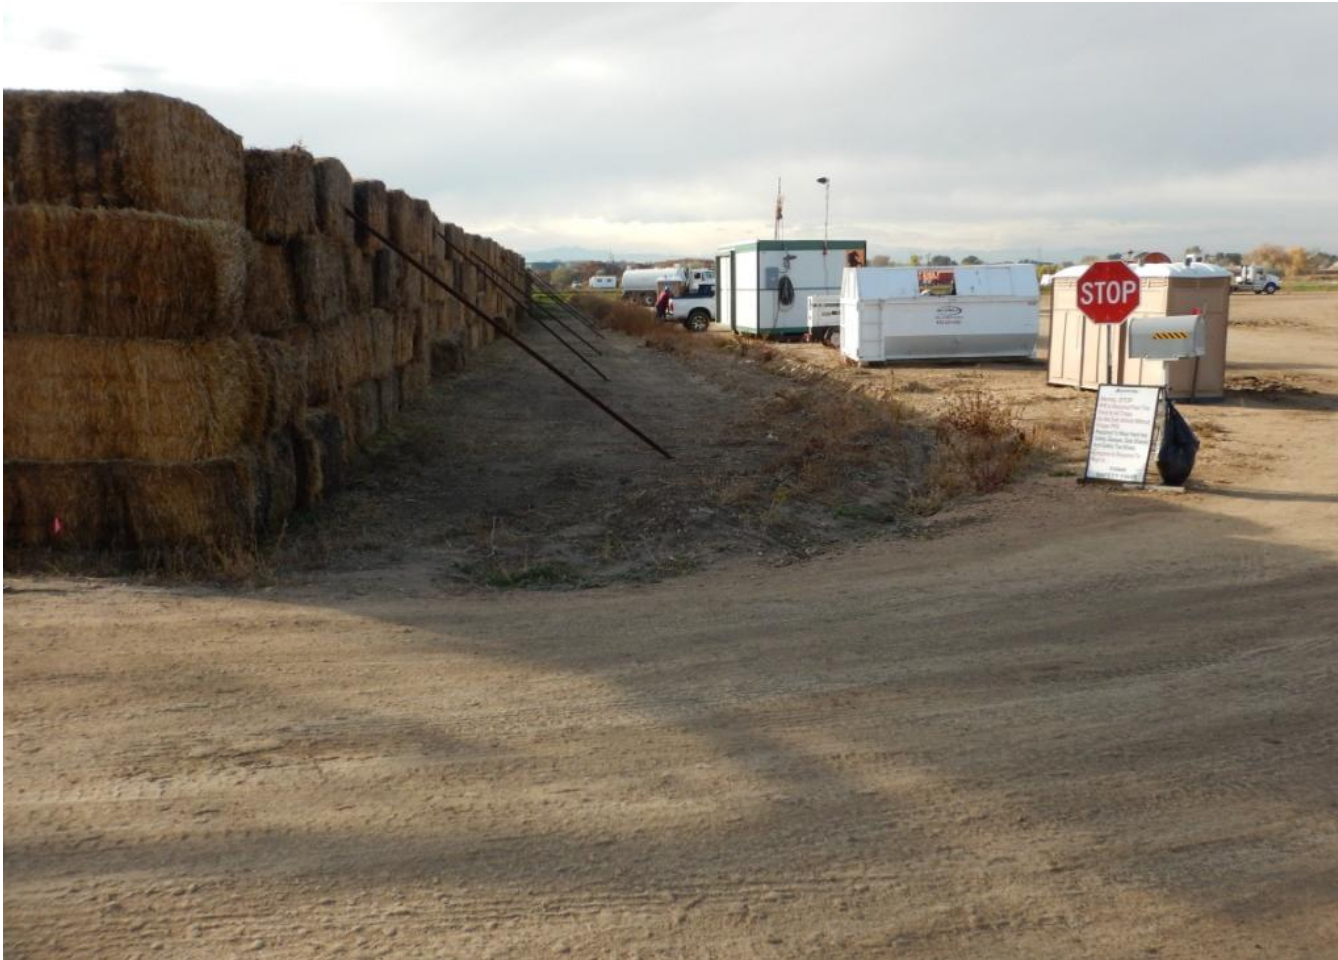
**Photo 2.** Photo taken from southeast entrance, facing West.

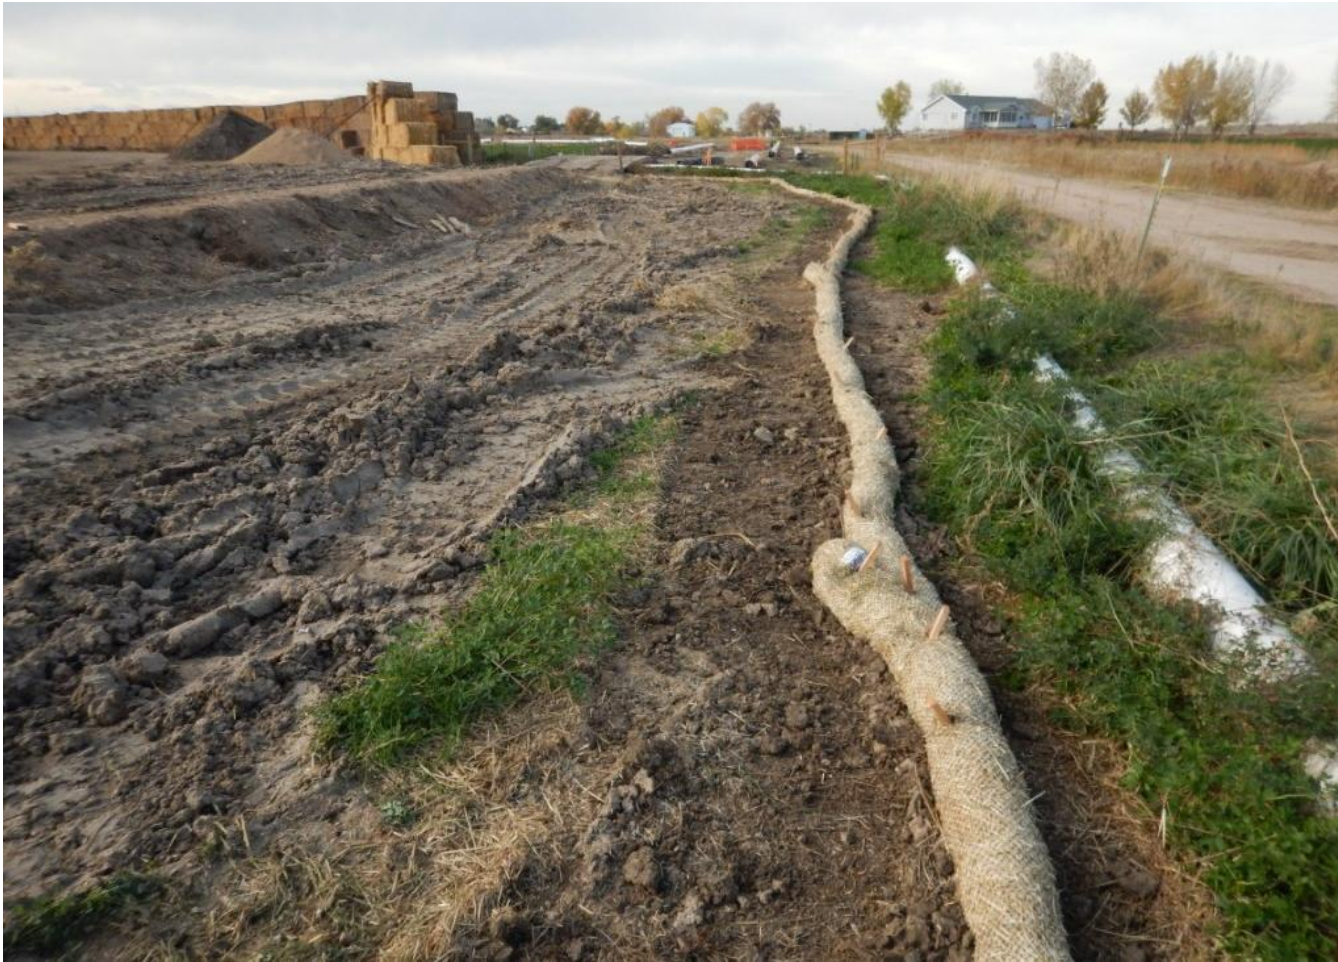
**Photo 3.** Photo taken from northeast location, facing North.

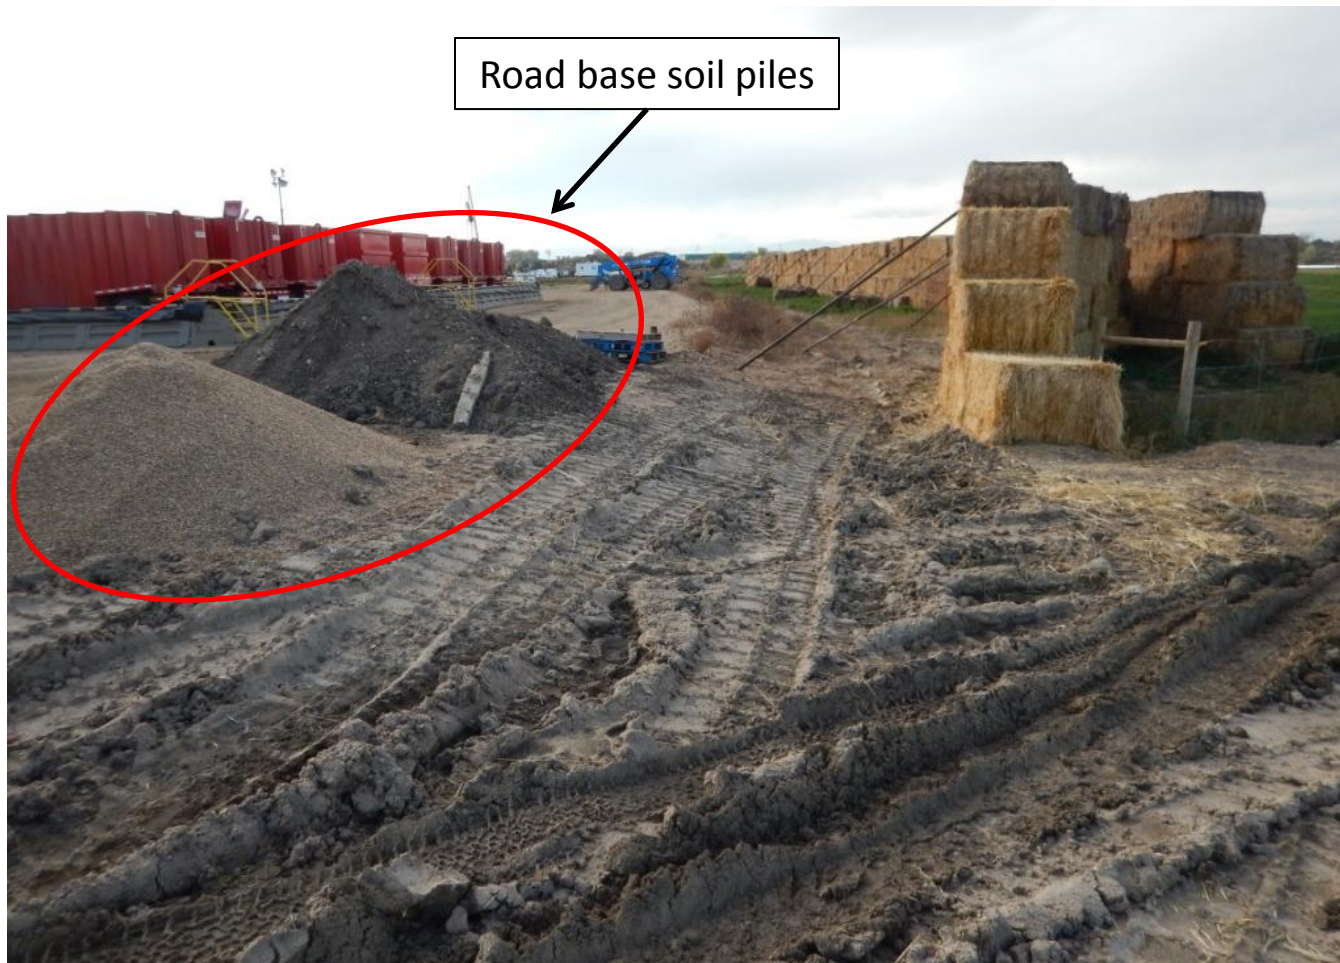
**Photo 4.** Photo taken from northeast location, facing West. Road base soil piles need to be removed if no longer needed.

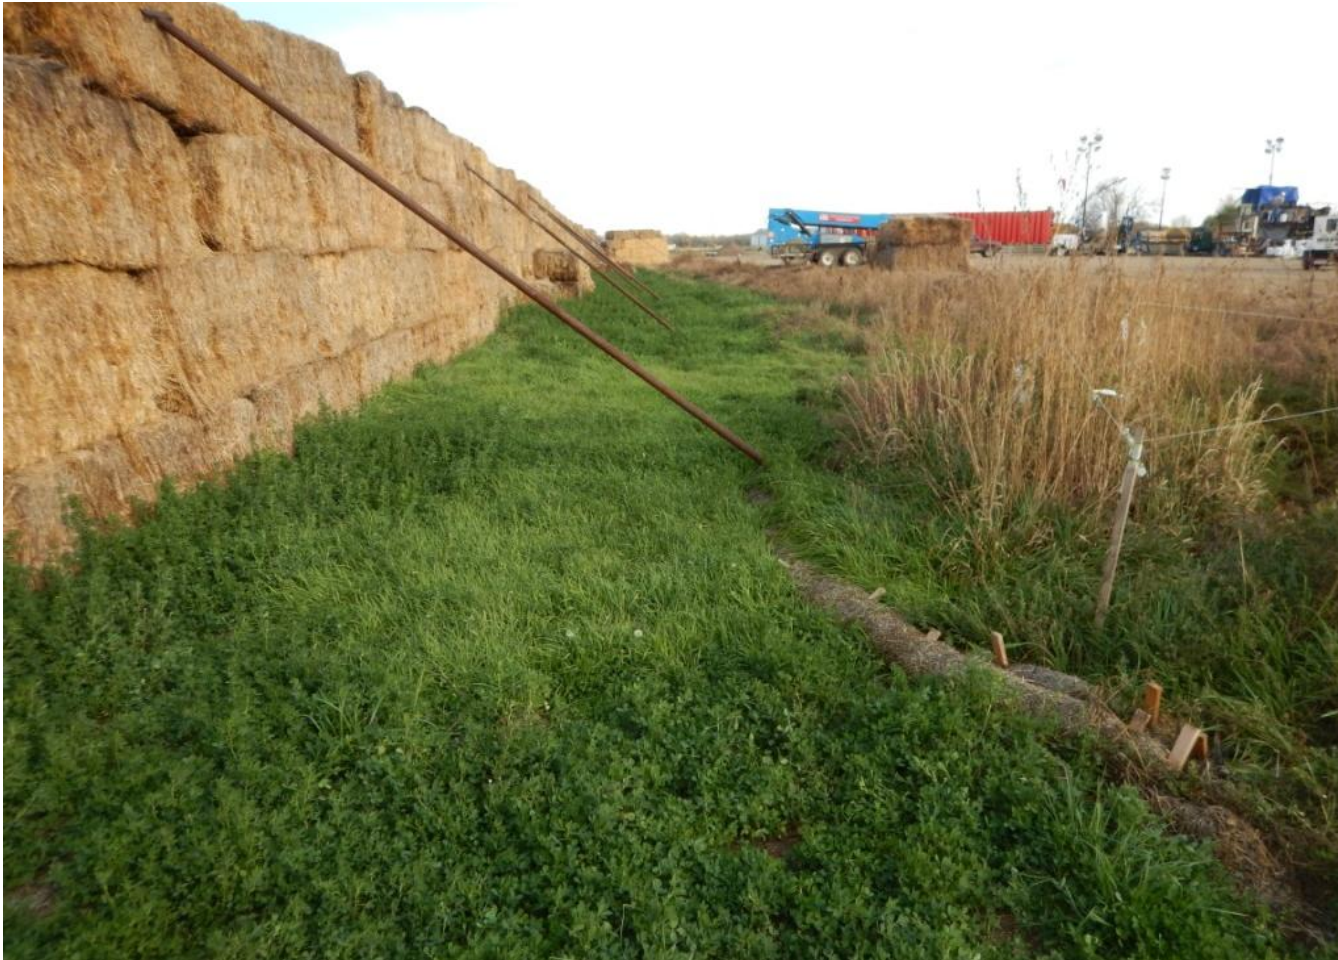
**Photo 5.** Photo taken from northwest location, facing East.

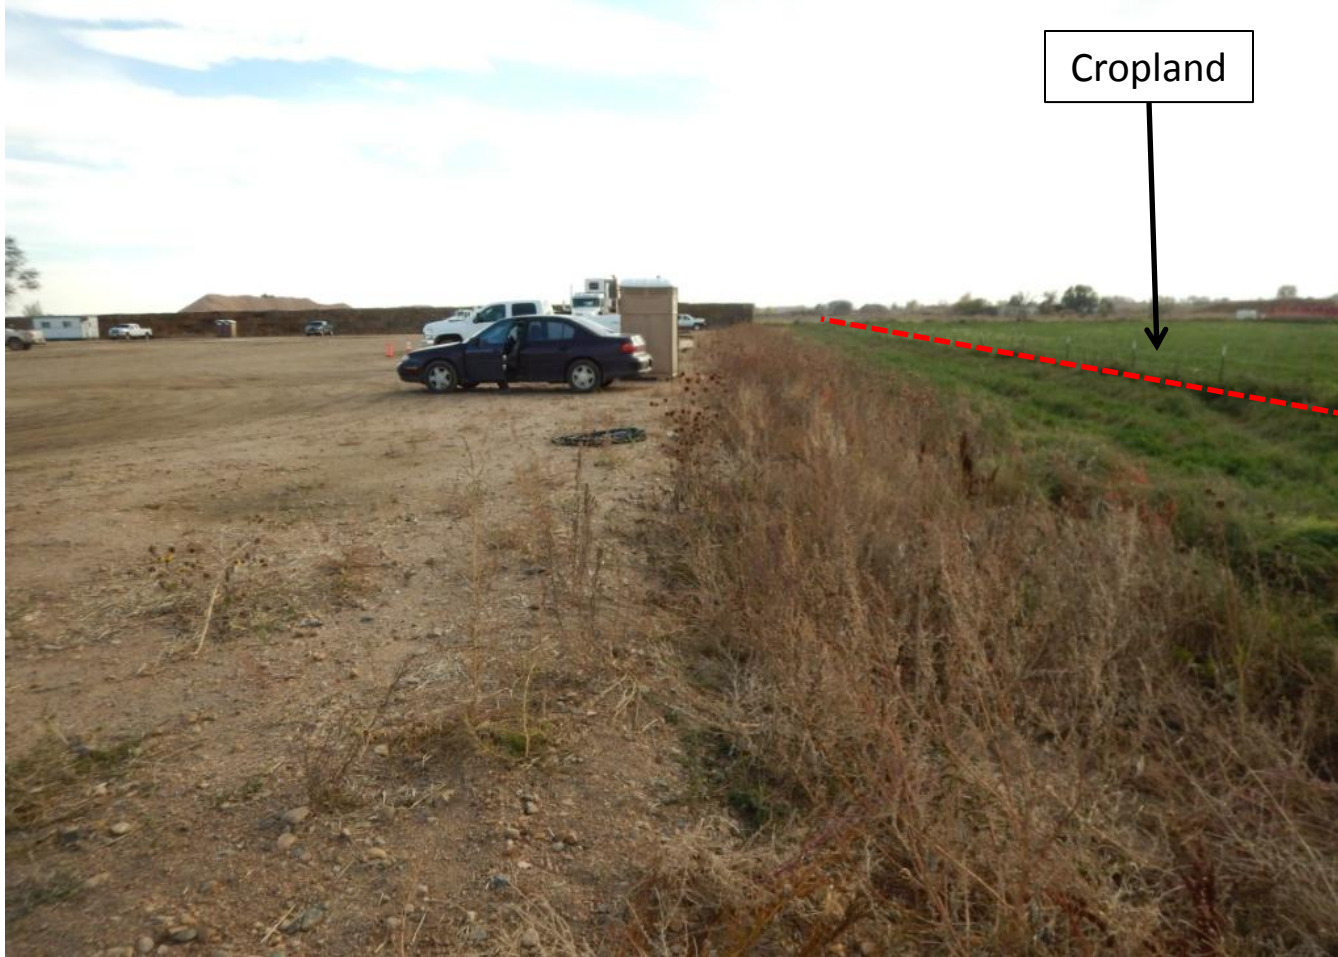
**Photo 6.** Photo taken from northwest location, facing South. Note the Kochia (*Kochia sp.*), Russian thistle (*Salsola sp.*) and Canada thistle (*Cirsium arvense*) in the photo. Weed maintenance is needed to prevent invasion of undesirable species and noxious weeds upon adjacent lands.

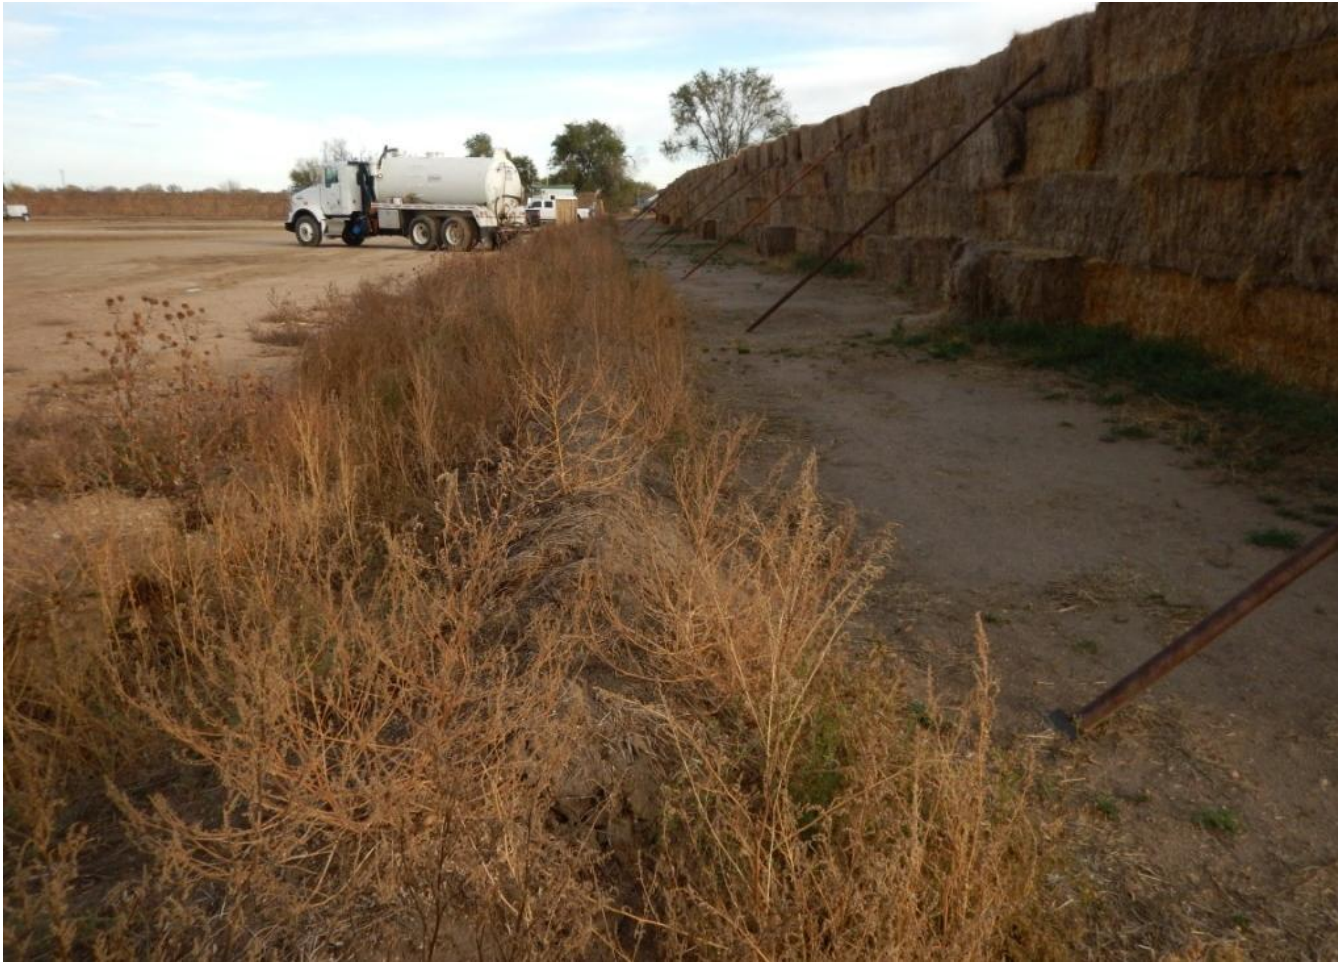
**Photo 7.** Photo taken from southwest location, facing East. Note the Kochia (*Kochia sp.*) and Russian thistle (*Salsola sp.*) in the photo. This is weed debris and will break off and encroach upon adjacent lands.

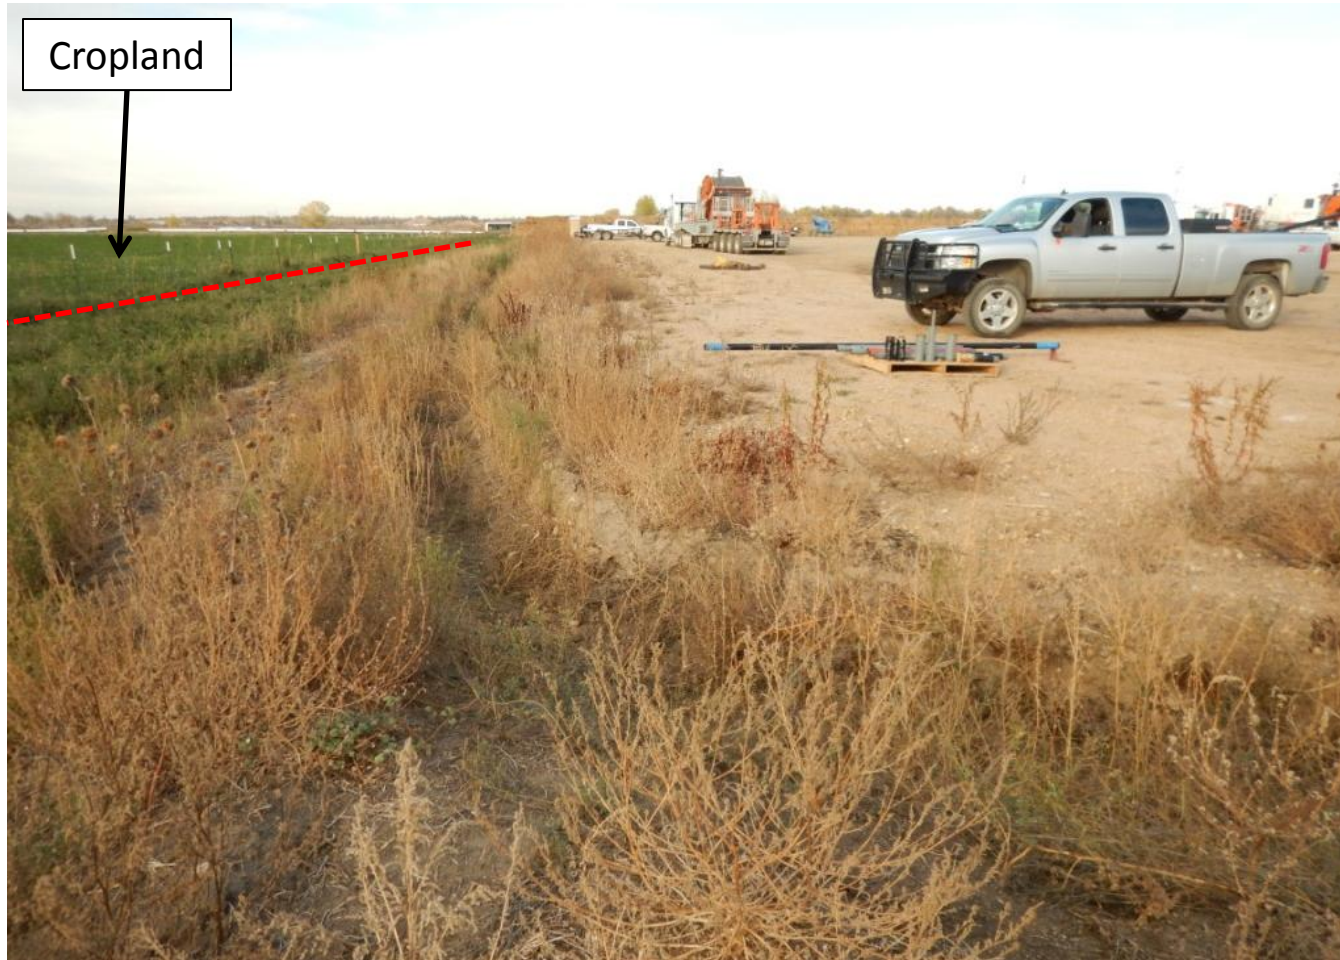
**Photo 8.** Photo taken from southwest location, facing North. Note the Kochia (*Kochia sp.*), Russian thistle (*Salsola sp.*) and Canada thistle (*Cirsium arvense*) in the photo. Weed maintenance is needed to prevent invasion of undesirable species and noxious weeds upon adjacent lands.

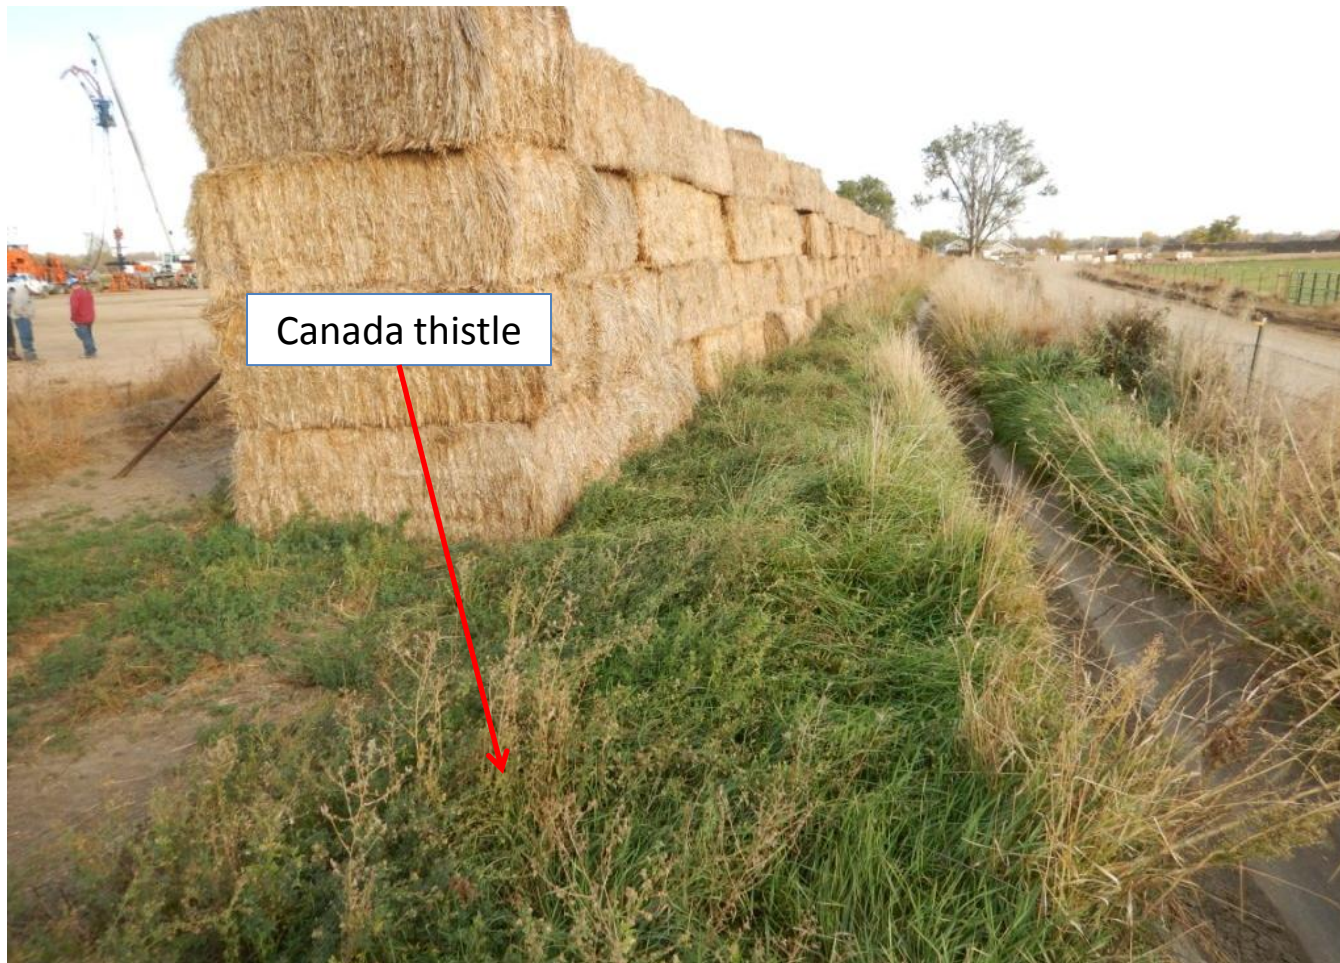
**Photo 9.** Photo taken from southwest location, facing East. Note the Canada thistle (*Cirsium arvense*) in the photo. Weed maintenance is needed to prevent invasion of undesirable species and noxious weeds upon adjacent lands.

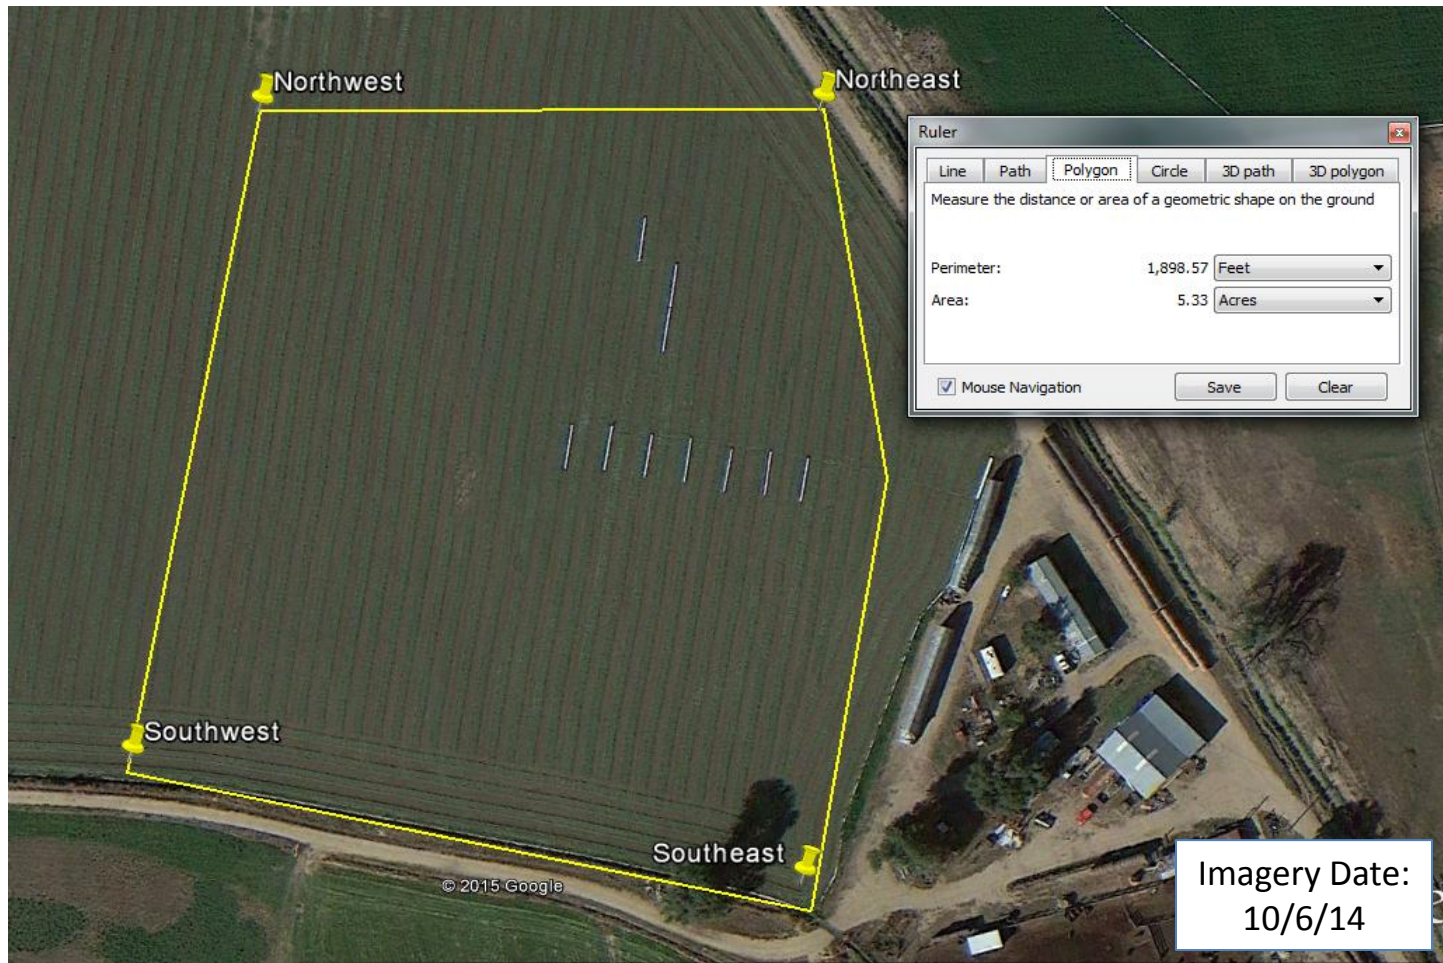
**Photo 10.** The perimeter, in yellow, illustrates the disturbance boundary as of 10/29/15. Total disturbance equals 5.33 acres.
