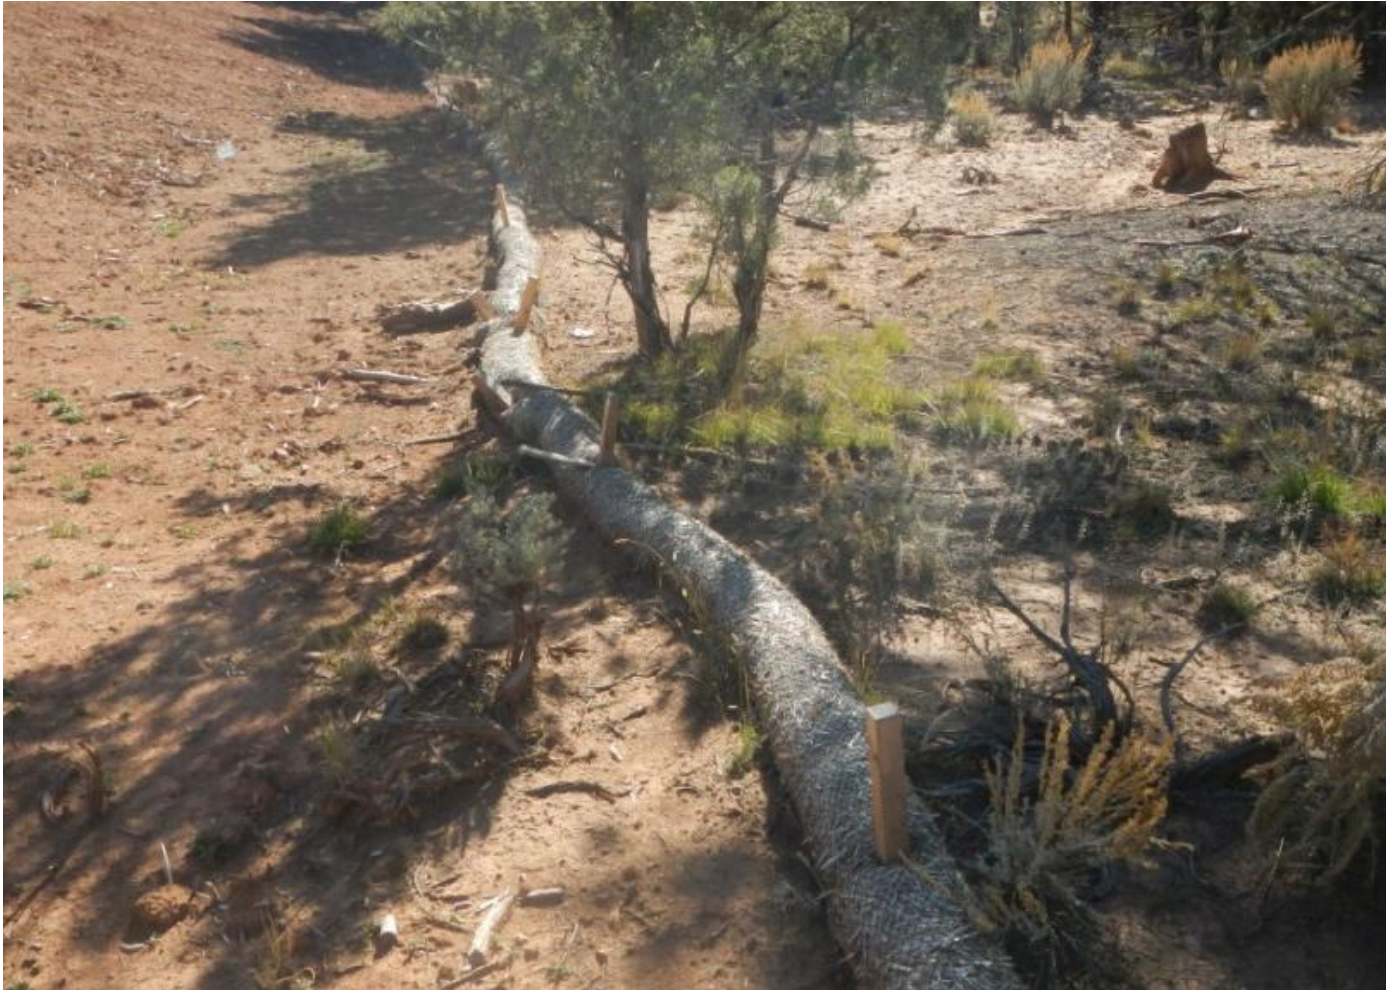
Photo 1. View of straw wattle installed along the western edge of the project area facing southward. Project fill slope located on left side of photo.

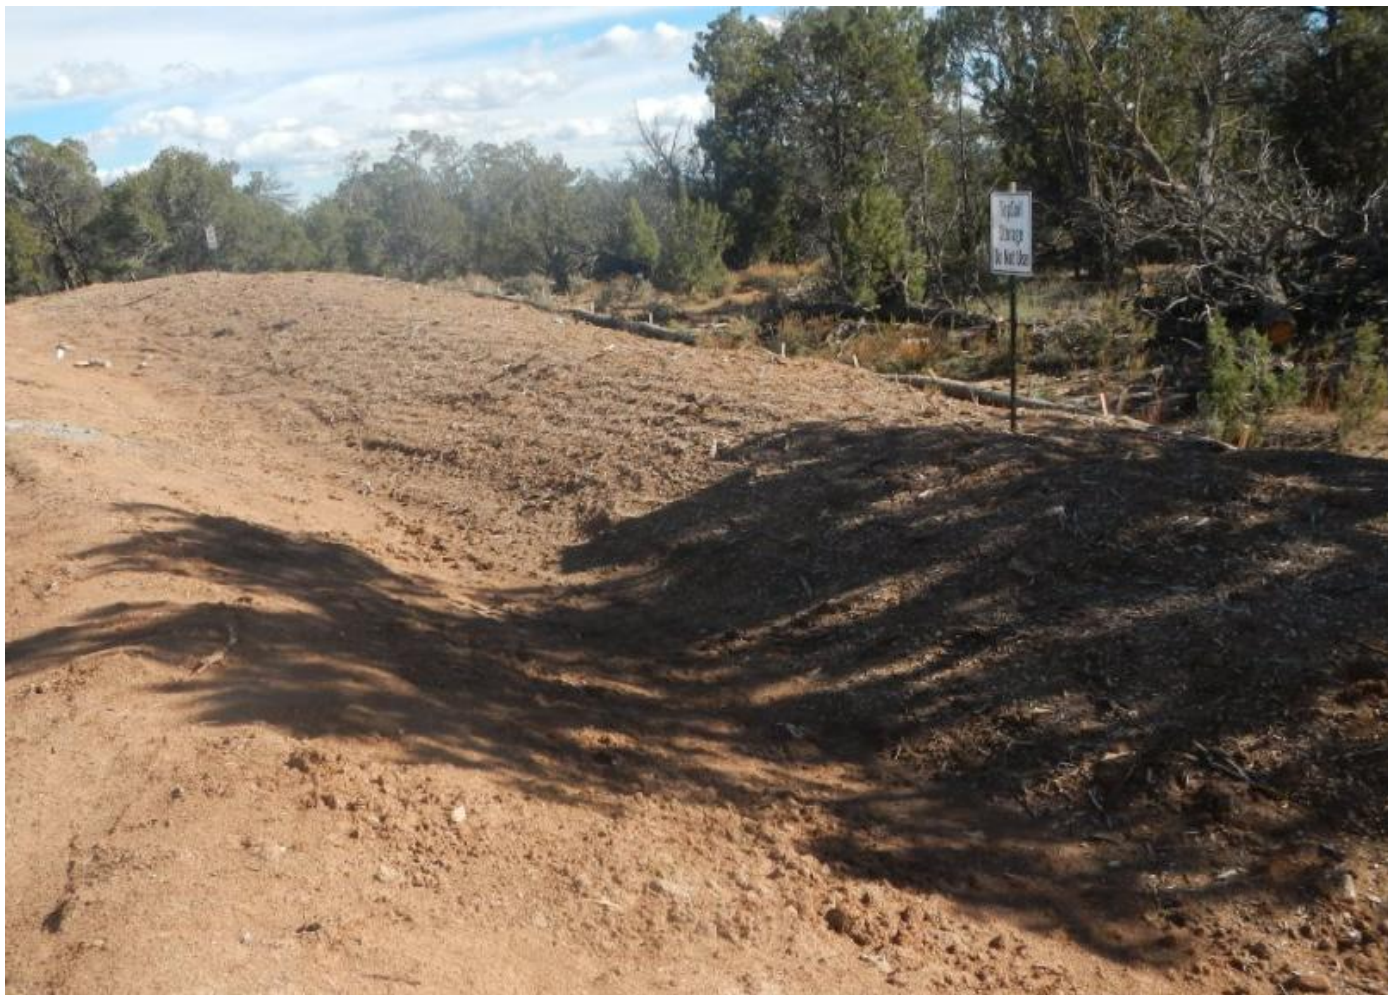
Photo 2. View of southern portion of the project area facing eastward from southwestern corner. Topsoil stockpile is located here. Straw wattles are placed at toe of topsoil stockpile.

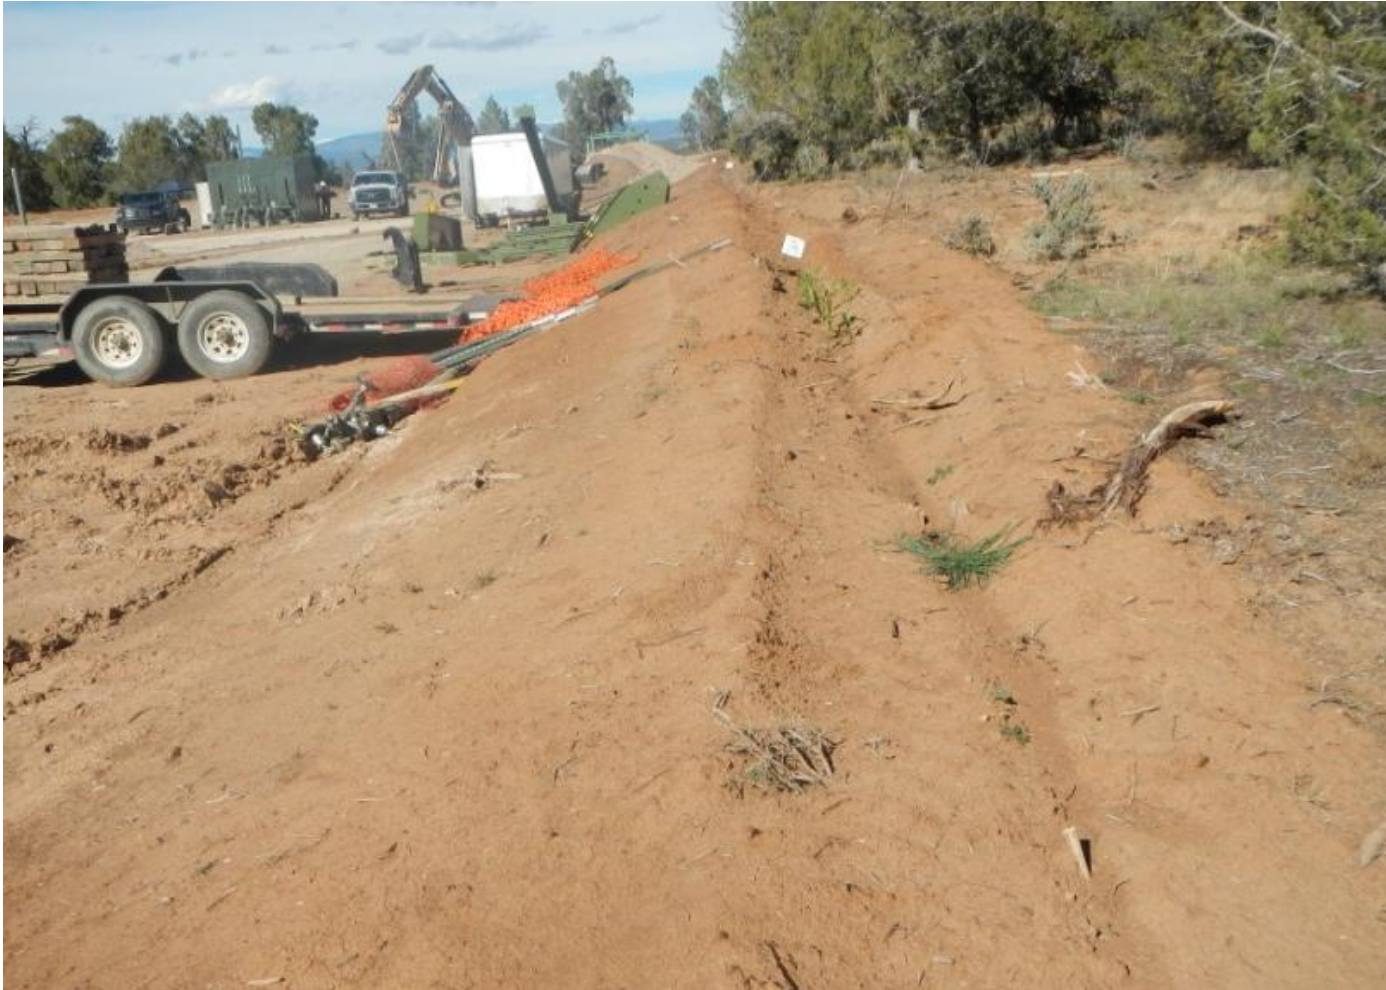
Photo 3. View of eastern portion of the project area from southeastern corner facing northward. Stormwater diversion will need BMPs to prevent downcutting and sediment loss from stormwater flows.

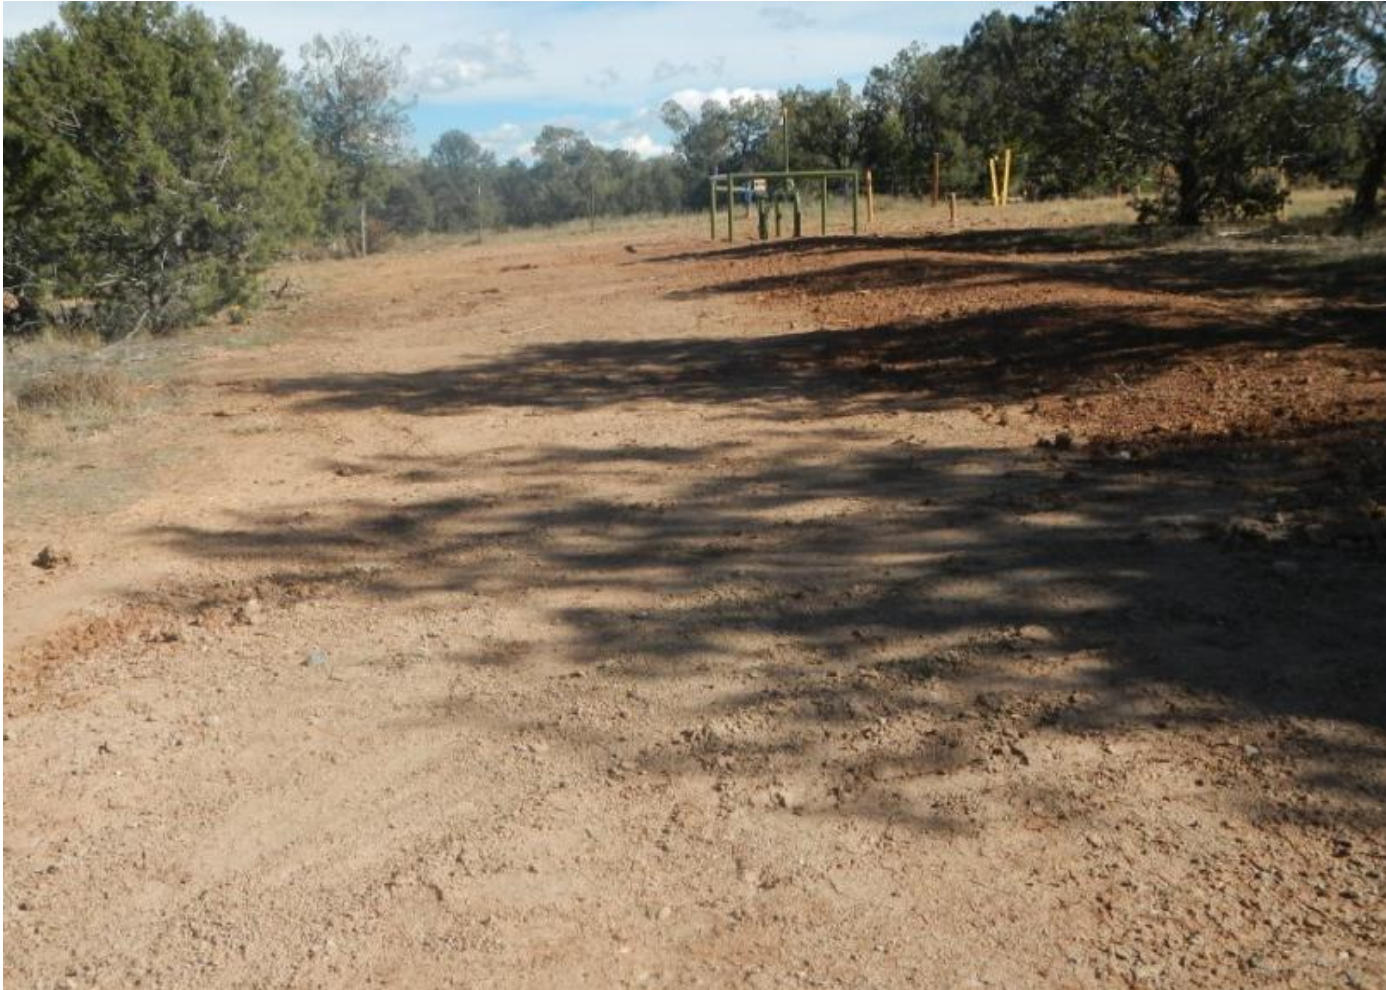
Photo 4. View of pipeline tie in northeastern portion of project area from northeastern corner facing eastward.

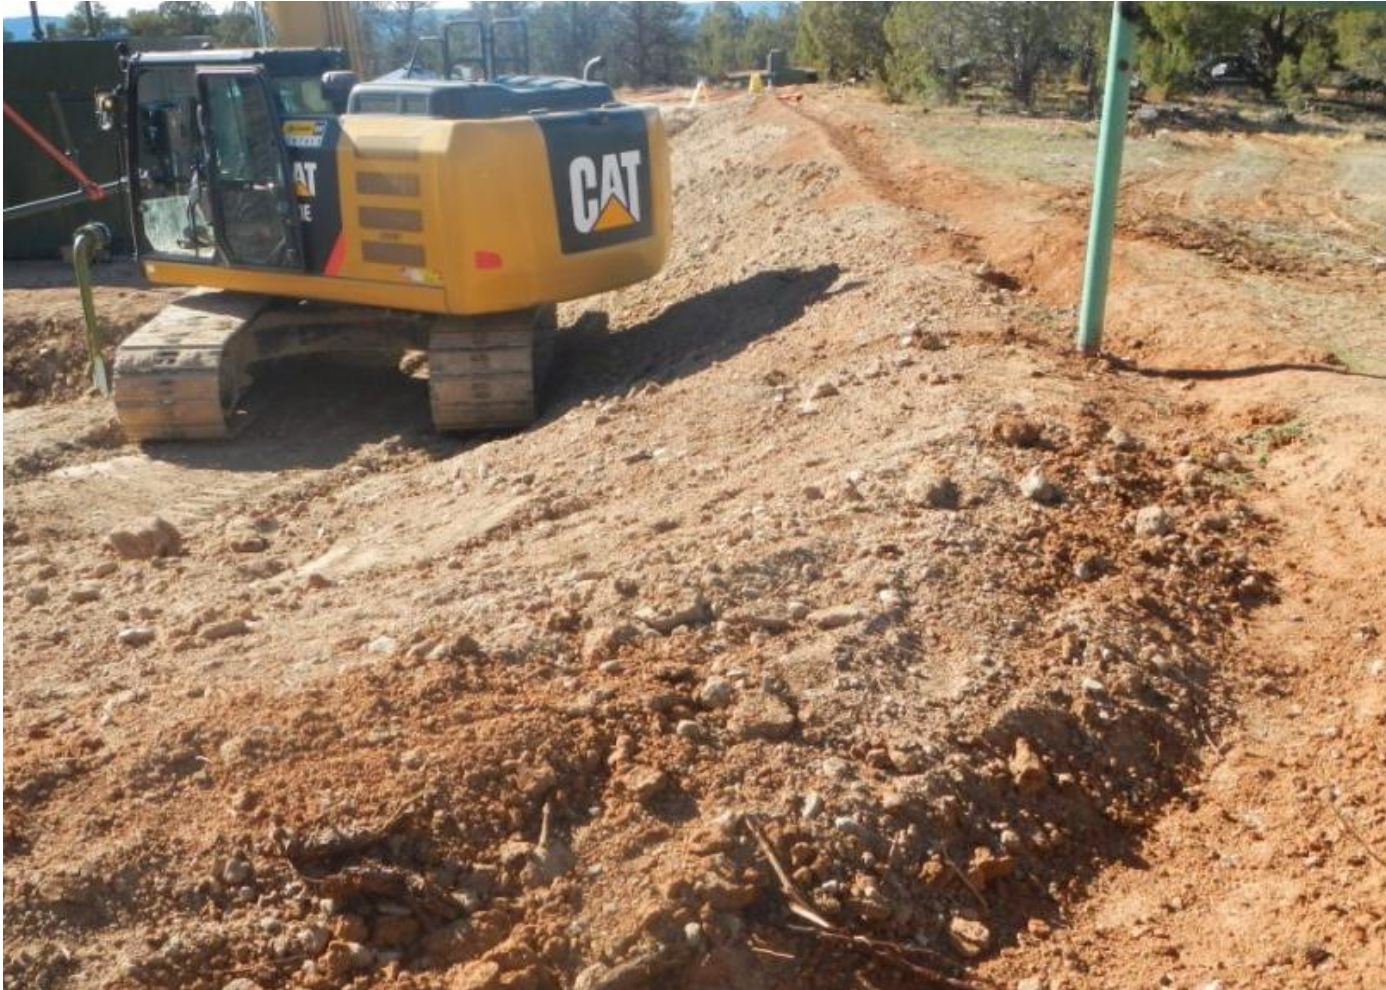
Photo 5. View of northern portion of project area from northeastern corner facing westward. Stormwater diversion will likely need BMPs for stabilization.

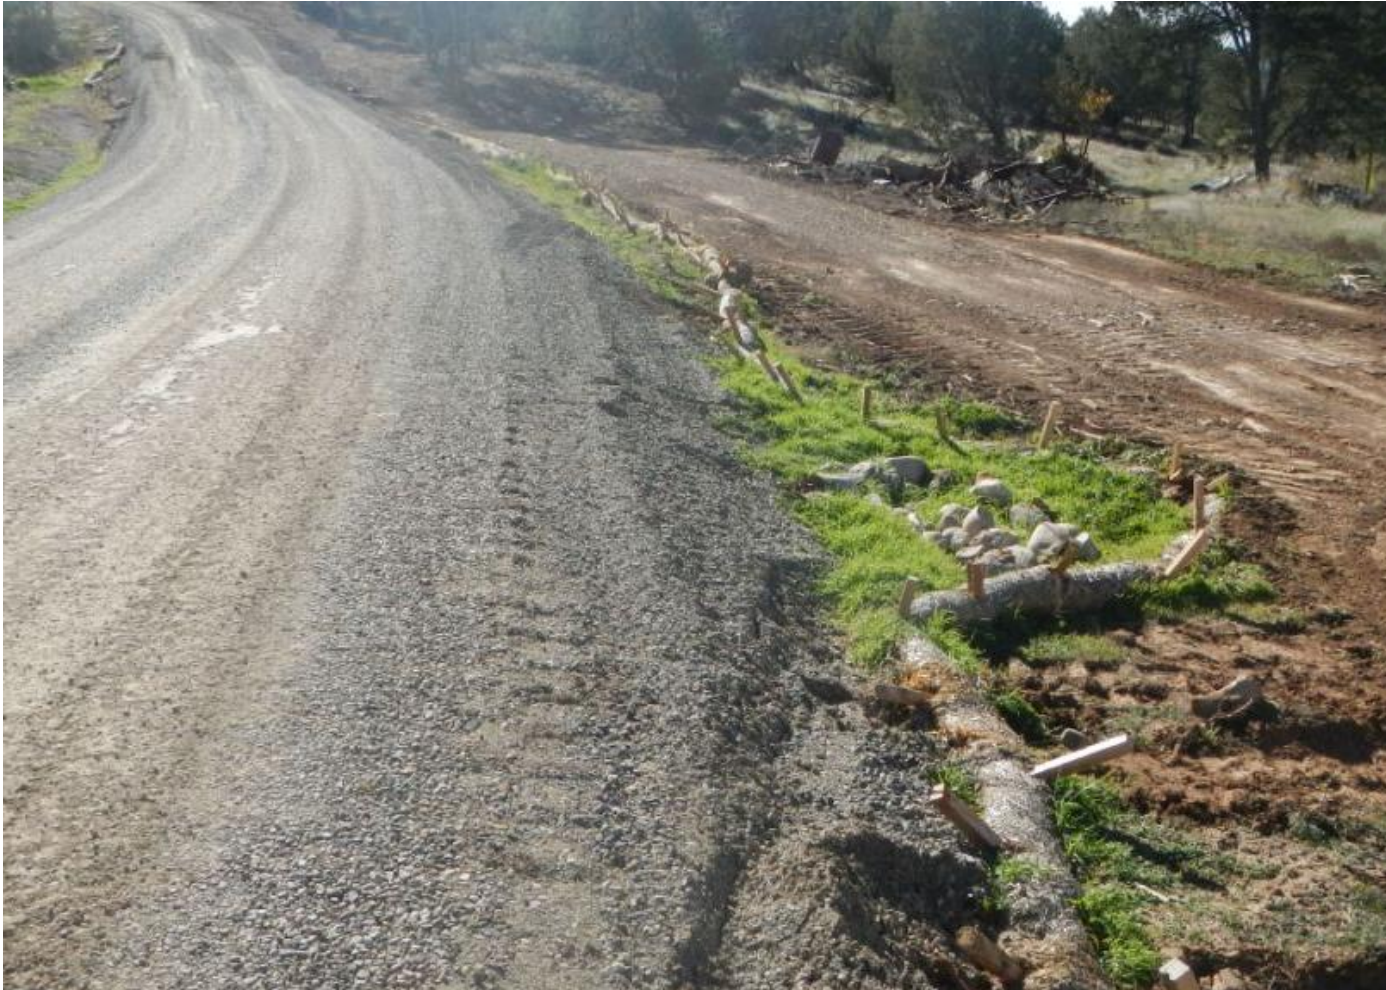
Photo 6. View of access road facing southward. Wattles and cobble armoring are present around culverts and drainage areas.
