**Re: Sump Replacement Summary Letter Report
Wardell-63N65W18NESE (Wardell H 18-9)
API: 05-123-15858
Facility ID: 328332
Legal: NESE Sec 18-T3N-R65W
Remediation Project #8961**

Sample Location
Map

FIGURE
1

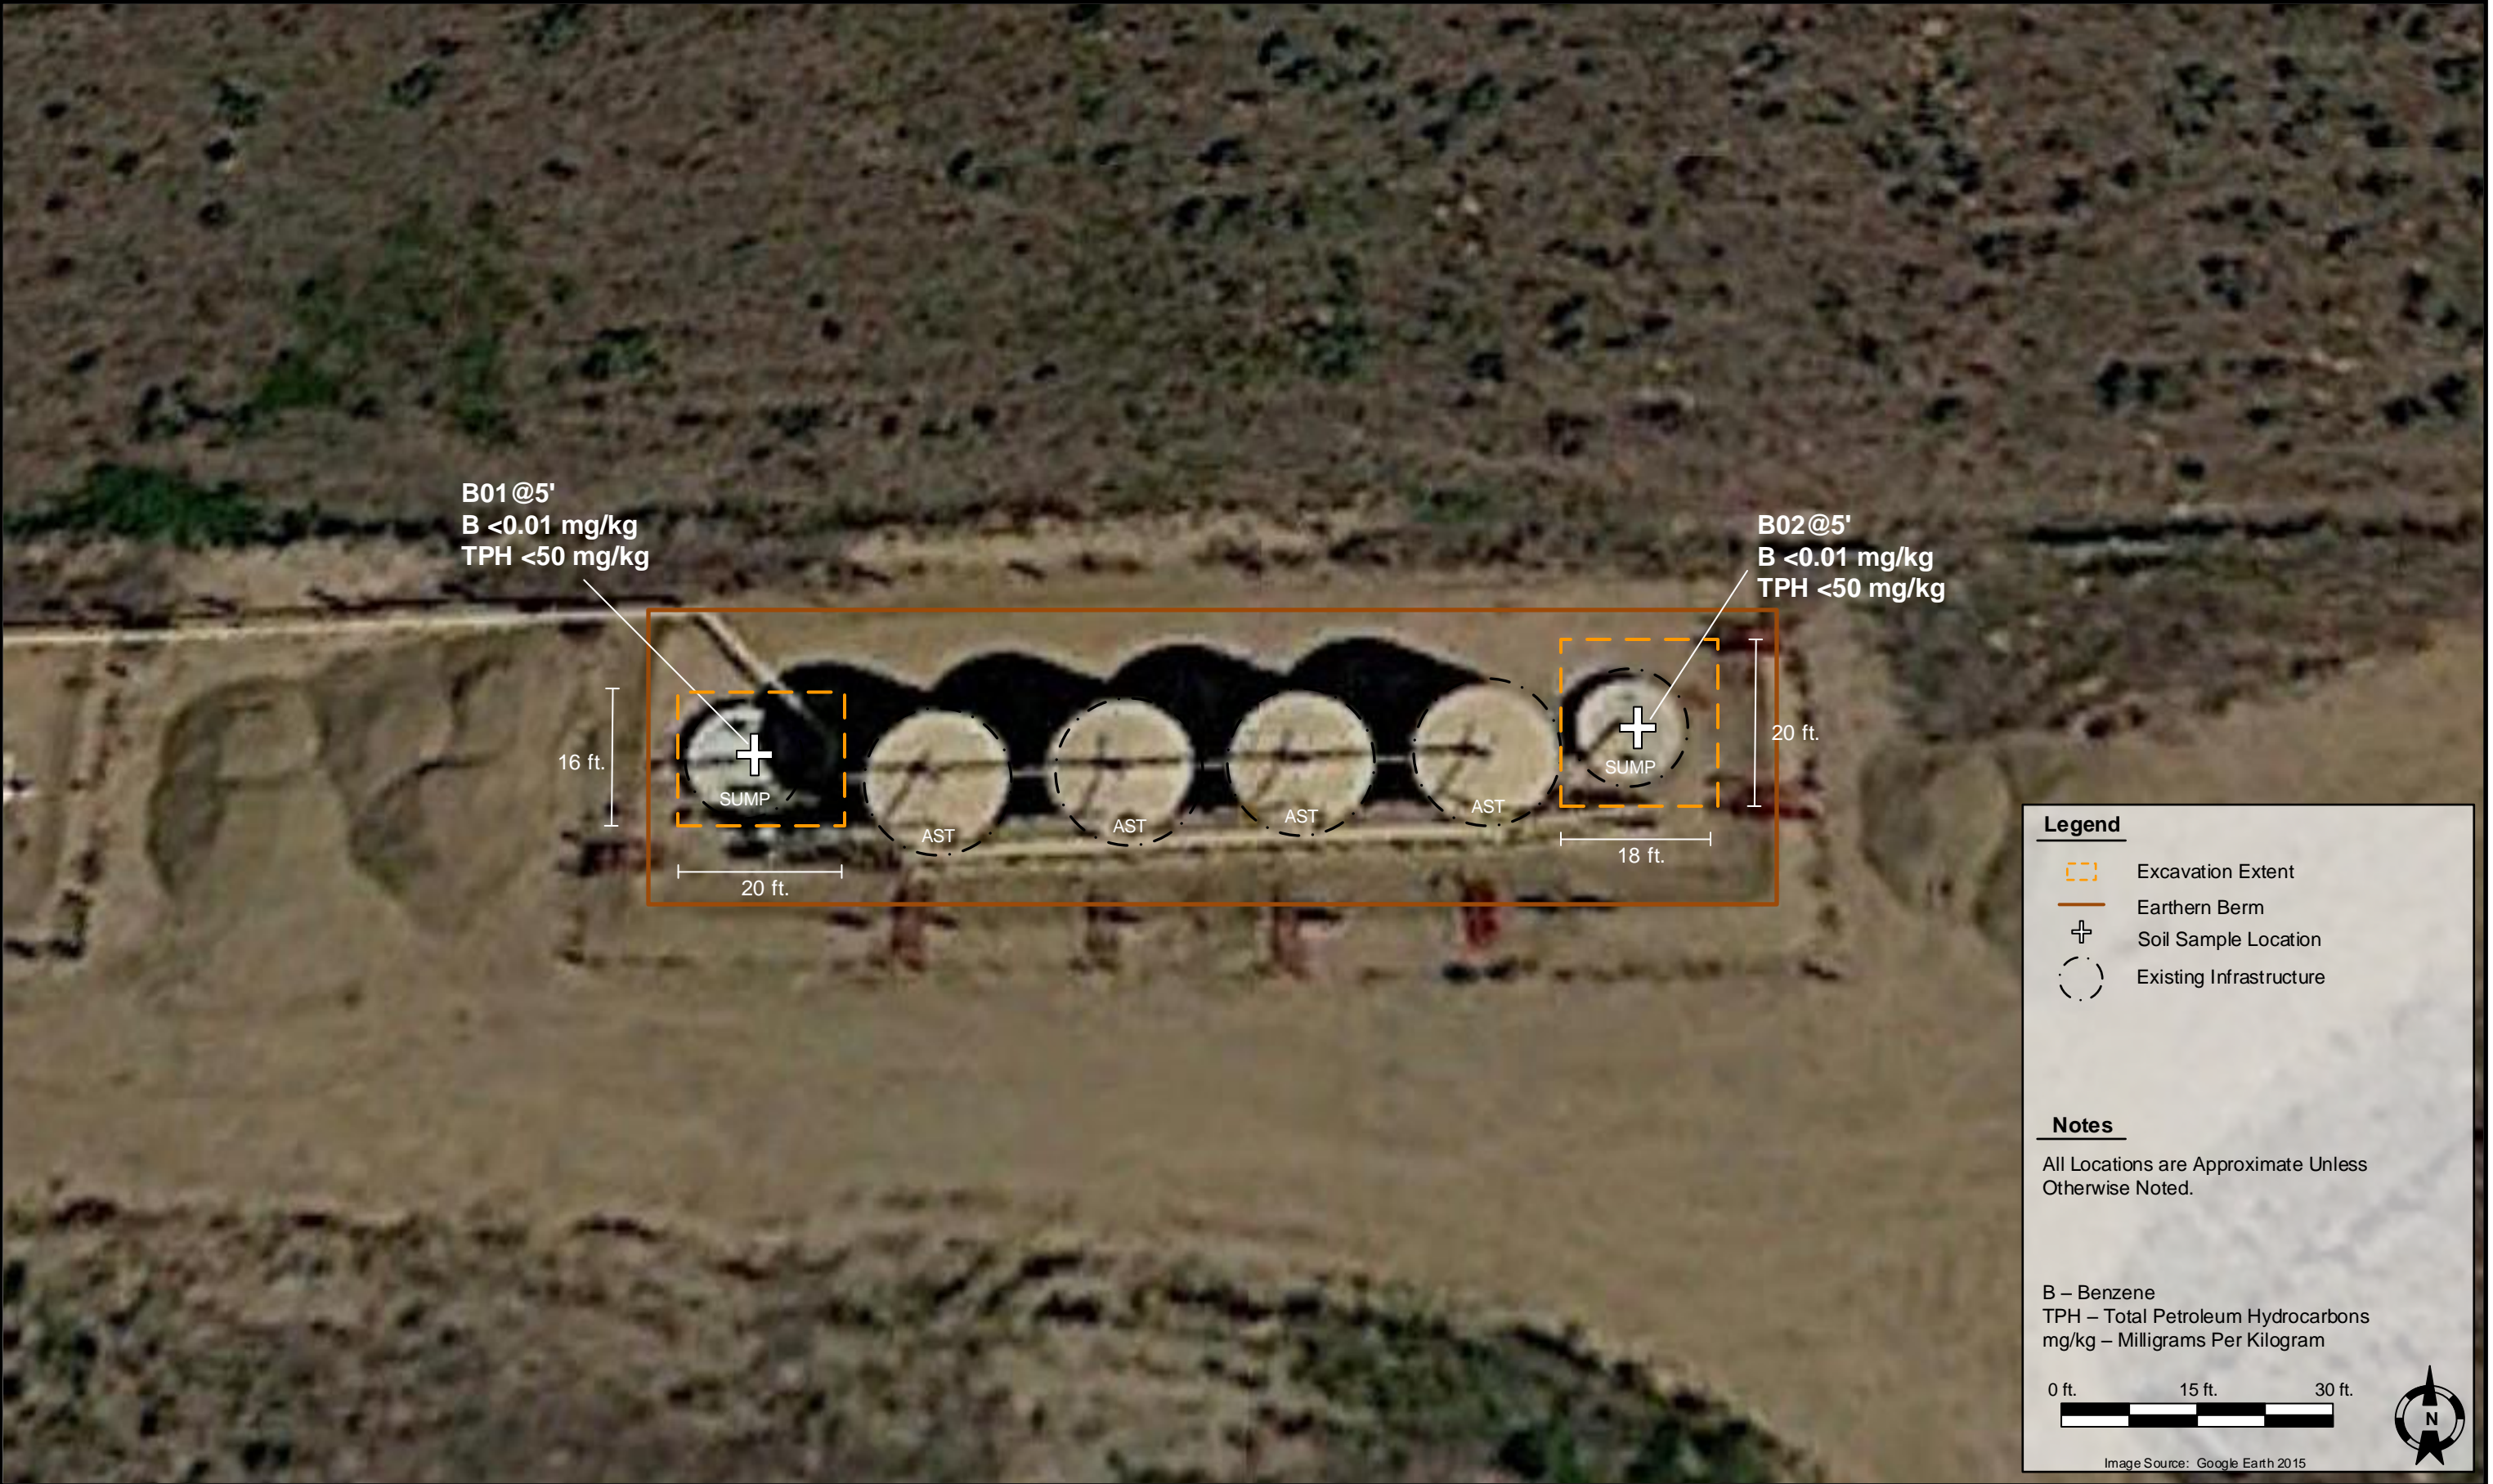
The field activities described herein were performed with the purpose of assessing potential hydrocarbon impacts at the site related to the replacement of two produced water sumps on August 15, 2014. Soil sampling activities, laboratory analytical results, and conclusions are presented below. The general site layout, excavation dimensions, and sample locations are provided in the attached site map (Attachment A).

The final extent of the western excavation area measured approximately 16 feet by 20 feet with an approximate depth of 5 feet below ground surface (bgs). The final extent of the eastern excavation area measured approximately 18 feet by 20 feet with an approximate depth of 5 feet bgs. No impacted material was removed from the site during replacement activities. A liner was not present in either excavation, and groundwater was not encountered in the excavation areas.

Confirmation soil samples were collected from the base and sidewalls of the western and eastern excavation areas at approximately 5 feet and 4 feet bgs, respectively. Soil samples were field screened for volatile organic compound (VOC) concentrations using a photoionization detector (PID). Confirmation soil samples collected from the base of each excavation area were
