Construction Inspection

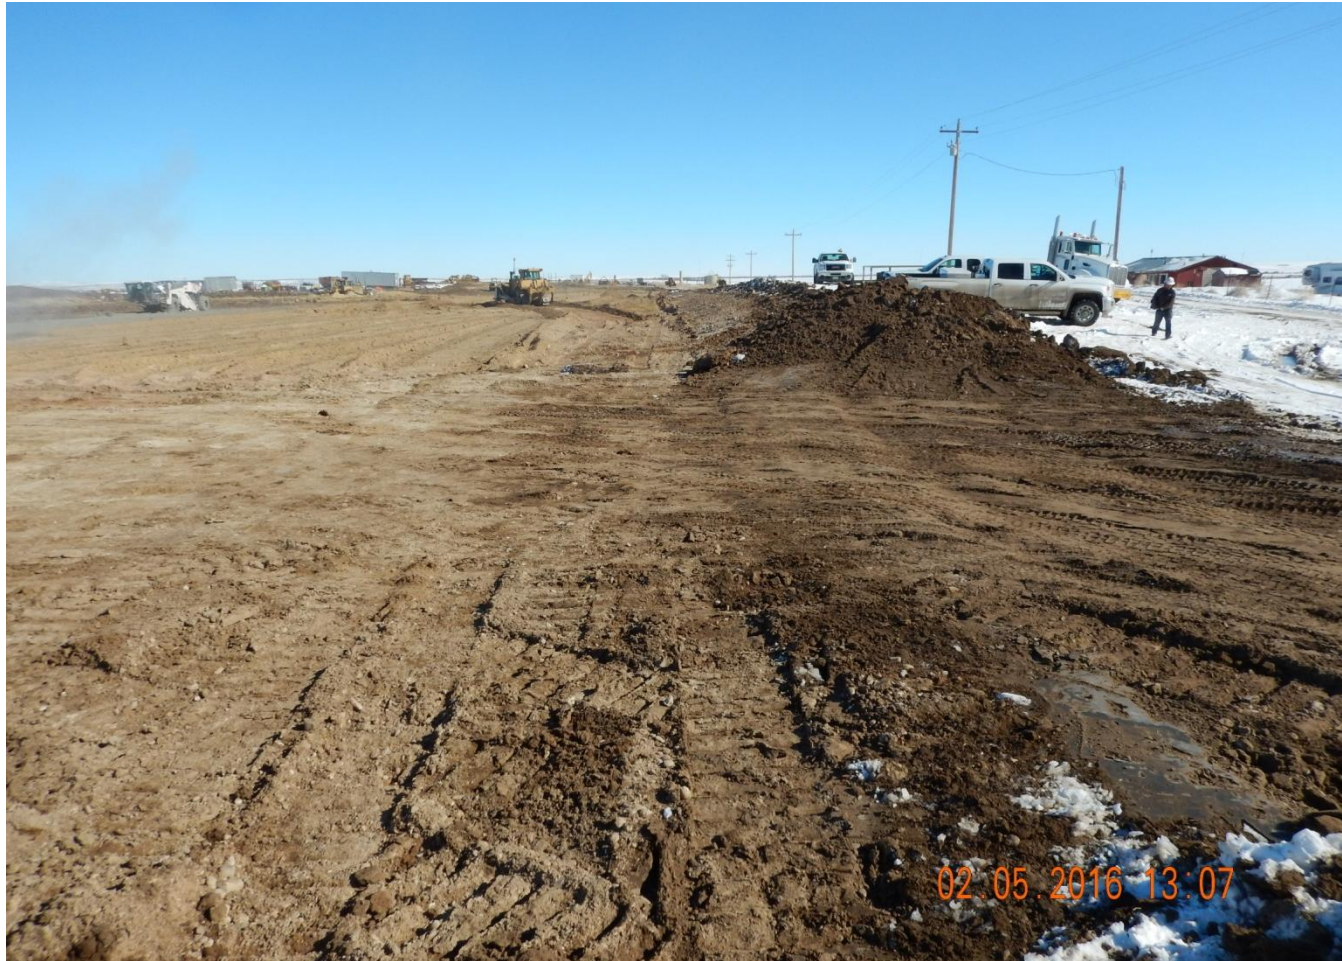
Photo 1. Photo taken from the entrance of location, facing East.

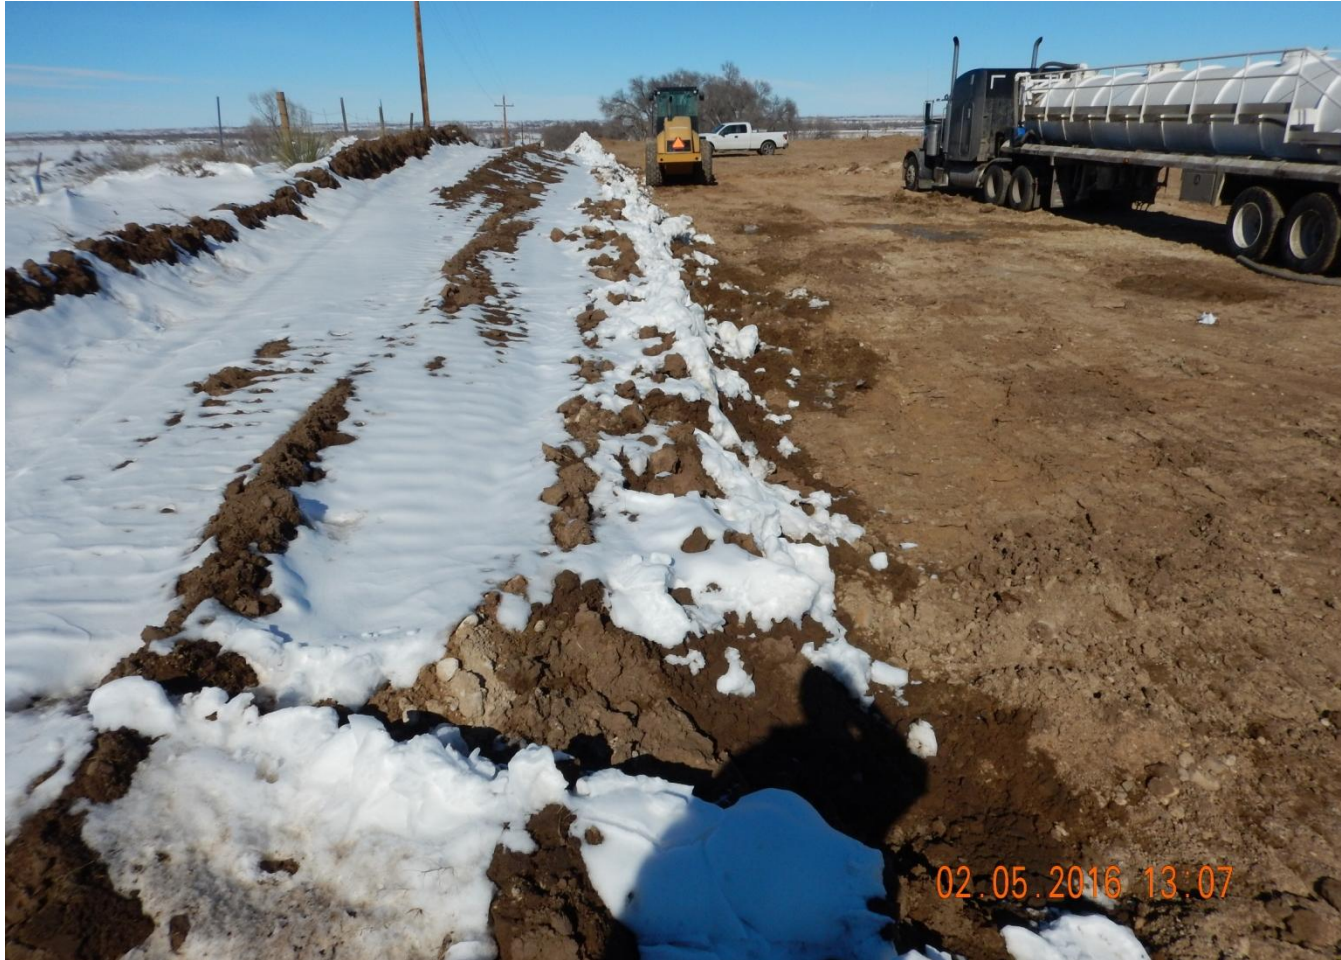
Photo 2. Photo taken from southwest location, facing North. Stormwater and sediment control BMPs installed along perimeter of location.

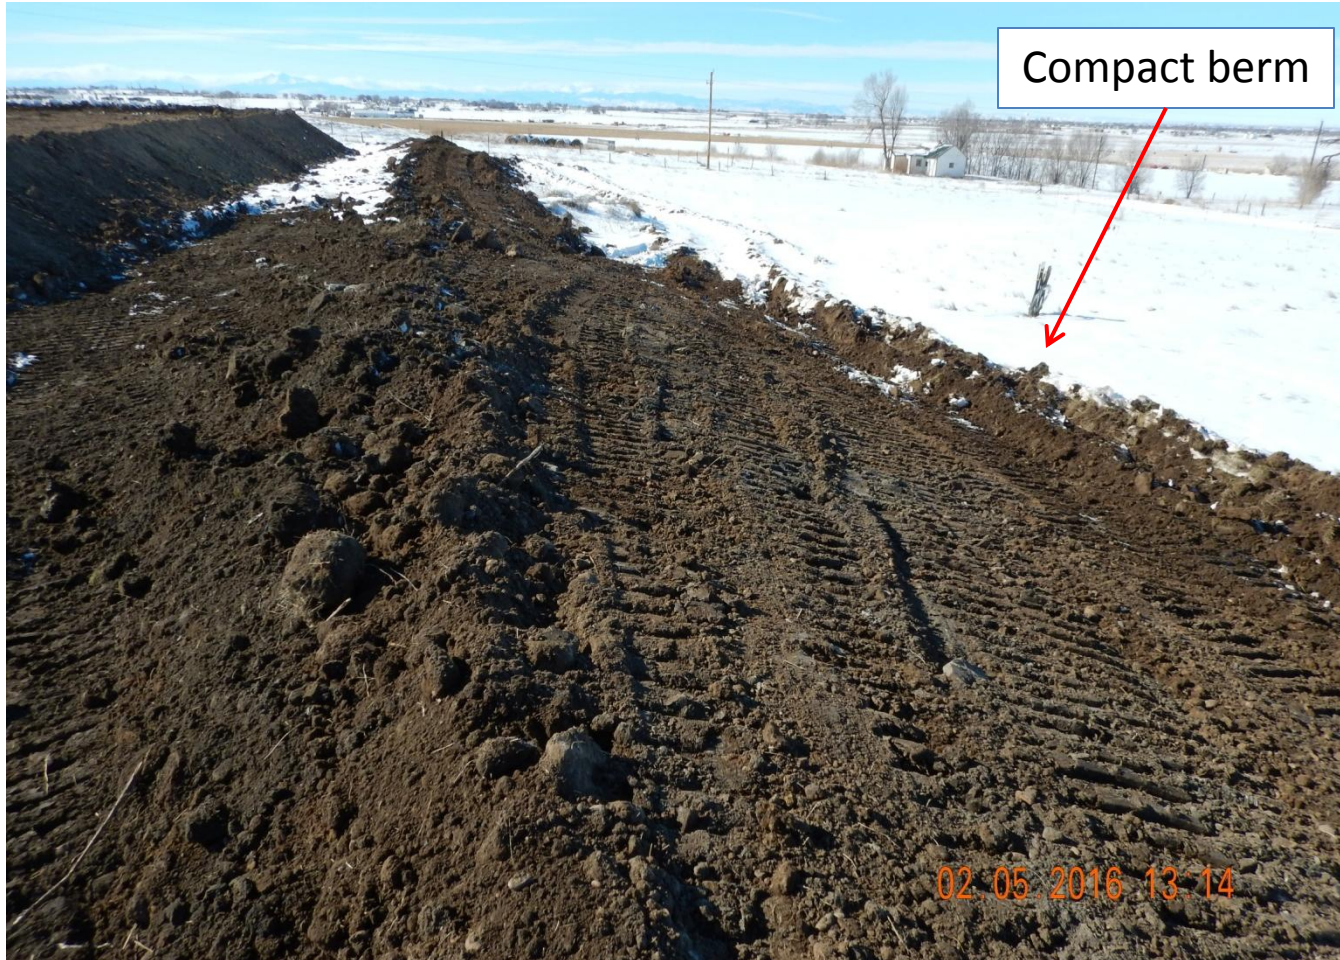
Photo 3. Photo taken from northern location, facing West. Stormwater and sediment control BMPs installed along perimeter of location. CDOT recommends that berms be properly compacted with no breaks in the berm. Operator said that perimeter berms will be compacted once favorable conditions are permitted.

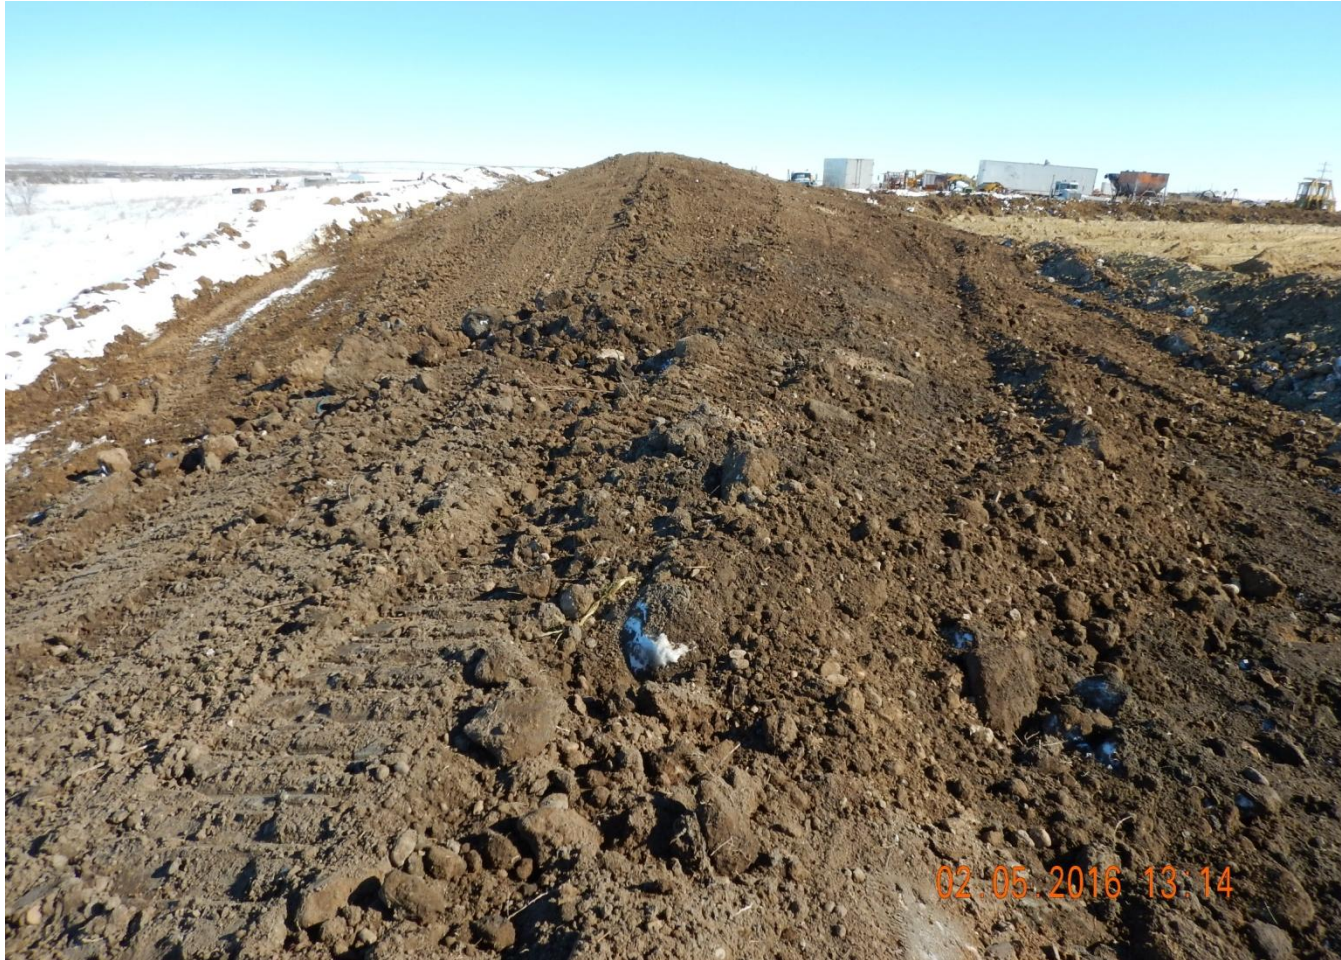
Photo 4. Photo taken from northern location, facing East. Topsoil stockpile in center of photo.

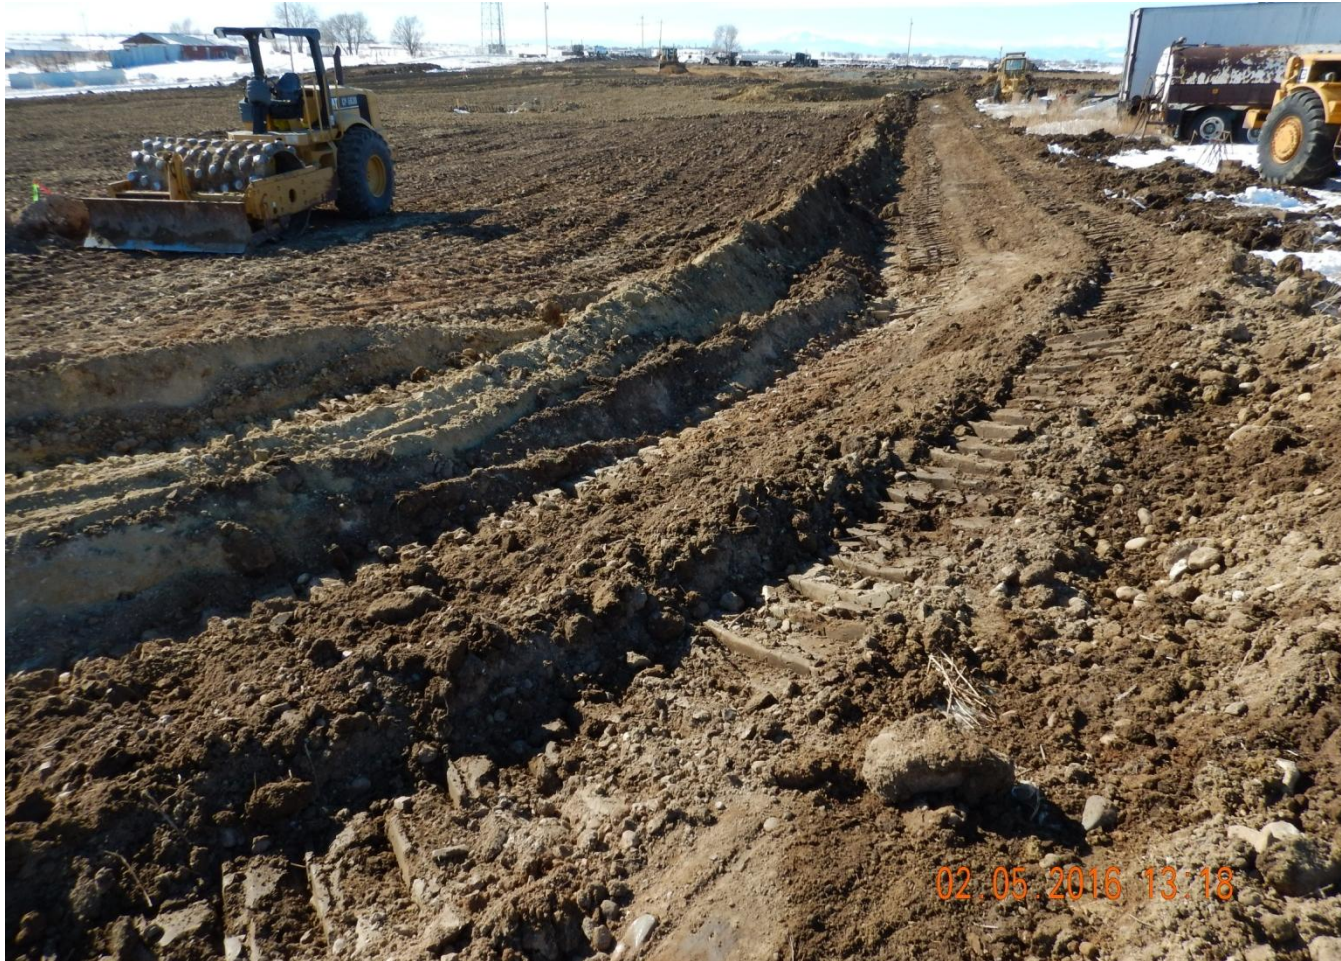
Photo 5. Photo taken from eastern location, facing West. Stormwater and sediment control BMPs installed along perimeter of location. CDOT recommends that berms be properly compacted with no breaks in the berm. Operator said that perimeter berms will be compacted once favorable conditions are permitted.

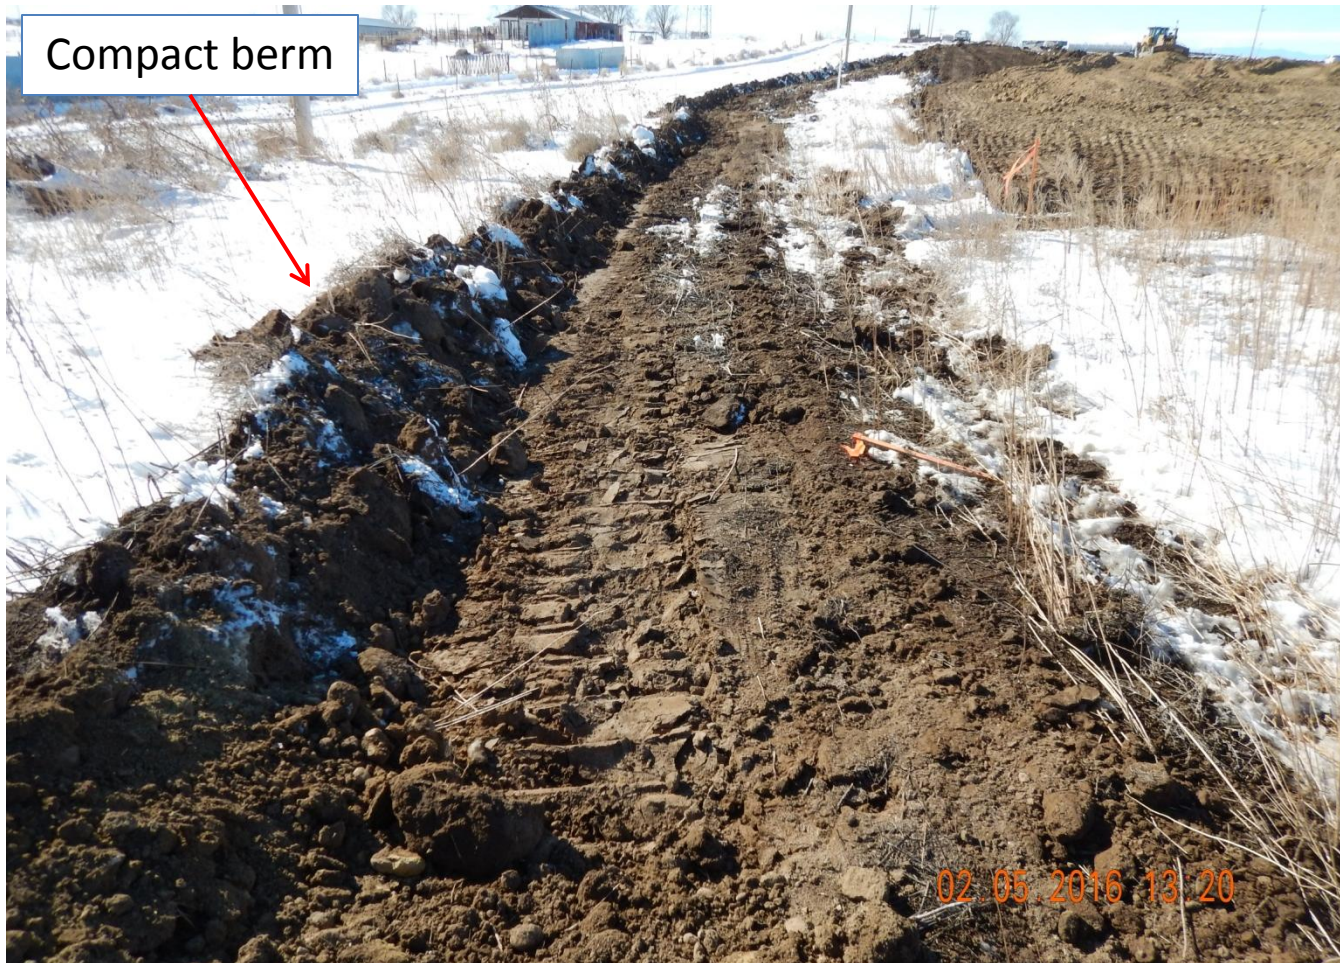
Photo 6. Photo taken from southeast location, facing West. Stormwater and sediment control BMPs installed along perimeter of location. CDOT recommends that berms be properly compacted with no breaks in the berm. Operator said that perimeter berms will be compacted once favorable conditions are permitted.

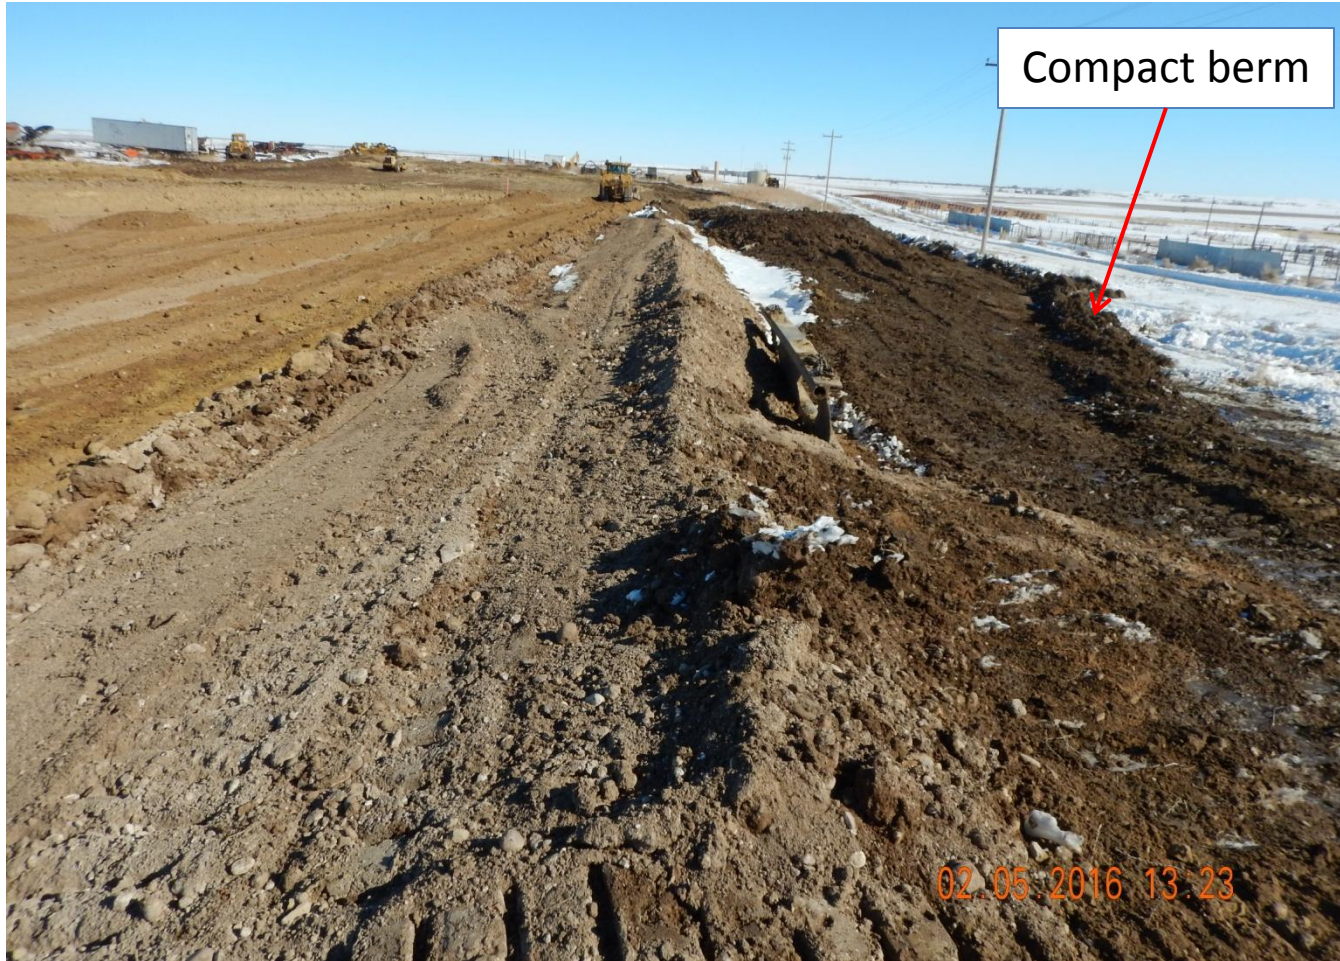
Photo 7. Photo taken from southern location, facing East. Stormwater and sediment control BMPs installed along perimeter of location. CDOT recommends that berms be properly compacted with no breaks in the berm. Operator said that perimeter berms will be compacted once favorable conditions are permitted.

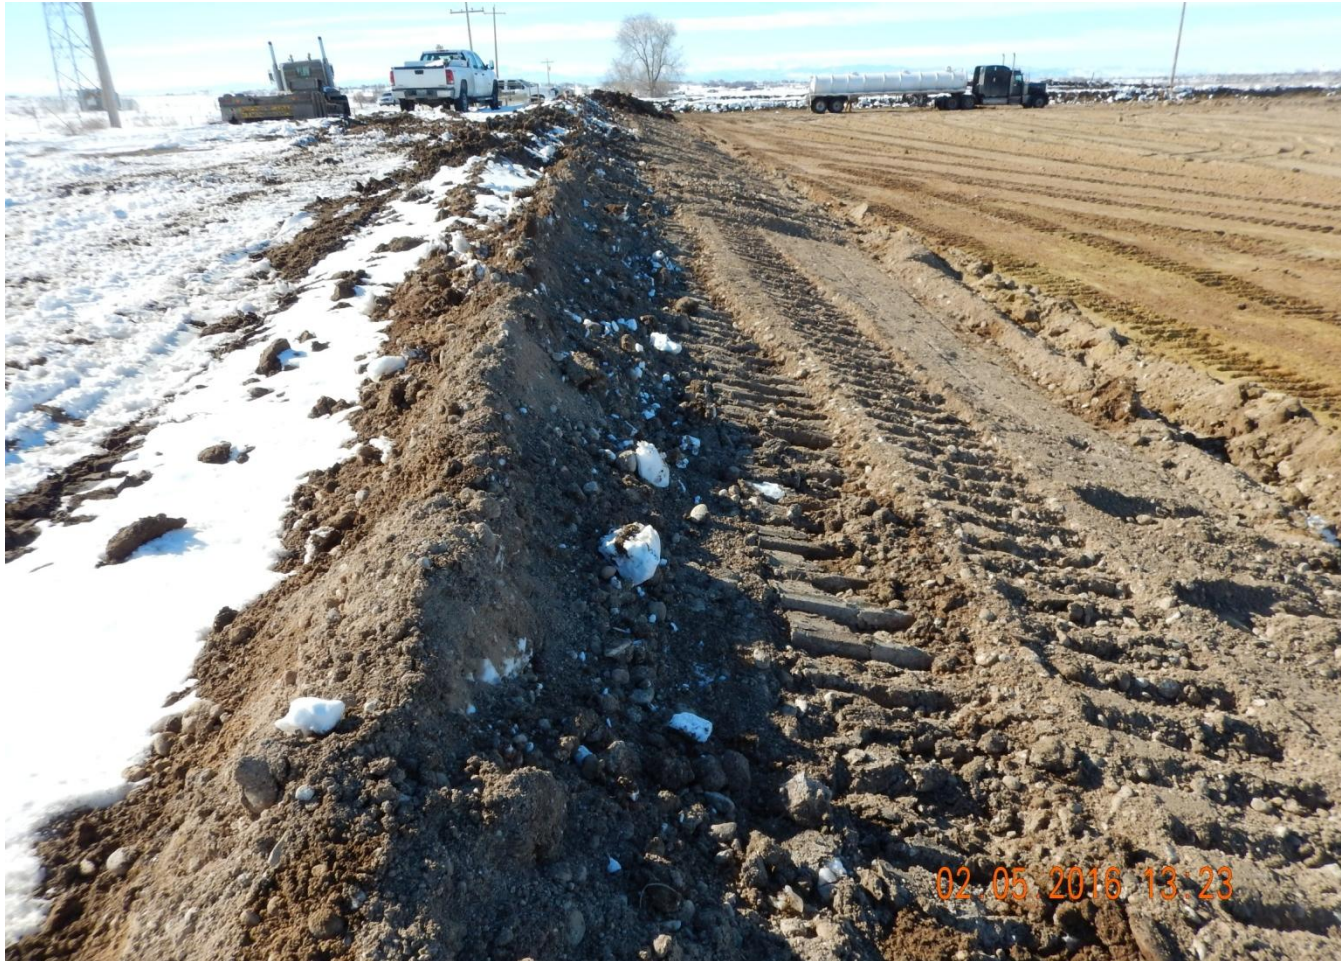
Photo 8. Photo taken from southern location, facing West. Stormwater and sediment control BMPs installed along perimeter of location. CDOT recommends that berms be properly compacted with no breaks in the berm. Operator said that perimeter berms will be compacted once favorable conditions are permitted.
