# Interim and Stormwater Inspection

Operator: Whiting Oil and Gas

Location ID: 434883

NENE Section 21 T10N R58W

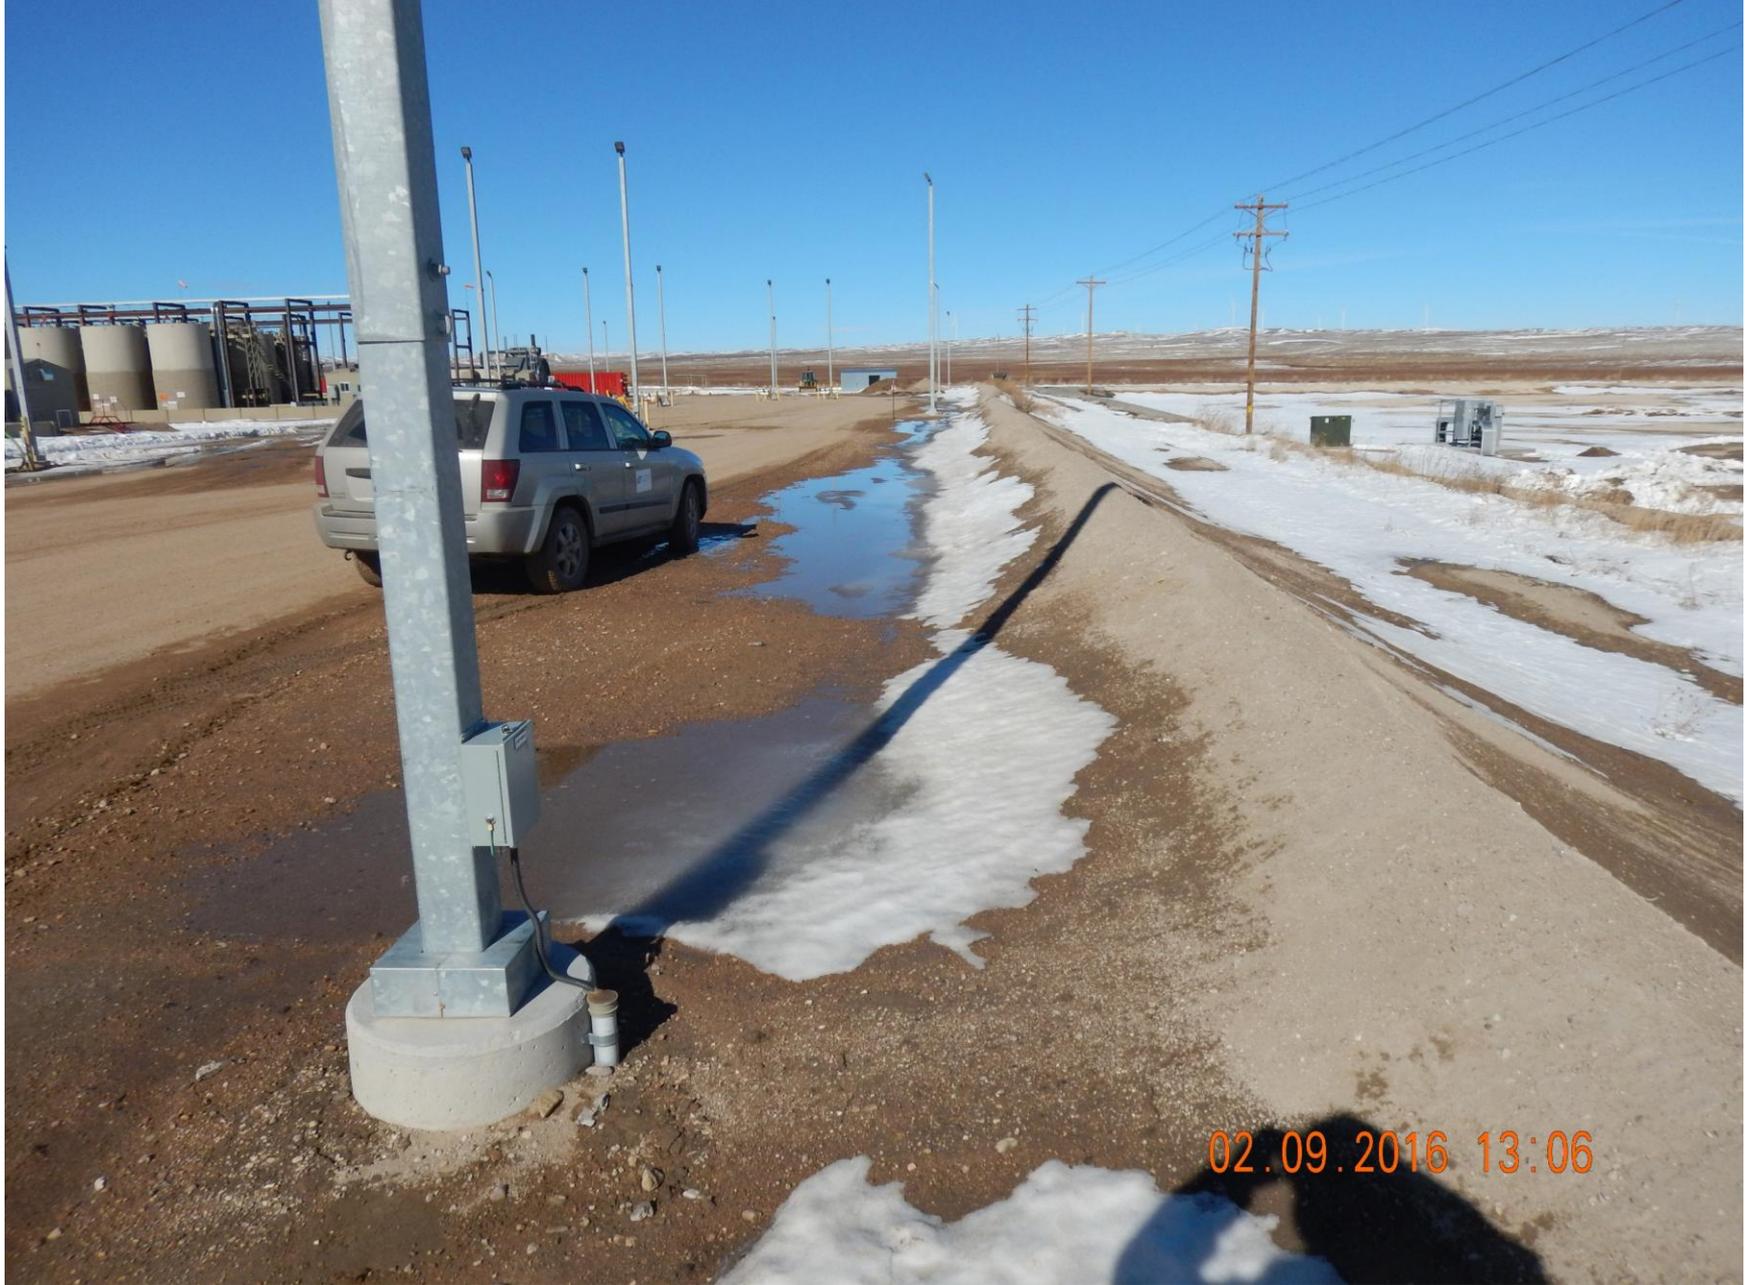
**Figure 1:** Photo taken from the southeast portion of location, facing north. Photo shows stormwater berm along eastern end. Note lack of vegetation on east facing slope of location, interim reclamation in process.

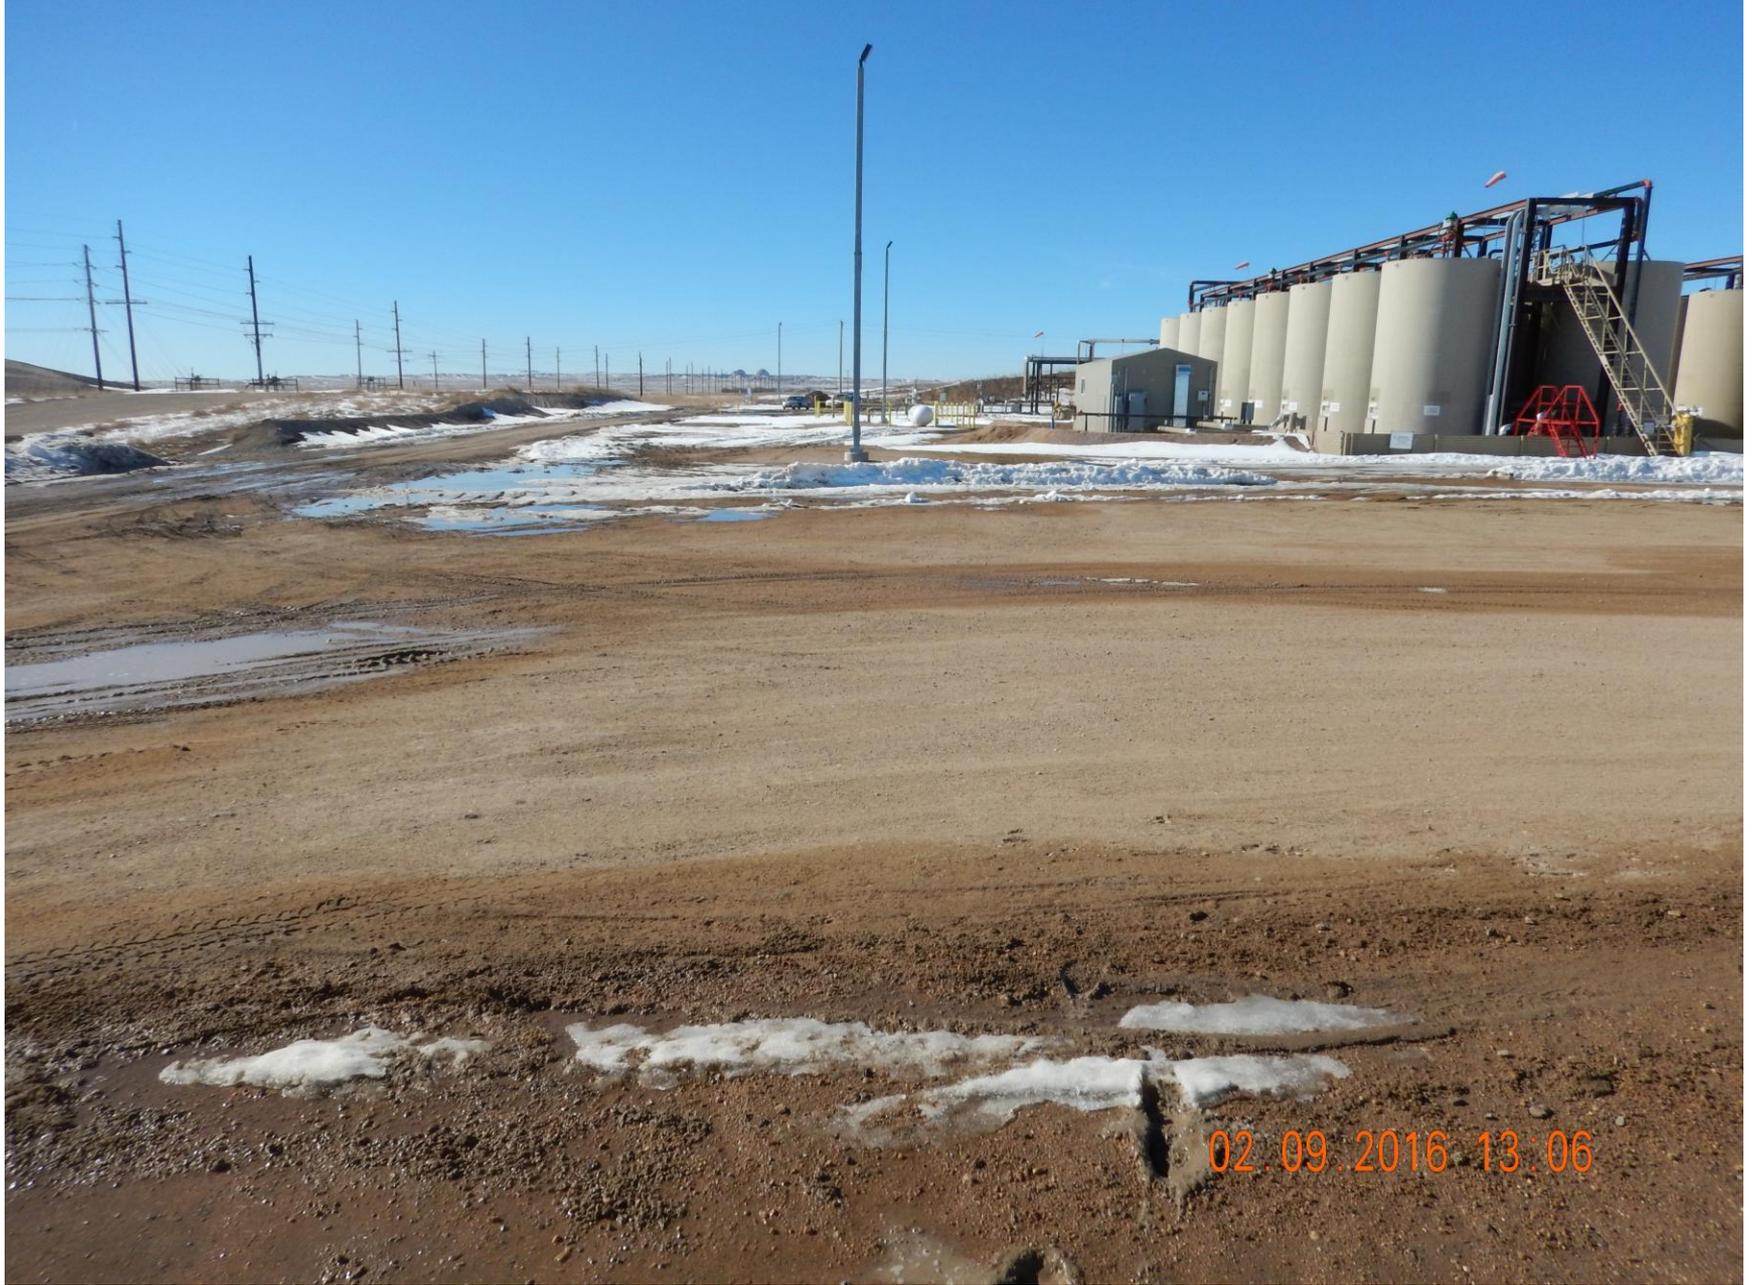
**Figure 2:** Photo taken from the southeast portion of location, facing west. Photo shows portion of project area and access road.

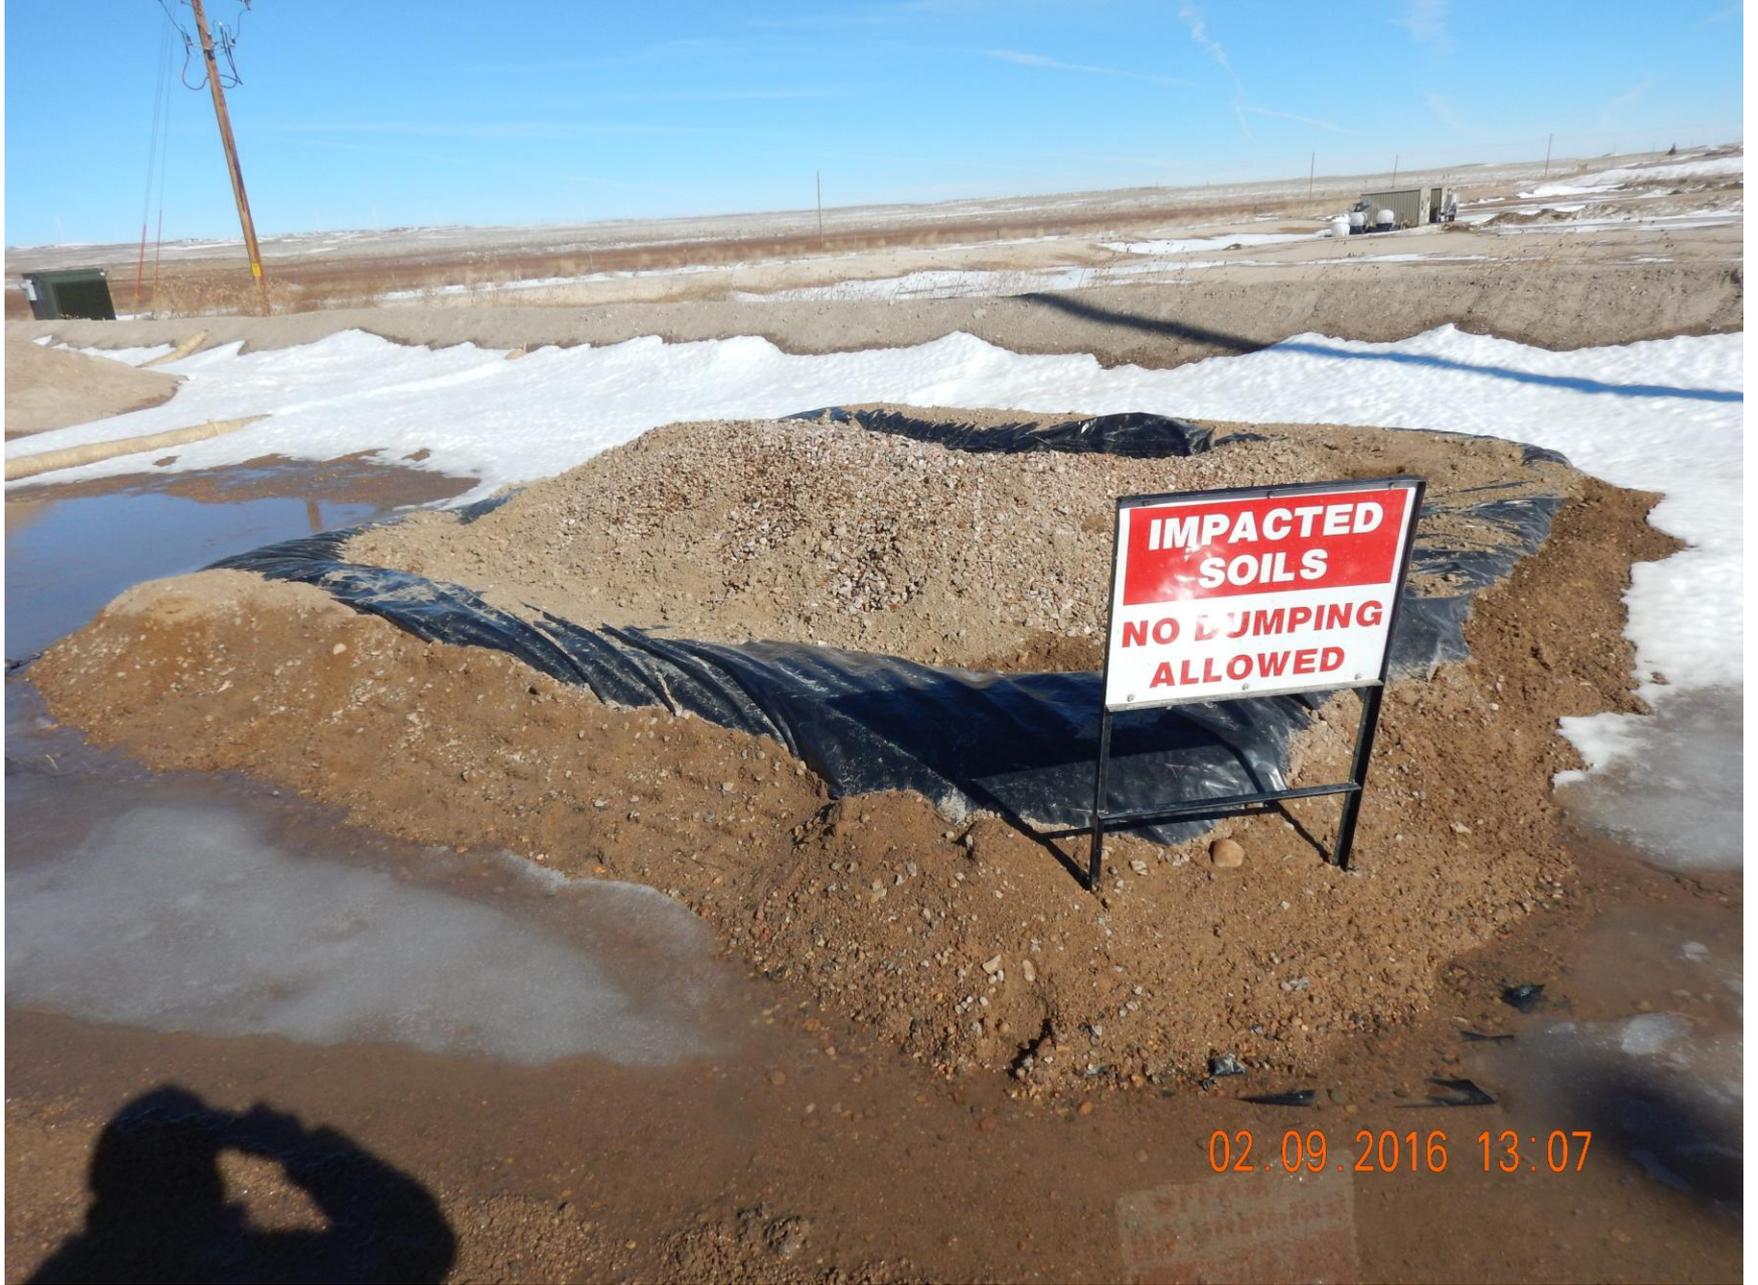
**Figure 3:** Photo taken from the eastern end of location, facing east. Photo of impacted soils.

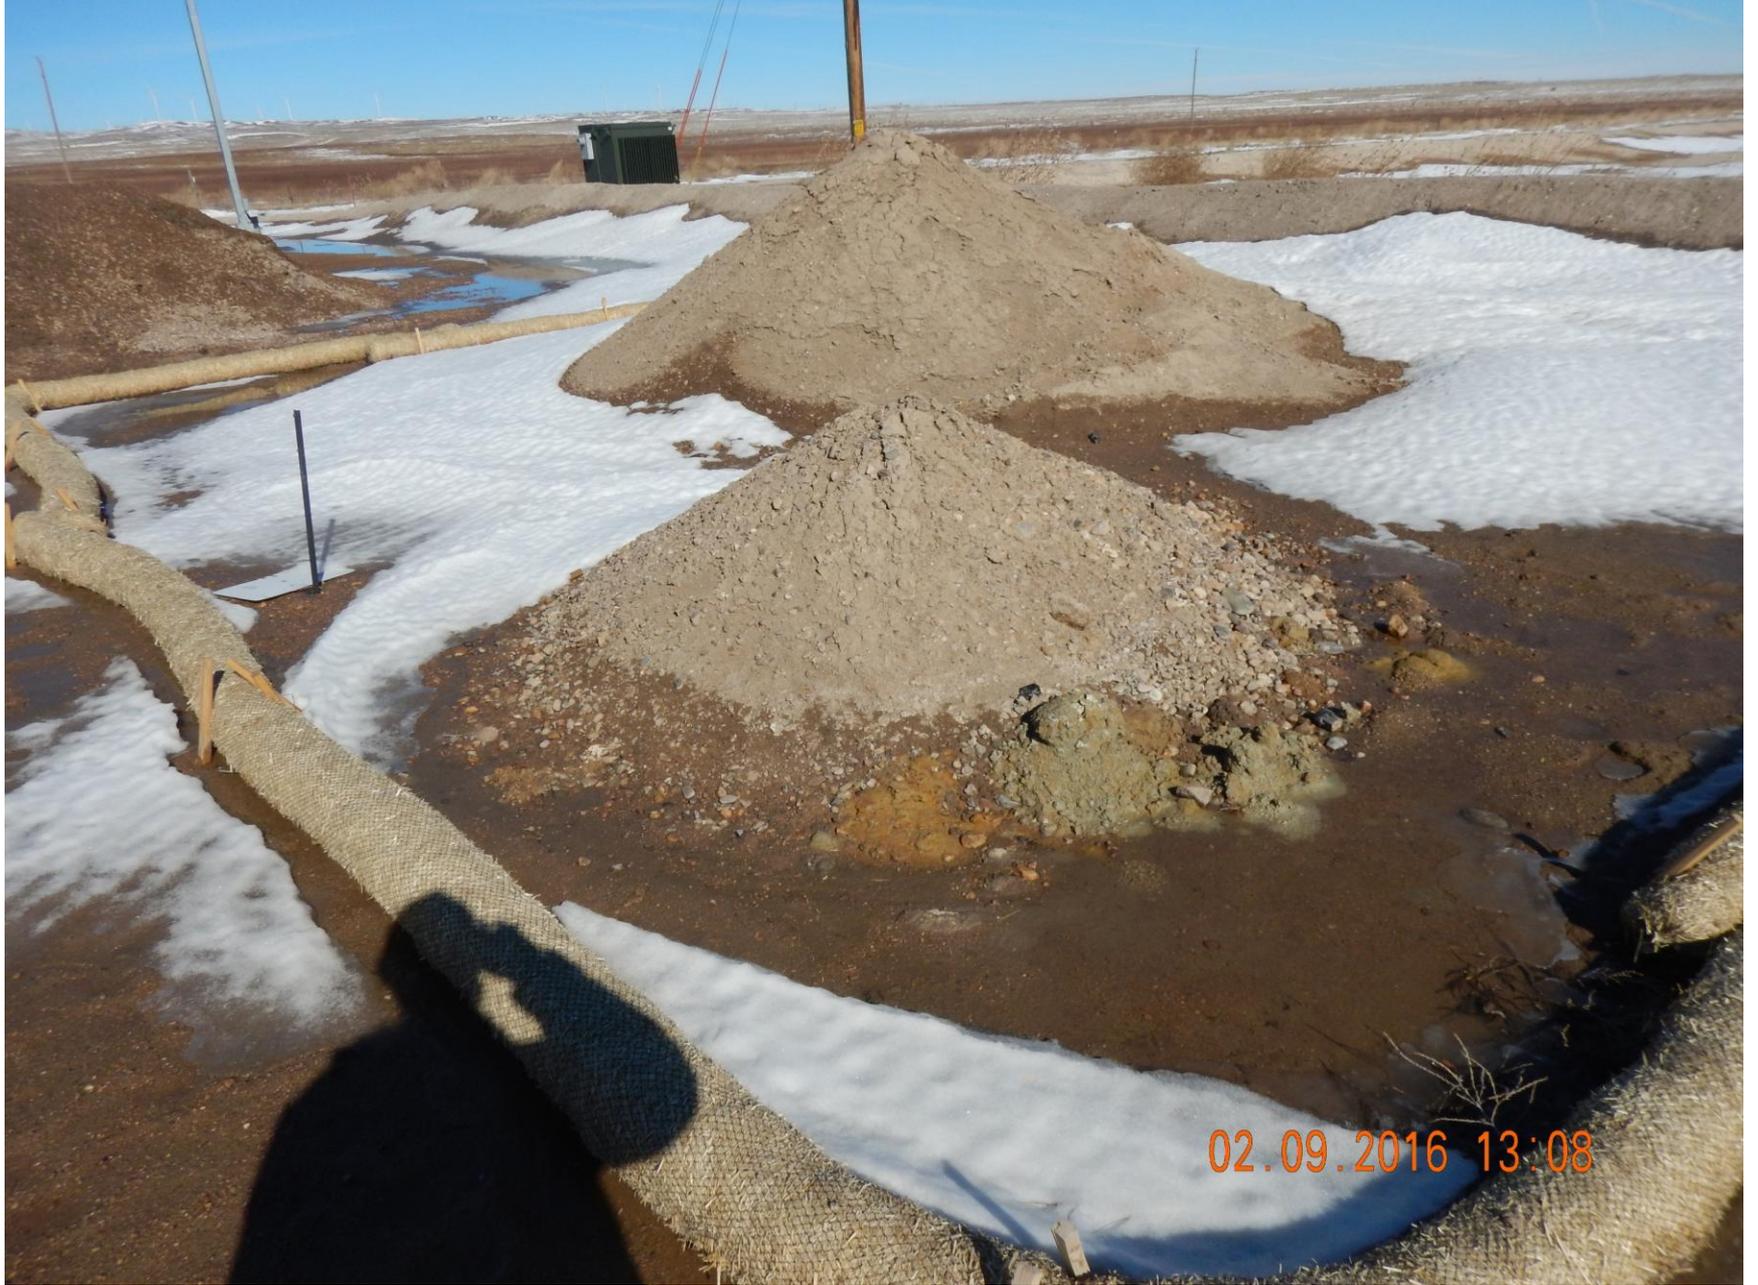
**Figure 4:** Photo taken from the eastern end of location, facing east. Photo of treated soils.

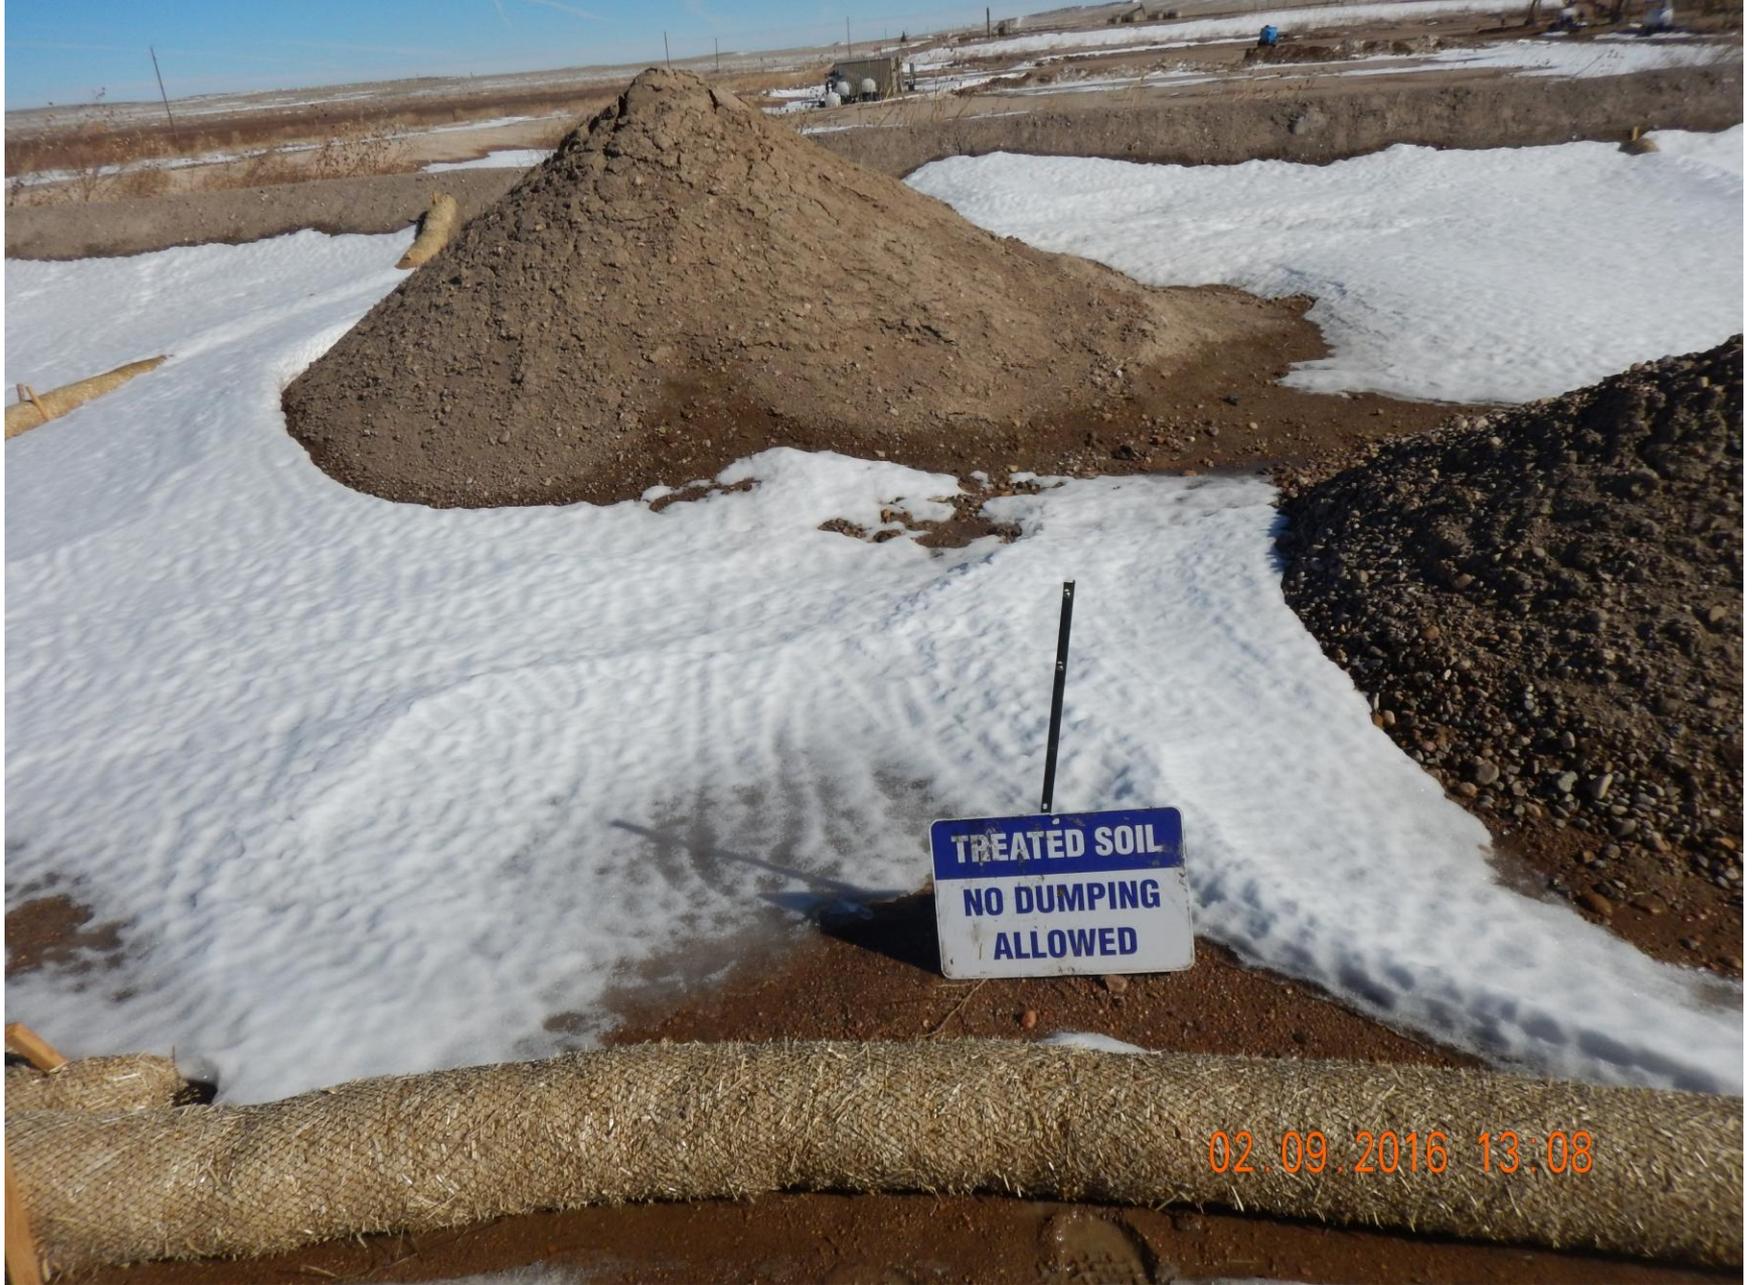
**Figure 5:** Photo taken from the eastern end of location, facing east. Photo of treated soils.

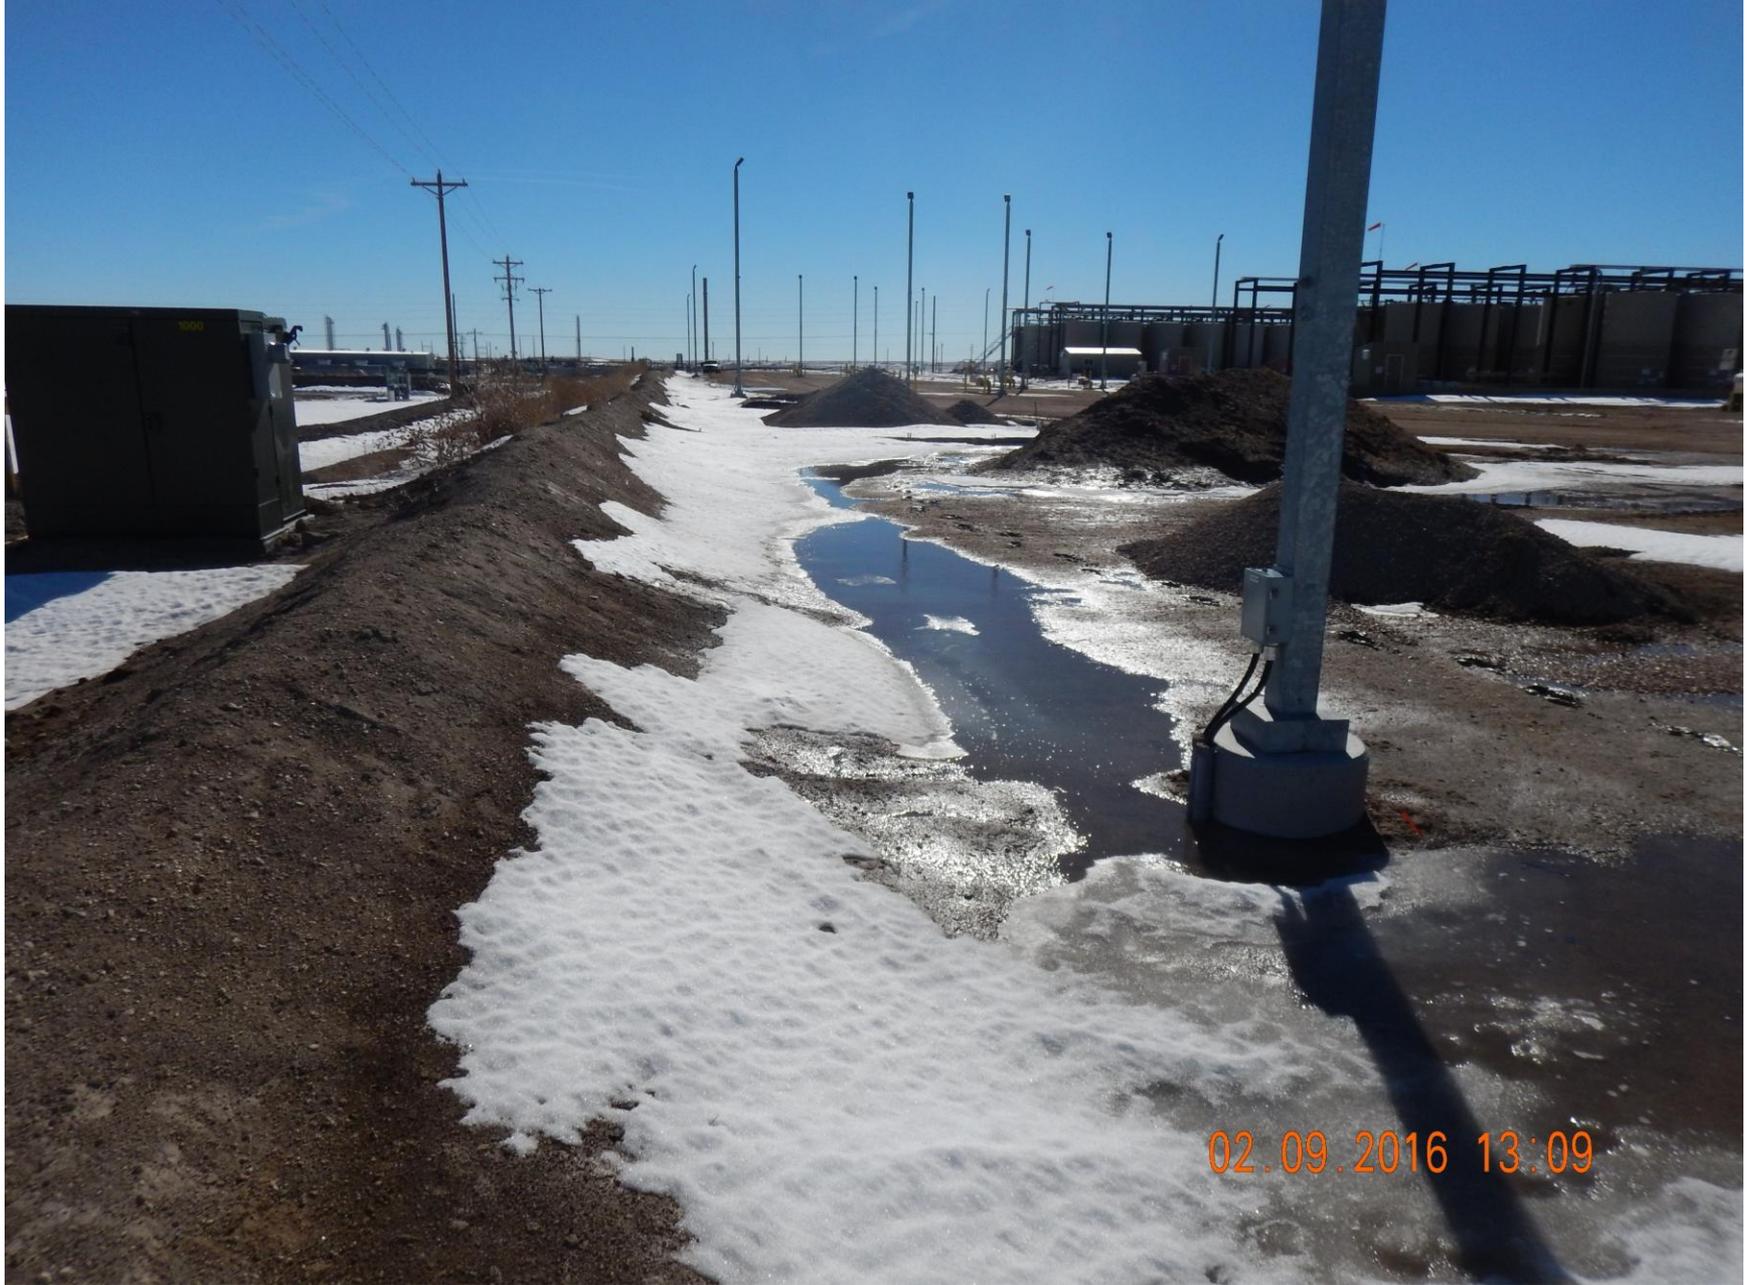
**Figure 6:** Photo taken from the northeast corner of location, facing south. Photo shows stormwater berm along eastern end of location, and portion of the project area.

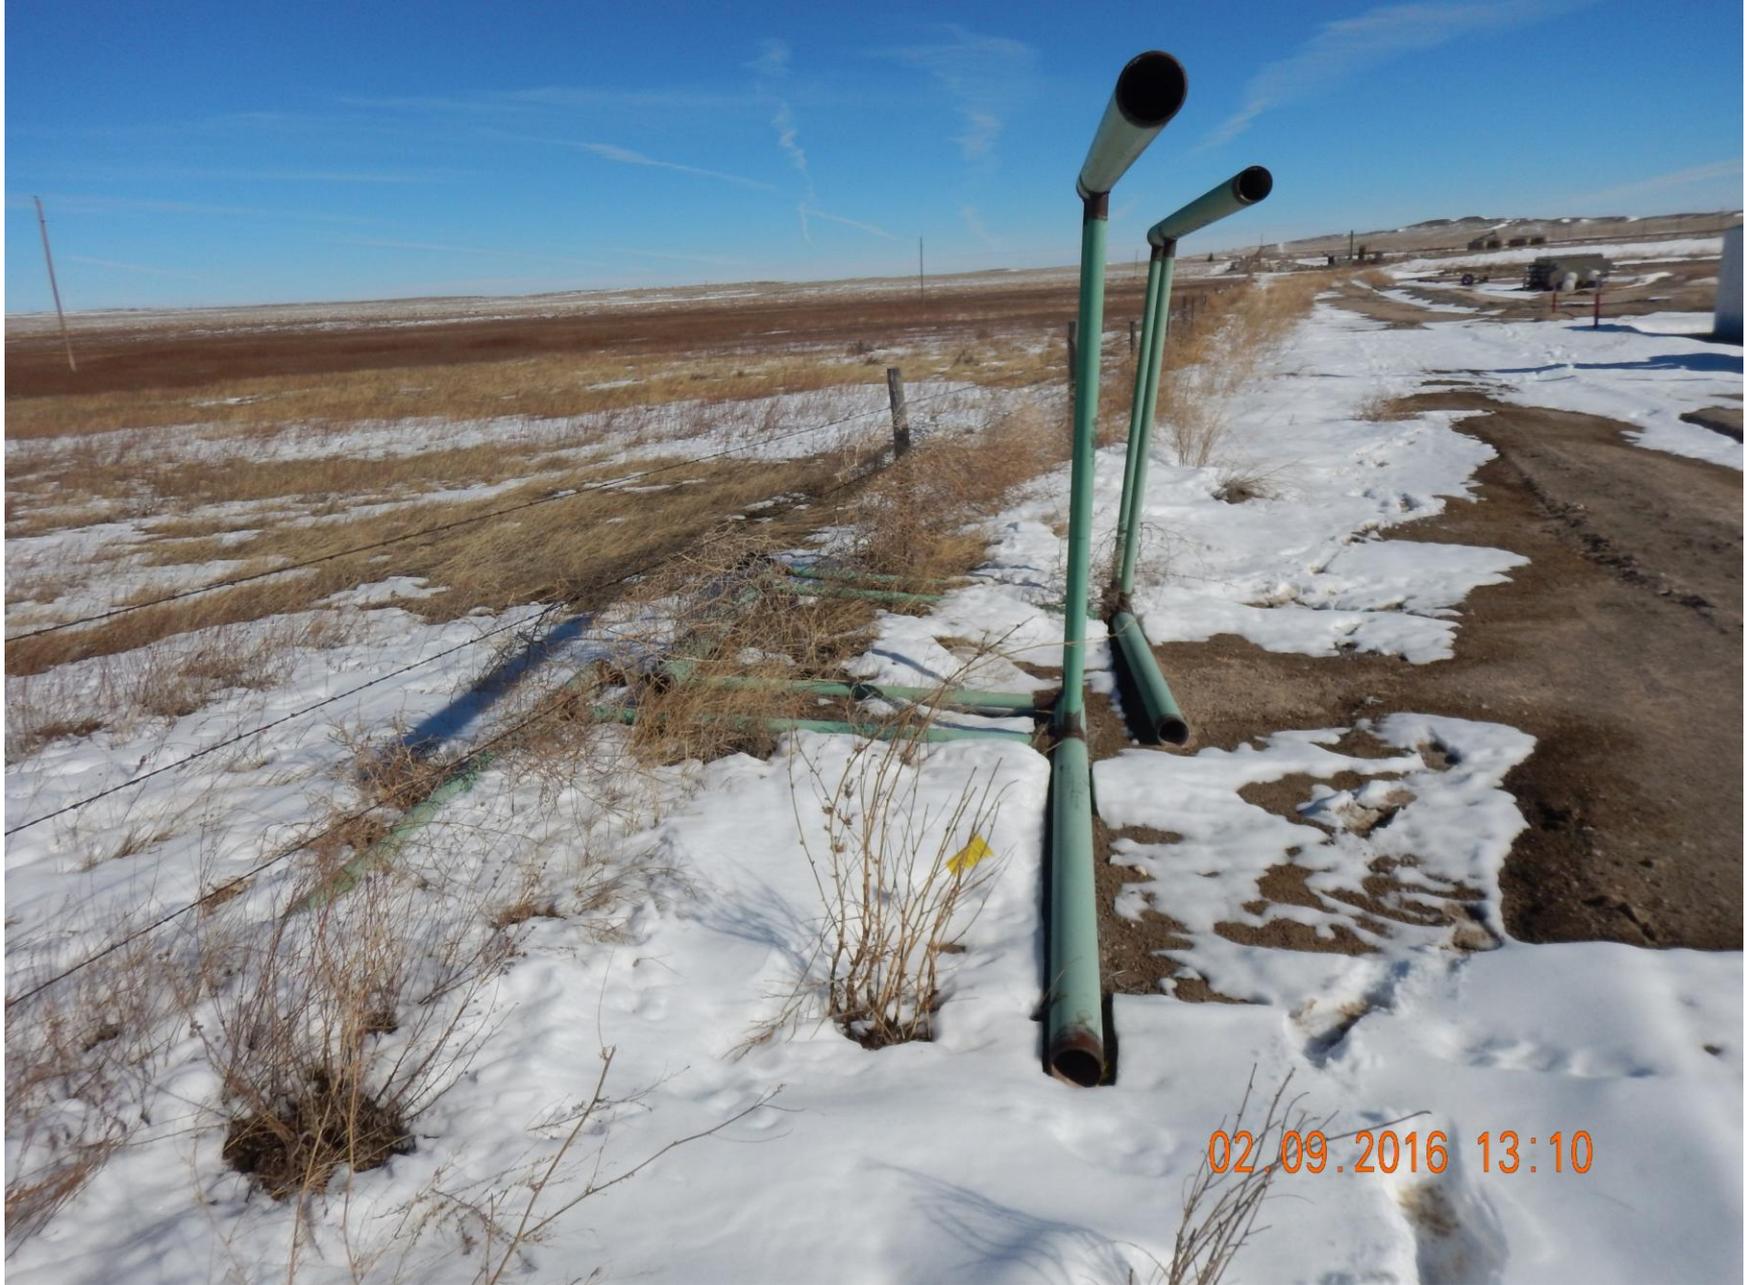
**Figure 8:** Photo taken from the north end of location, facing west. Photo shows equipment being stored off project area.

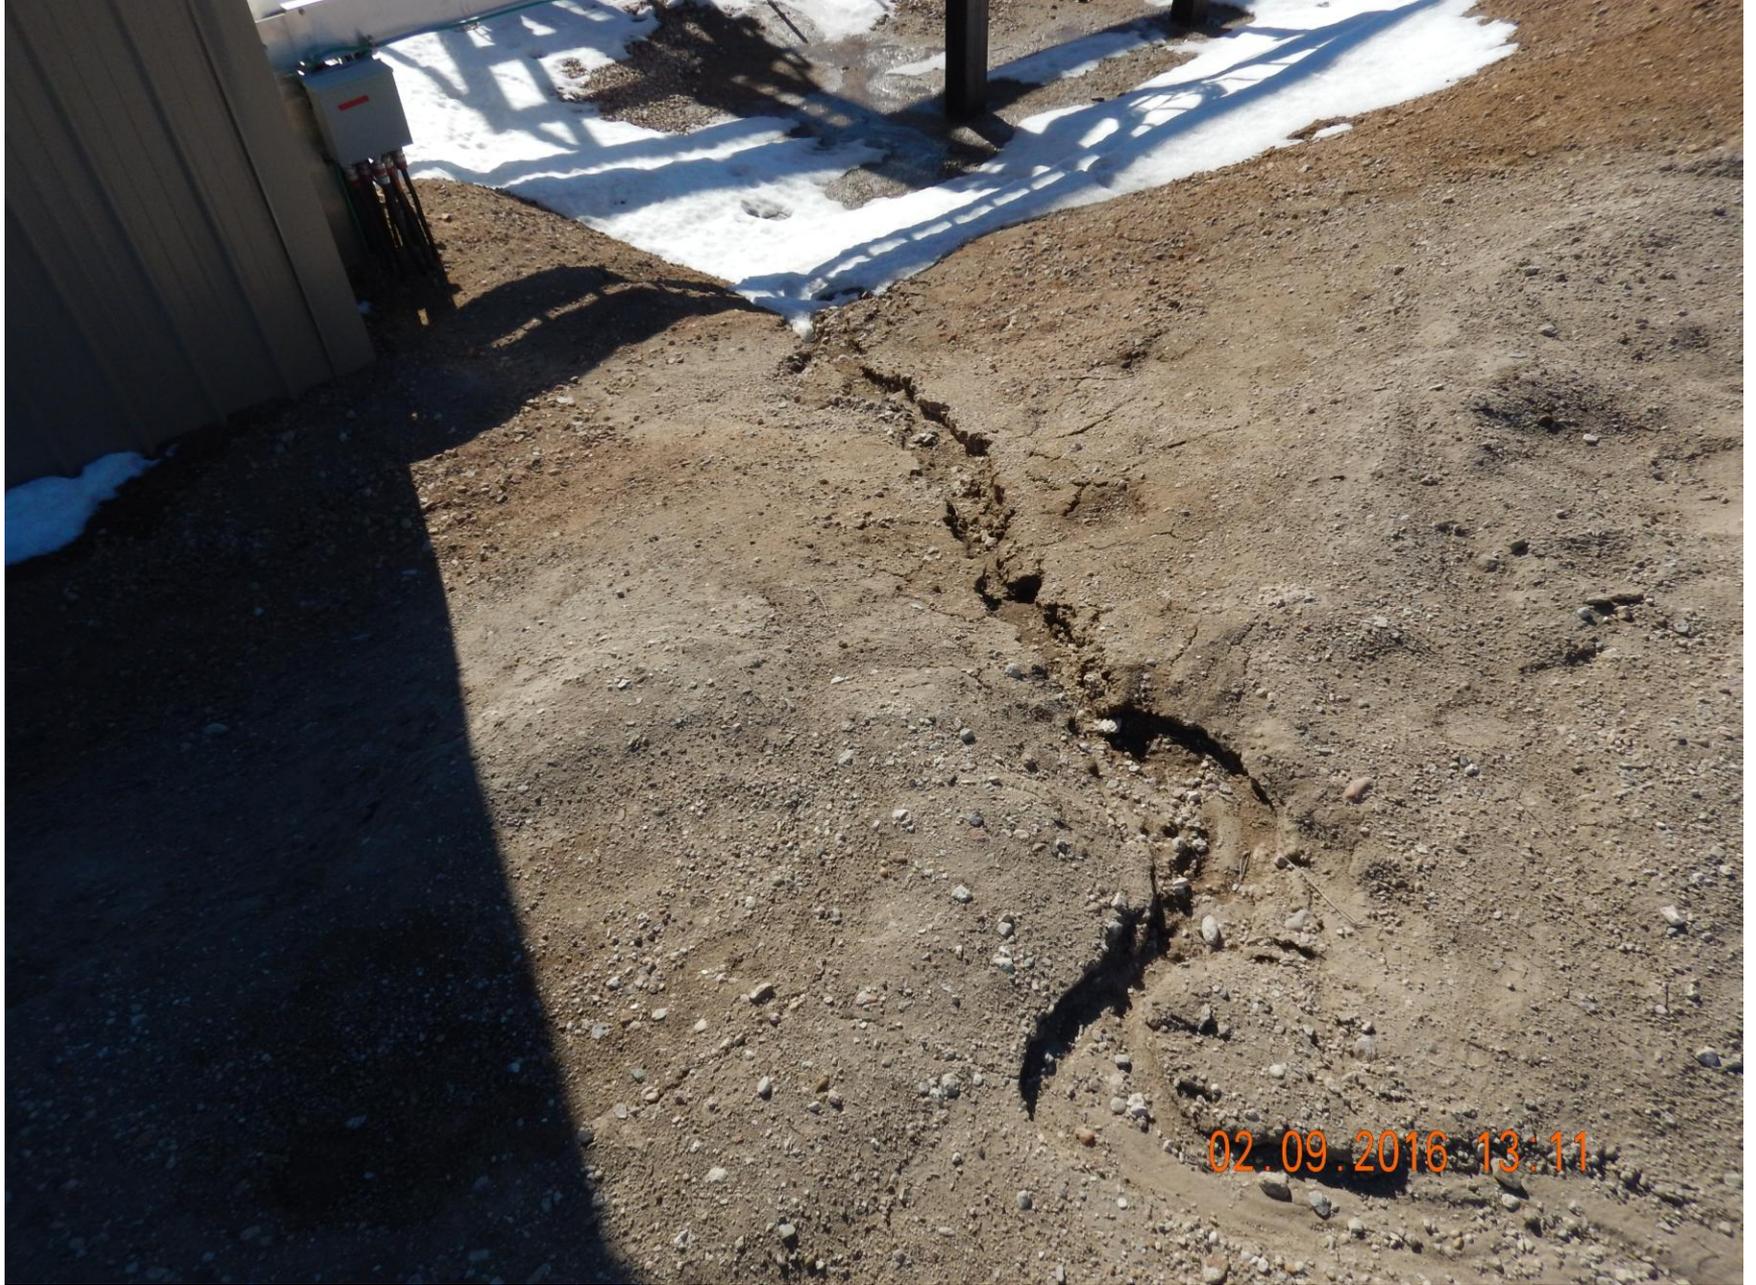
**Figure 9:** Photo taken from the north end of the location. Photo of erosion forming on slope of the perimeter. This is evidence that slope is not stabilized.

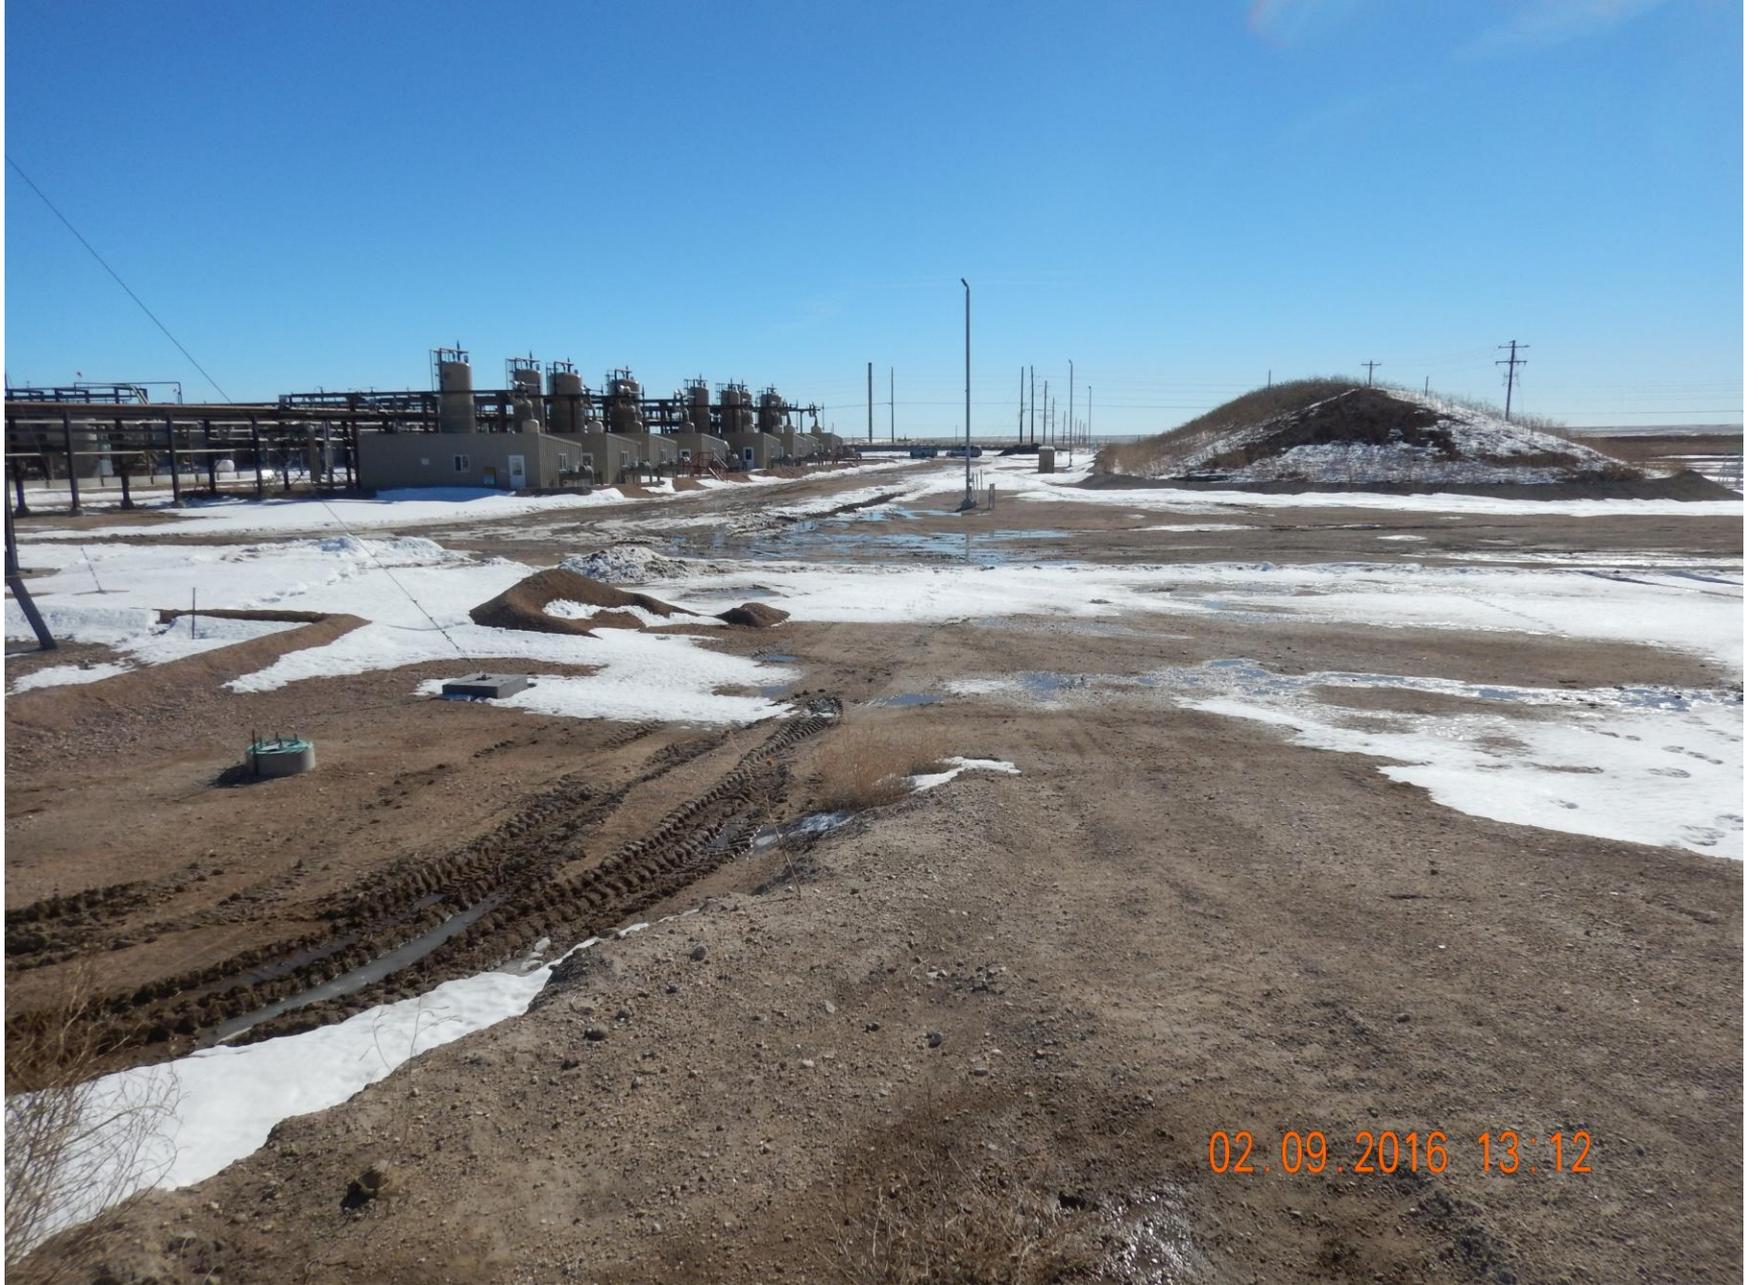
**Figure 10:** Photo taken from the northwestern end of location, facing south. Photo shows existing topsoil berm and portion of the project area.

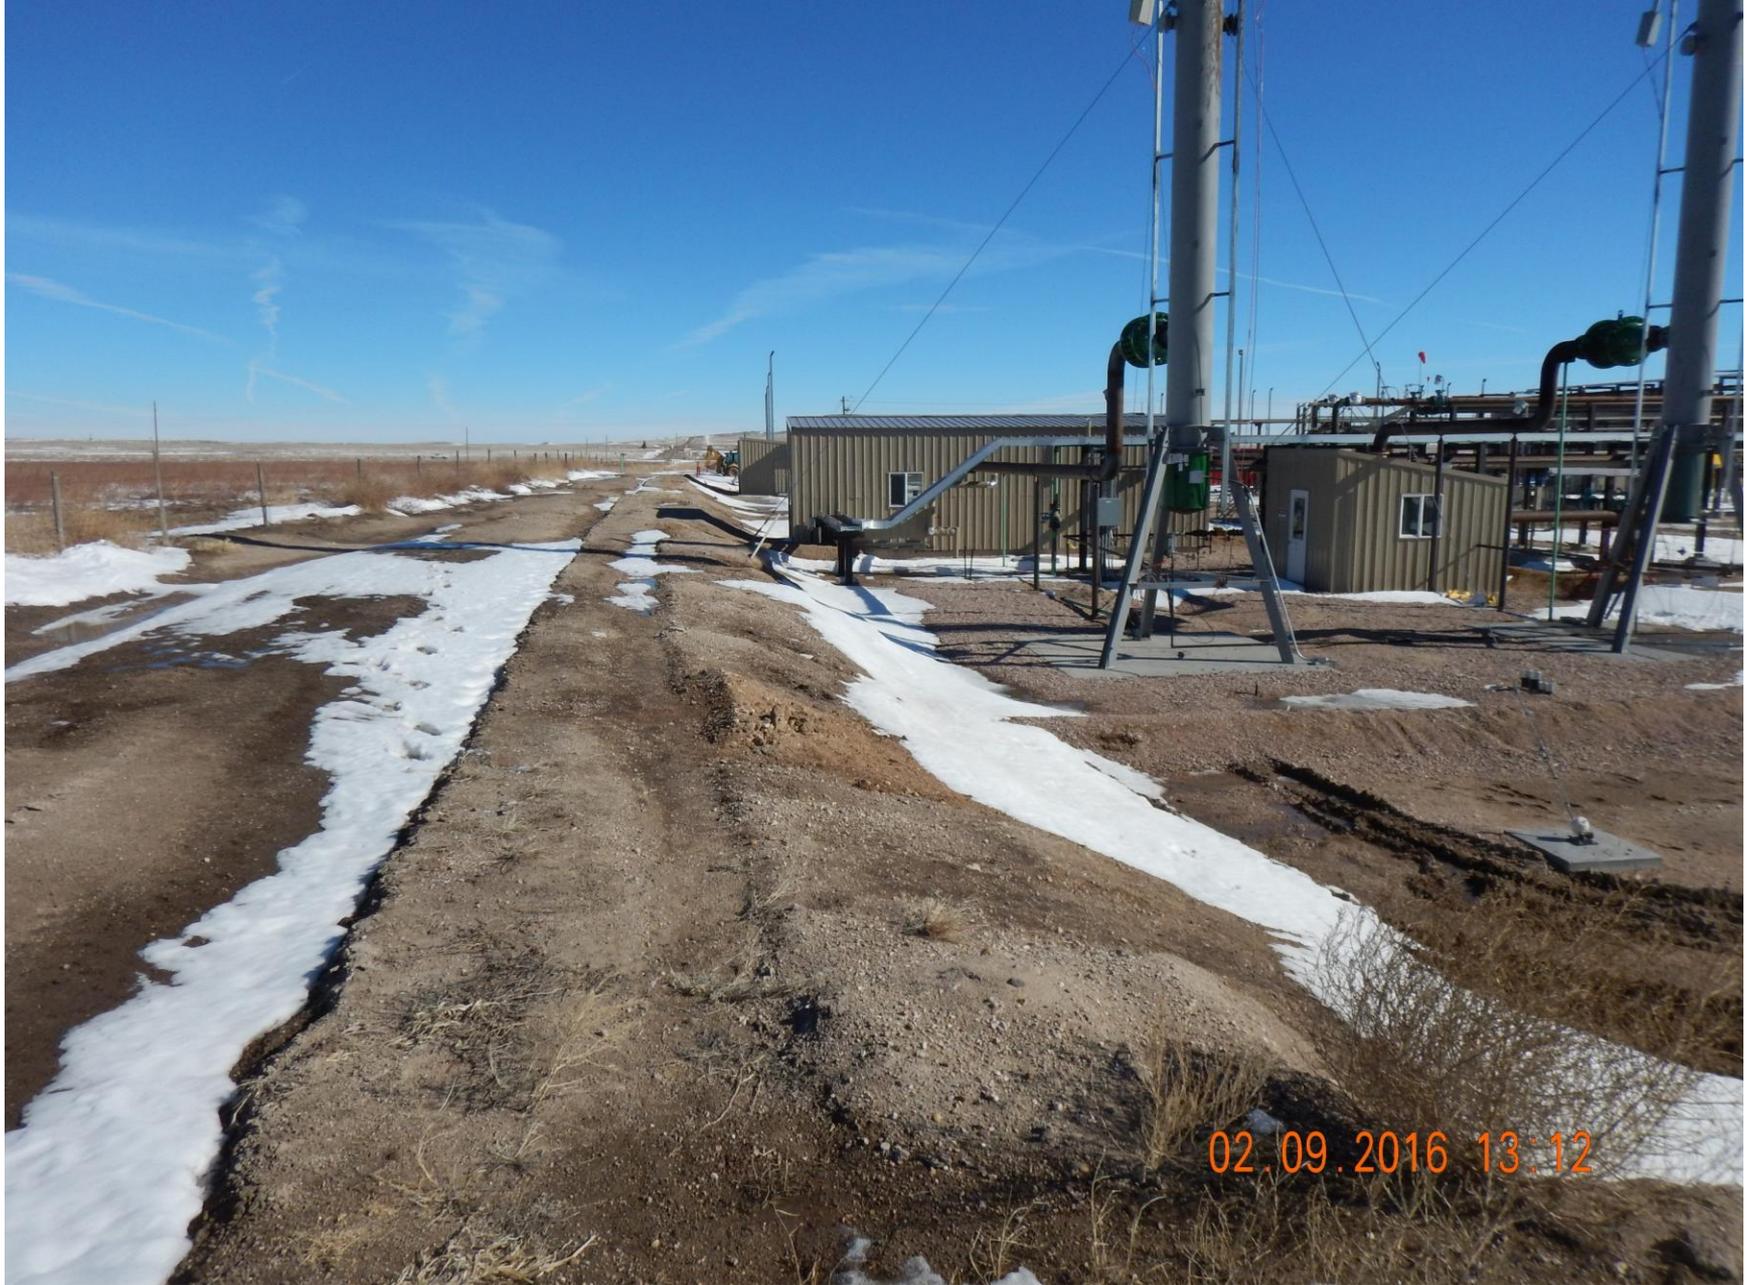
**Figure 11:** Photo taken from the northwestern portion of location, facing east. Photo shows portion of project area and interim area.
