# Interim and Stormwater Inspection

Operator: Whiting Oil and Gas

Location ID: 434883

NENE Section 21 T10N R58W

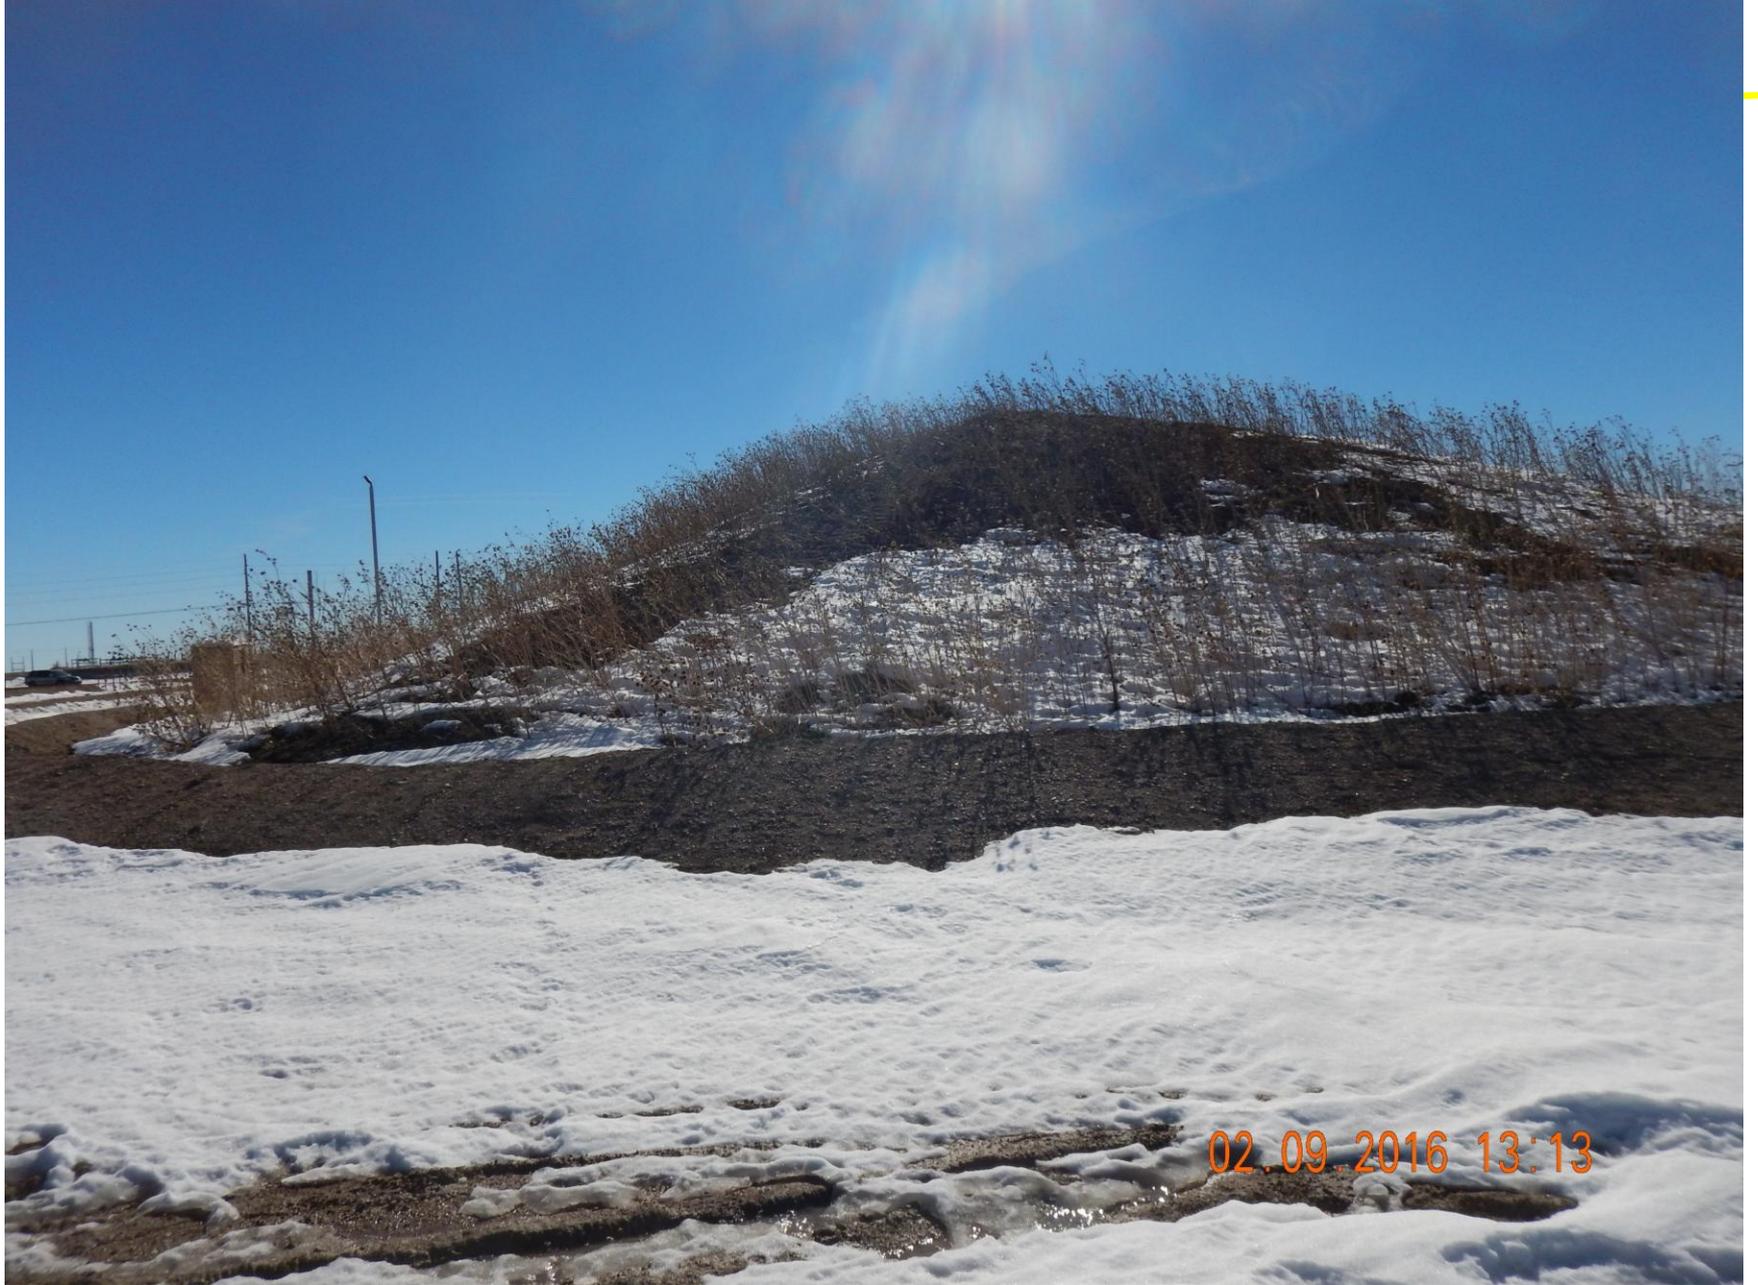
**Figure 12:** Photo taken from the topsoil berm on the west end of location, facing north. Photo shows lack of vegetative growth on interim area. Yellow line(s) show access road(s) at western access point.

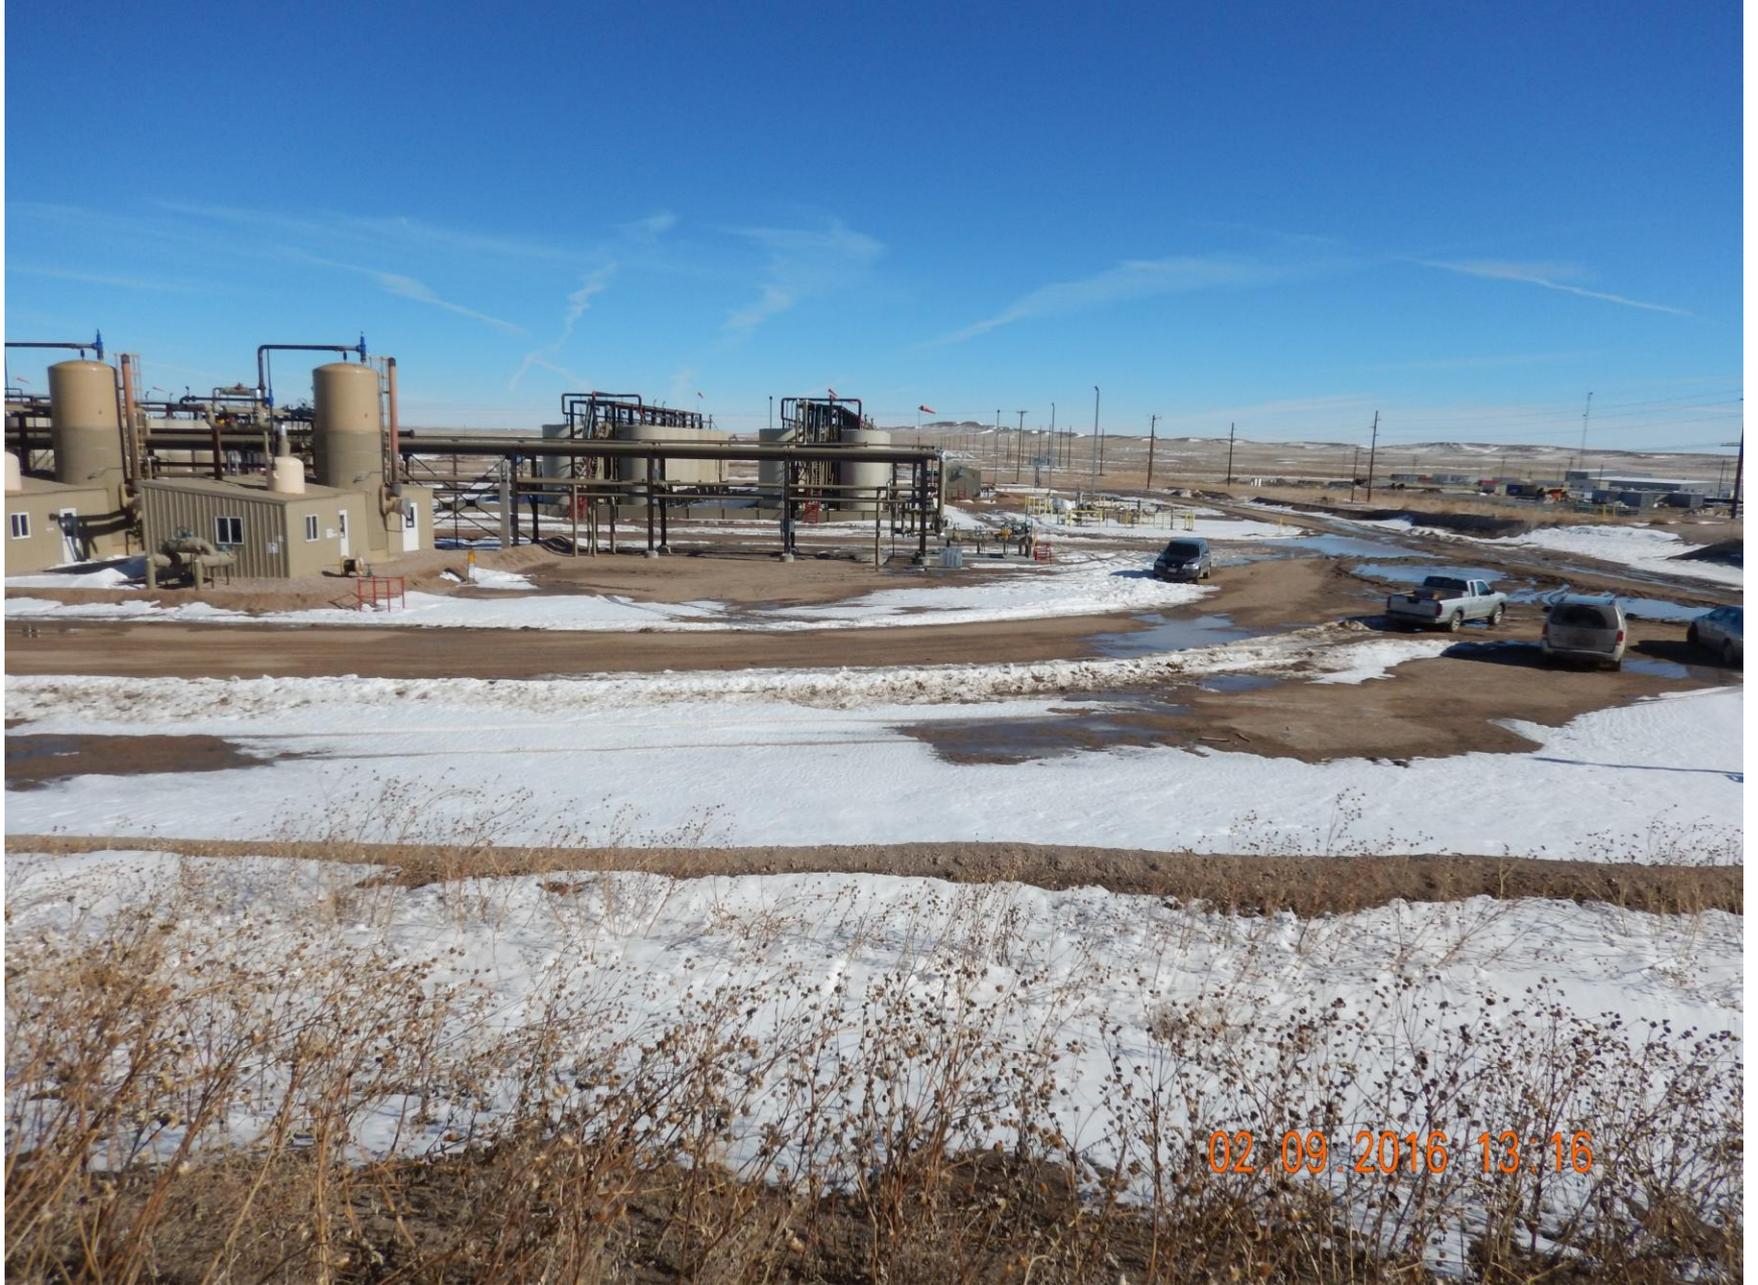
**Figure 15:** Photo taken from the existing topsoil berm on the southwestern portion of the location, facing east. Photo shows project area and access road.
