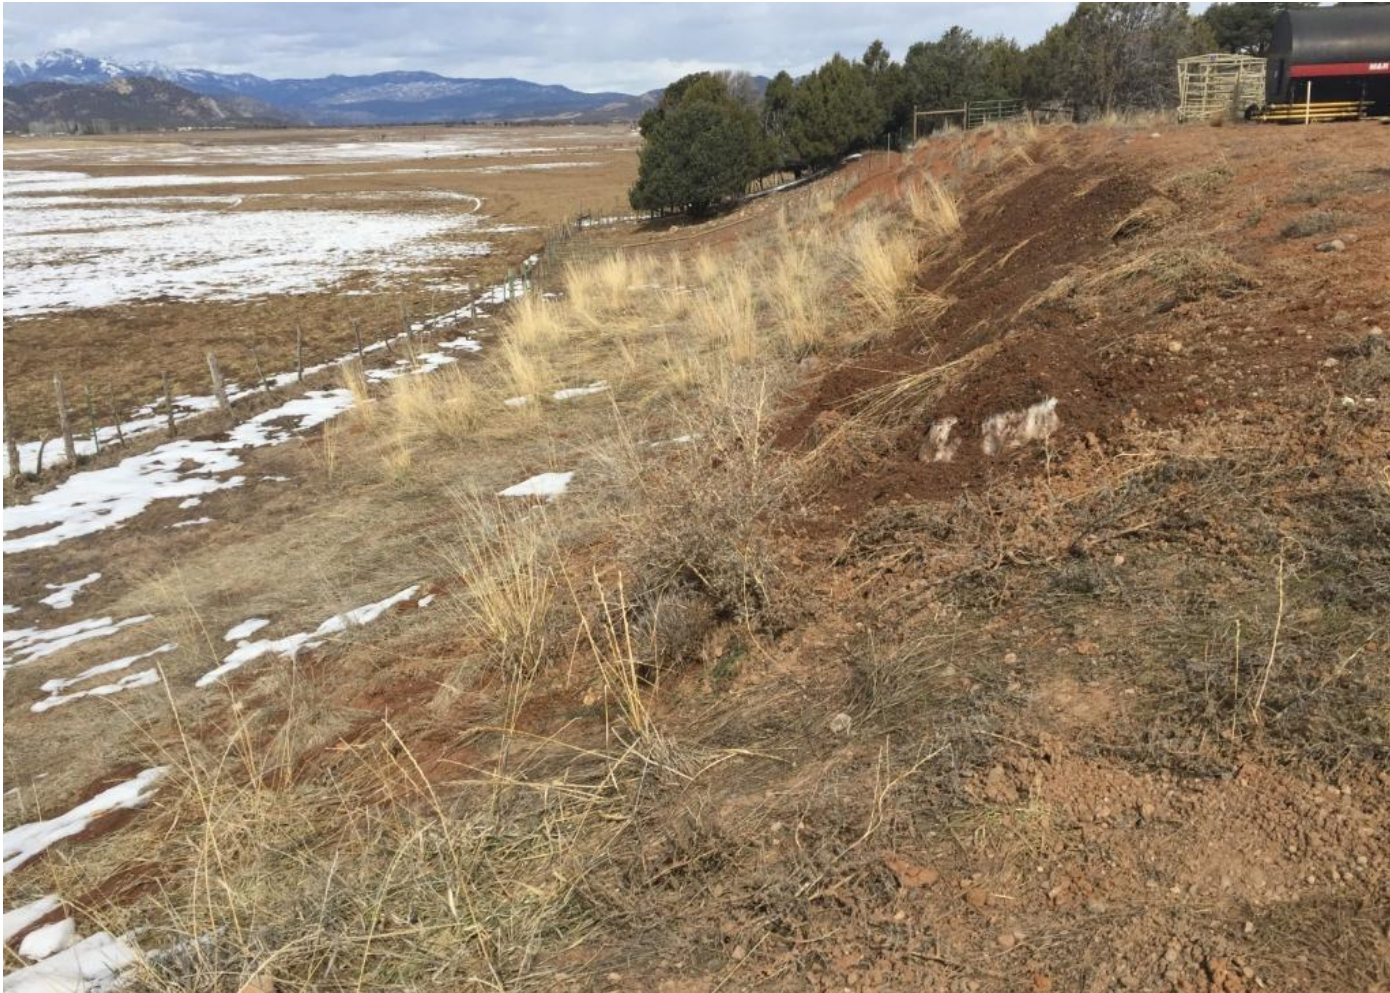
Photo 1. View of the western portion of the project area from the southwestern corner facing northward. Revegetation is comprised of seeded species such as smooth brome (*Bromus inermis*) and intermediate wheatgrass (*Thinopyron intermedium*) as well as weedy kochia (*Kochia scoparia*) and cheatgrass (*Bromus tectorum*).

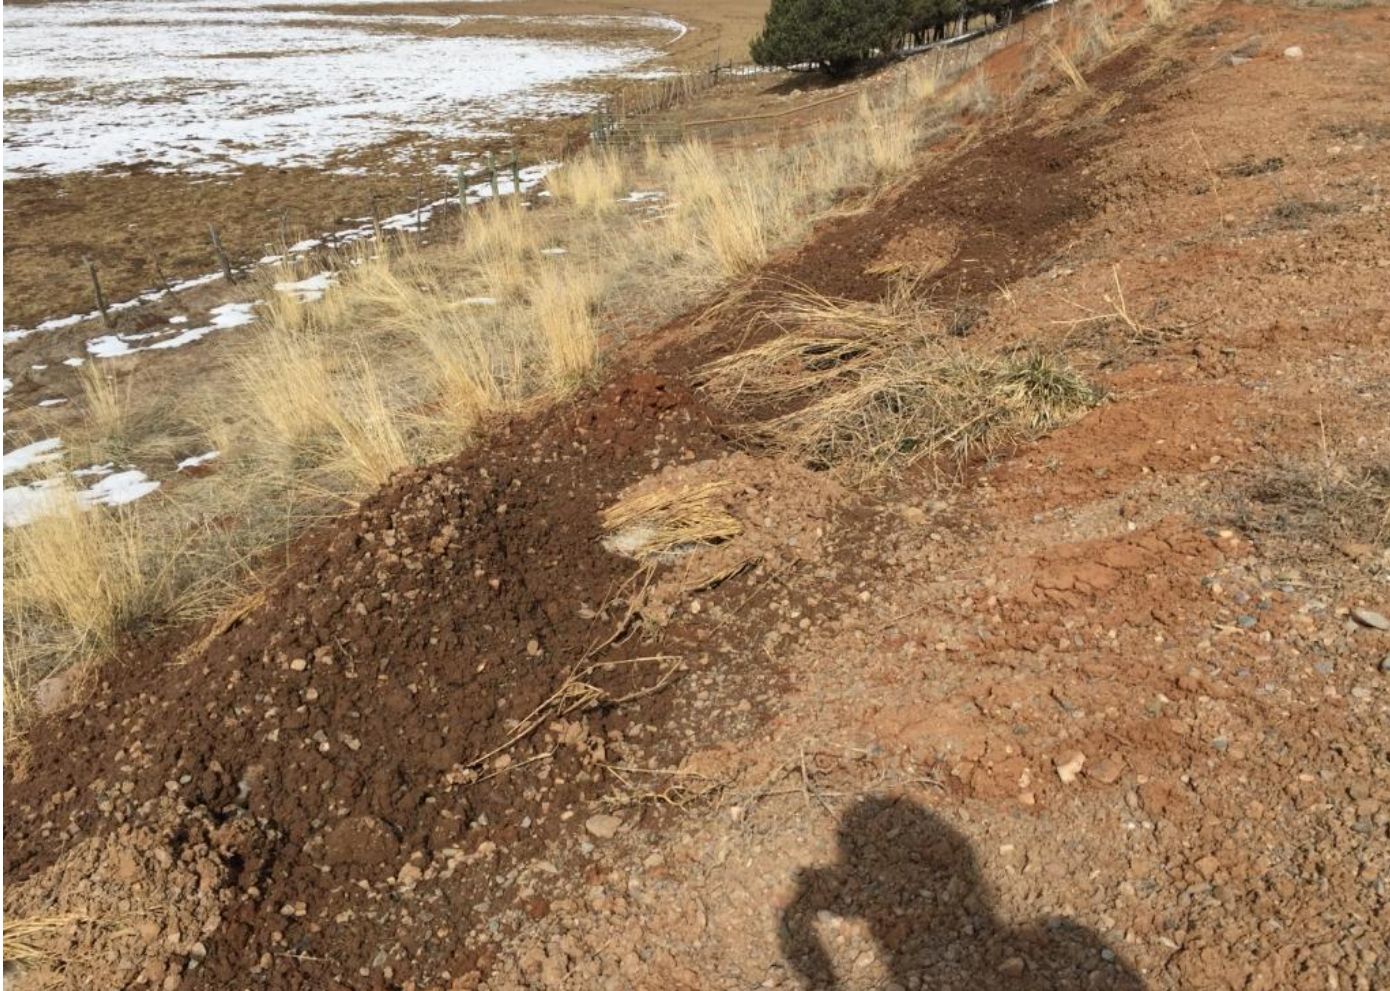
Photo 2. Area in western portion of the interim reclamation area where vegetation has been damaged from what appears to be recent workover activities.

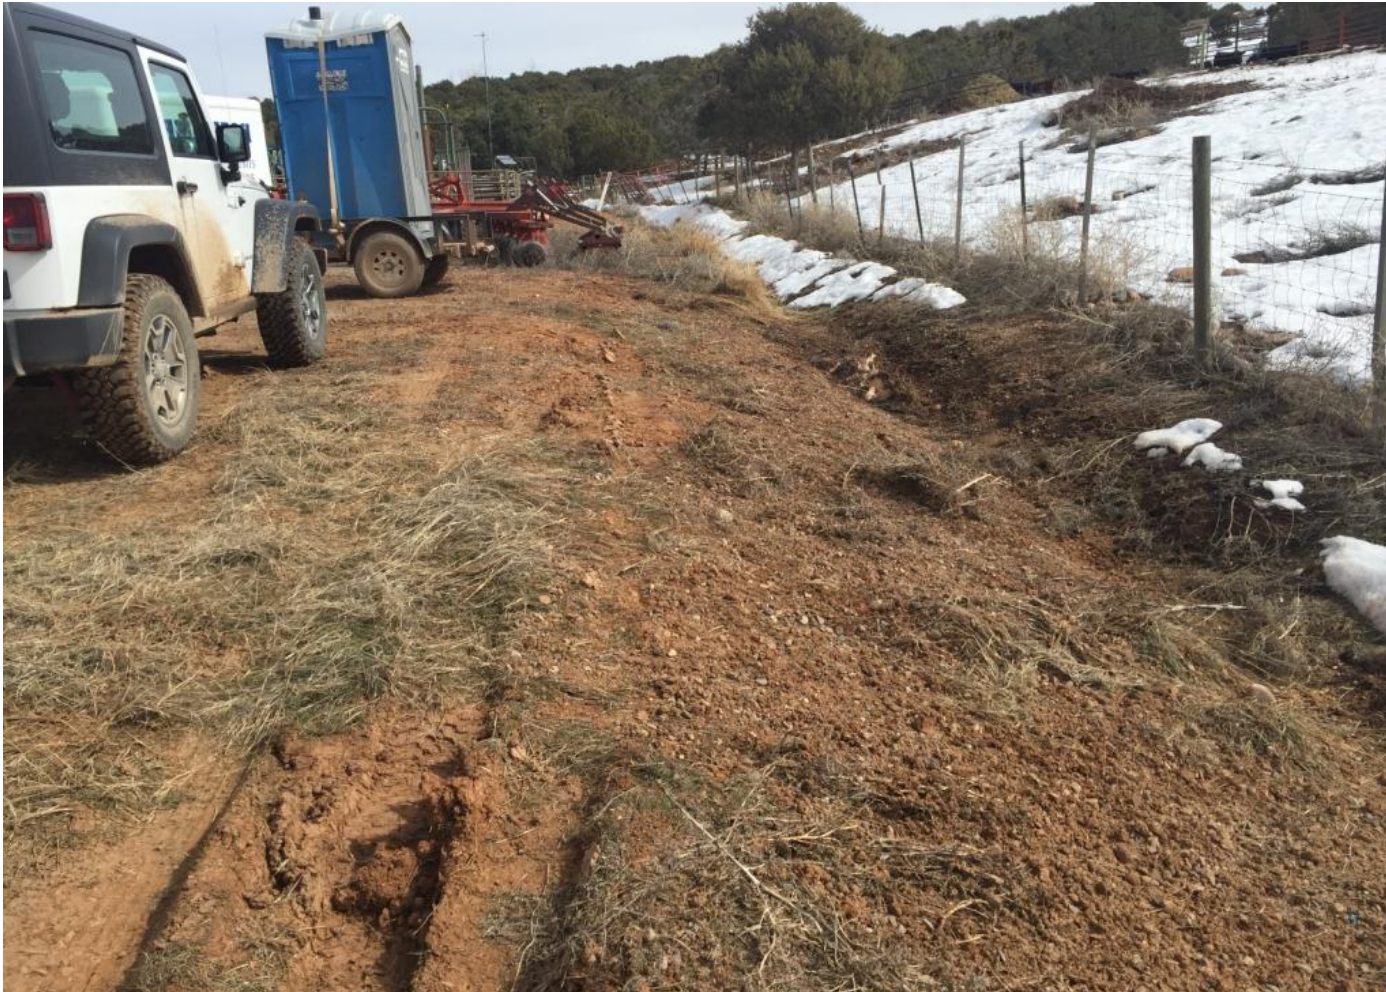
Photo 4. View of the southern portion of the interim reclamation area from the southwestern corner facing eastward. Portions of interim reclamation area where vegetation has been damaged will need revegetation.
