RE: Pressure test on gathering line located northeast of HWY 85 & WCR 18.5

**RE: Subsurface Assessment at a Property on Weld County Road 18 ½, Ft. Lupton, Colorado.
Cordilleran Project Number ED06070**

Table 1
Duke Energy Field Services
Laboratory Results for Soil Samples Collected
Under the Gathering Line at Weld County Road 18 ½ near Ft. Lupton, Colorado

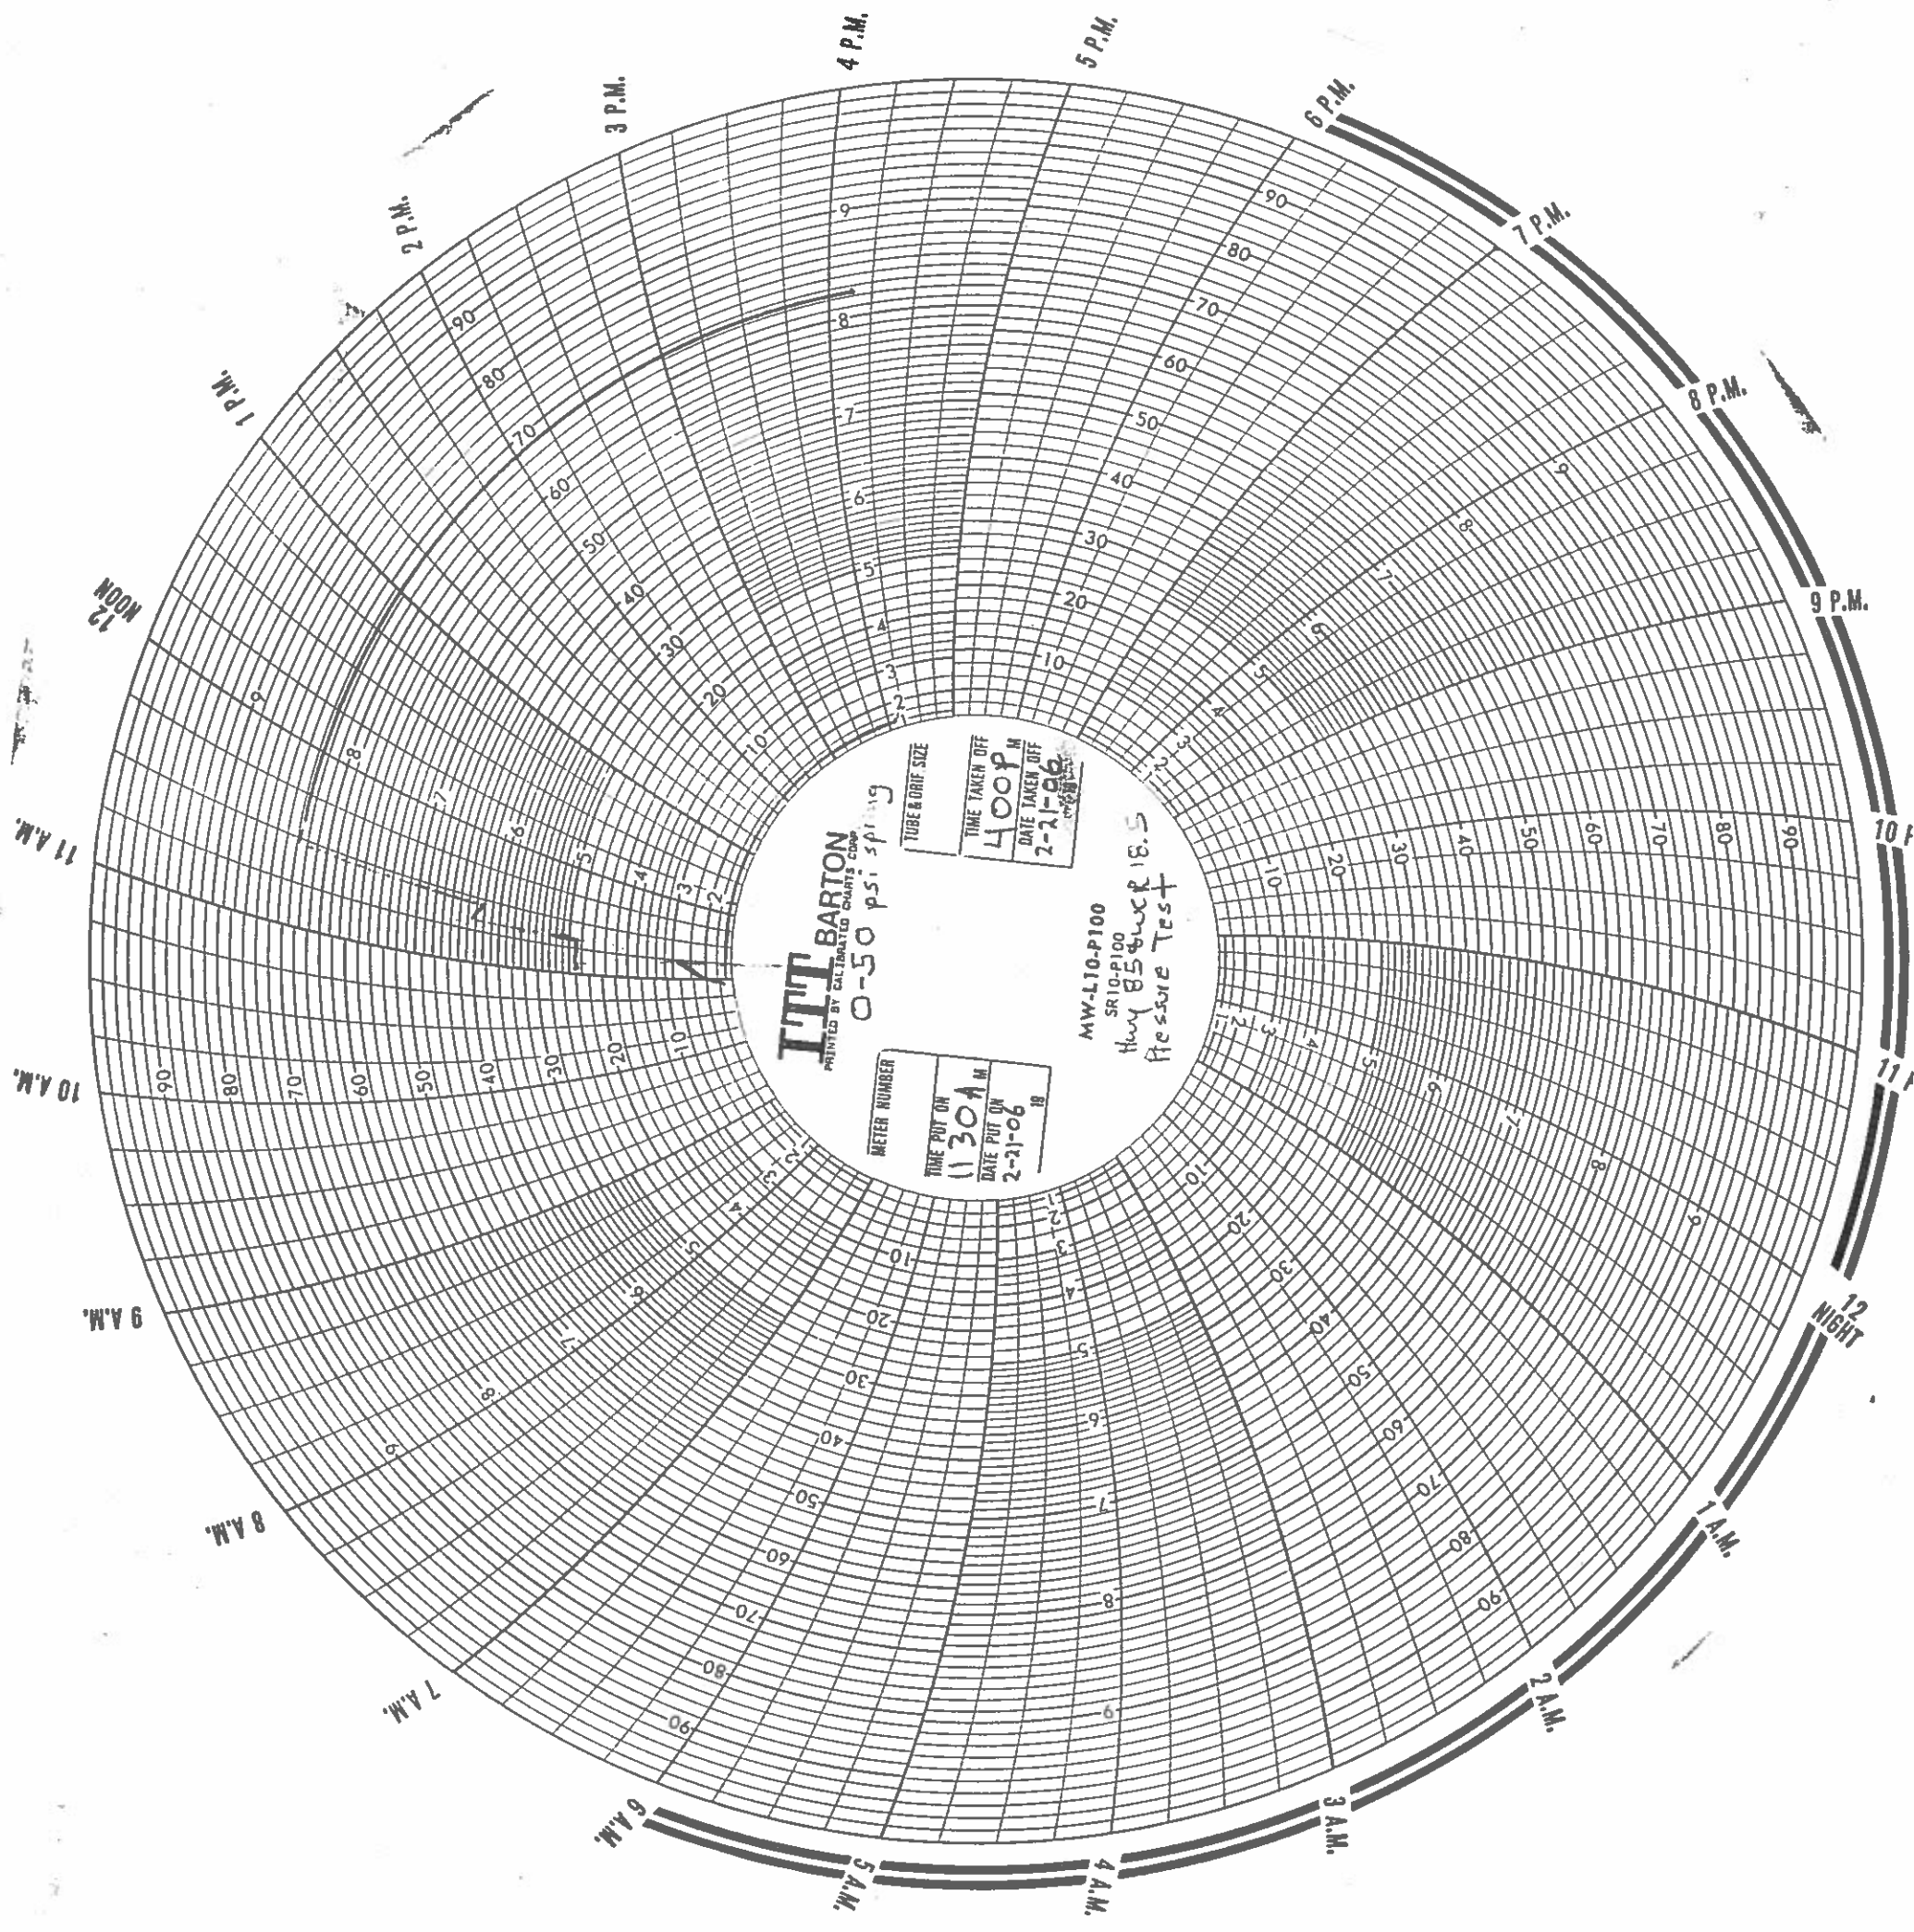
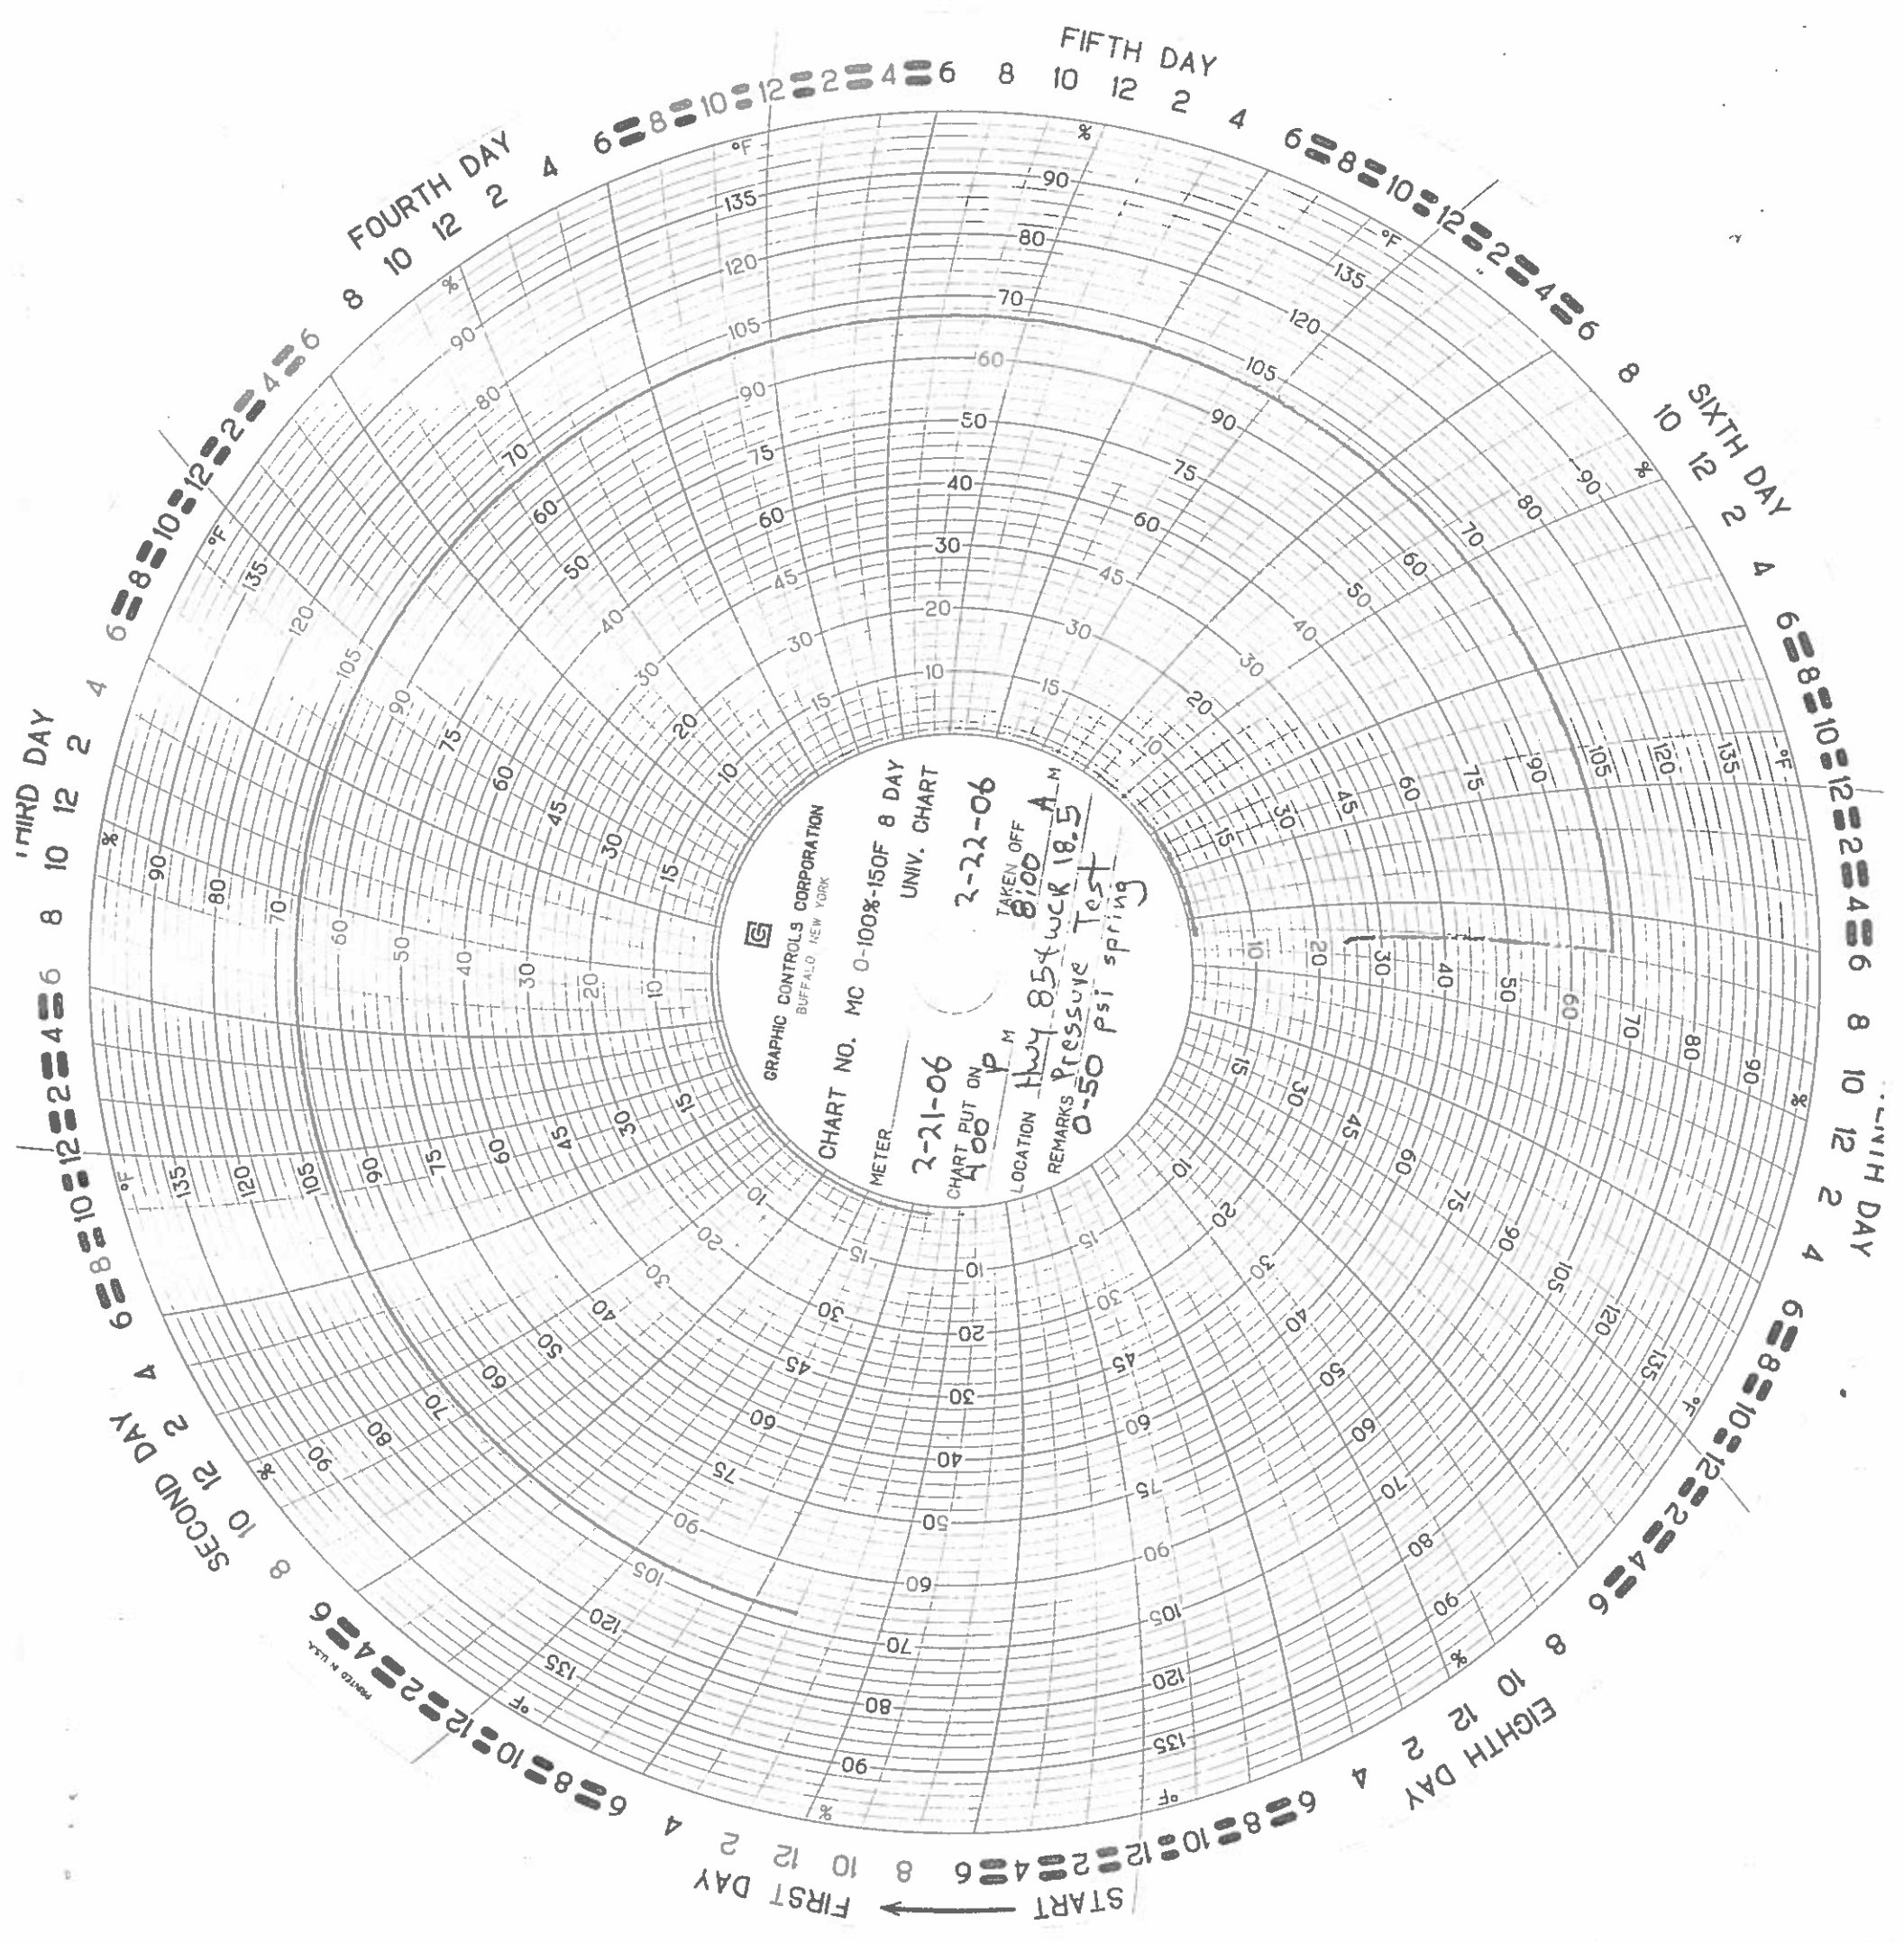
Charts from the gathering line pressure test are also attached. The first chart runs from 11:30 a.m. to 4:00 p.m. on 2-21-06, and the second chart runs from 4:00 p.m. 2-21-06 to 8:00 a.m. 2-22-06. A zero to fifty psi recorder was utilized for the test. Tracking at 67% this would equal about 33psi. Historical average line pressure for this line would have been approximately 20 psi.

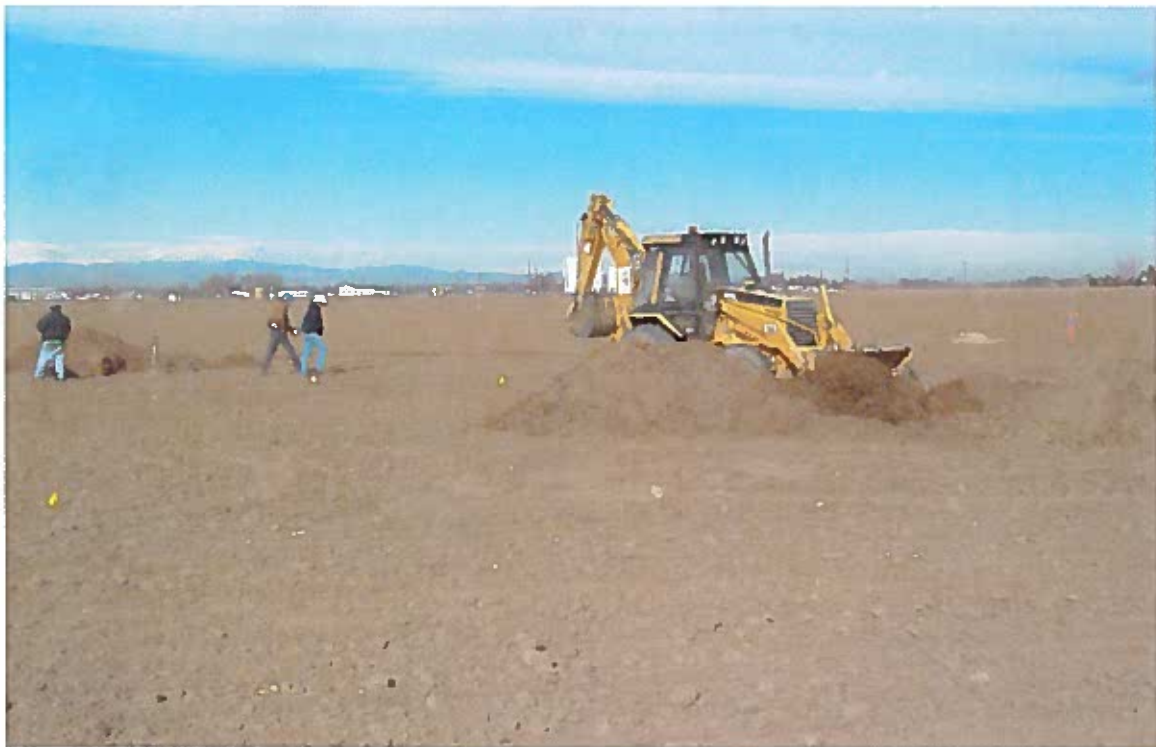
Photo 1 – Looking northwest at test pit 1 (right), test pit 2 (left), and the test boring (right background by orange stake) that encountered hydrocarbon-impacted soil at 19 feet bgs.

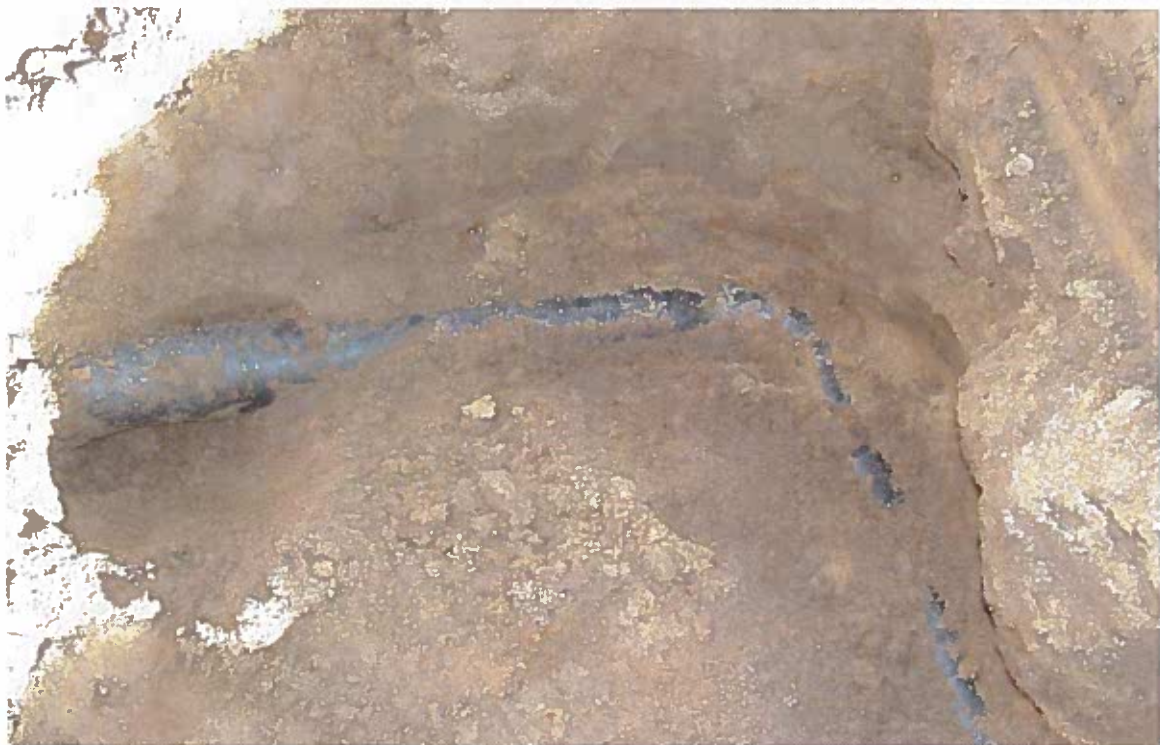
Photo 2 – Looking into test pit 1 at 90 degree elbow where DEFS line changes from 3-inch to 4-inch. No staining or odors observed under line or connections.

Elkhorn used a backhoe and hand labor to uncover the line at the first (east) elbow. The gathering line was encountered at a depth of approximately five feet bgs. No staining, hydrocarbon odors or other evidence of a release was noted in the vicinity of the elbow. Cordilleran collected a soil sample directly under the line at the elbow (TP-1@5ft). Photographs of the excavation (test pit 1) and line/elbow are included in Attachment 1.

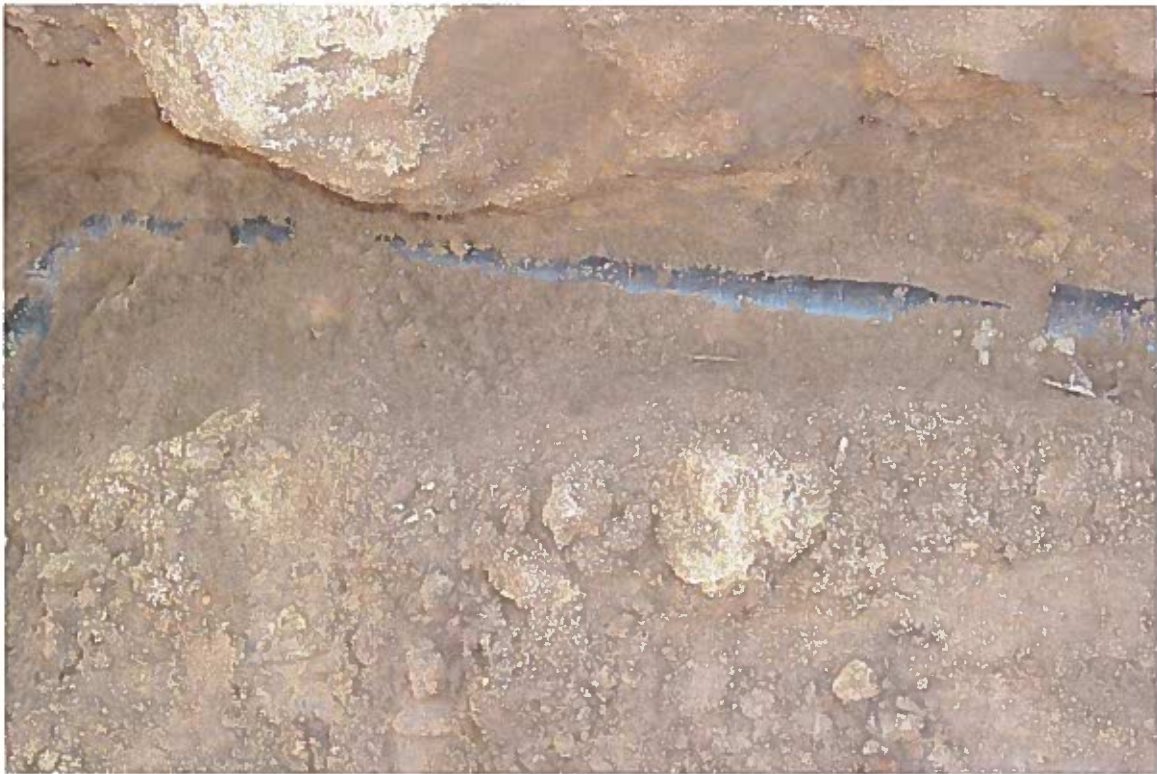
Photo 3 – Looking into test pit 1 at intact DEFS line. No staining or odors were noted.

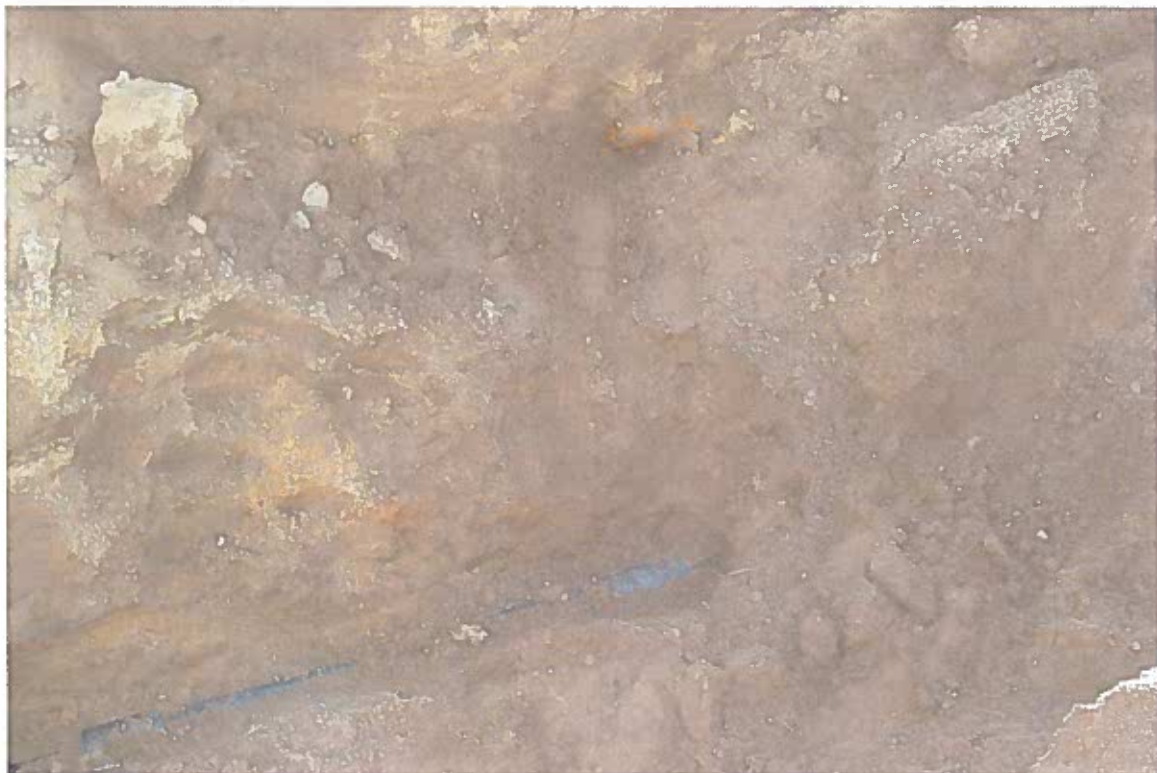
Photo 4 – Looking into test pit 1 at 3-inch DEFS line (bottom) under 2-inch flow line (top).

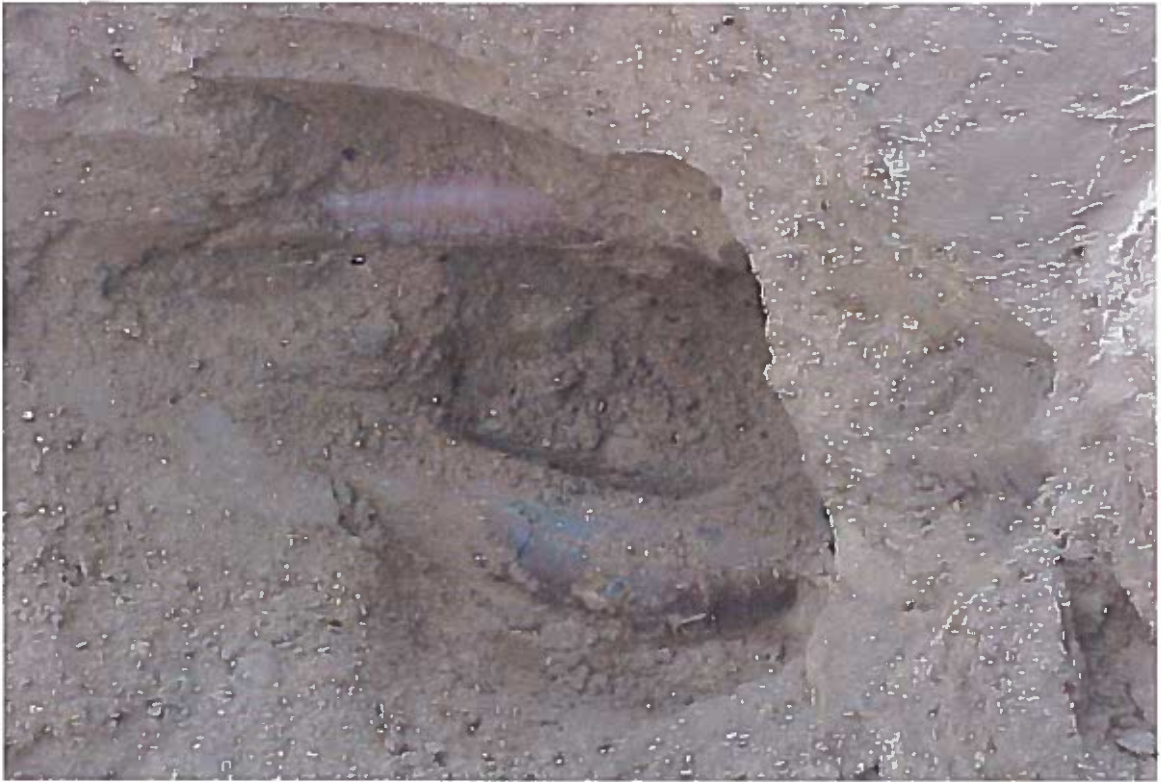
Photo 5 – Looking into test pit 2 at the 90 degree elbow on the DEFS line under a 3-inch fiberglass line that is not owned by DEFS. No staining or odor was noted under the DEFS line.

After determining that the first elbow had not leaked, DEFS directed Elkhorn to also uncover the second 90 degree elbow, which was located approximately 50 feet west of test pit 1. Once again, the DEFS gathering line and elbow were found at a depth of approximately five feet bgs and once again no staining or odors were noted in the soil underlying the elbow or line. While excavating the second elbow, Elkhorn found an unmarked 3-inch diameter fiberglass line directly over the elbow in the DEFS line. A photograph of the elbow and fiberglass line is included in Attachment 1. DEFS does not own the 3-inch fiberglass line and none of the personnel involved with the assessment activities could confirm who owns it. Cordilleran collected a soil sample directly under the elbow (TP-2@5ft). The approximate location of the abandoned DEFS line and the sampling locations are shown on Figure 2.

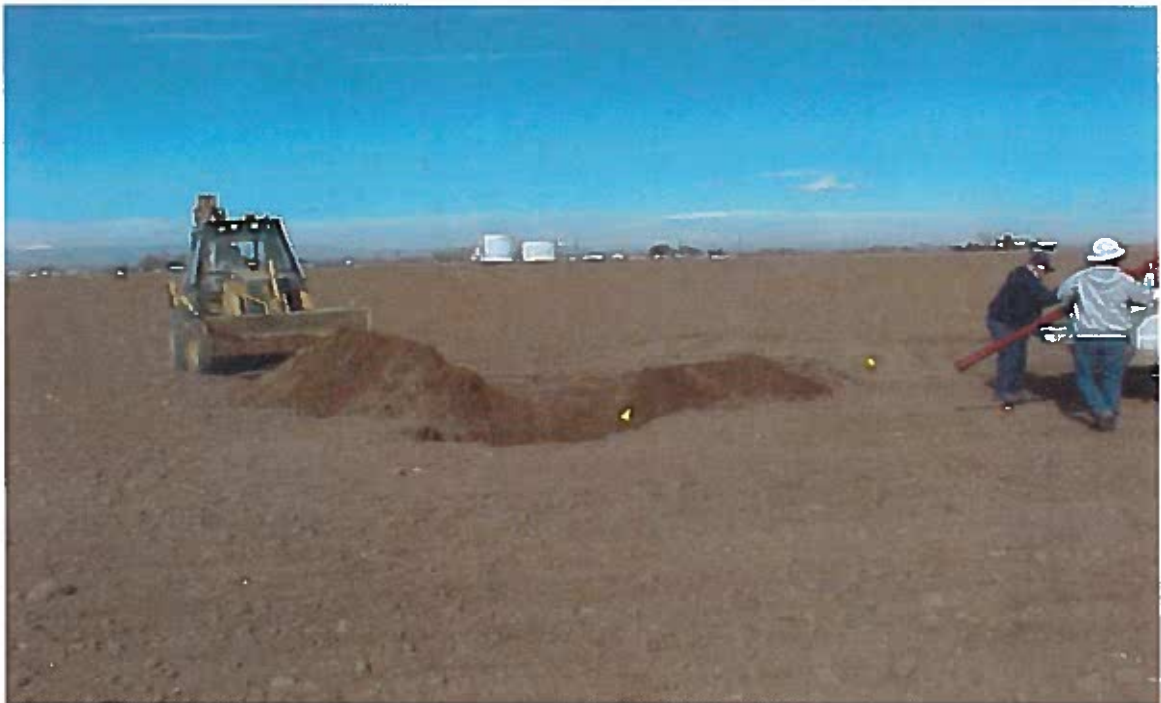
Photo 6 – Looking northwest at backhoe filling test pit 2 with excavated soil after completing assessment.
