Re: Gregery Well Pad Monthly Inspection

Thomas L Spring LLC – Gregory Well Pad – Monthly Inspection

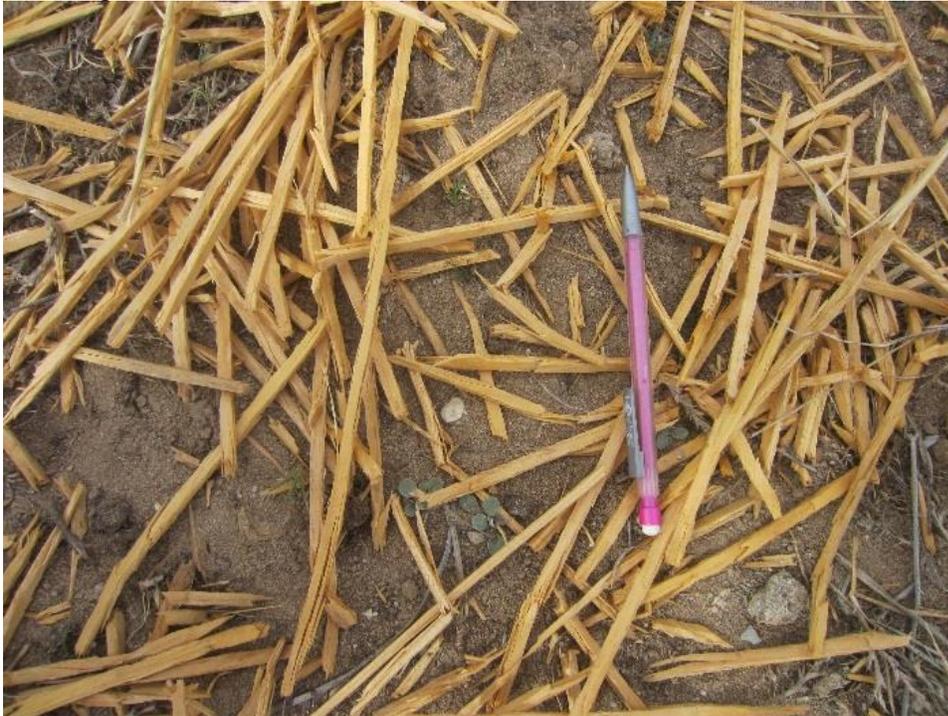
There are seedlings starting to germinate along the road corridor including both grass and forb species (see attached photograph), but it is too early to identify them. There was less germination on the well pad itself, but it is still very early in the season and this area is not as protected as the road. The past several weeks have been unseasonably warm, but there will likely still be snow this spring and nighttime temperatures are still below freezing.

Seedling Germination

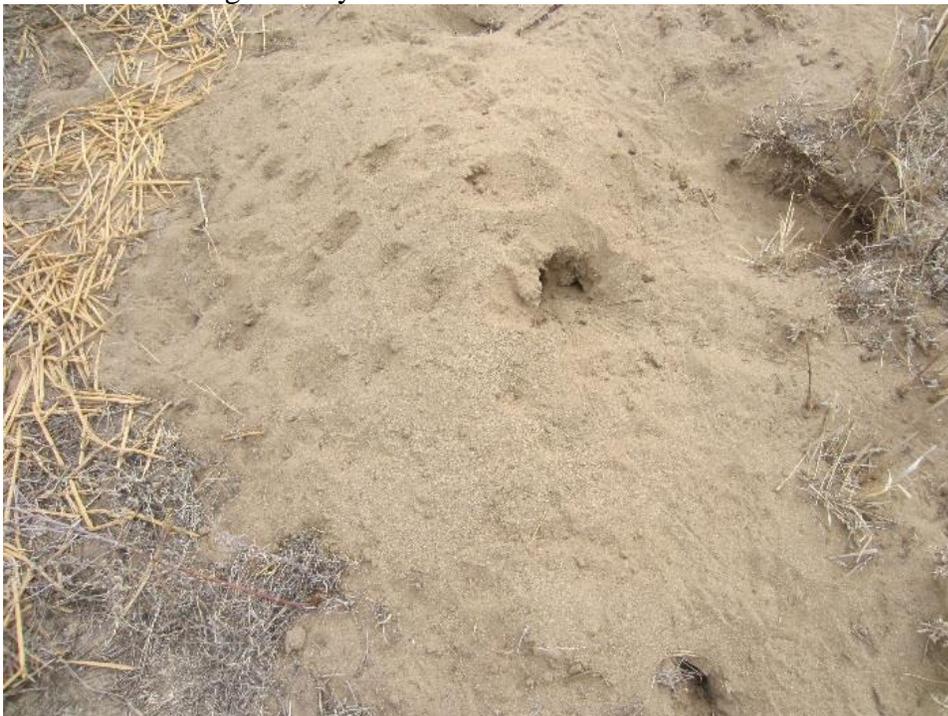
As noted on the previous inspections, there was substantial evidence of rodent burrowing activity both in and adjacent to the road corridor. While there is less rodent activity on the revegetated area of the well pad than on the road, there is substantial rodent activity all around the revegetated area within the fenced area. I saw evidence of fresh excavation as well as continued use of existing burrows (see attached photograph). I also walked out into the pasture to evaluate if there was more rodent activity in the revegetation area than in the pasture on the whole. There is substantial rodent activity elsewhere in this pasture and I did not take any quantitative data, but anecdotally there appears to be more rodent activity on the revegetation area. It is still too early in the season to determine if this rodent activity will have an impact on reclamation success.

Rodent Burrowing Activity
