**MARATHON OIL COMPANY  
NOTICE OF COMPLETION REPORT FOR  
INTERIM RECLAMATION OF  
697-26A**

*January 20, 2012*

**697-26A pad location  
Interim Reclamation - Revegetation**

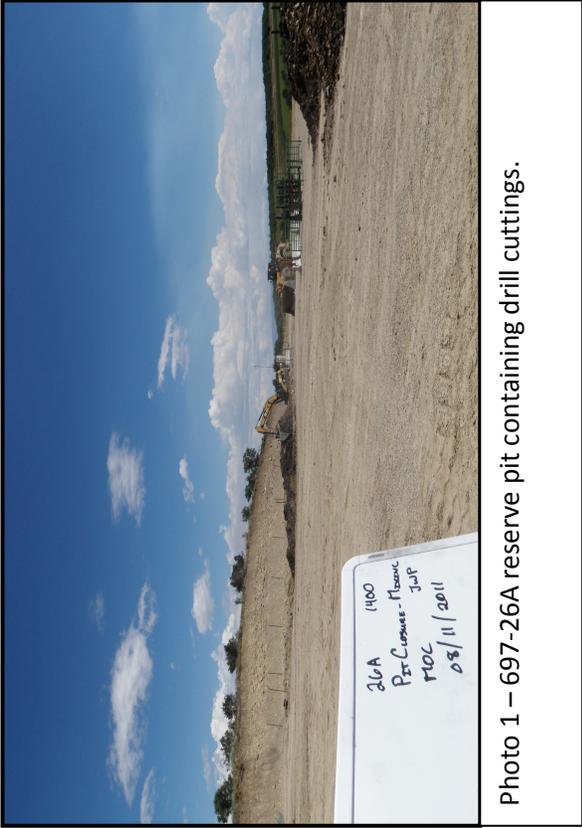
This report covers the activities associated with the closure of the on-site reserve pit at Marathon Oil Company's 697-26A well pad. At the time of the initial site visit, the pit contained what appeared to be drill cuttings in an unlined pit (Photo 1, Appendix A).

Photo 1 – 697-26A reserve pit containing drill cuttings.

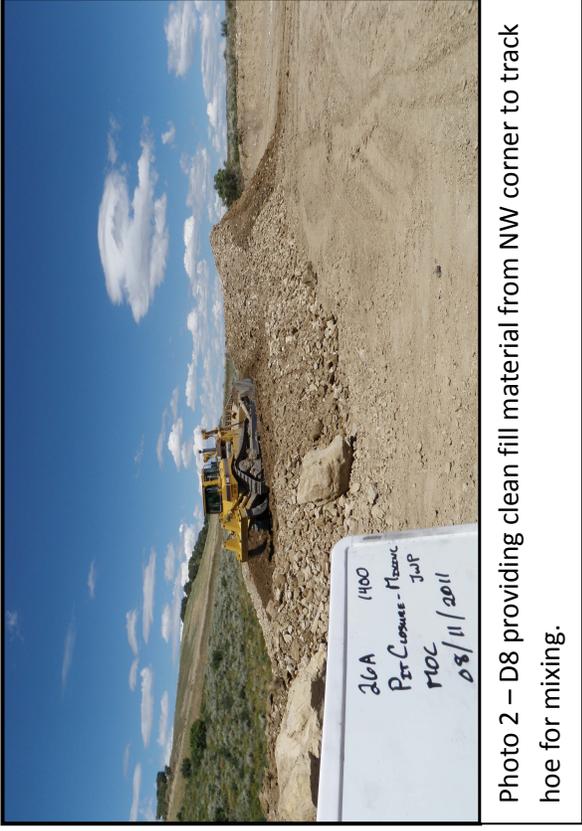
Photo 2 – D8 providing clean fill material from NW corner to track hoe for mixing.

The mixing of pit contents with clean soil occurred inside of the pit. Native soil was obtained from portions of the pad slated for removal during re-contouring activities necessary for interim reclamation. A bulldozer and a front-end loader were used to push and carry the soil from the pad's western edge onto its interior surface where it could be used as clean material for mixing with the pit's contents (Photo 2). After a pile of clean soil had been established on the pad, the clean soil was systematically added to the cuttings inside of the pit using an excavator and bulldozer to turn and mix the materials (Photos 3 and 4).

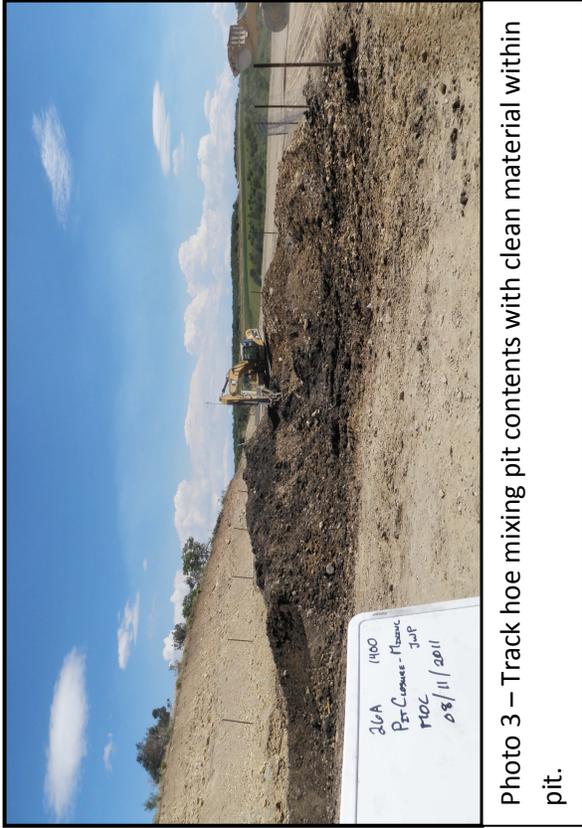
Photo 3 – Track hoe mixing pit contents with clean material within pit.

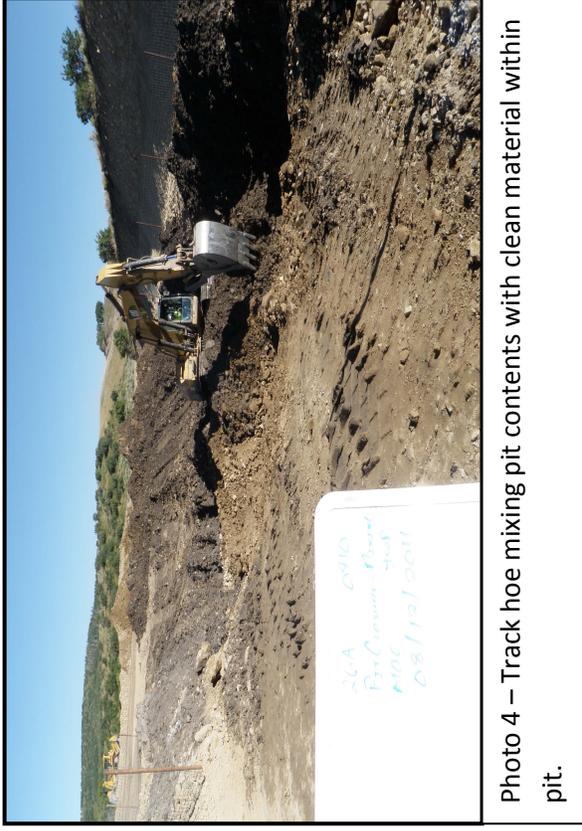
Photo 4 – Track hoe mixing pit contents with clean material within pit.

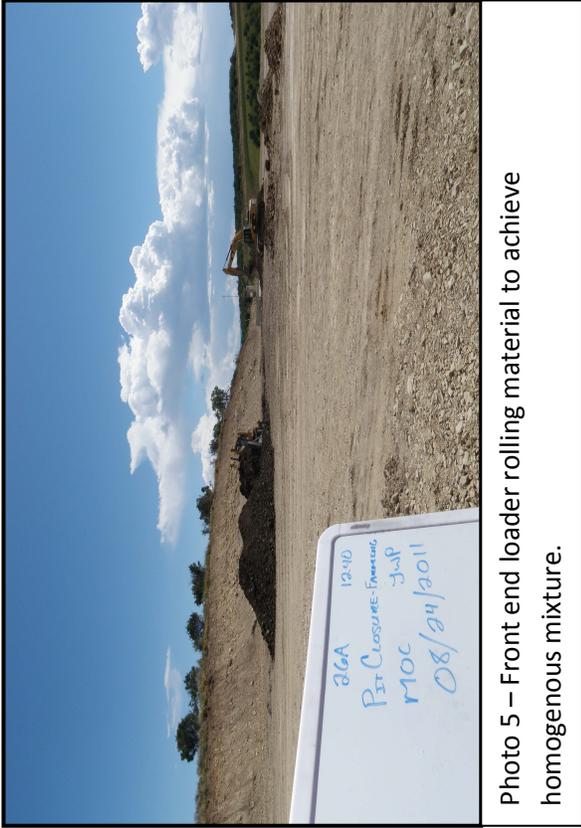
Photo 5 – Front end loader rolling material to achieve homogenous mixture.

The mixing was performed within the pit in order to dry and solidify the pit material, as well as to dilute the concentrations of its COGCC Table 910-1 constituents. The mixed material was then placed on the drilling pad where a bulldozer and a front-end loader continued the mixing process by combining additional clean soil with the extracted material and rolling the two together to reach a dry, homogenous mixture (Photo 5). Samples of the mixed soil were collected for laboratory analysis. These samples were tested only for the constituents that previously exceeded COGCC Table 910-1 limits. The final mixing ratio of clean soil to pit

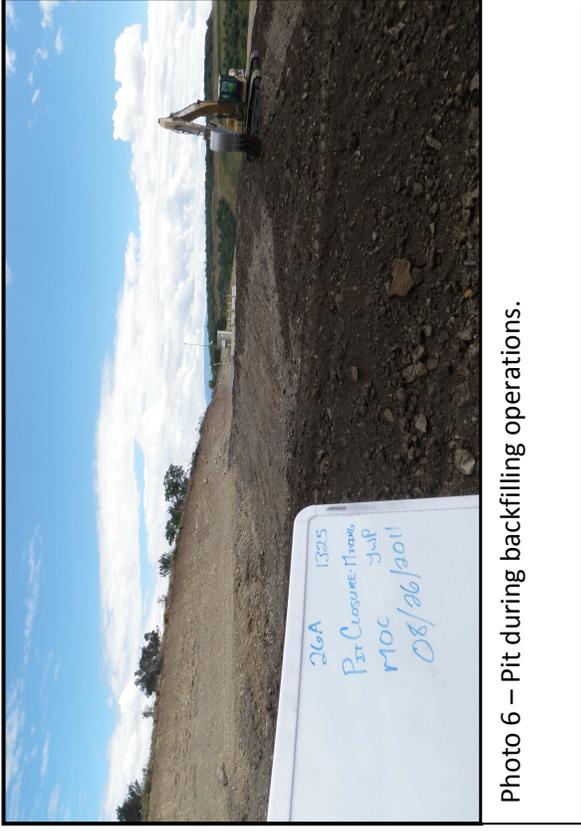
Photo 6 – Pit during backfilling operations.

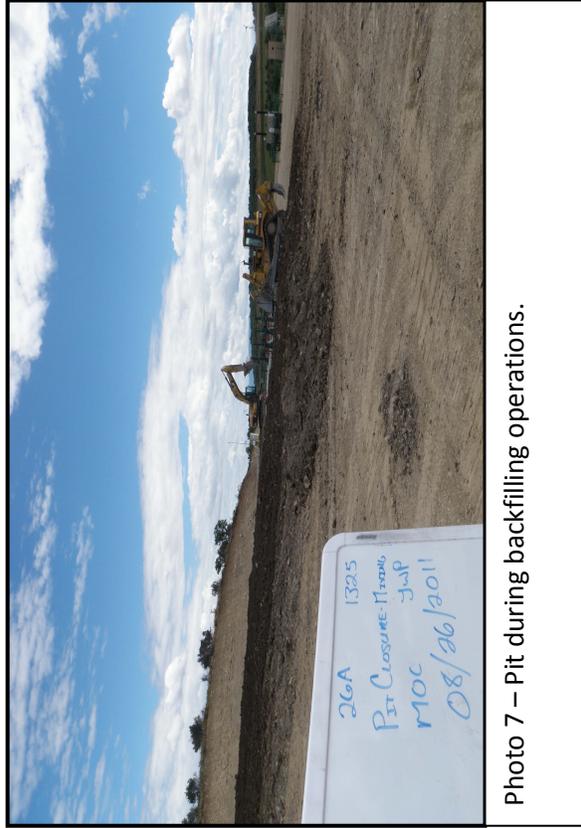
Photo 7 – Pit during backfilling operations.

Backfilling of the excavation was achieved by placing the 1:1 mixture of clean soil and cuttings back into the excavation (Photo 7). The mixed material was placed load-by-load into the excavation with each load being thoroughly compacted using the tracks of a dozer. This process continued until the excavation was completely filled.

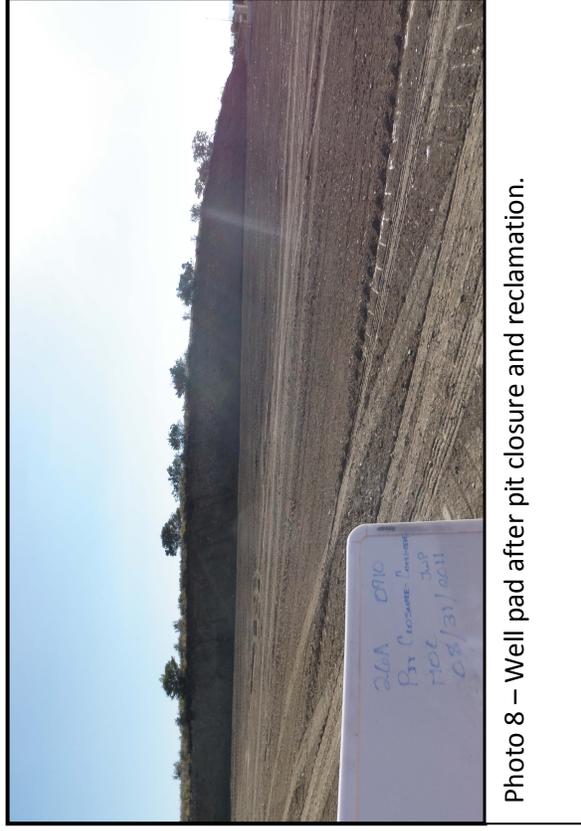
Photo 8 – Well pad after pit closure and reclamation.

Once the excavation had been backfilled, areas of the well pad no longer required for production were roughly graded to their original contour (Photo 8). These re-contoured areas were then top-soiled, thereby mitigating the potential effects of physical parameters on reclamation success. Backfilling and re-contouring operations concluded on August 30, 2011.

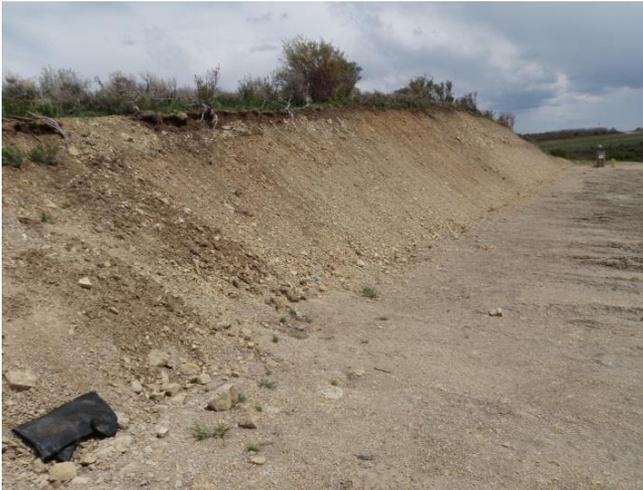
Northeastern cut slope

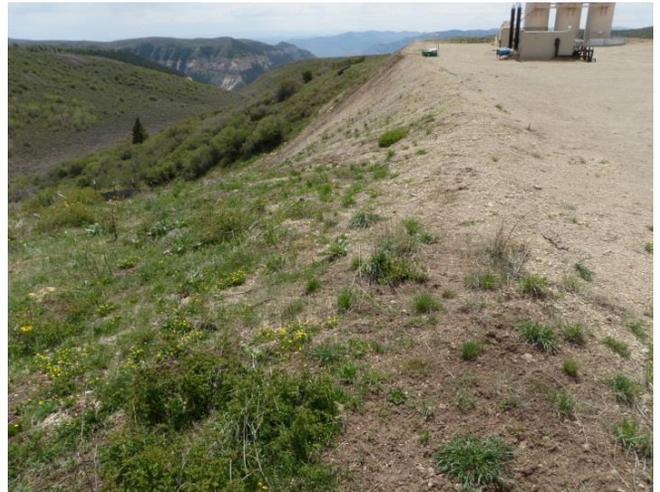
Southeastern edge of pad

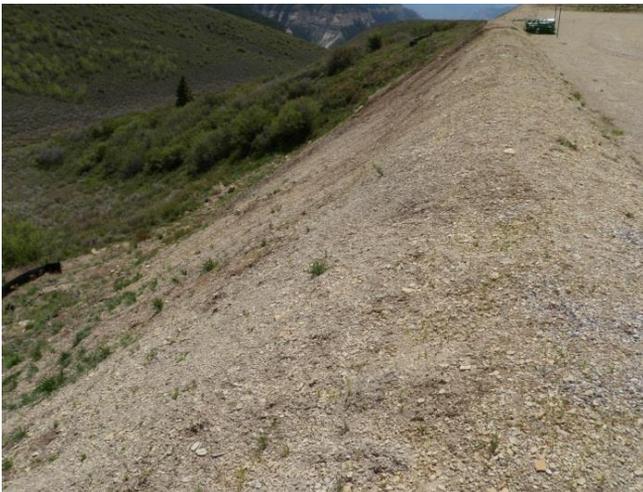
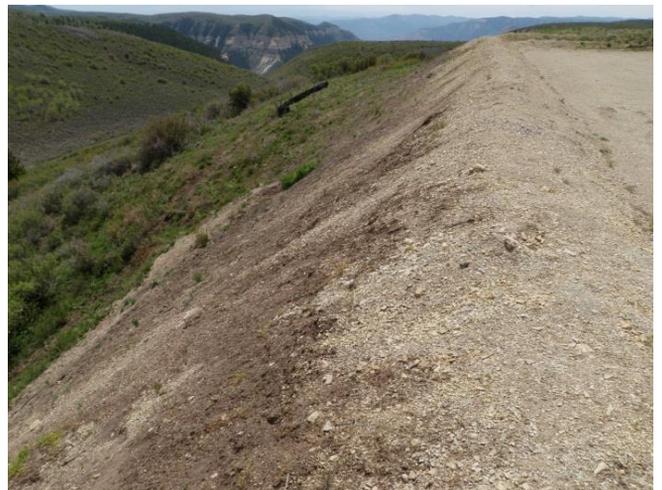
Southeastern fill slope

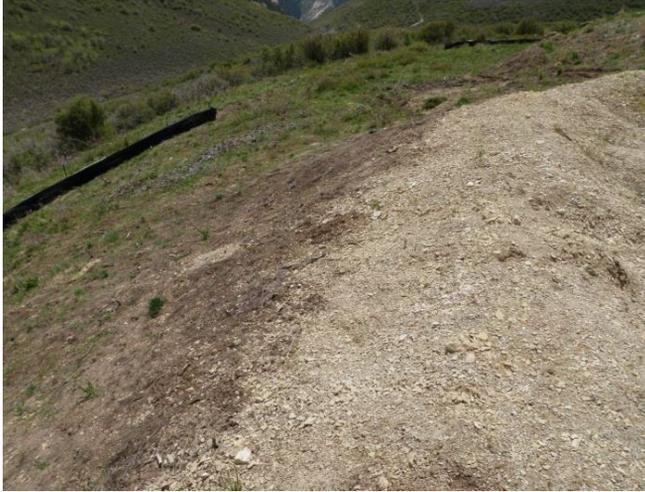
South corner of pad

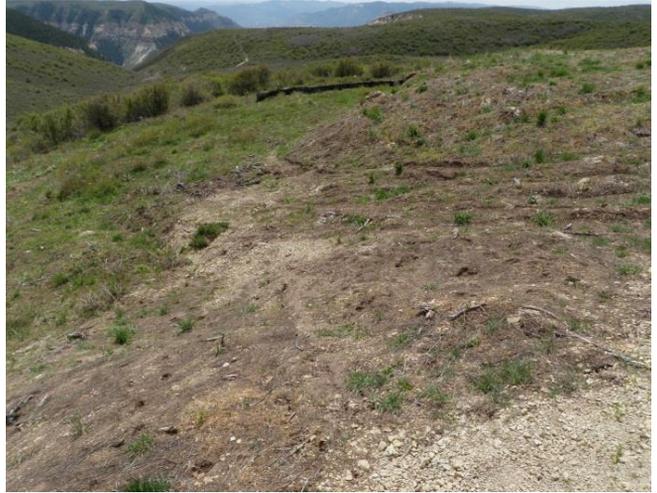
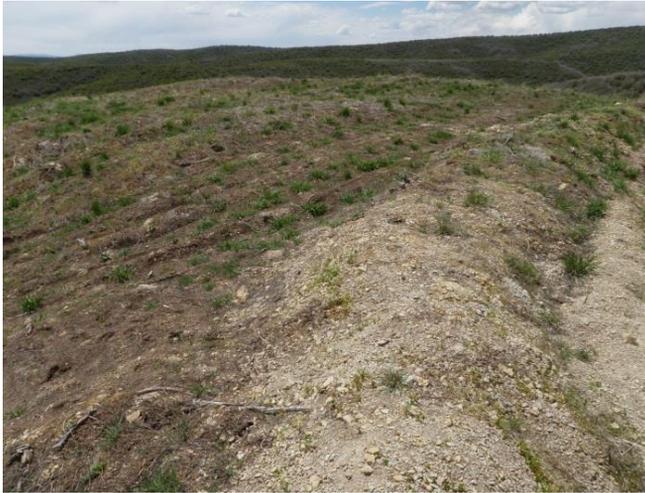
Top soil pile near south corner of pad

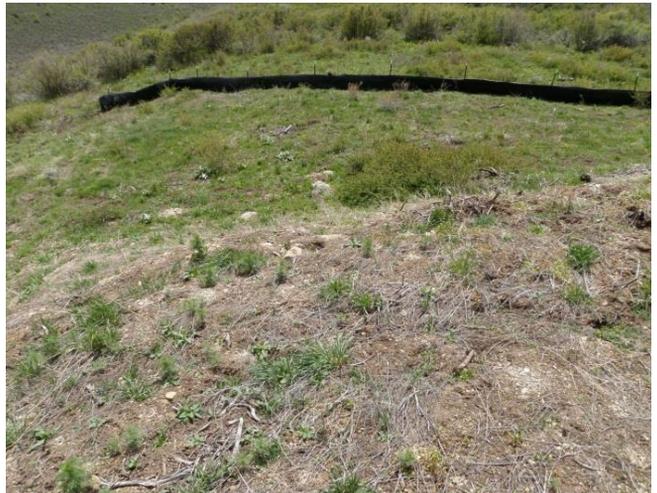
Reclaimed area near south corner of pad

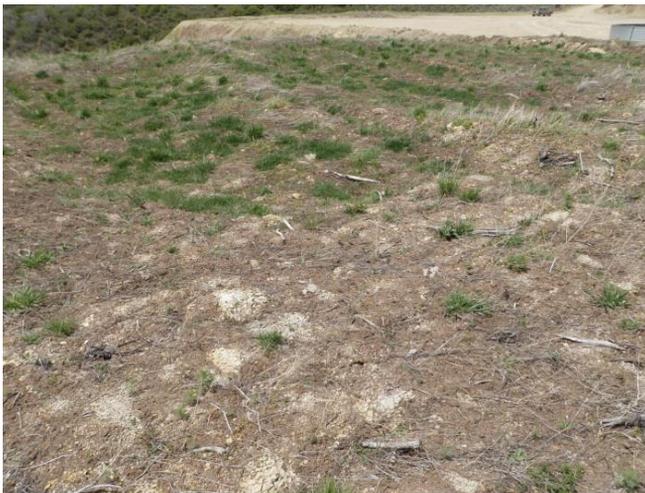
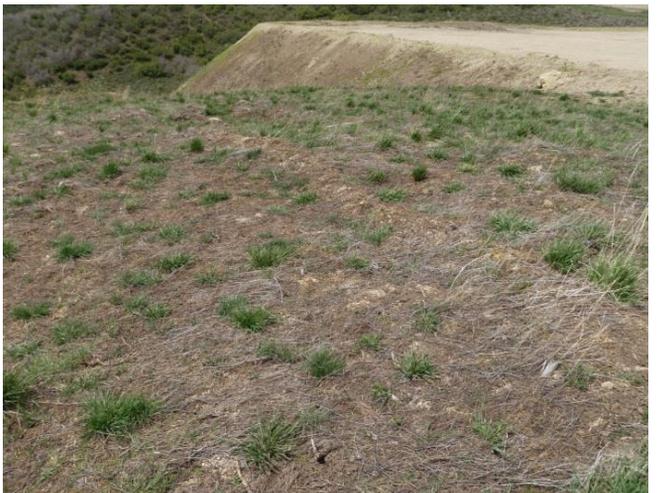
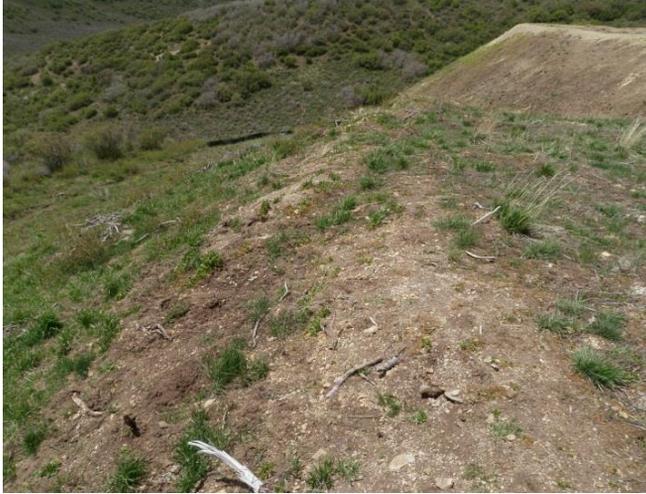
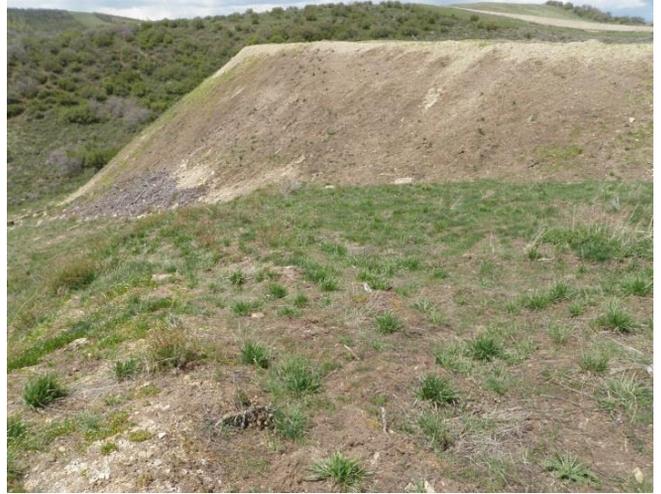
Reclaimed area southwest of pad

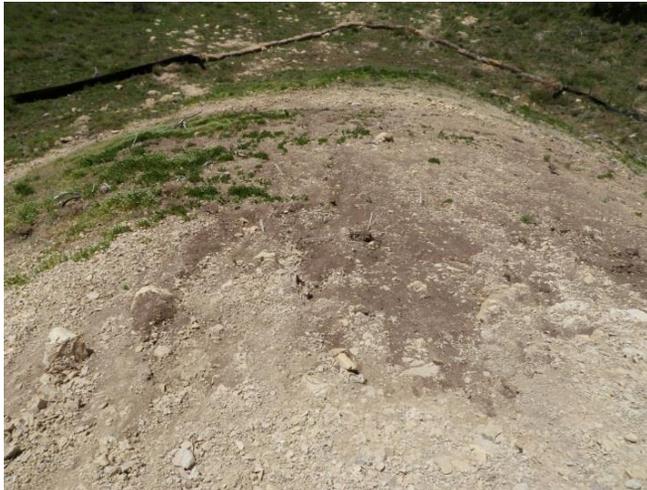
West corner fill slope

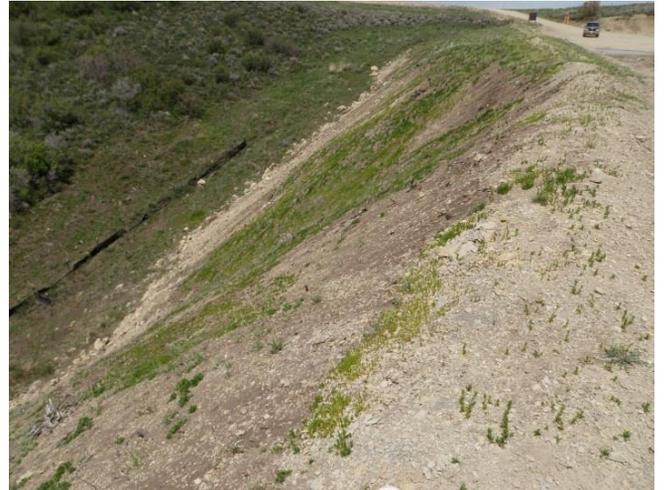
Northwestern fill slope

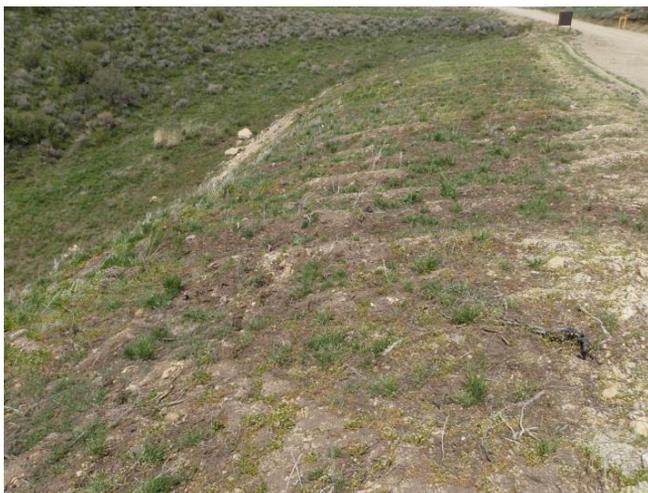
Reclaimed area northwest of pad

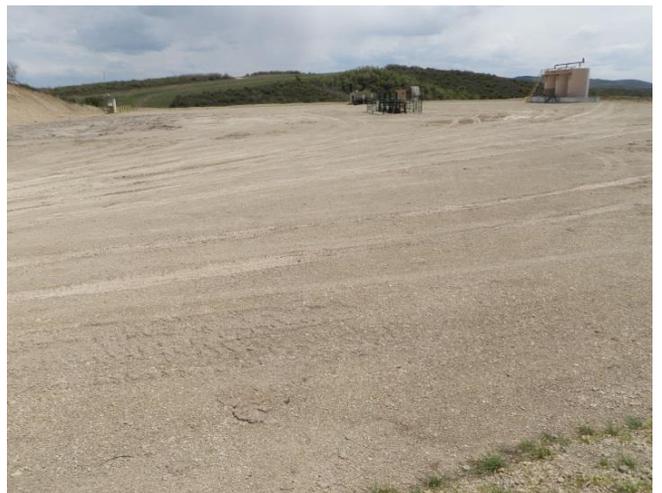
Looking east across pad
