Interim Reclamation Inspection

Operator: High Plains Energy

Location #: 430585

Logan County, CO

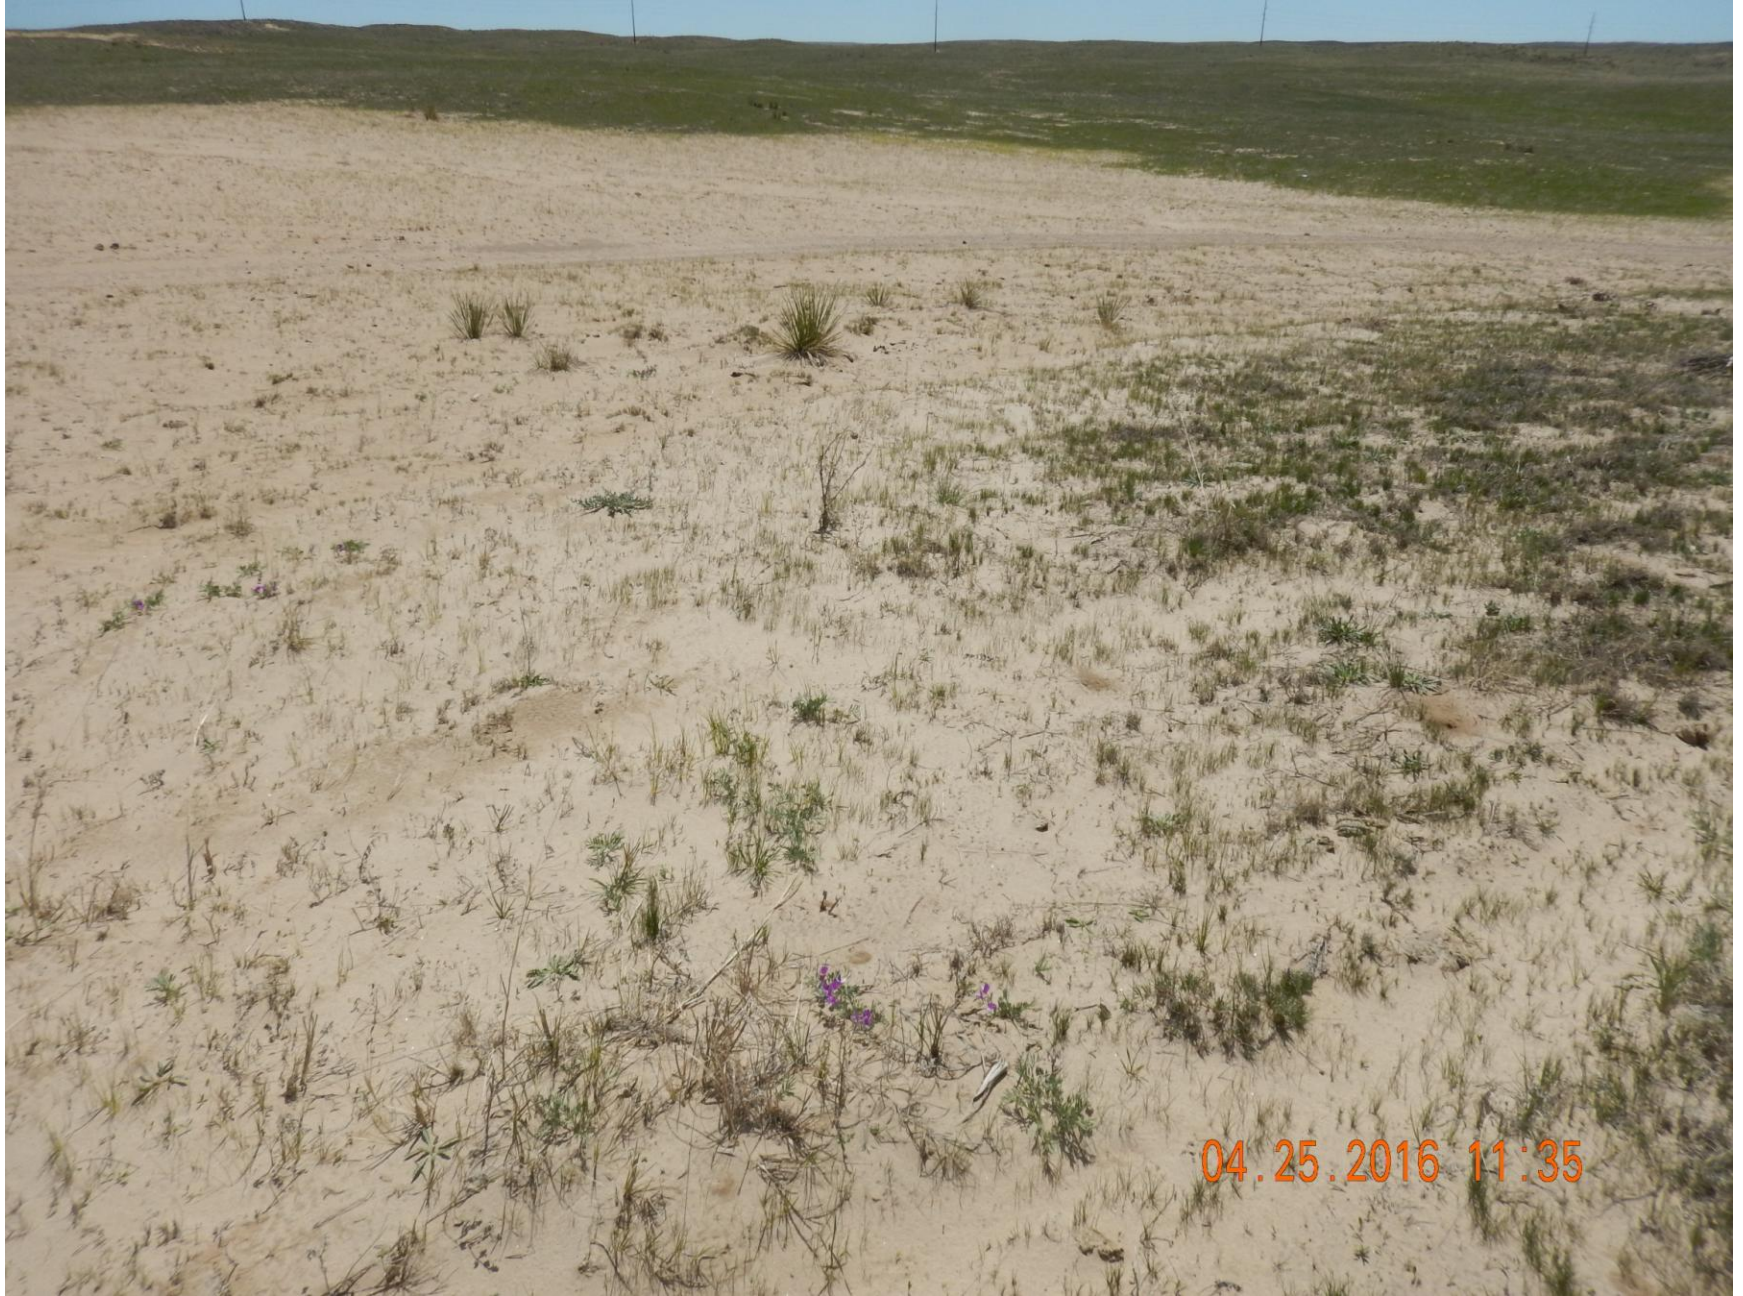
Figure 1: Photo taken from the southwest corner of the location, facing south. Photo shows large areas of the location where revegetation is not progressing.

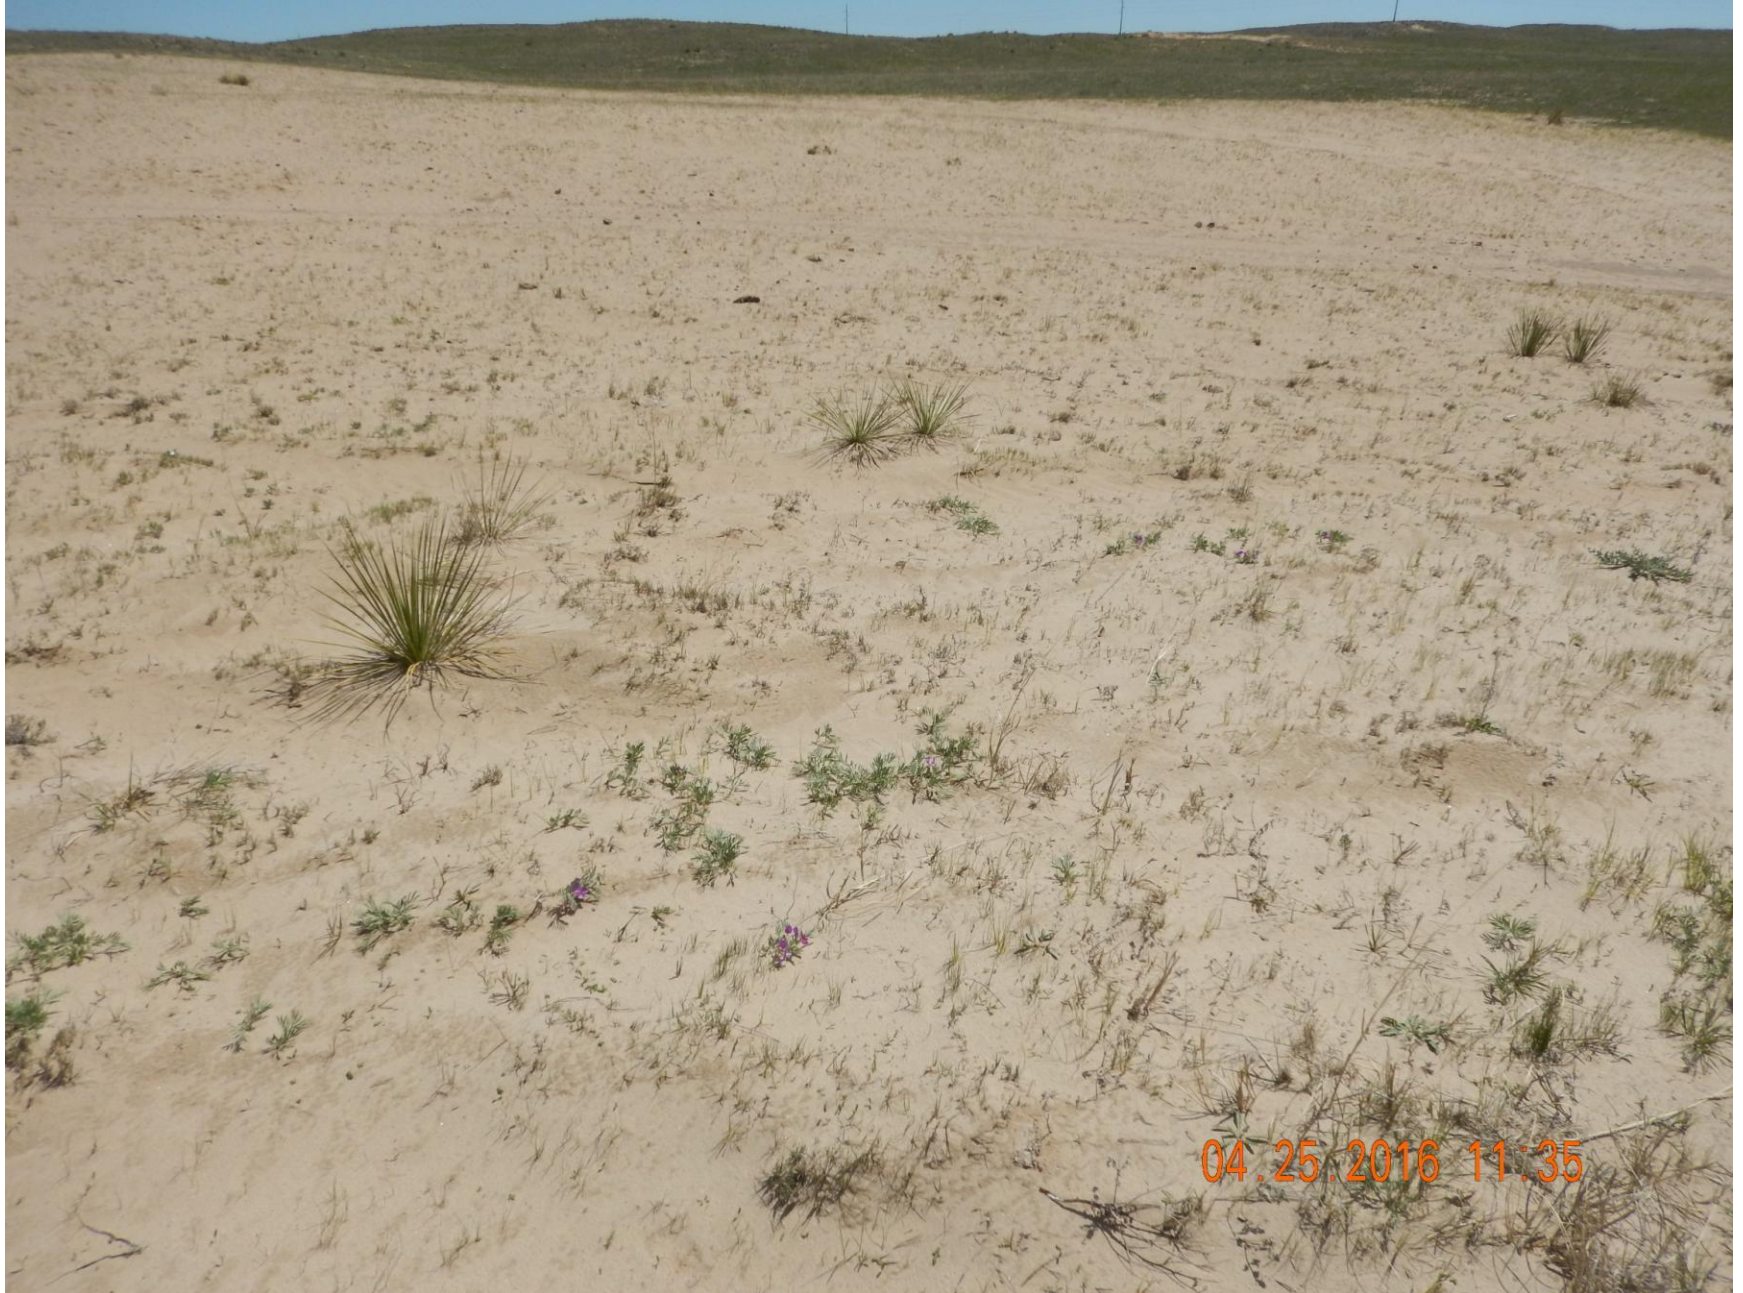
Figure 2: Photo taken from the southwest corner of the location, facing southeast. Photo shows large areas of the location where revegetation is not progressing.

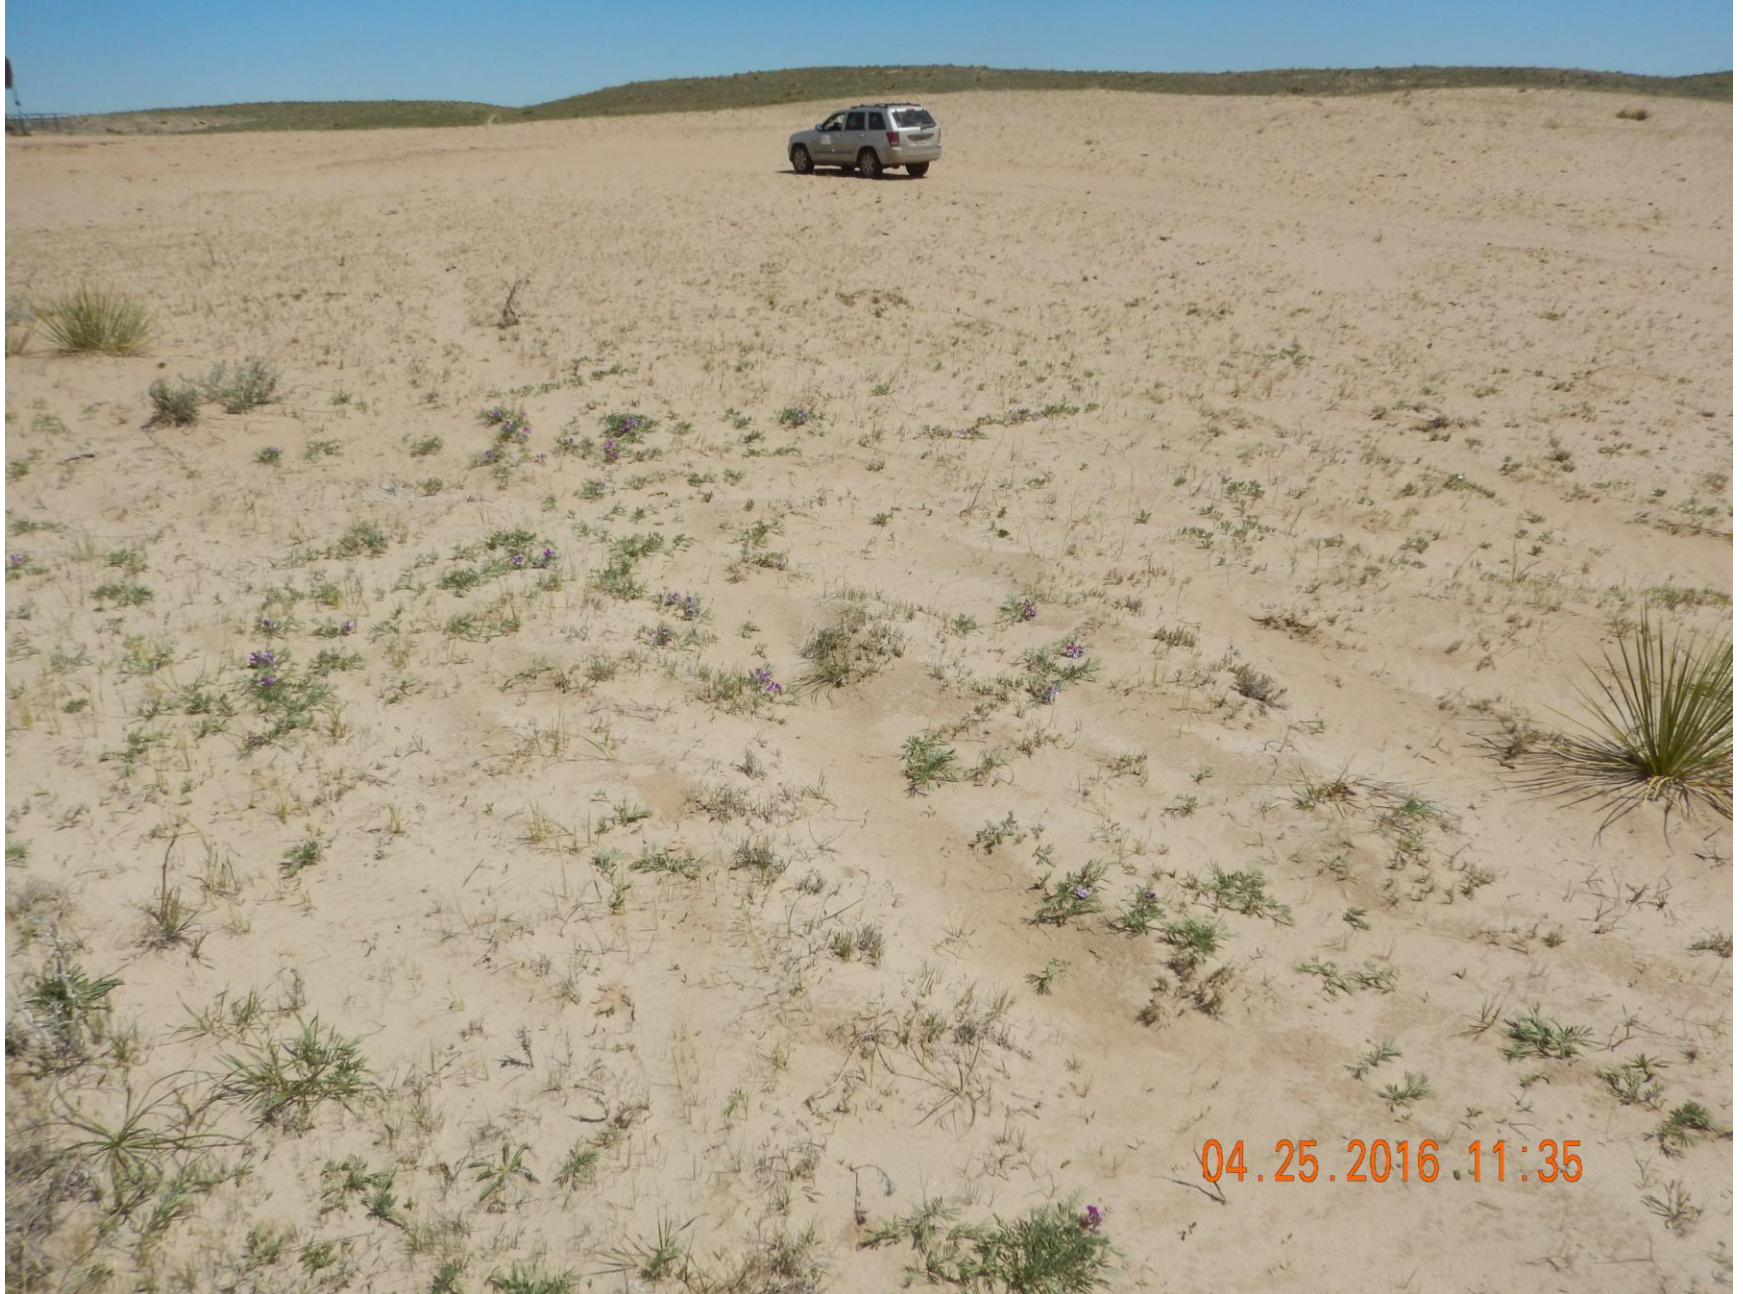
Figure 3: Photo taken from the southwest corner of the location, facing east. Photo shows large areas of the location where revegetation is not progressing.

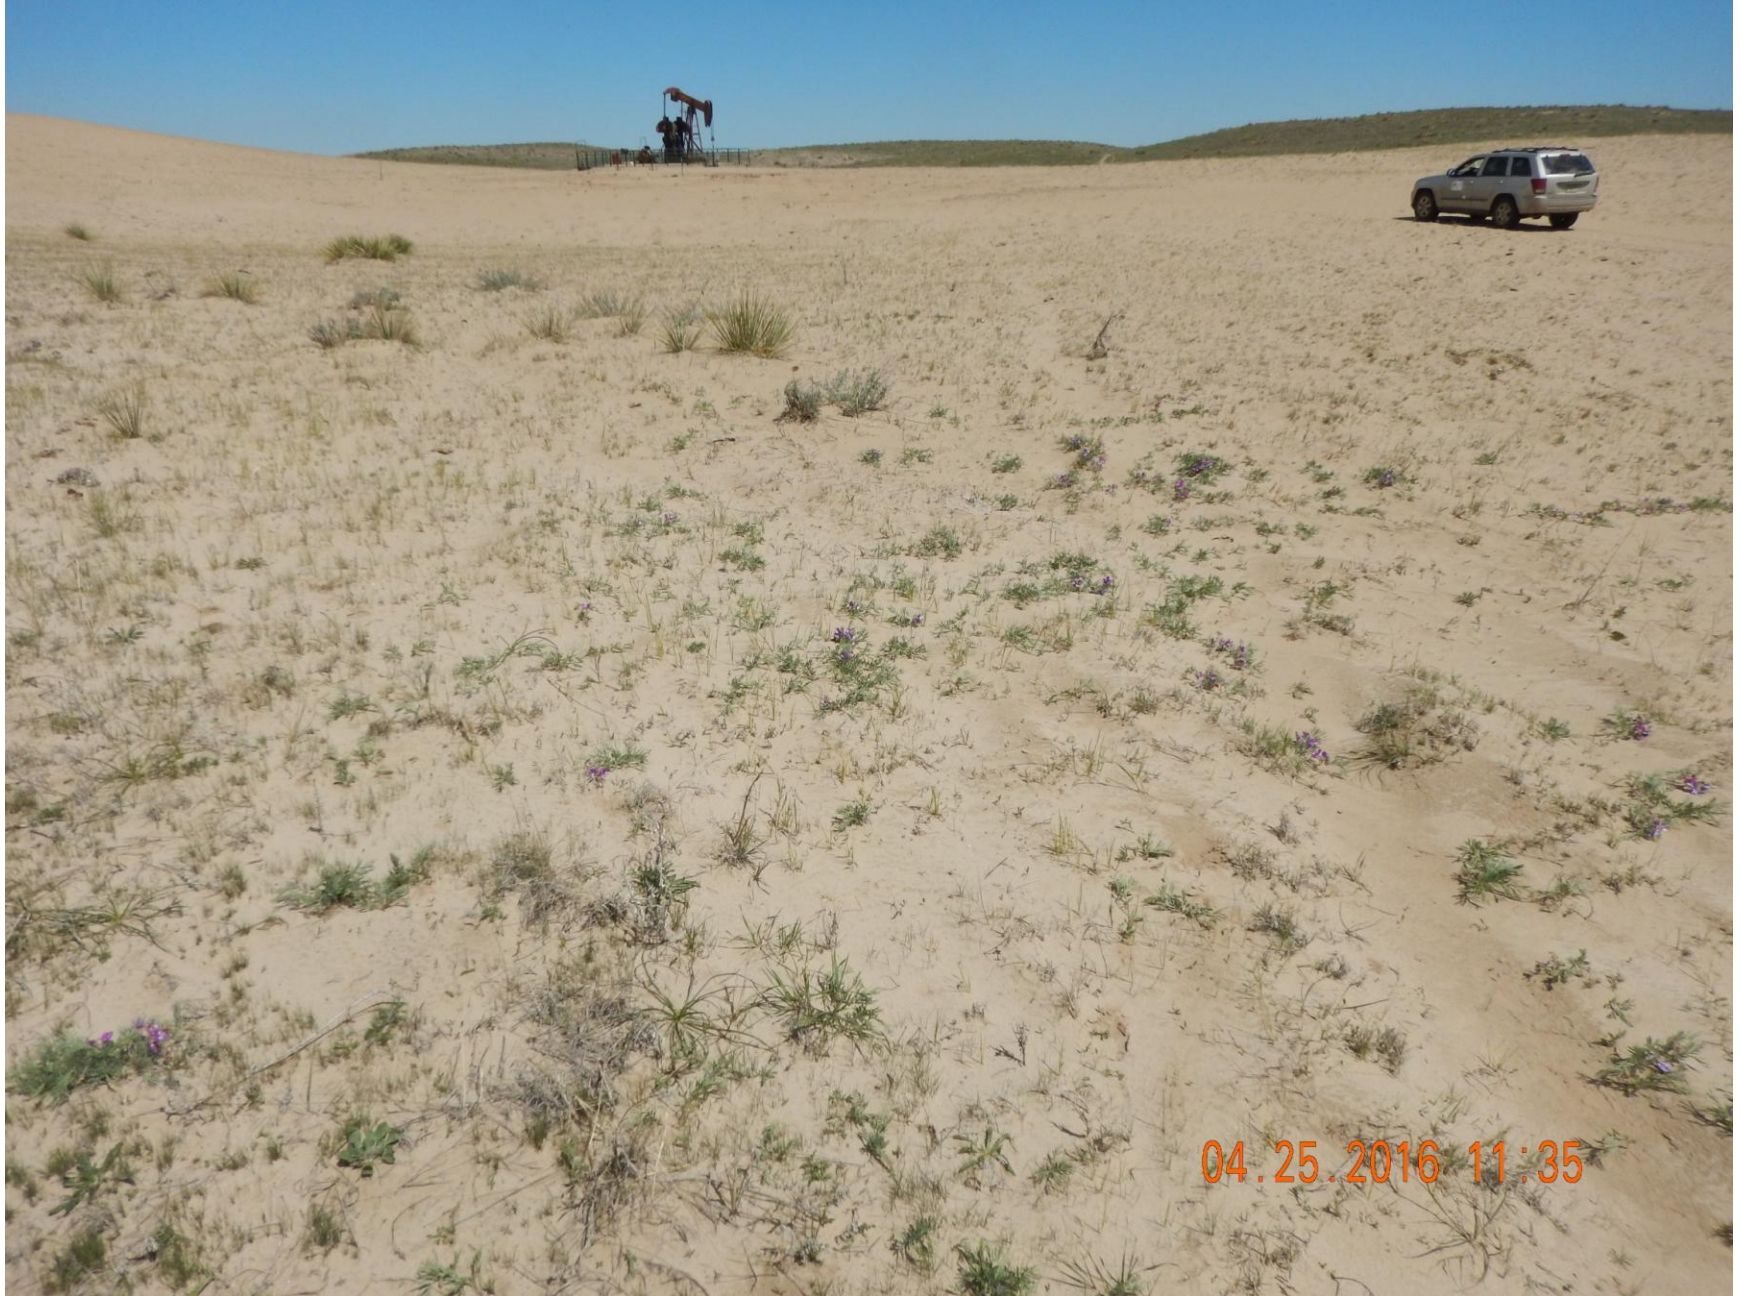
Figure 4: Photo taken from the southwest corner of the location, facing northeast. Photo shows large areas of the location where revegetation is not progressing.

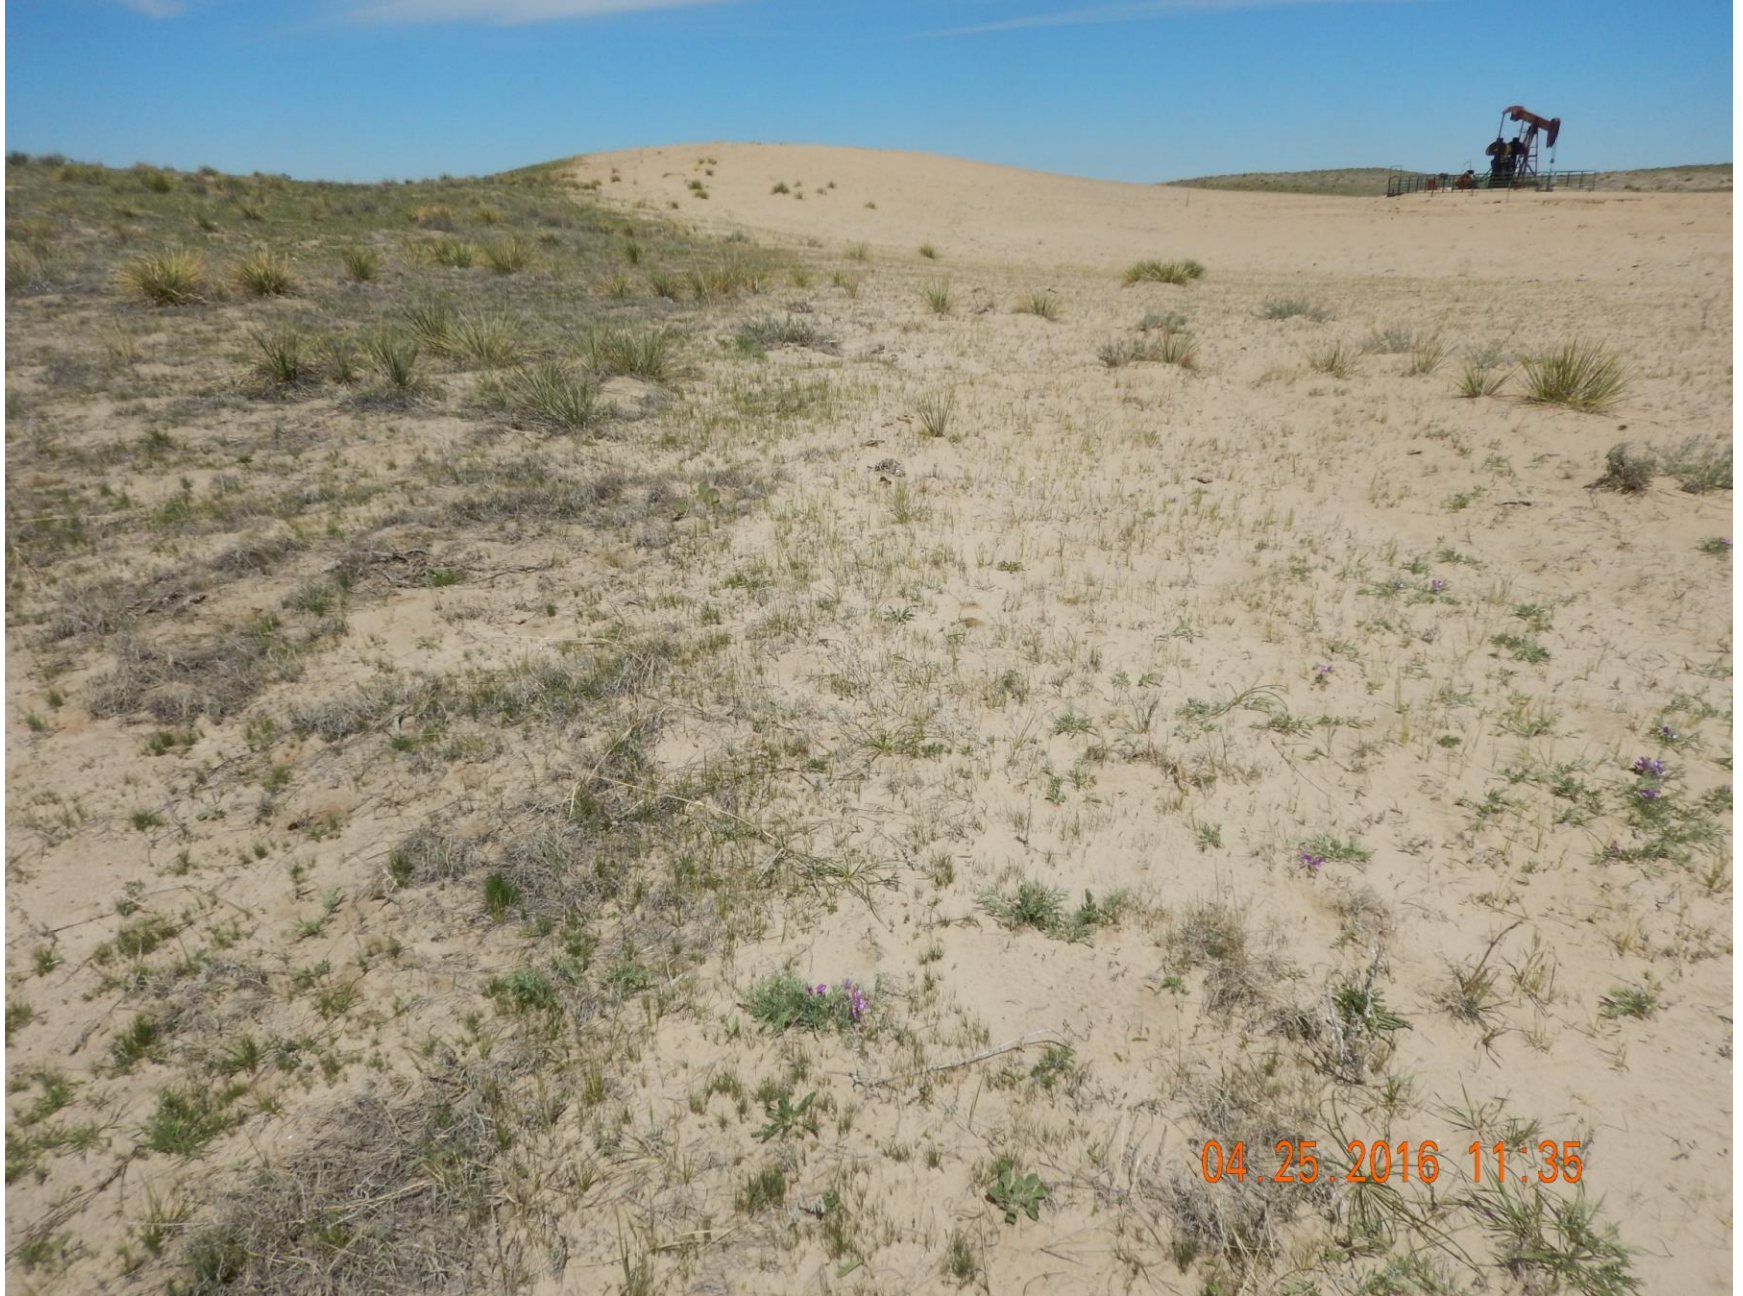
Figure 5: Photo taken from the southwest corner of the location, facing north. Photo shows large areas of the location where revegetation is not progressing.

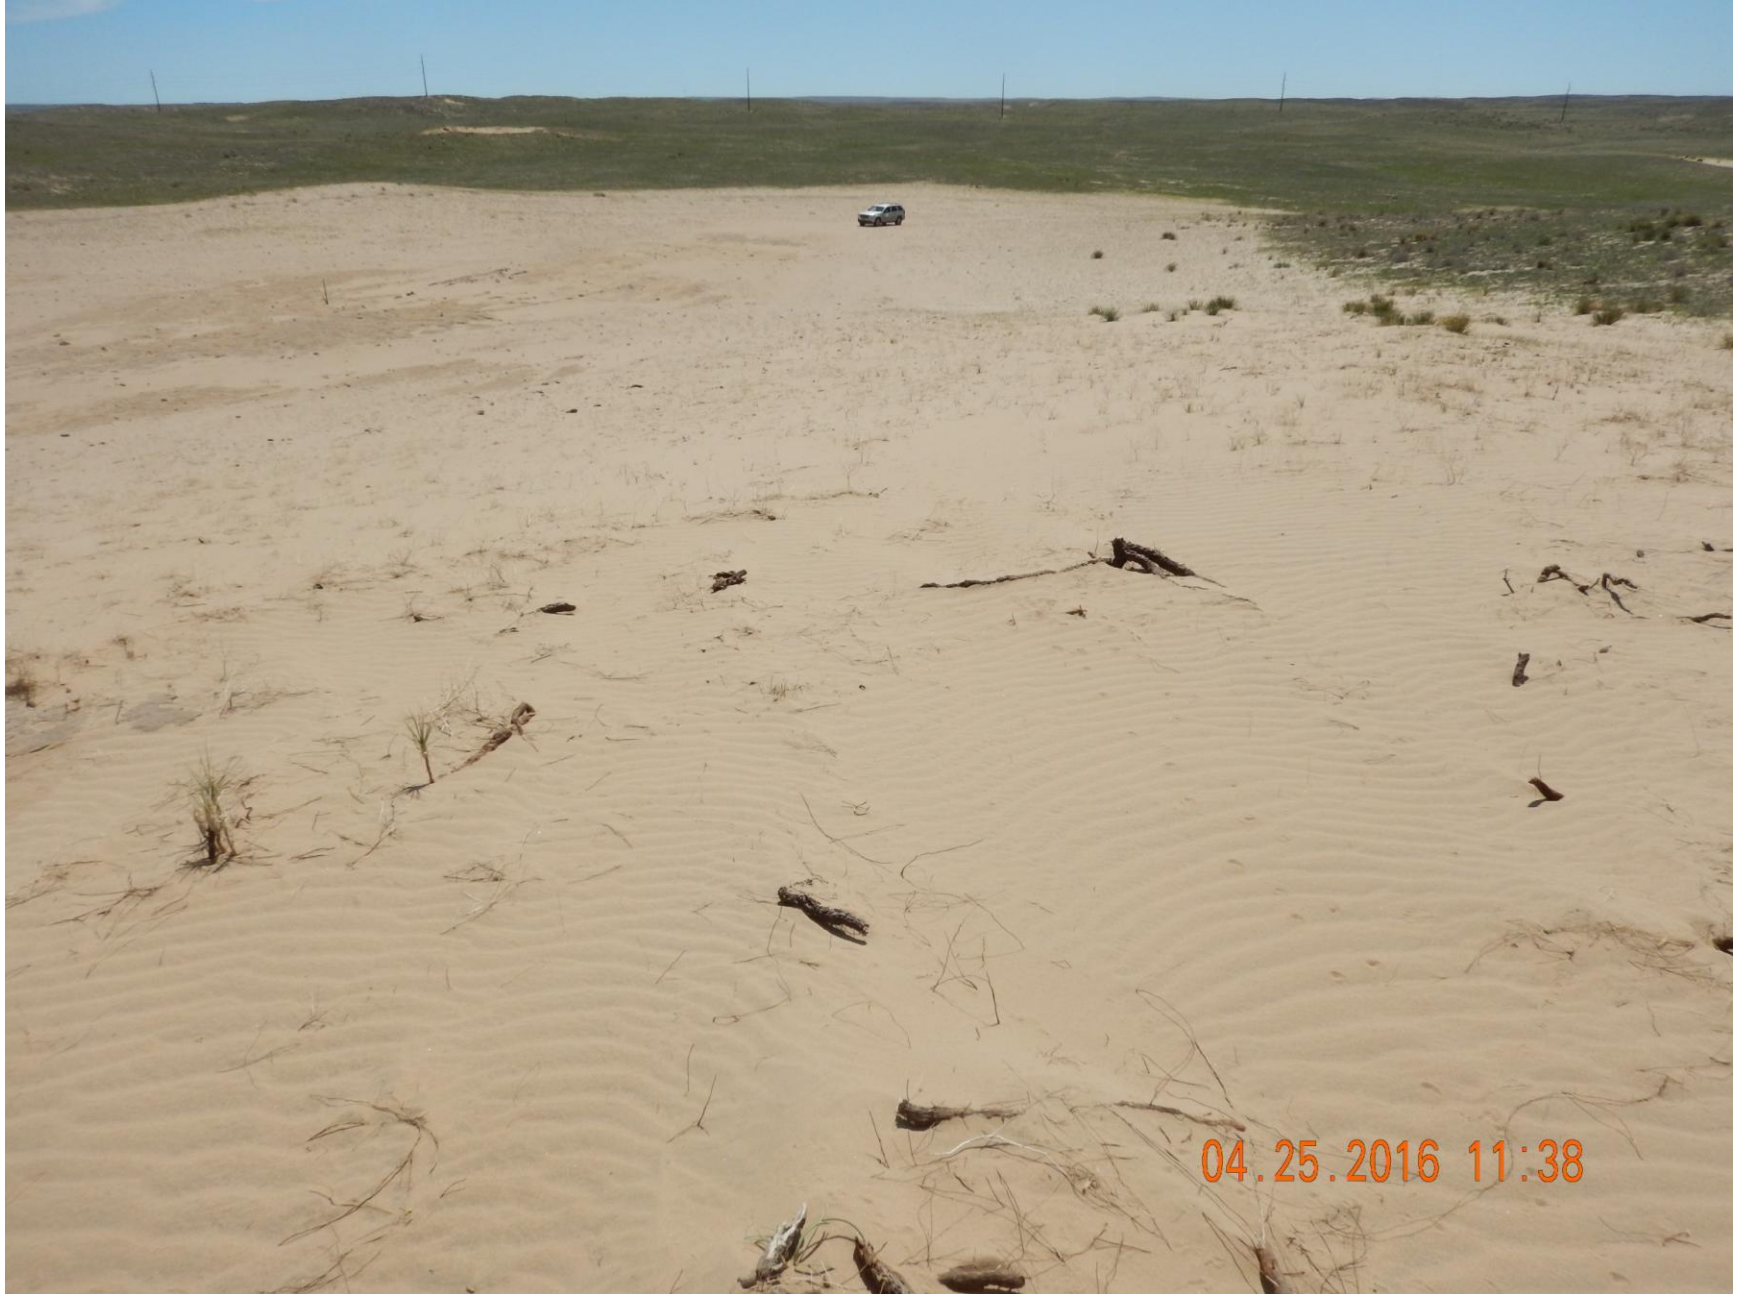
Figure 6: Photo taken from the northwest corner of the location, facing south. Photo shows large areas of the location where revegetation is not progressing.

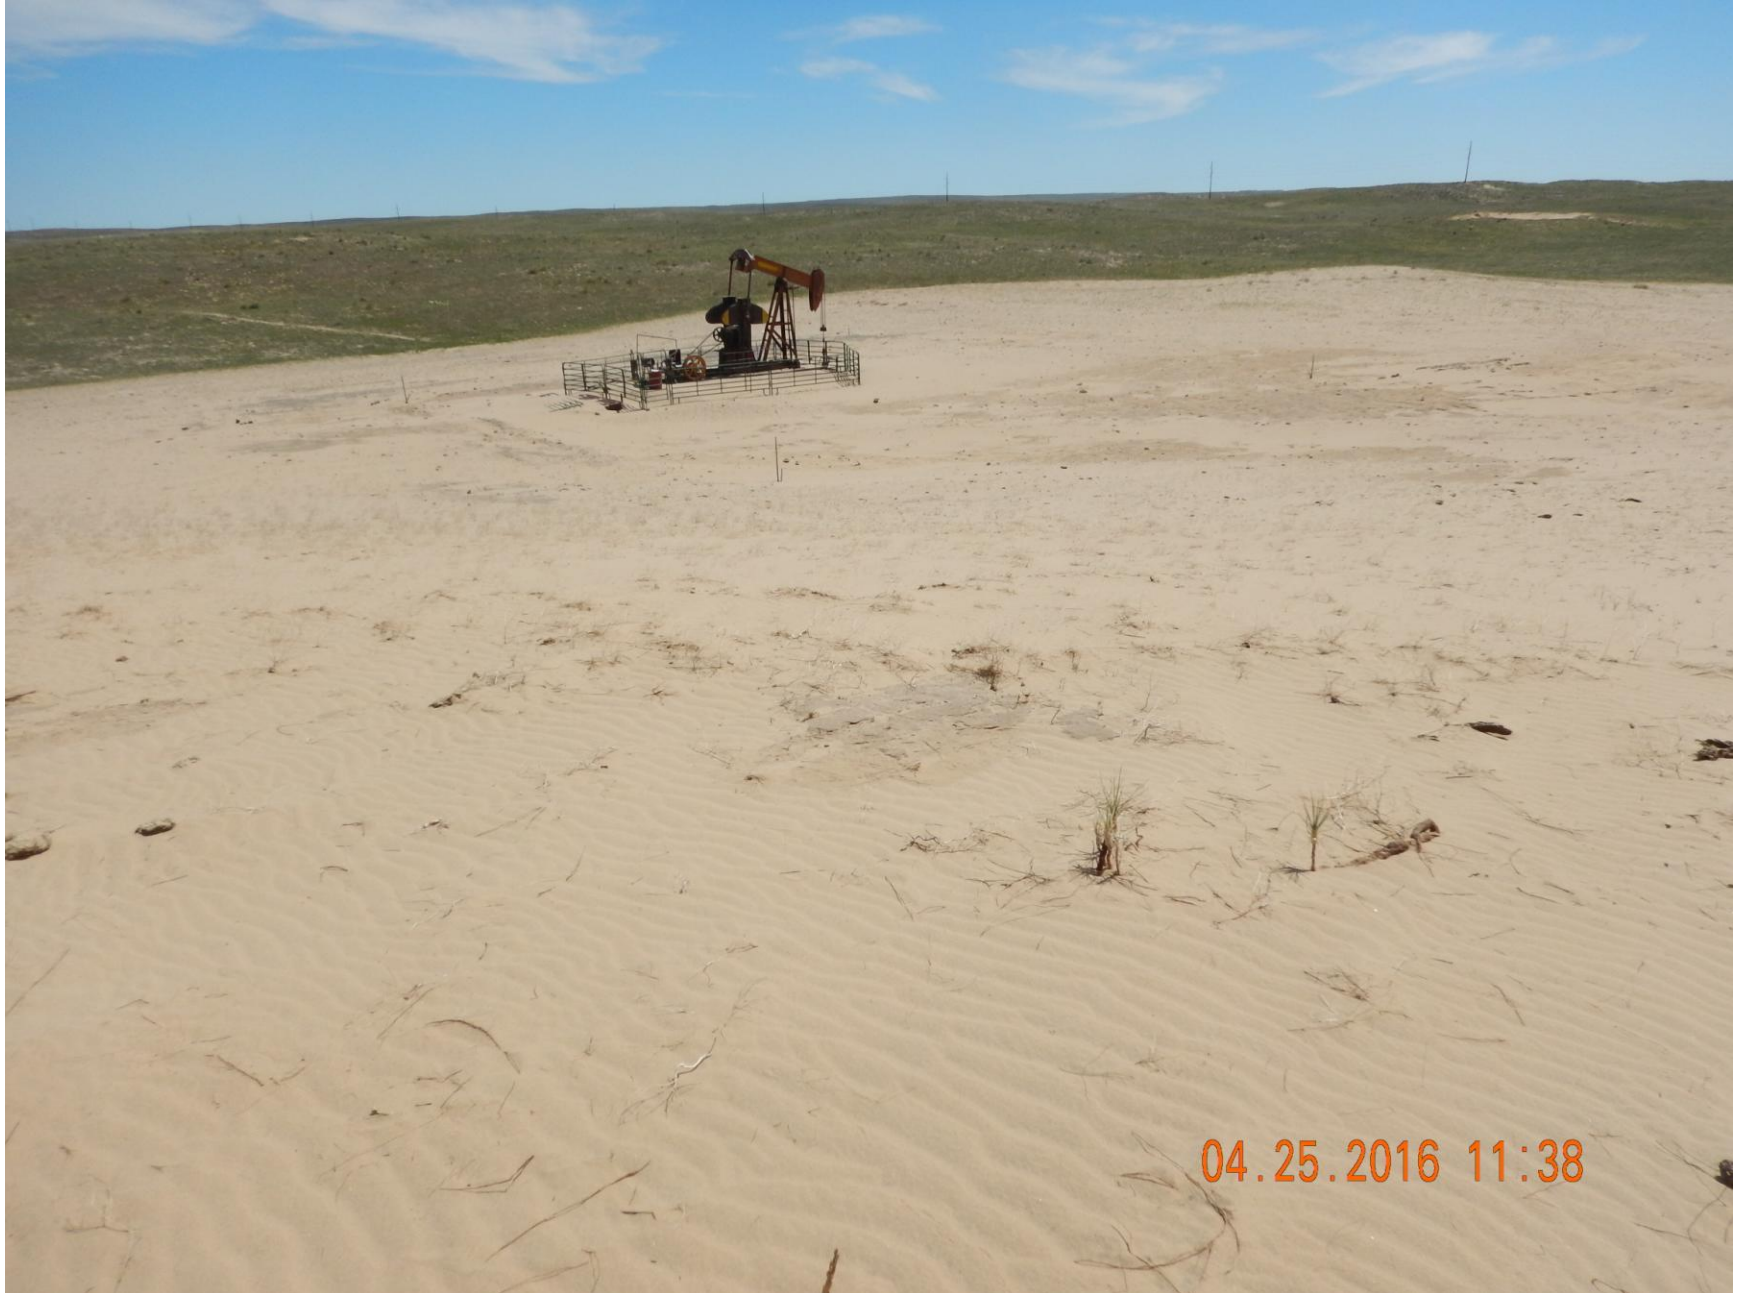
Figure 7: Photo taken from the northwest corner of the location, facing southeast. Photo shows large areas of the location where revegetation is not progressing.

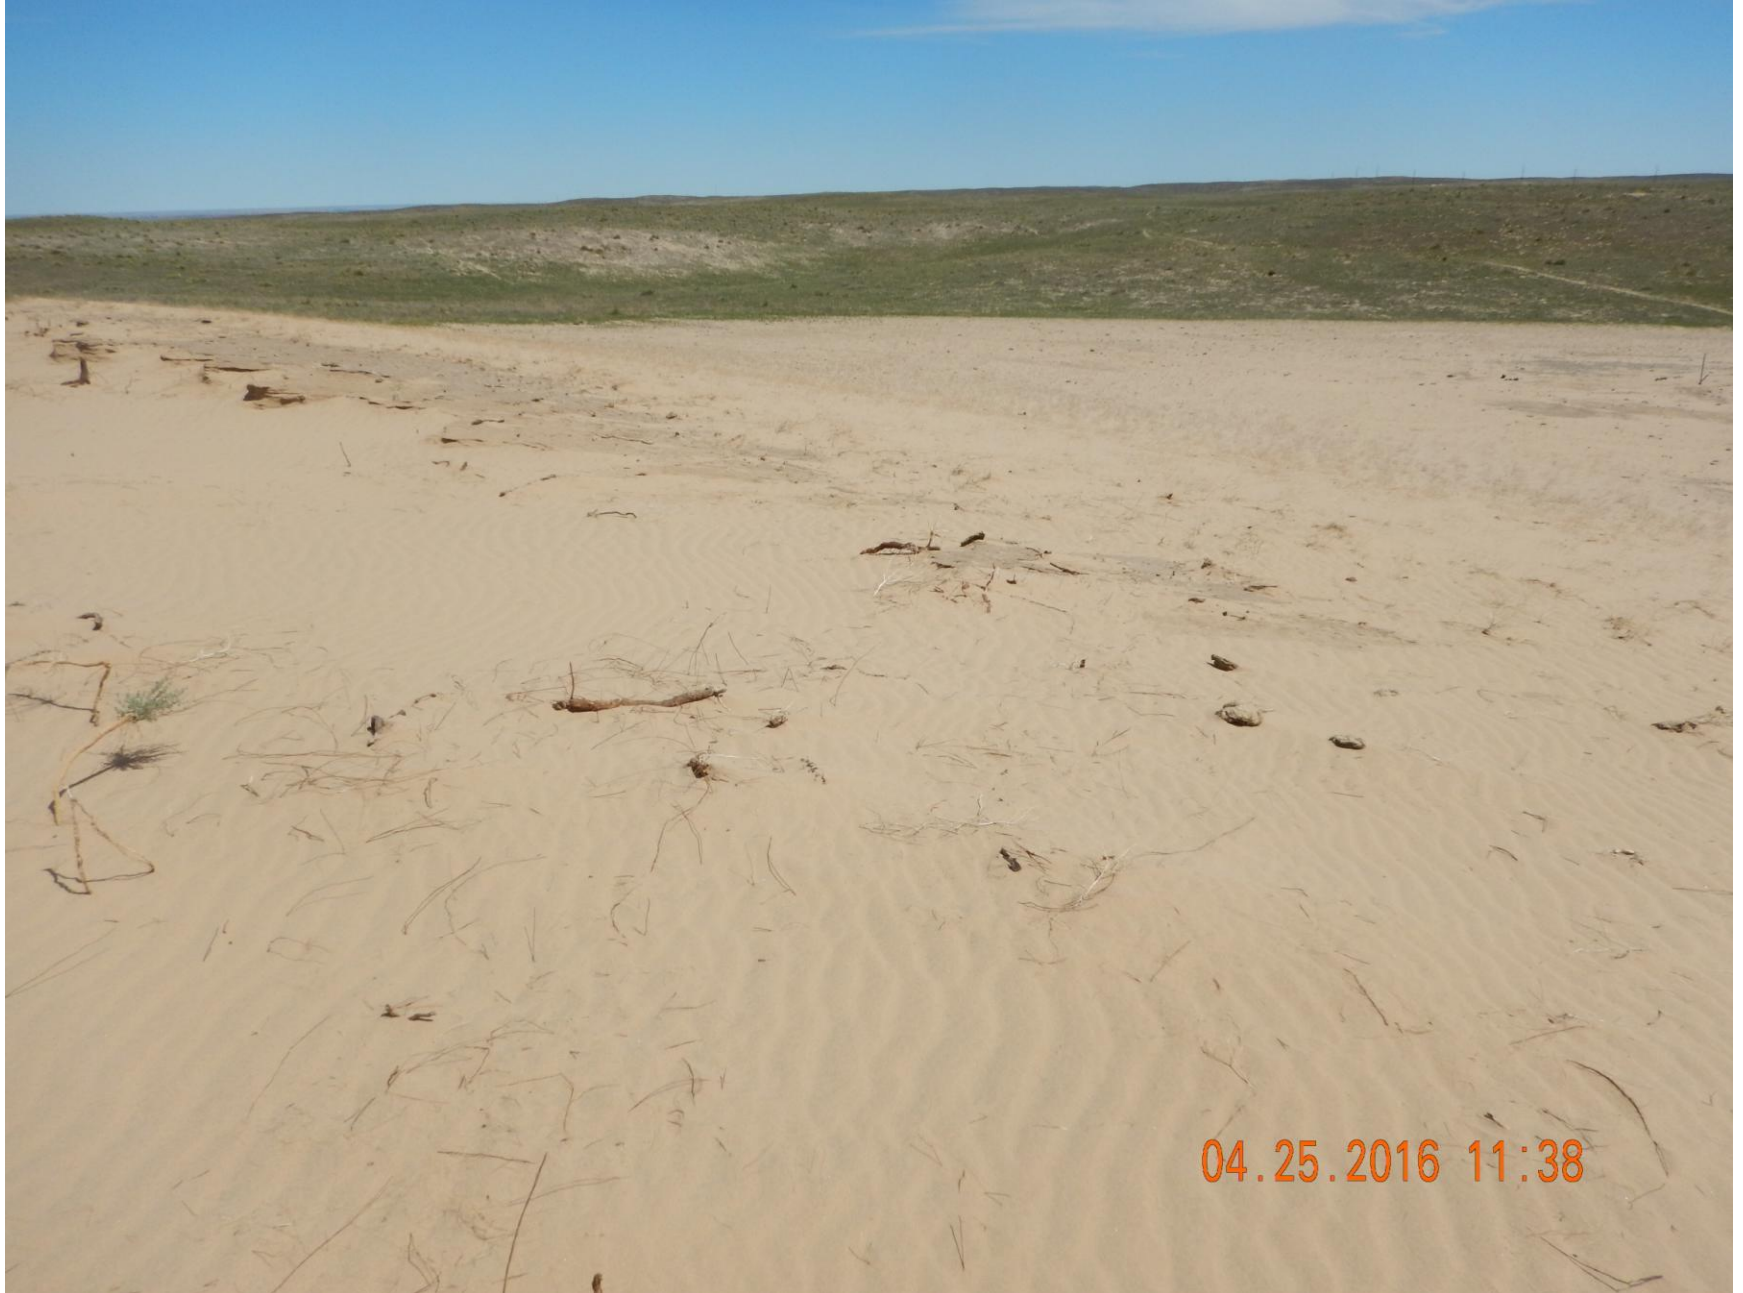
Figure 8: Photo taken from the northwest corner of the location, facing east. Photo shows large areas of the location where revegetation is not progressing.

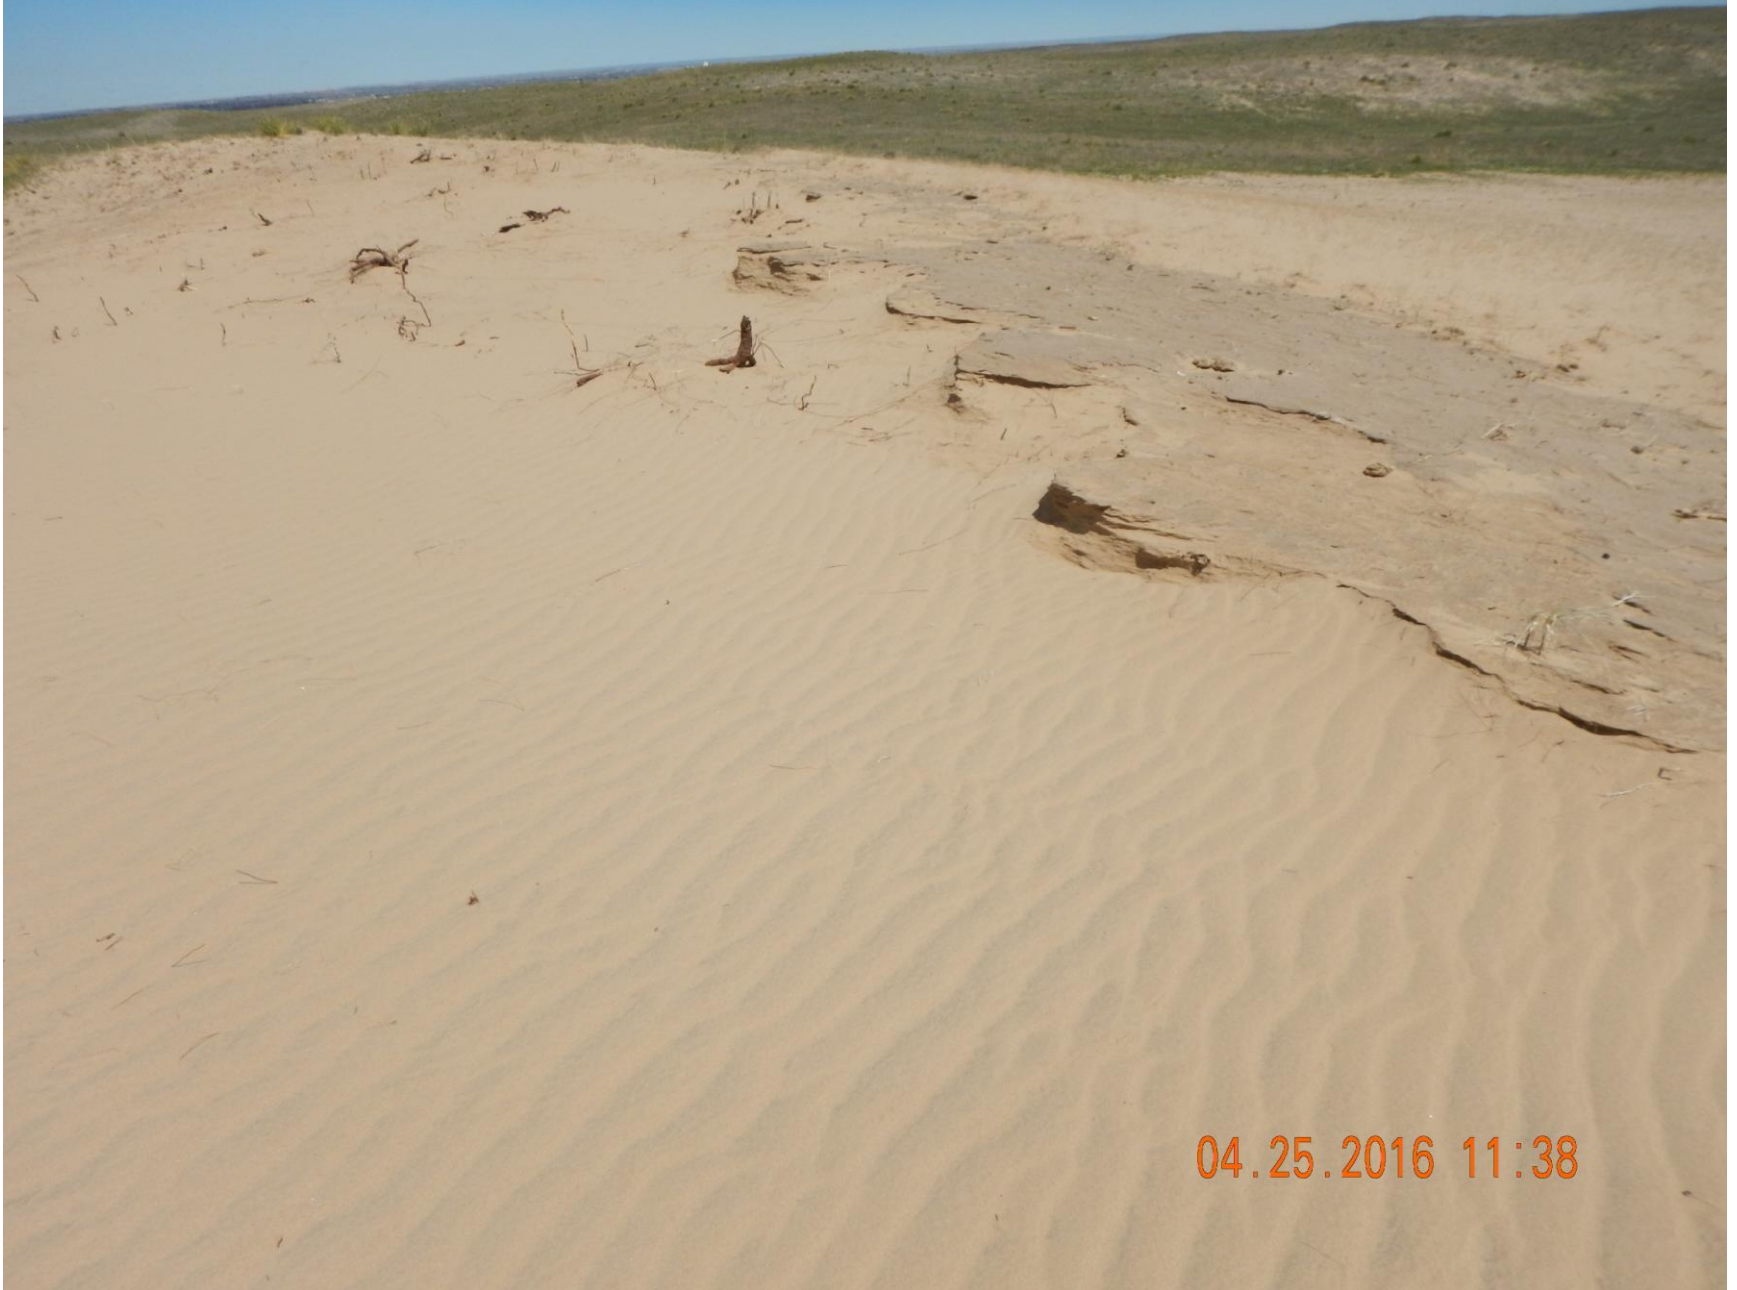
Figure 9: Photo taken from the northwest corner of the location, facing northeast. Photo shows large areas of the location where revegetation is not progressing.

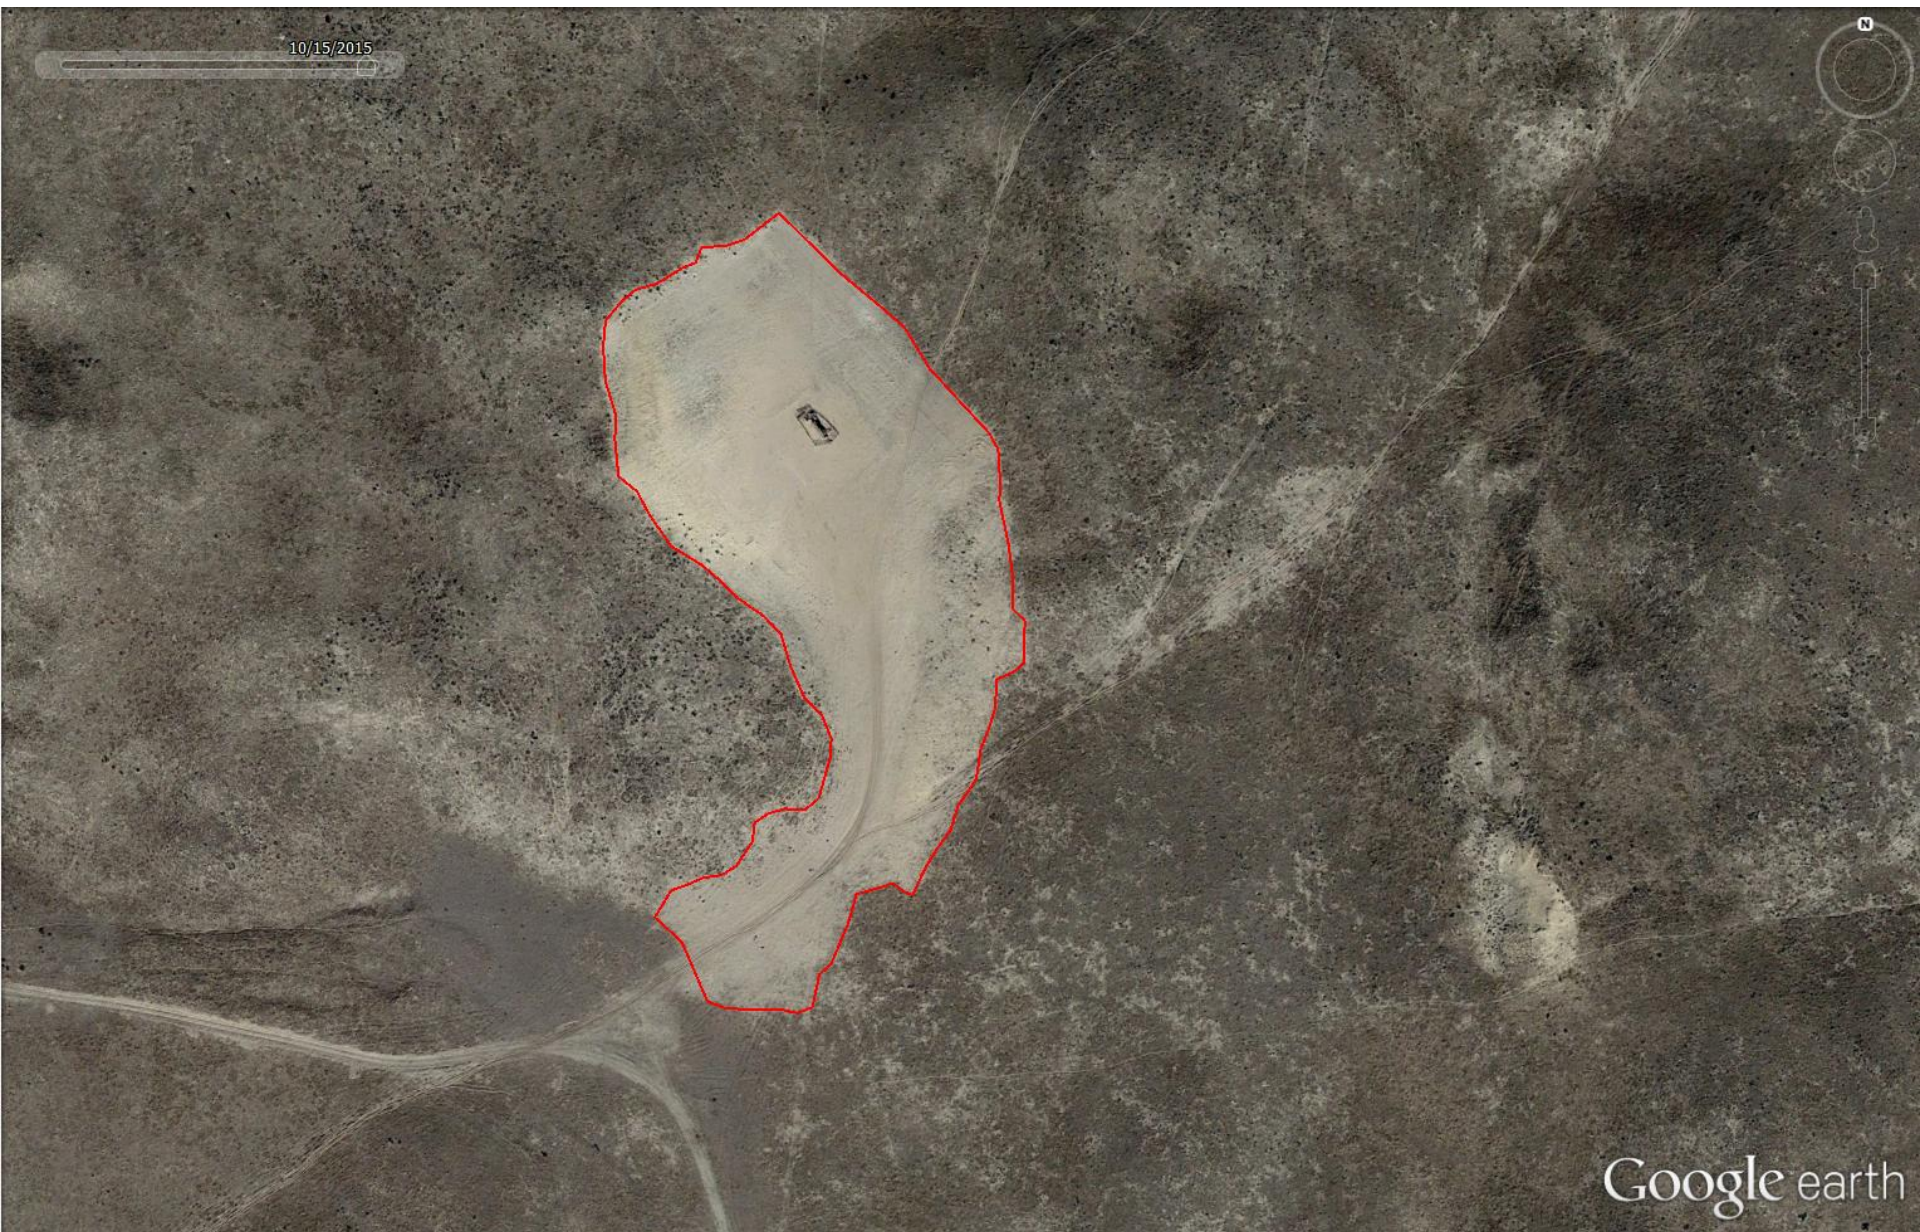
Figure 11: 2015 aerial imagery. Image shows size/perimeter of disturbance 1 year after location was constructed. Two growing seasons have passed at this point.
