Interim Reclamation Inspection

Operator: High Plains Energy

Location #: 430585

Logan County, CO

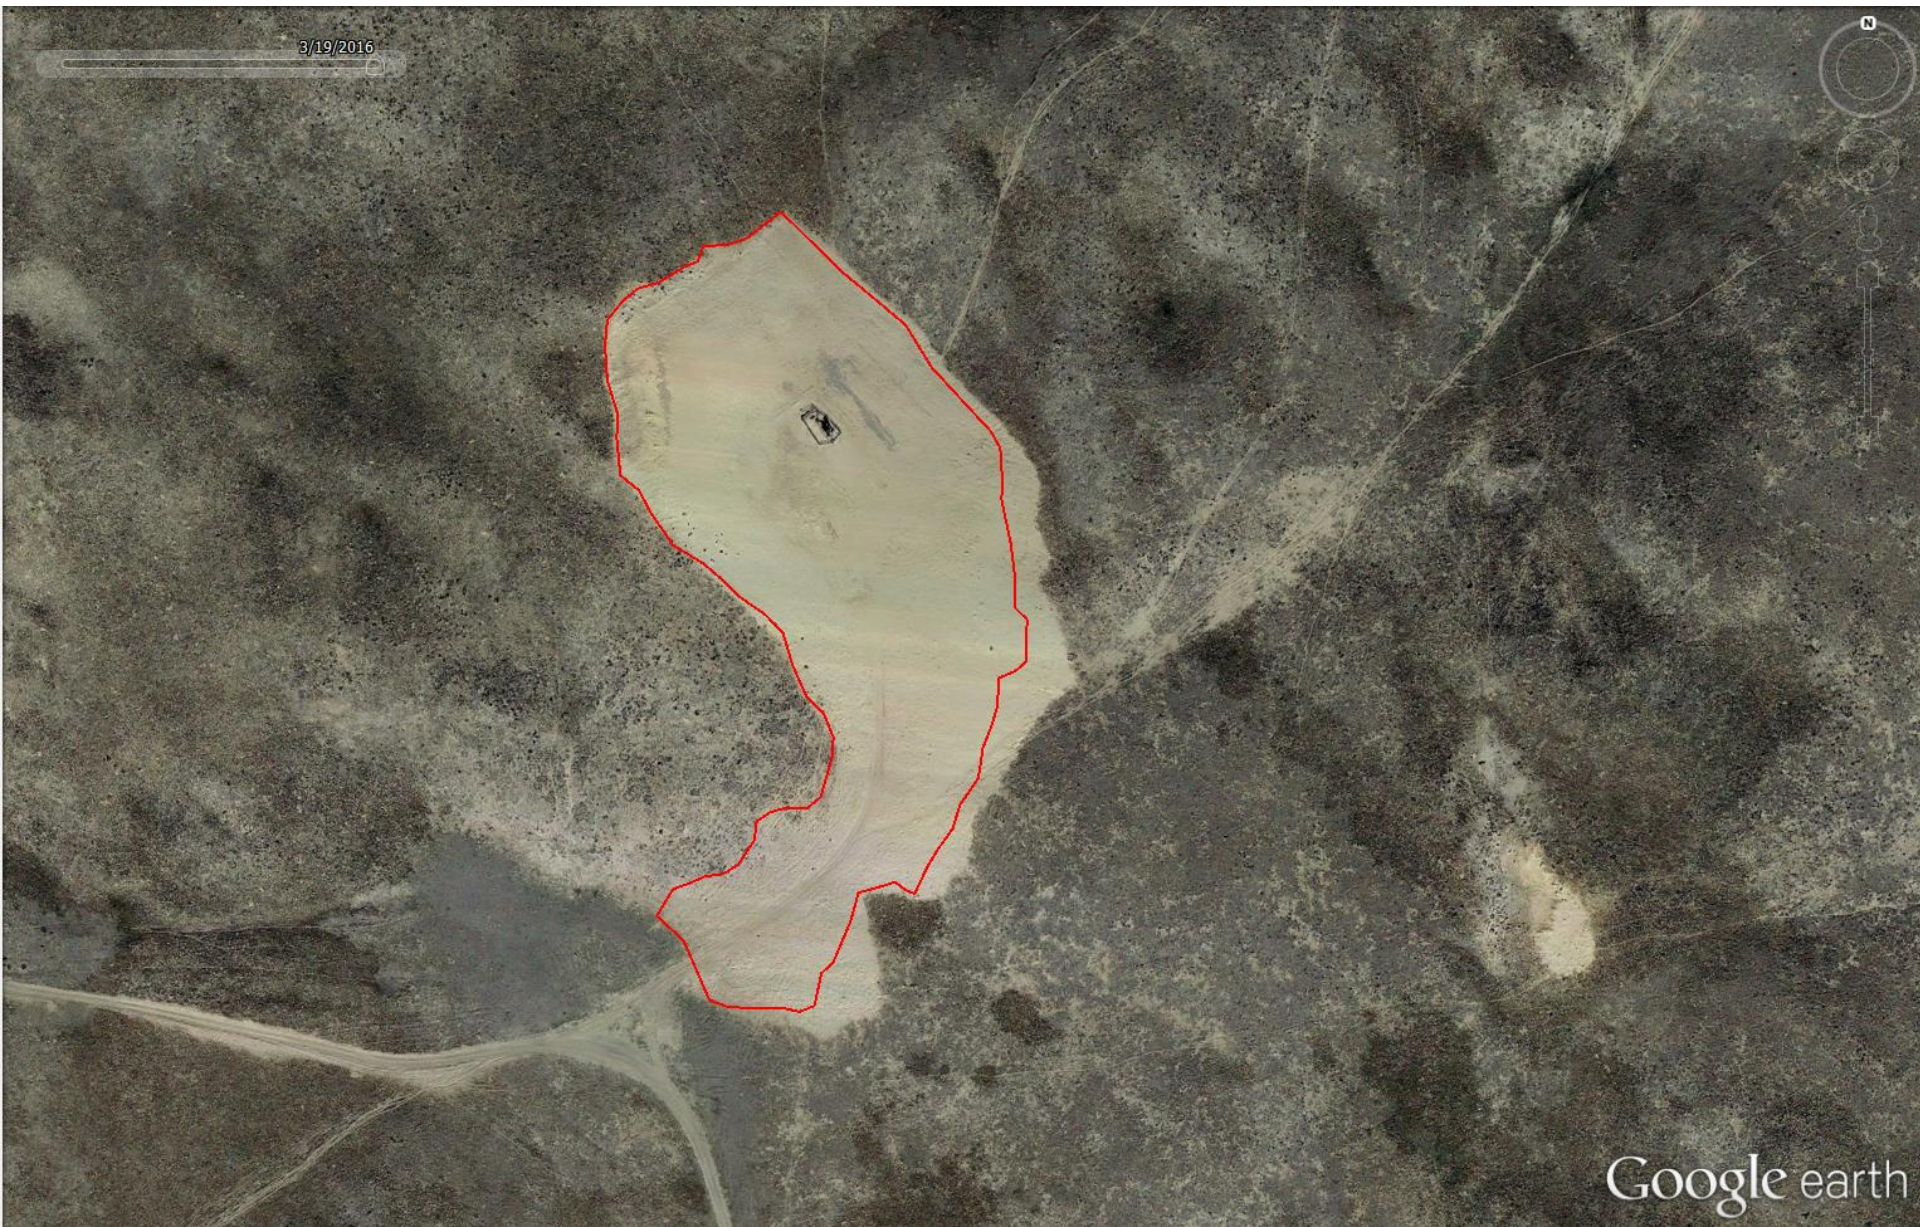
Figure 12: 2016 Aerial imagery. Image shows locations current size of disturbance compared to 2015 (red line). Note locations current area of disturbance has not been reduced in size as required by interim reclamation rules, but rather, has increased in size.
