HRM- Stormwater and Erosion Overview Map

**#6
Tank Battery
w/ stormwater**

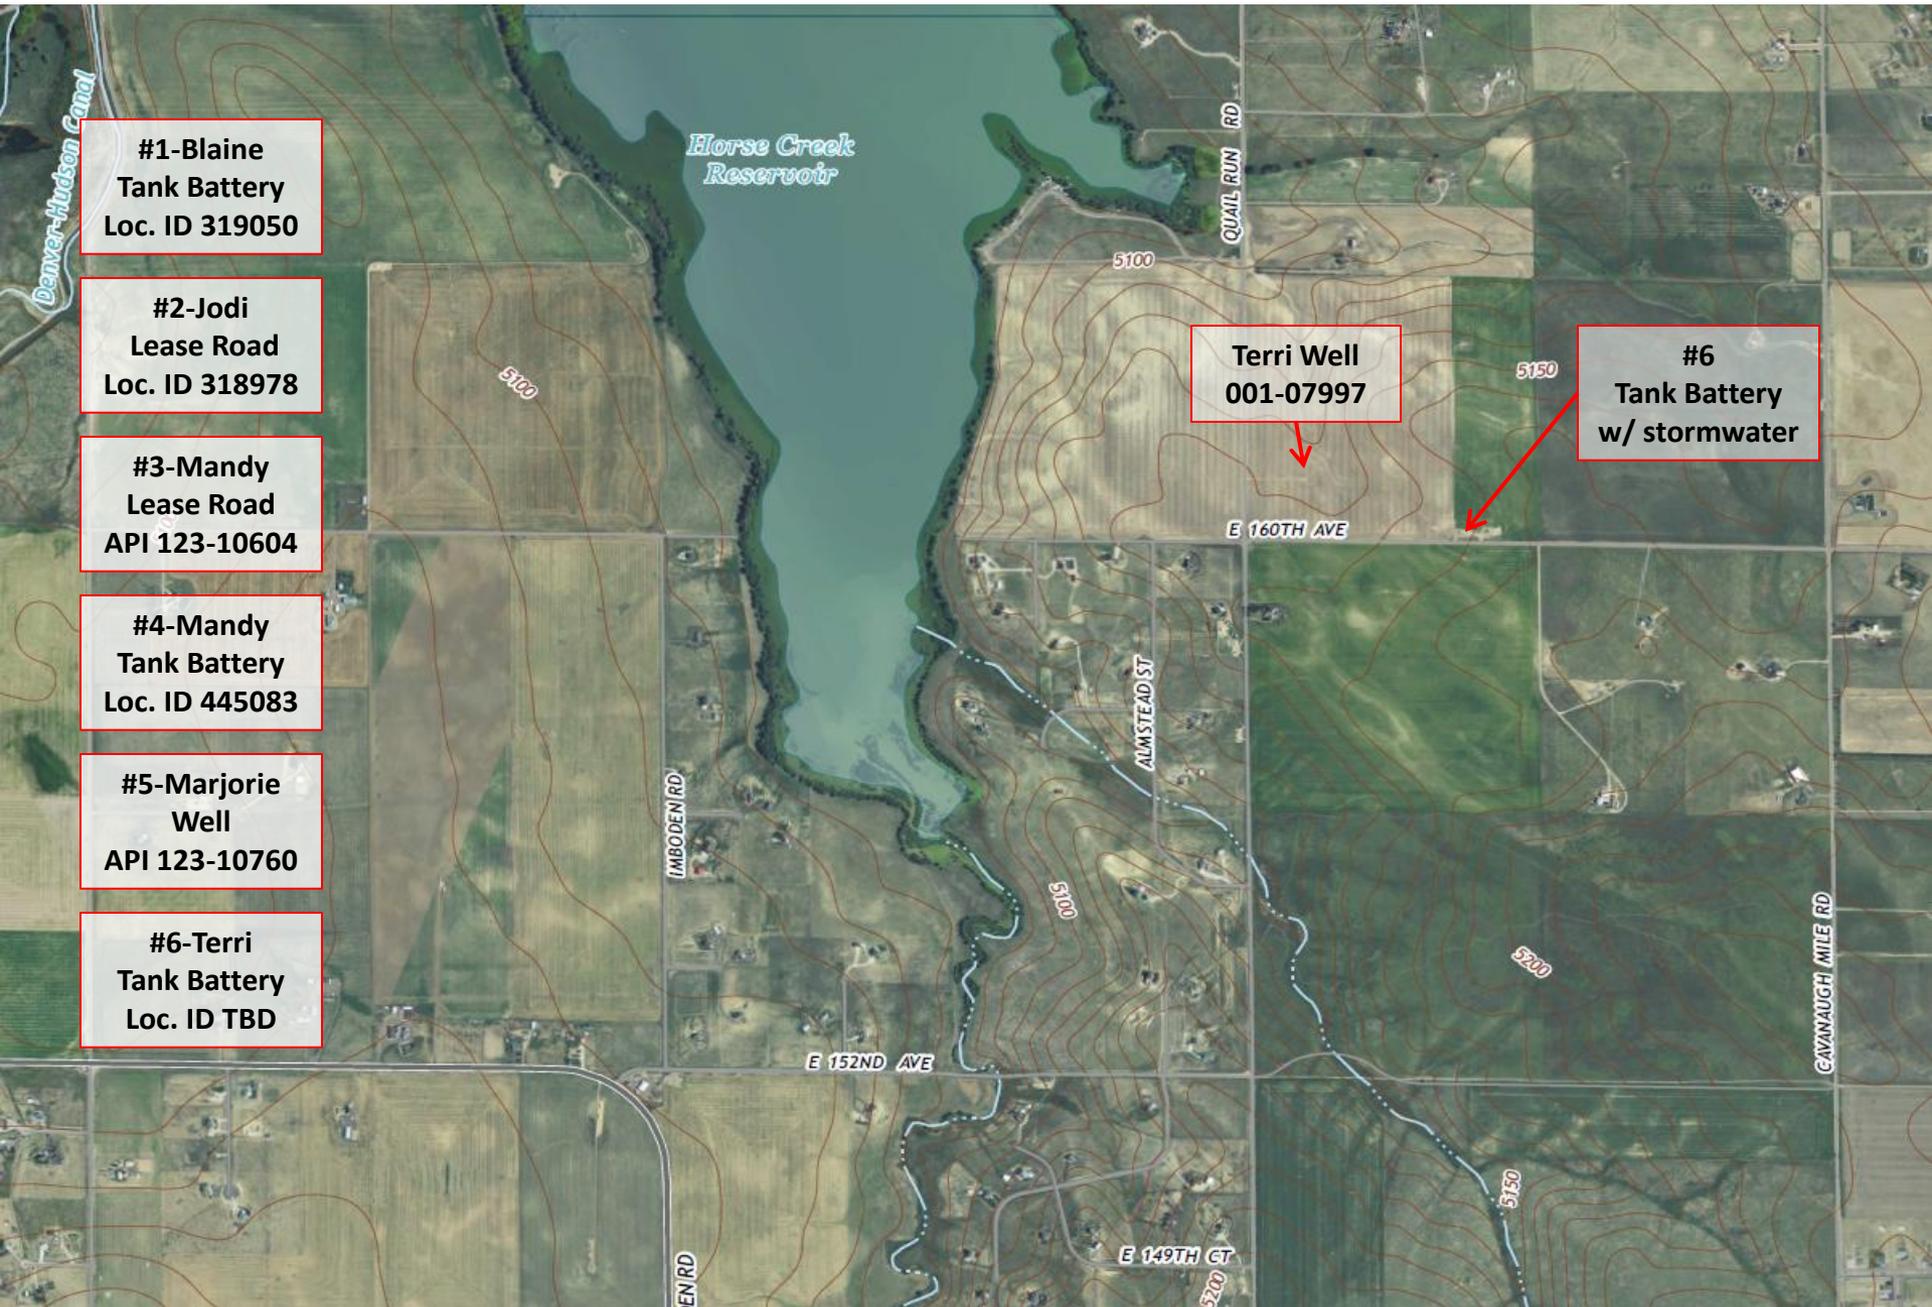
**#1-Blaine
Tank Battery
Loc. ID 319050**

**#2-Jodi
Lease Road
Loc. ID 318978**

**#3-Mandy
Lease Road
API 123-10604**

**#4-Mandy
Tank Battery
Loc. ID 445083**

**#5-Marjorie
Well
API 123-10760**

**#6-Terri
Tank Battery
Loc. ID TBD**

**Terri Well
001-07997**

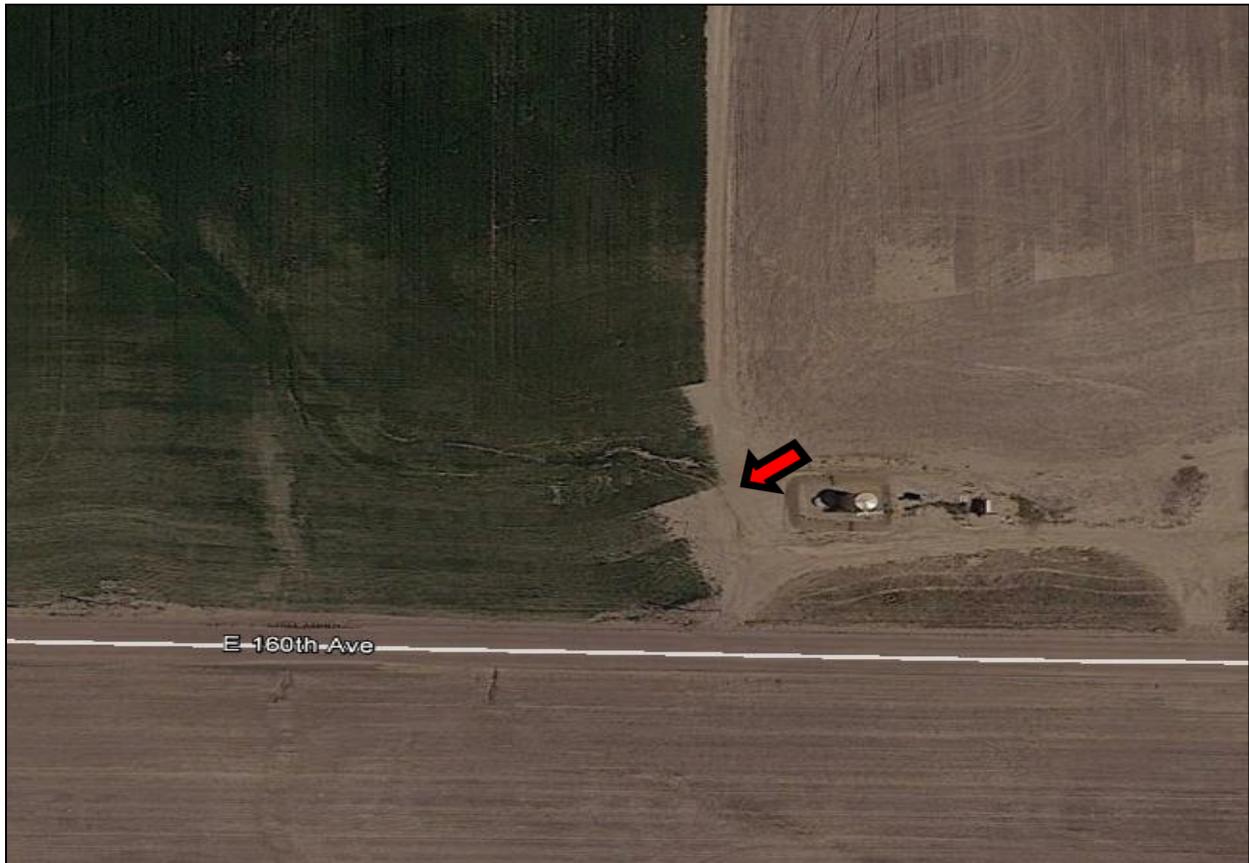
Photo 1: Aerial imagery illustrating erosion initiates on the tank battery location, traveling west onto cropland.

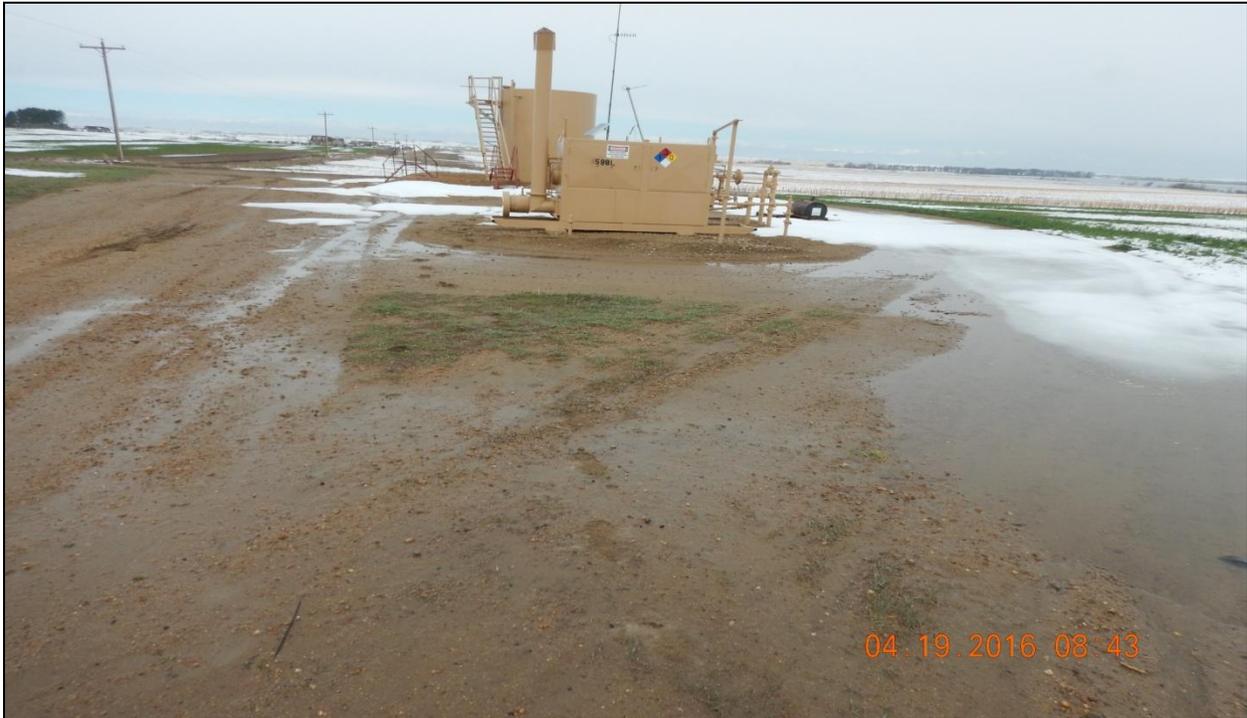
Photo 2: Photo taken 4/19/16 east of tank battery location, facing West. This photo illustrates where stormwater initiates then travels west onto cropland.

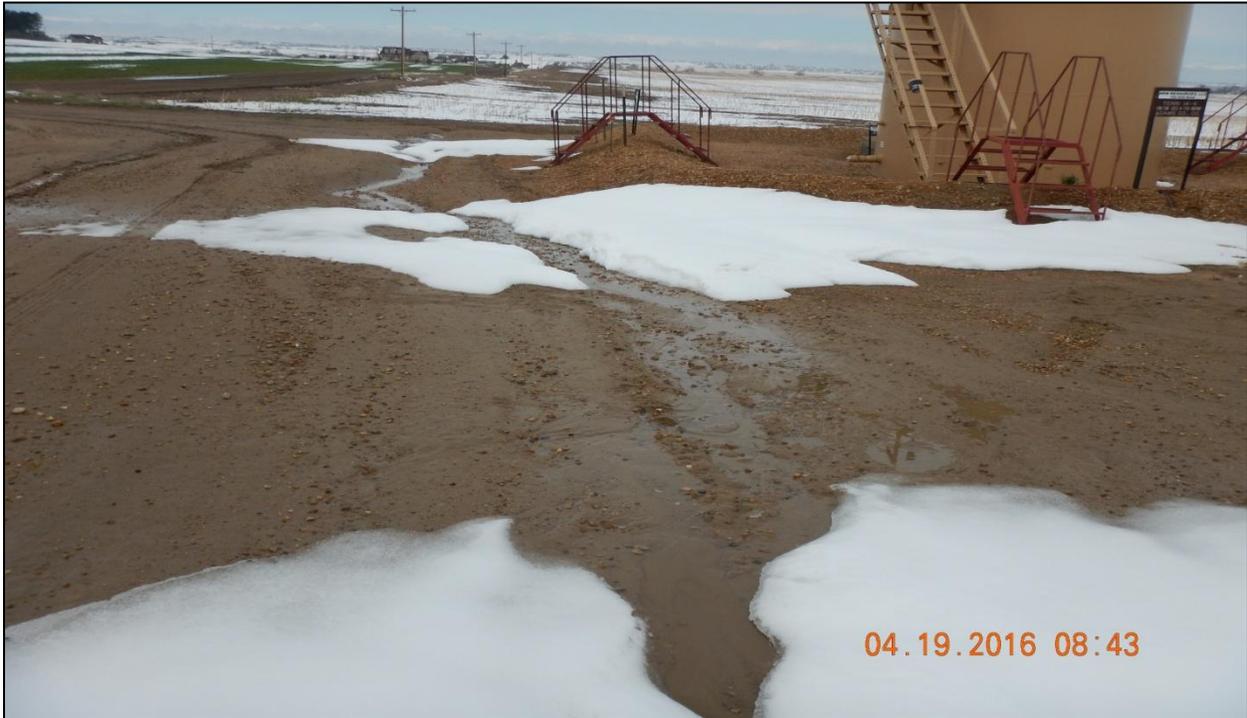
Photo 3: Photo taken 4/19/16 east of tank battery location, facing West. This photo illustrates where stormwater initiates then travels west onto cropland.

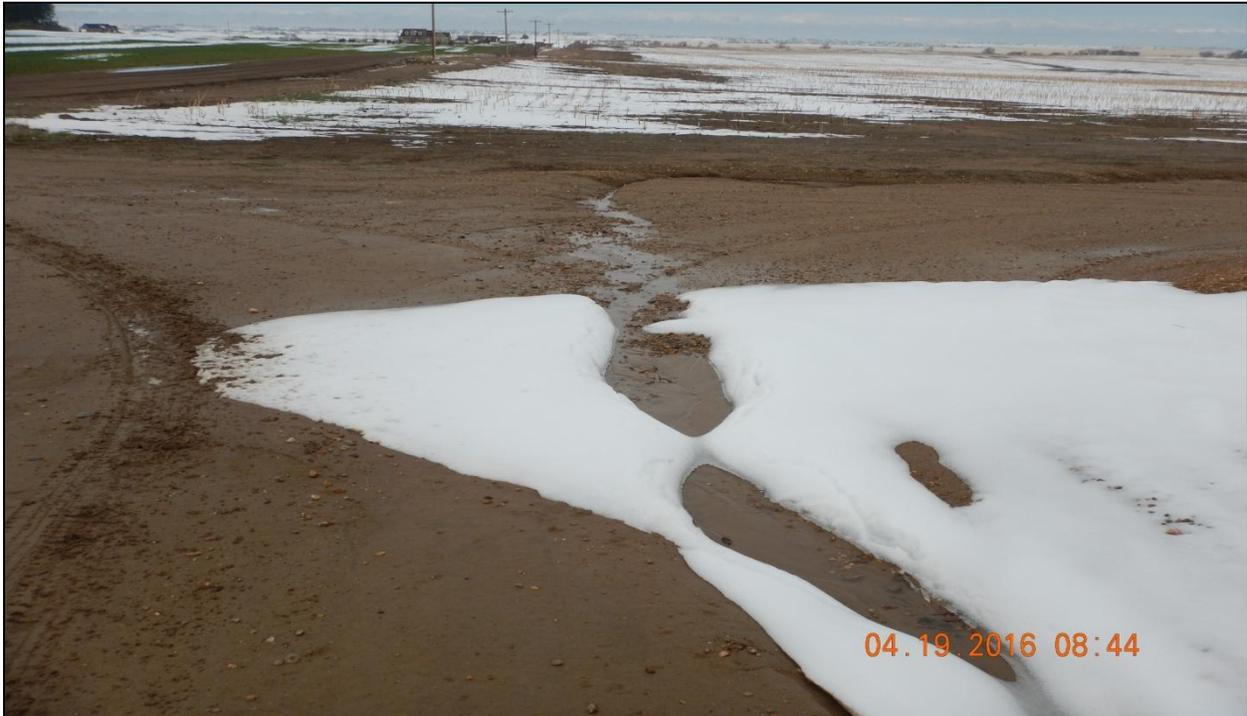
Photo 4: Photo taken 4/19/16 from tank battery location, facing West. Stormwater travels west, then curves north (see next photo).

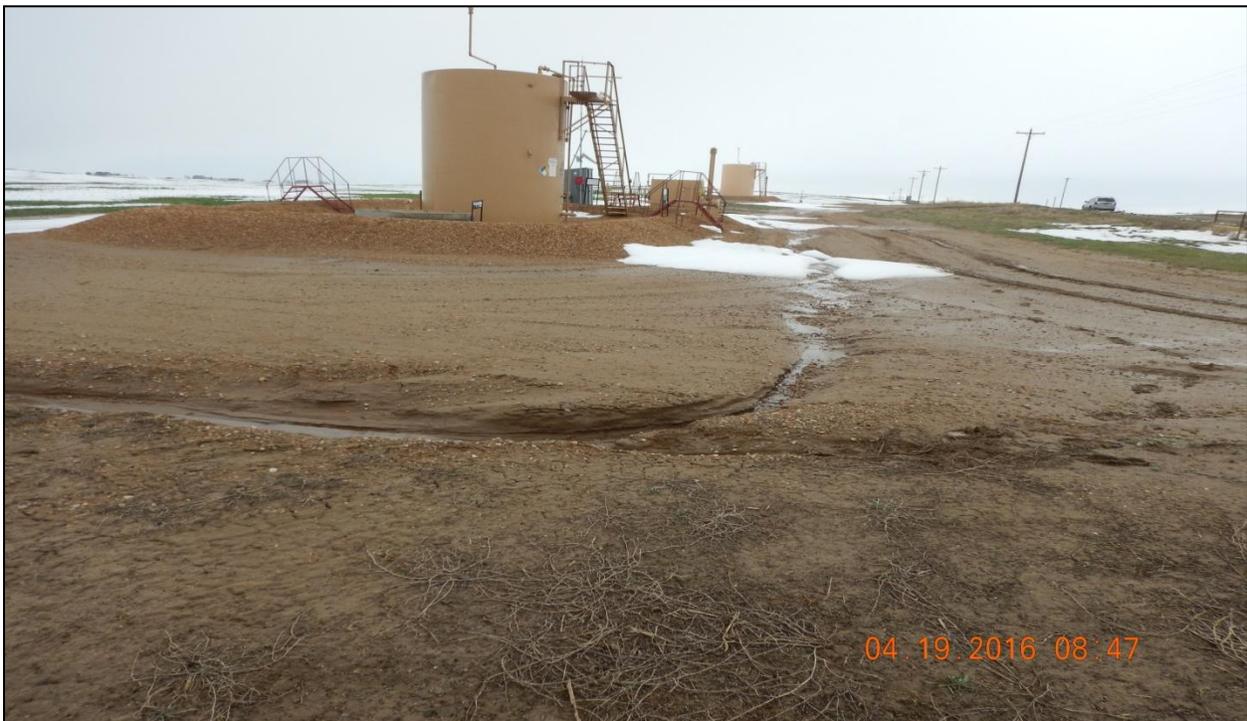
Photo 5: Photo taken 4/19/16 west of tank battery location, facing East. This photo illustrates the transition of the stormwater traveling north.

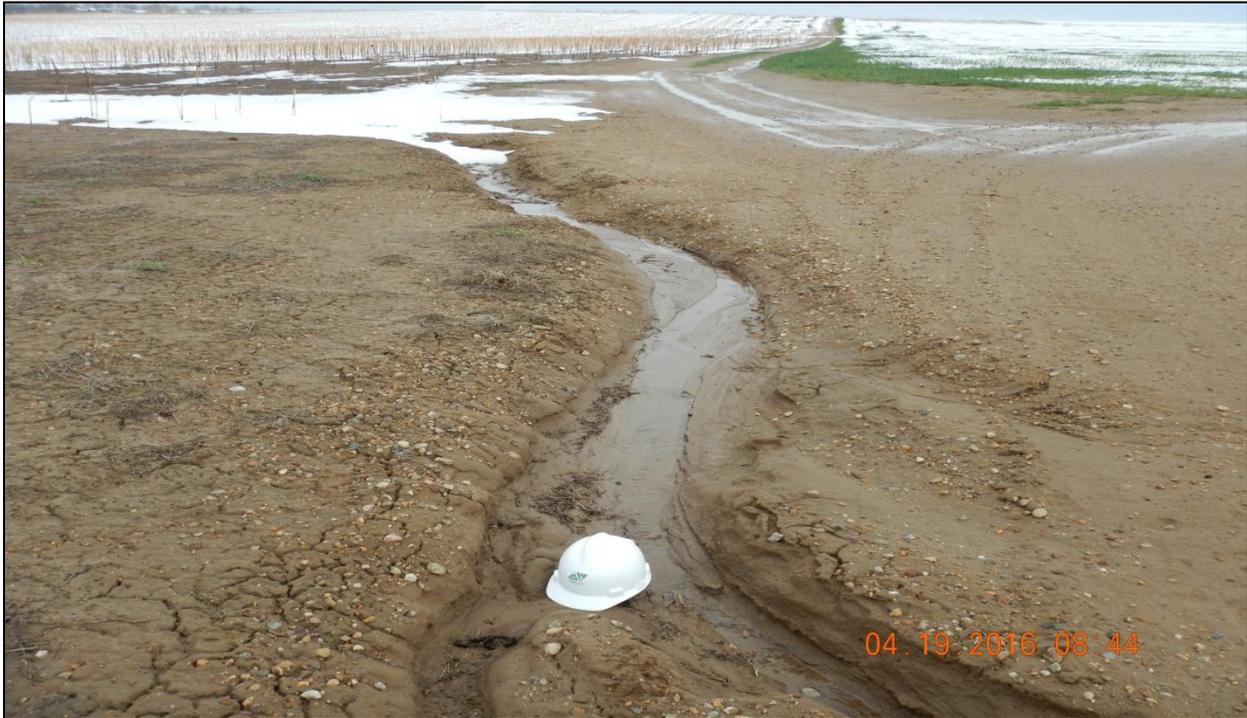
Photo 6: Photo taken 4/19/16 west of tank battery location, facing North. Erosion continues north approximately 50 feet, then heads west onto cropland (see next photo).

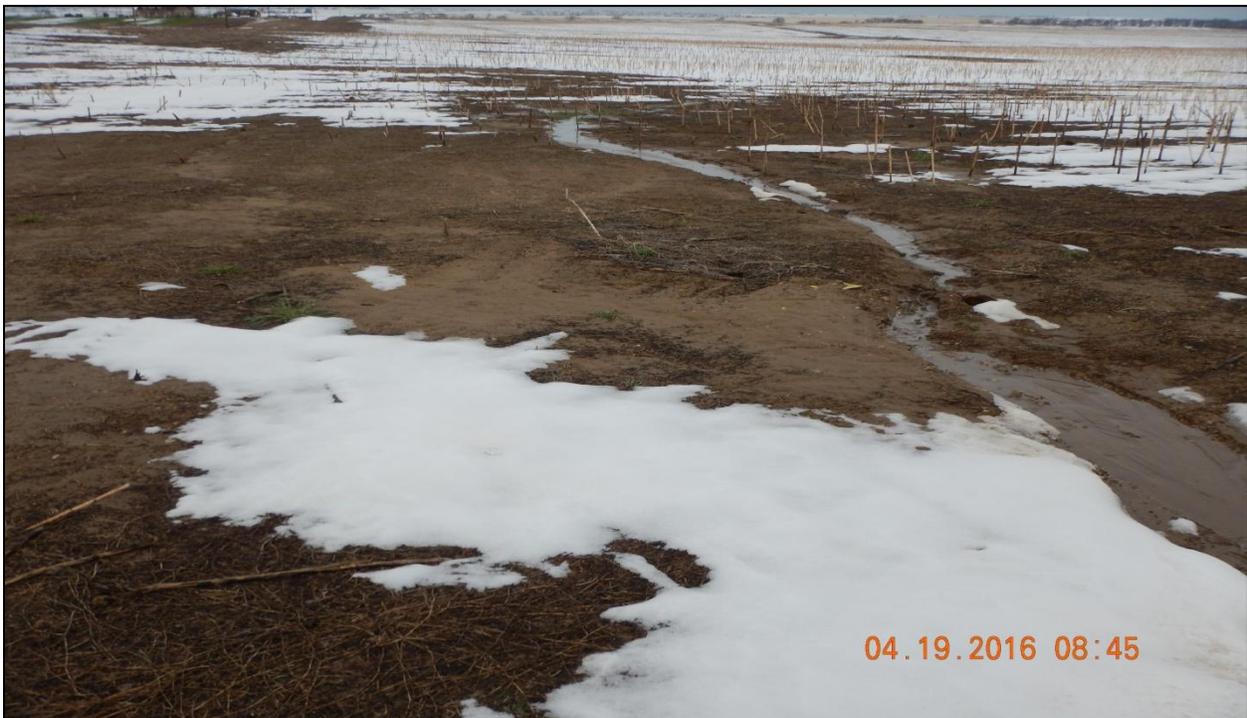
Photo 7: Photo taken 4/19/16 west of tank battery location, facing West. Stormwater continues to travel west. Notice the sediment deposition in center of photo.

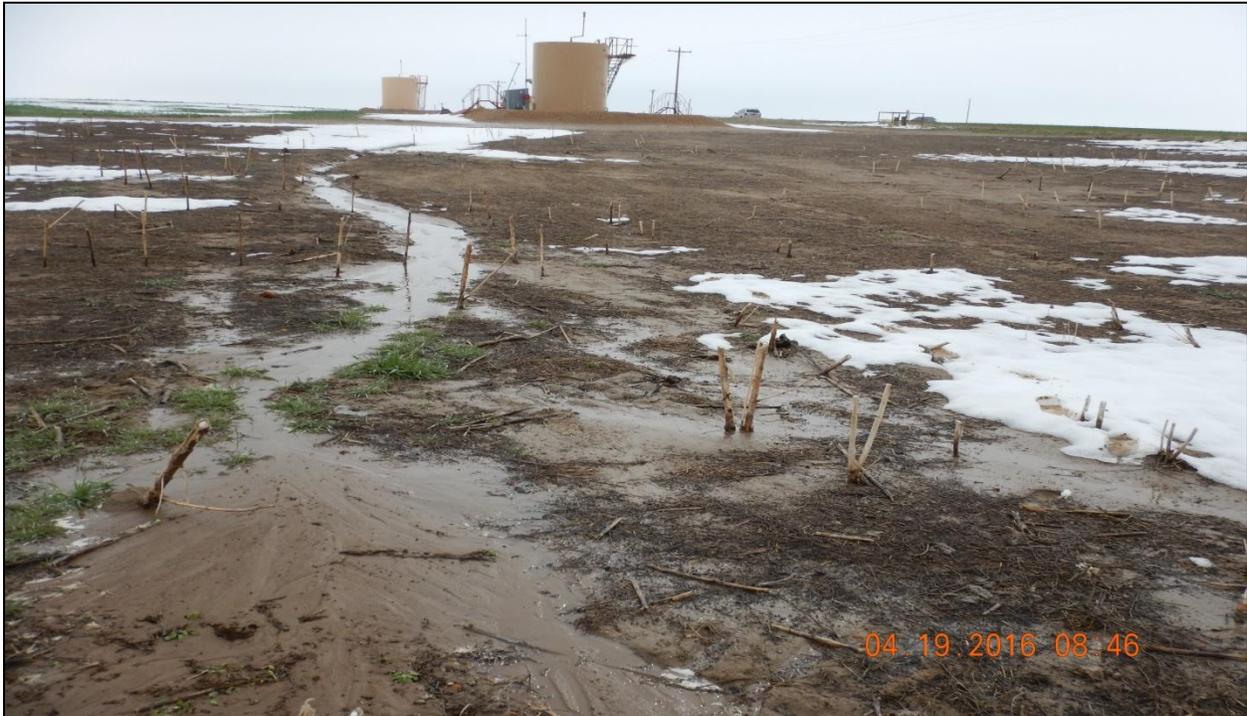
Photo 8: Photo taken 4/19/16 west of tank battery location, facing East. Notice the sediment deposition in center of photo.
