HRM - Stormwater and Erosion Overview Map

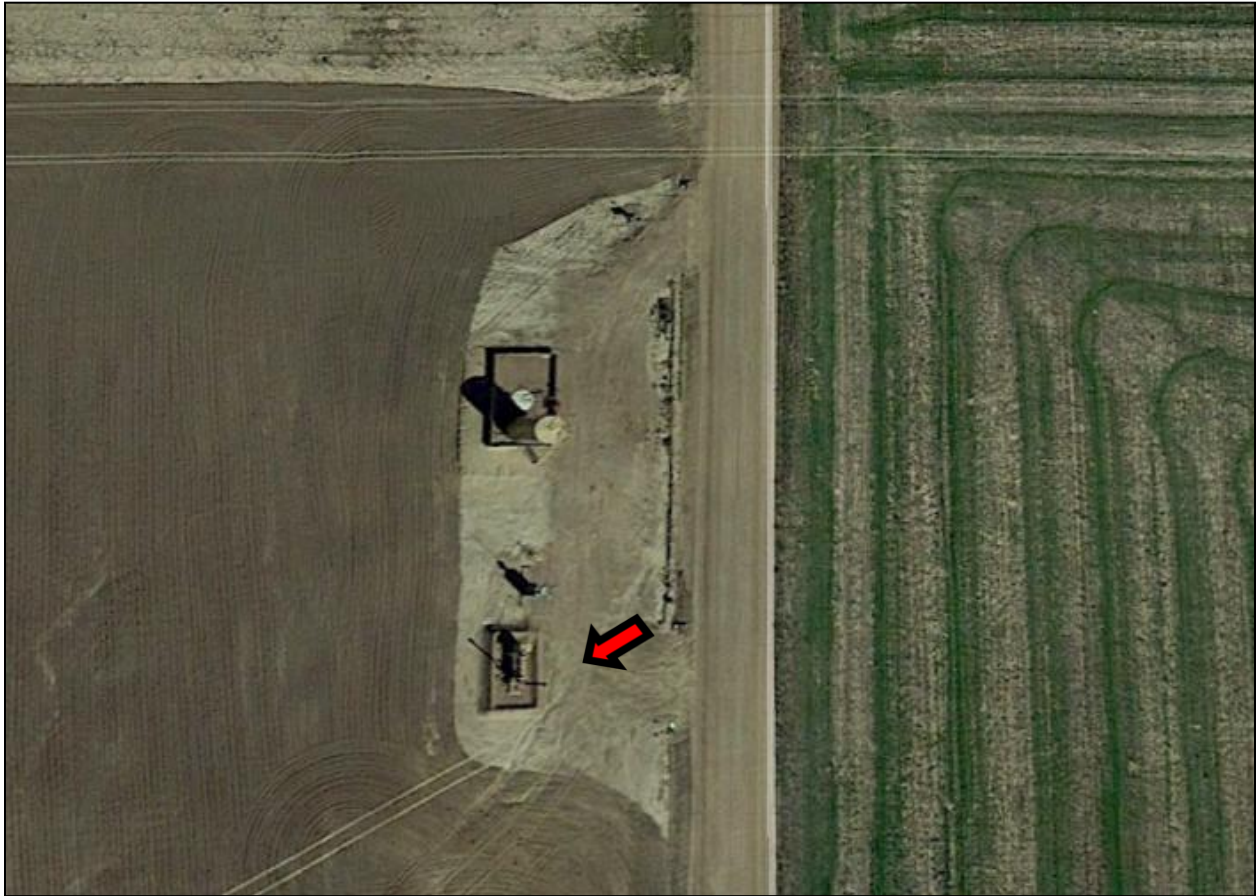
Photo 1: Aerial imagery illustrating erosion and transport of sediment initiates on location, traveling southwest onto cropland. Refer to Document# 682400493 for complete field photos from the 3/8/16 inspection.

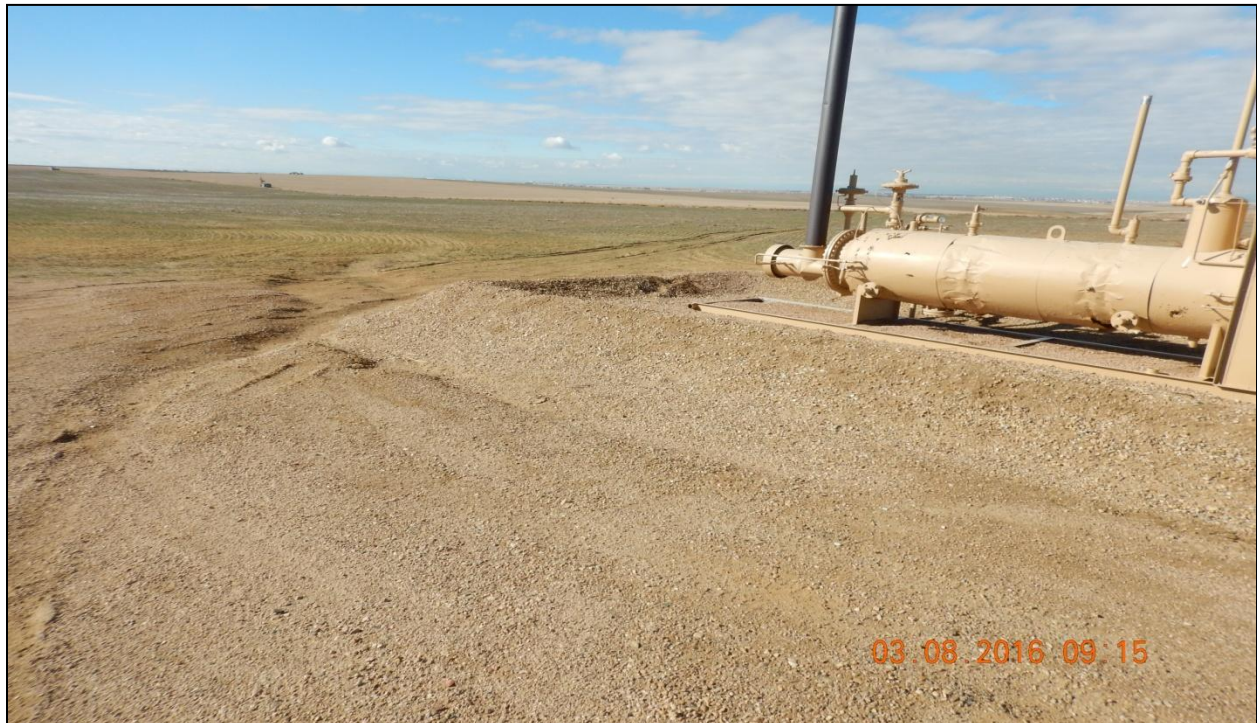
Photo 2: Photo taken 3/8/16 from the southern tank battery location, facing Southwest. Need to control stormwater runoff that minimizes erosion and transport of sediment offsite per Rule 1002.

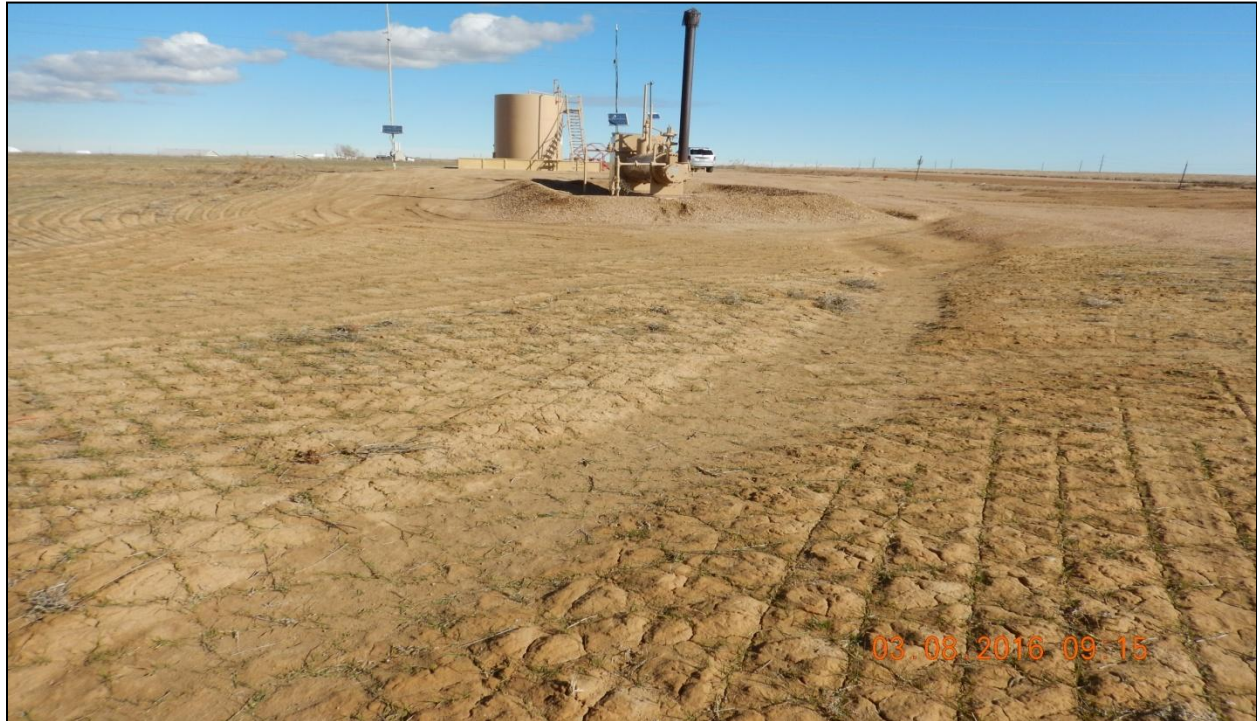
Photo 3: Photo taken 3/8/16 from the southern tank battery location, facing North. Need to control stormwater runoff that minimizes erosion and transport of sediment offsite per Rule 1002.

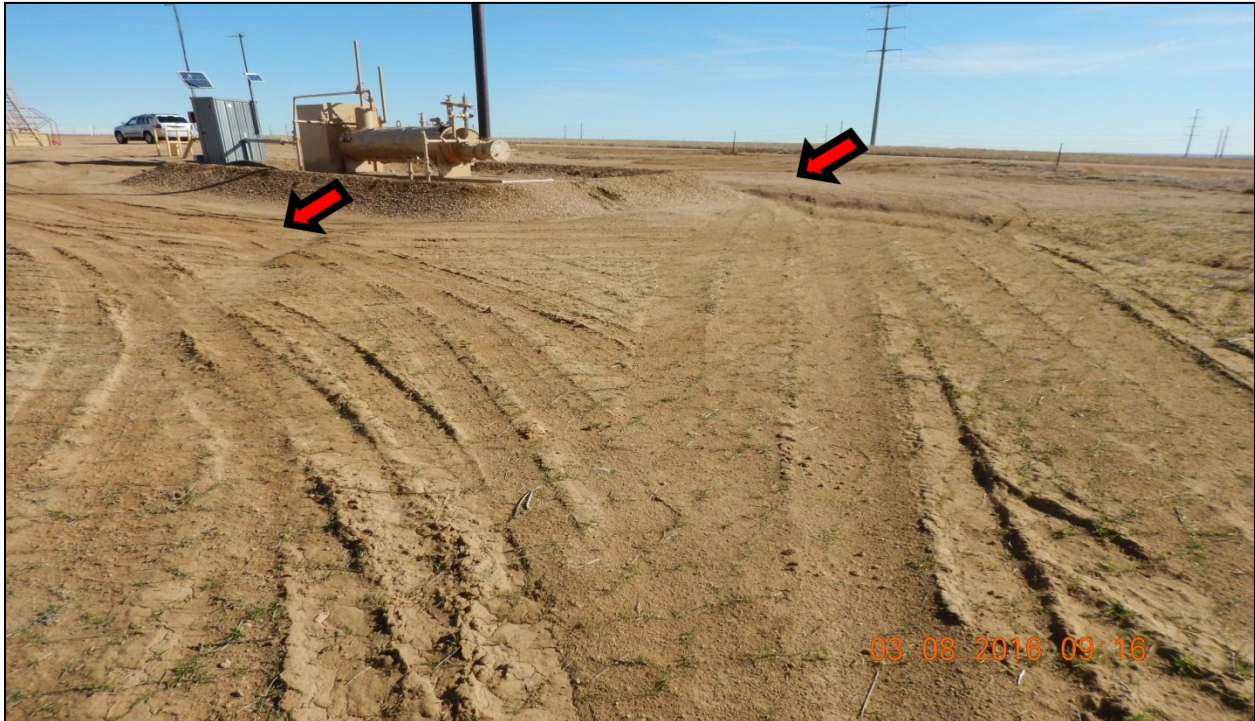
Photo 4: Photo taken 3/8/16 from the southern tank battery location, facing Northeast. Need to control stormwater runoff that minimizes erosion and transport of sediment offsite per Rule 1002.

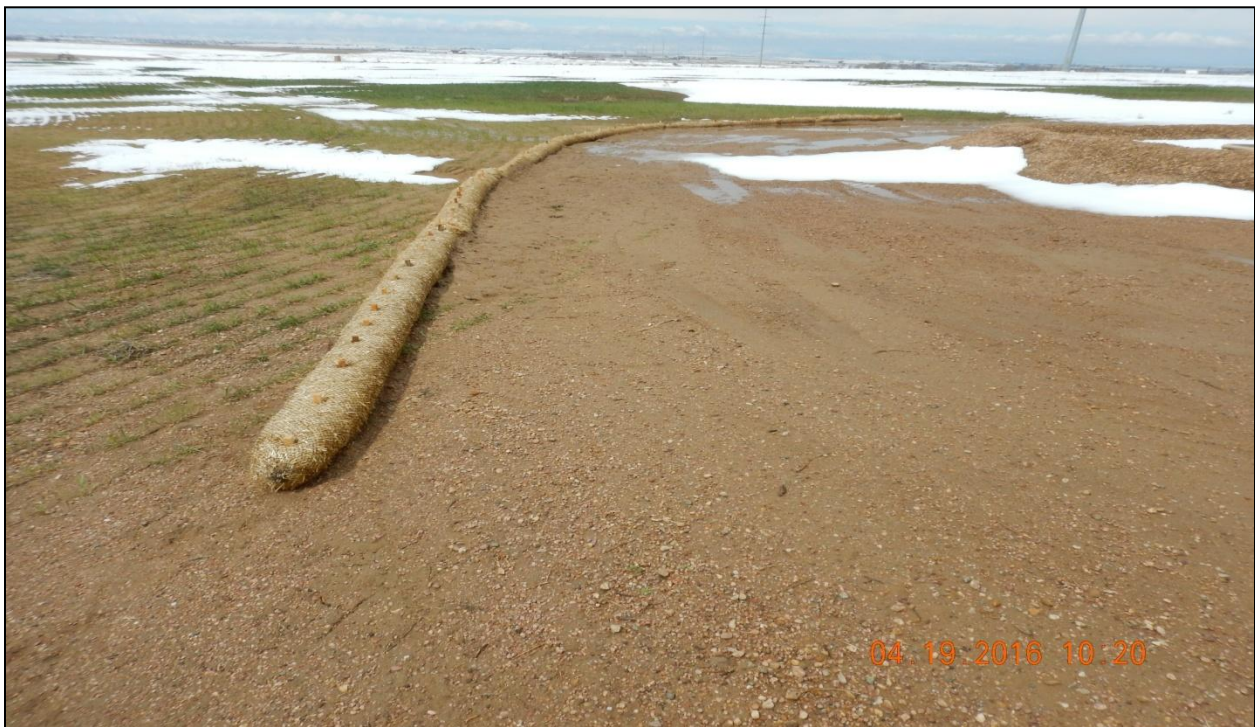
Photo 5: Photo taken 4/19/16 from southern tank battery location, facing West. Installed wattles around south, southwest location. Wattles not properly installed- see following photos.

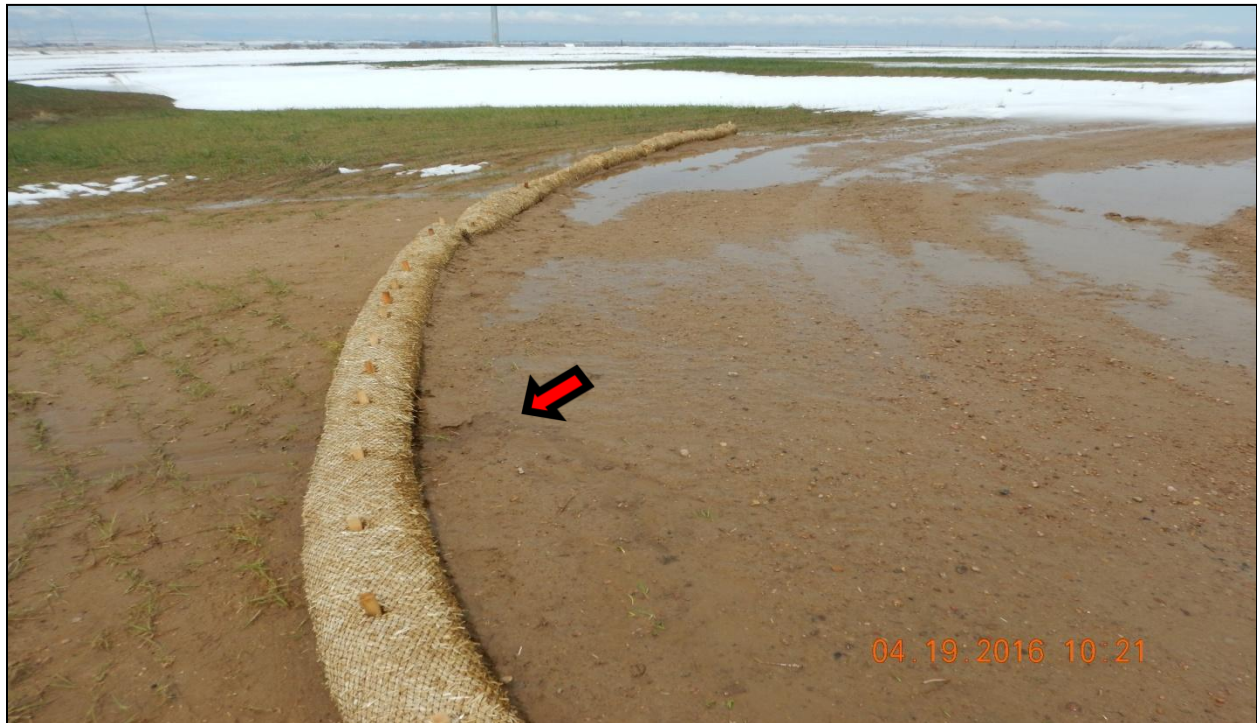
Photo 6: Photo taken 4/19/16 from southern tank battery location, facing West. Installed wattles around south, southwest location. Wattles not properly installed-transport of sediment still occurring.

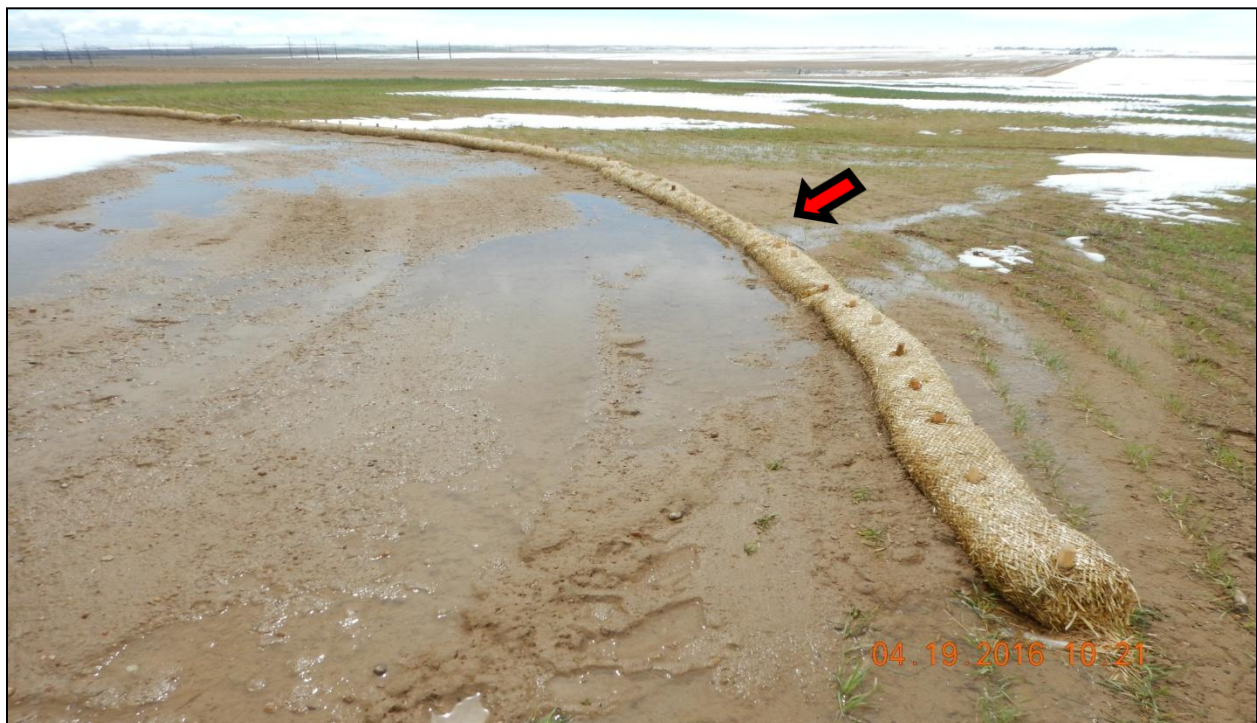
Photo 7: Photo taken 4/19/16 from southwest tank battery location, facing Southeast. Installed wattles around south, southwest location. Wattles not properly installed-transport of sediment still occurring.
