Final Reclamation Inspection

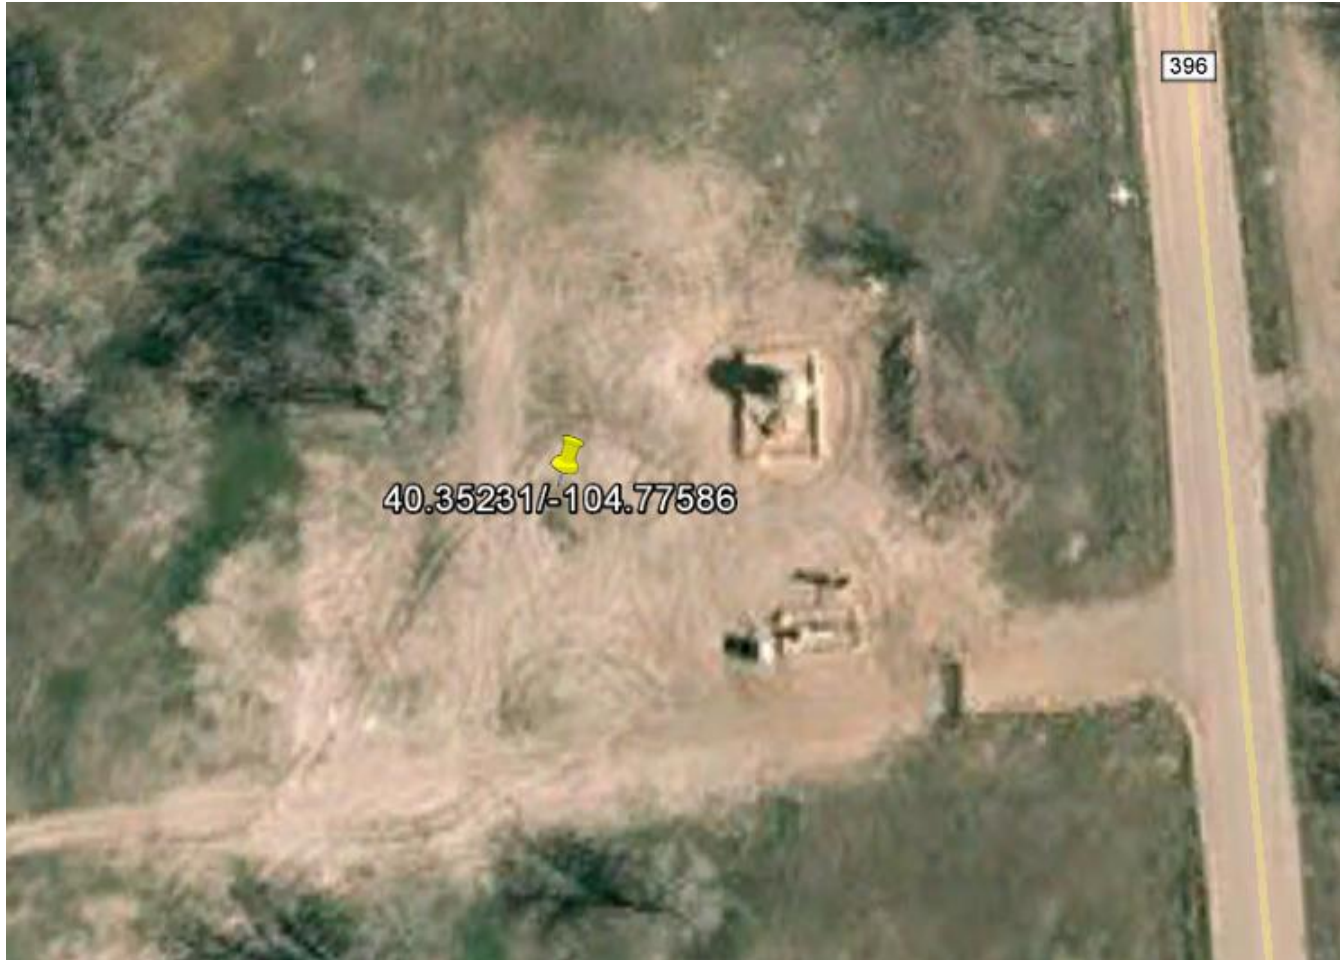
Photo 1. Google Earth aerial imagery taken 2/29/2008 of the total disturbance.

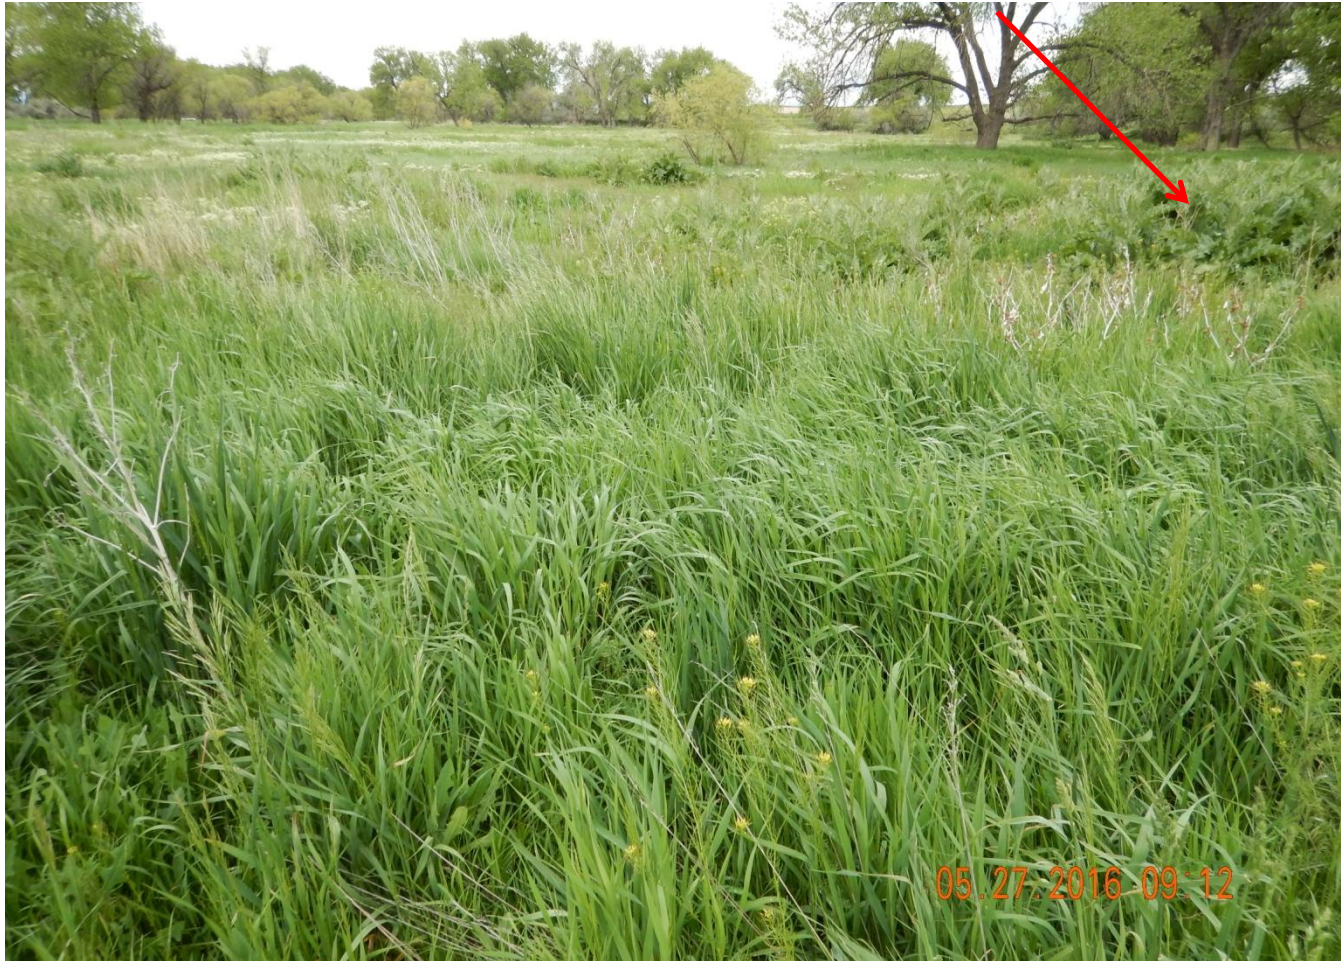
Photo 2. Photo taken from center of location, facing West. Need to reclaim well location per Rule 1004. Location has 3 List B Colorado Noxious weeds.

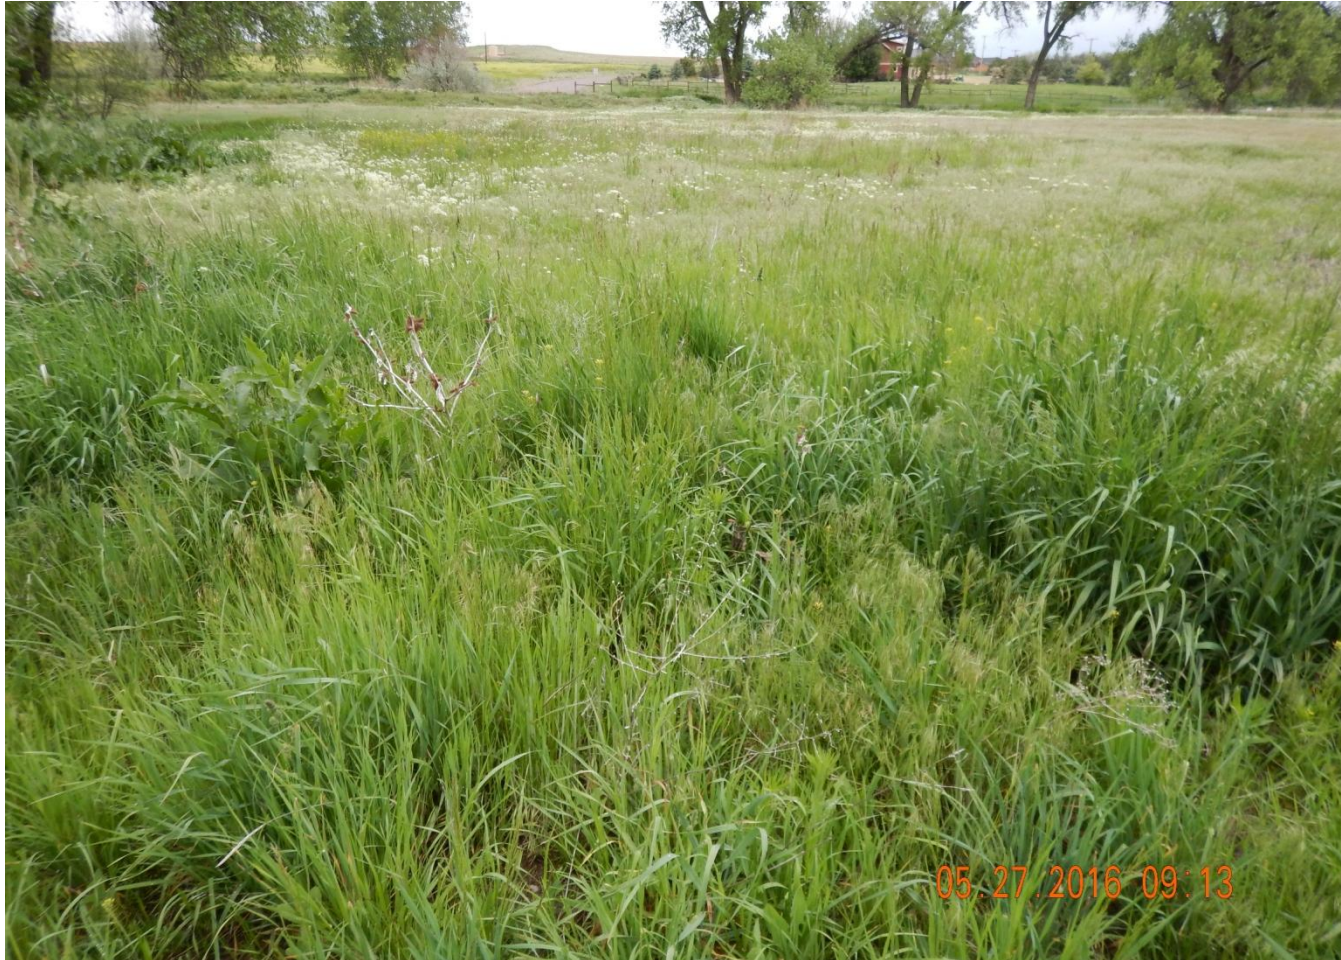
Photo 3. Photo taken from center of location, facing North. Need to reclaim well location per Rule 1004. Location has 3 List B Colorado Noxious weeds.

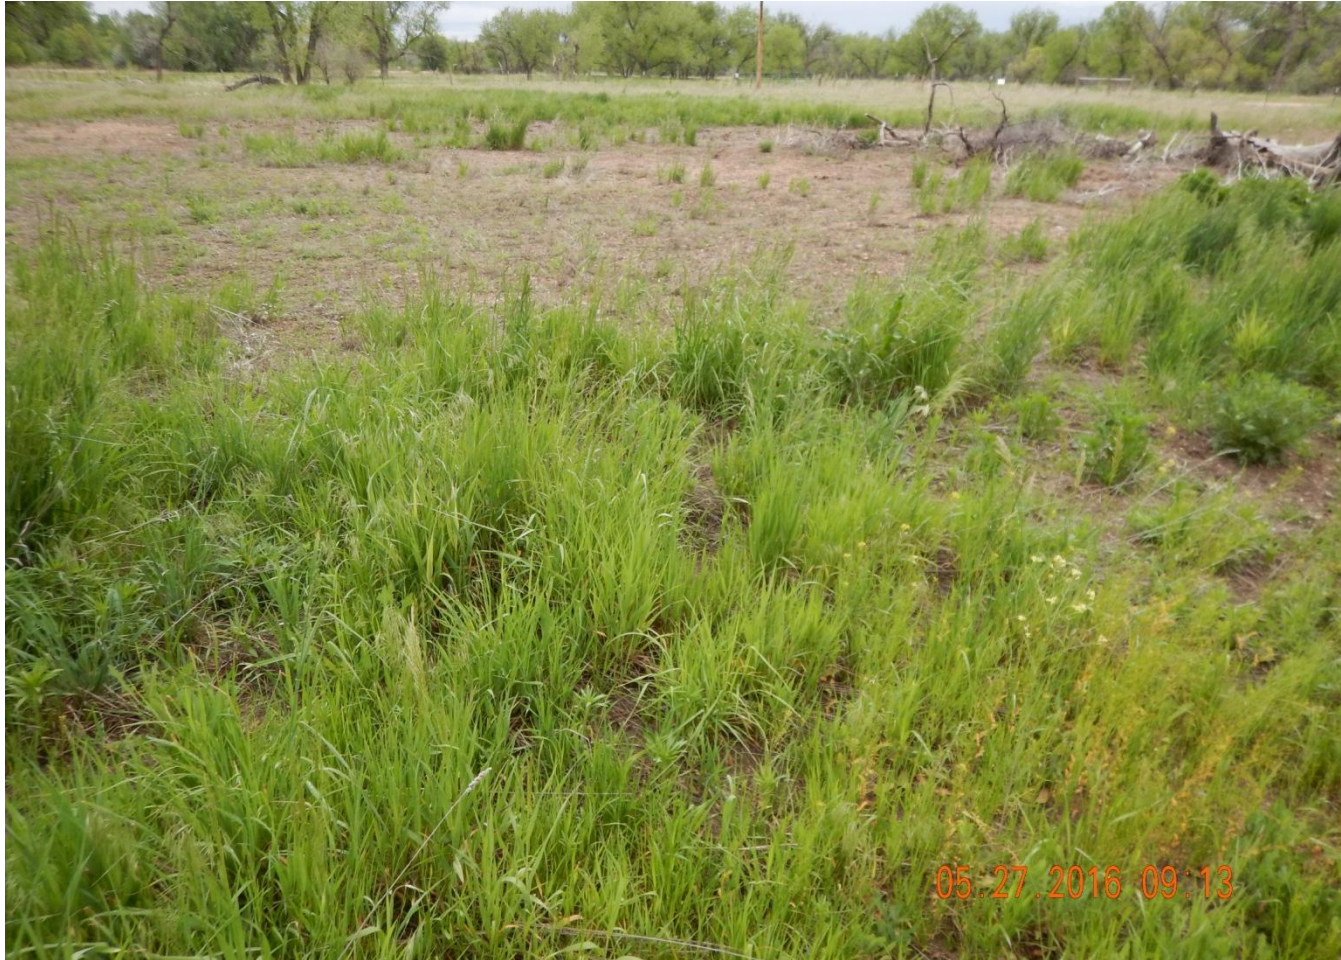
Photo 4. Photo taken from center of location, facing East. Need to reclaim well location per Rule 1004. Location has 3 List B Colorado Noxious weeds.

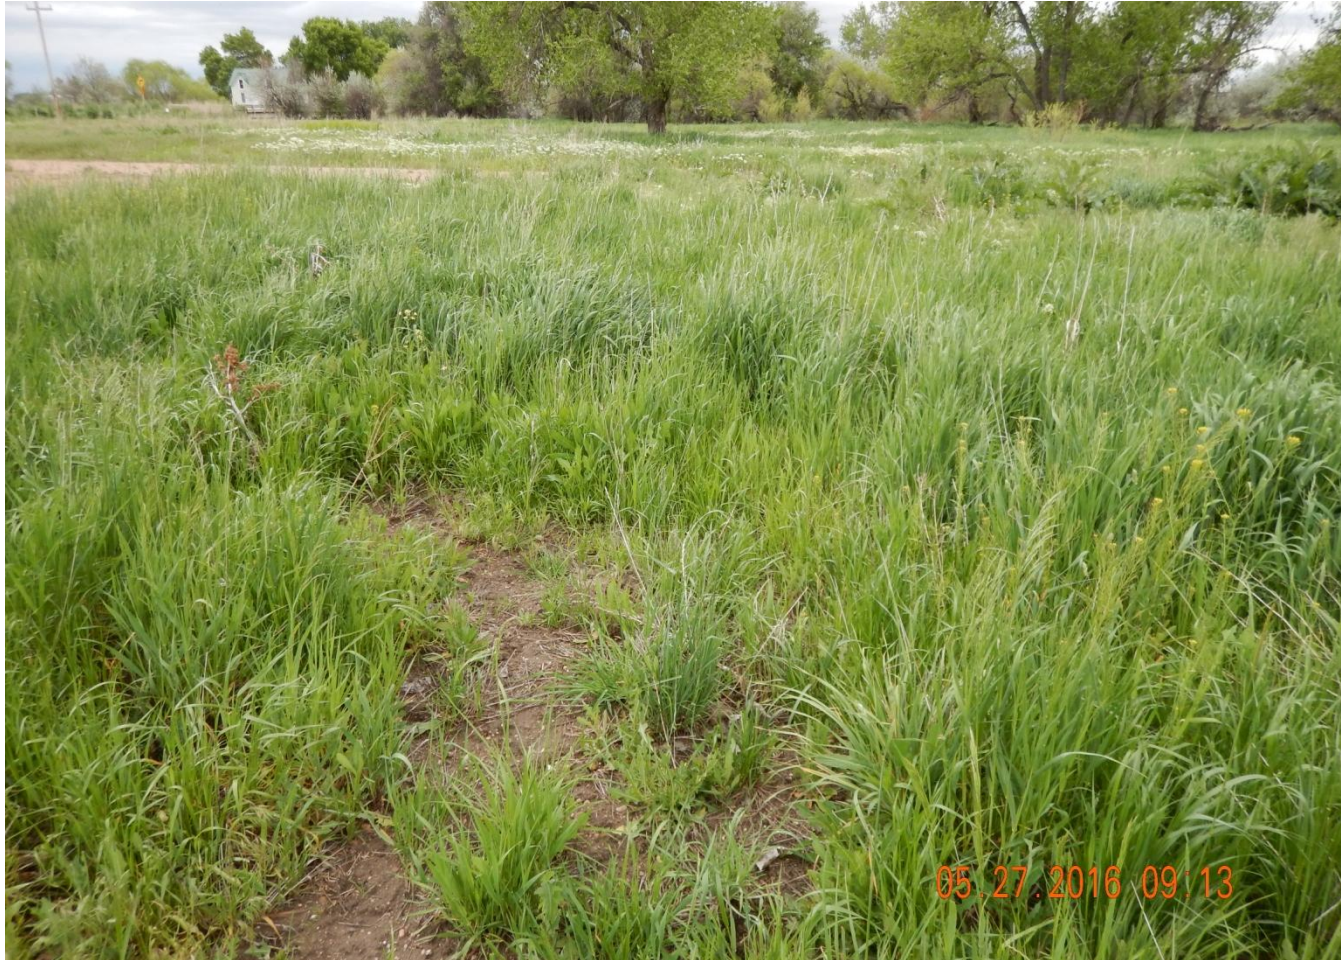
Photo 5. Photo taken from center of location, facing South. Need to reclaim well location per Rule 1004. Location has 3 List B Colorado Noxious weeds.

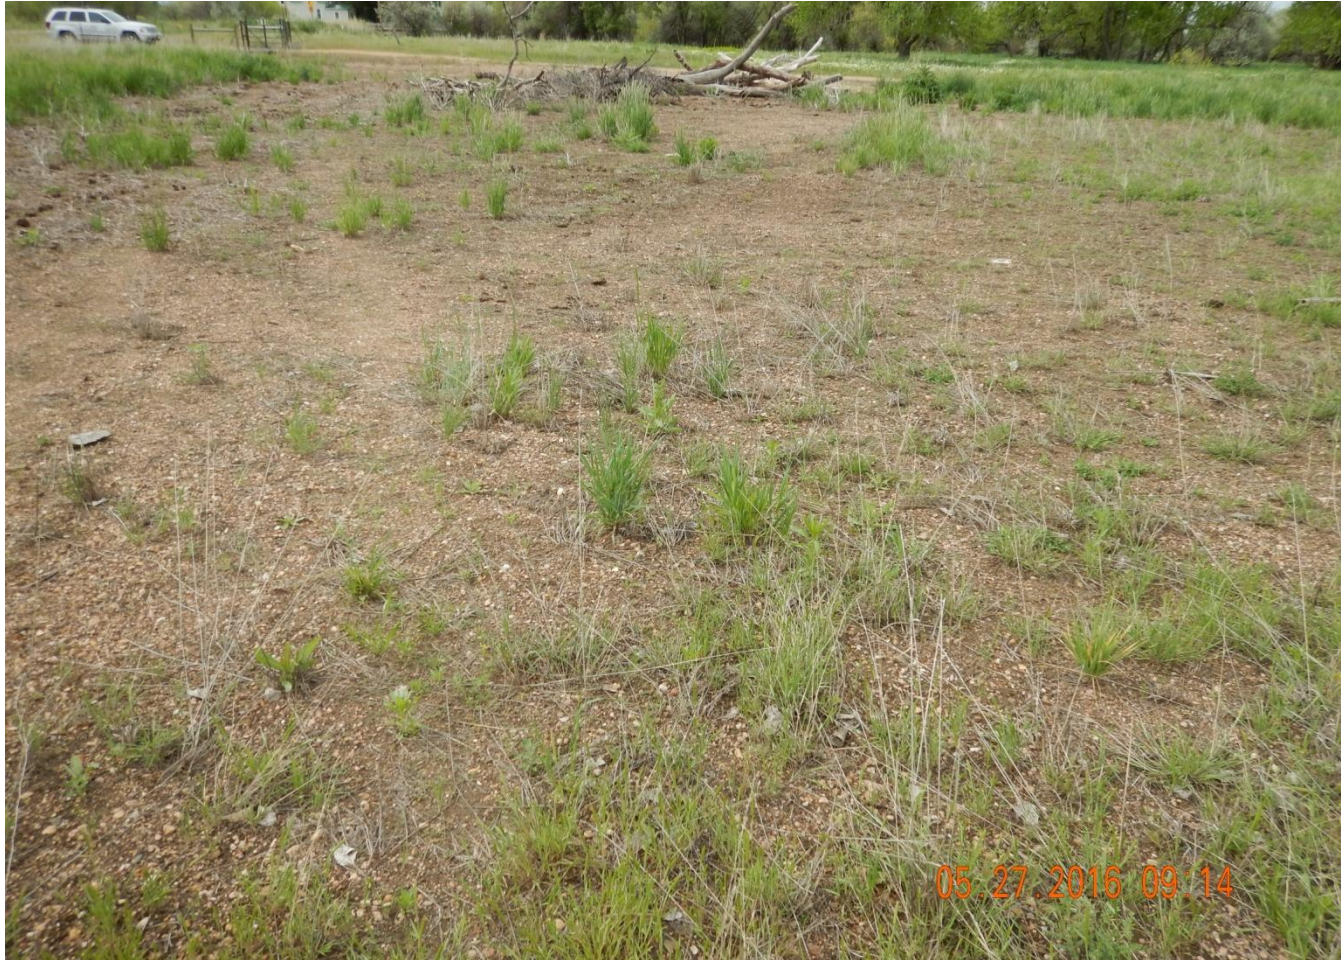
Photo 6. Photo taken from eastern location, facing South. Need to reclaim well location per Rule 1004. It appears the location was never cross-ripped to alleviate compaction because little to no vegetative growth is establishing.

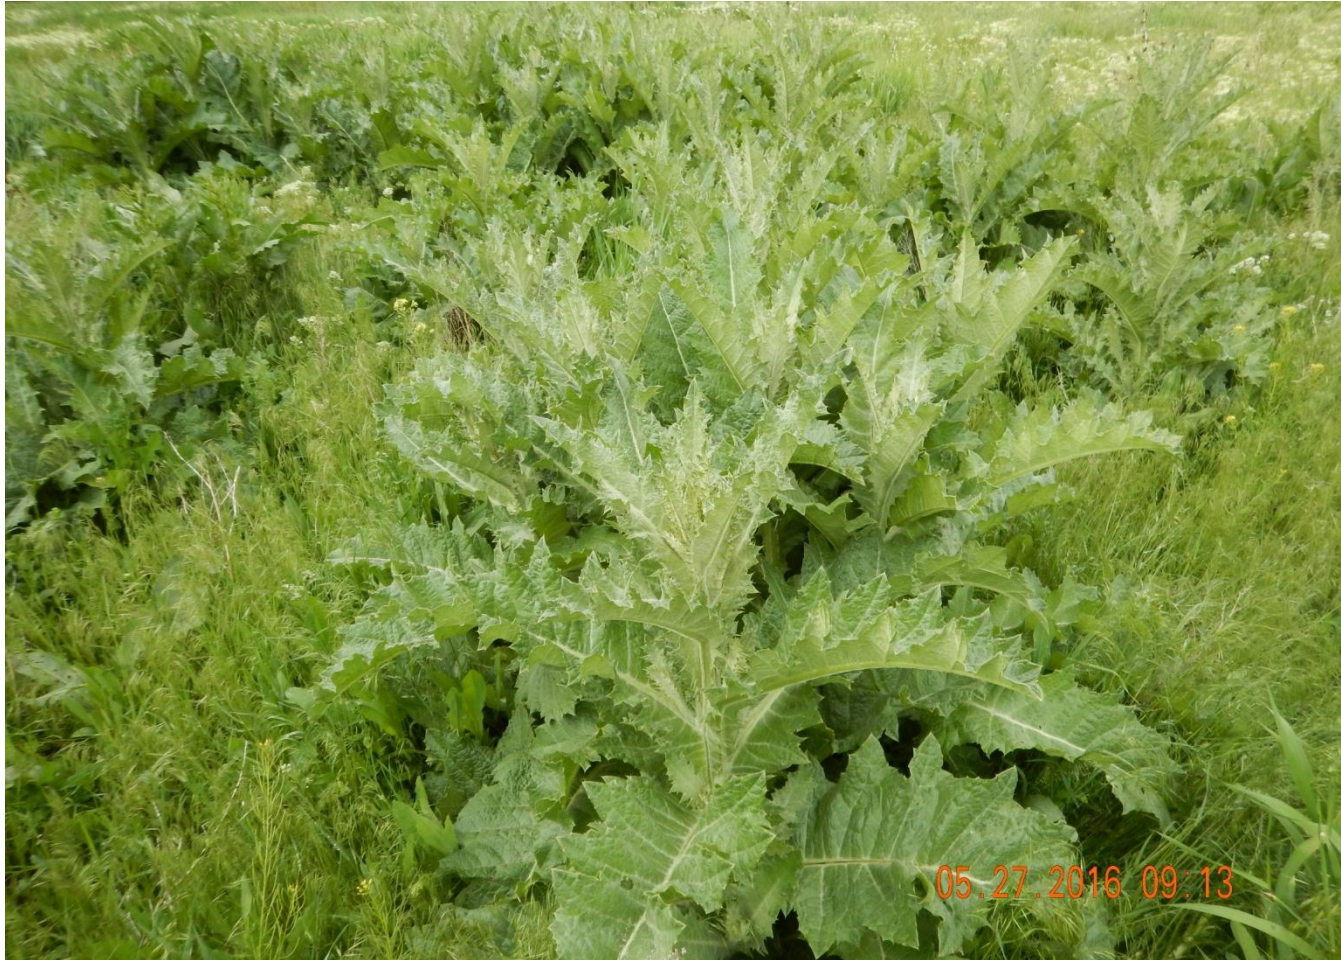
Photo 7. Photo taken of a List B Colorado Noxious weed species, Scotch thistle (*Onopordum* sp.).

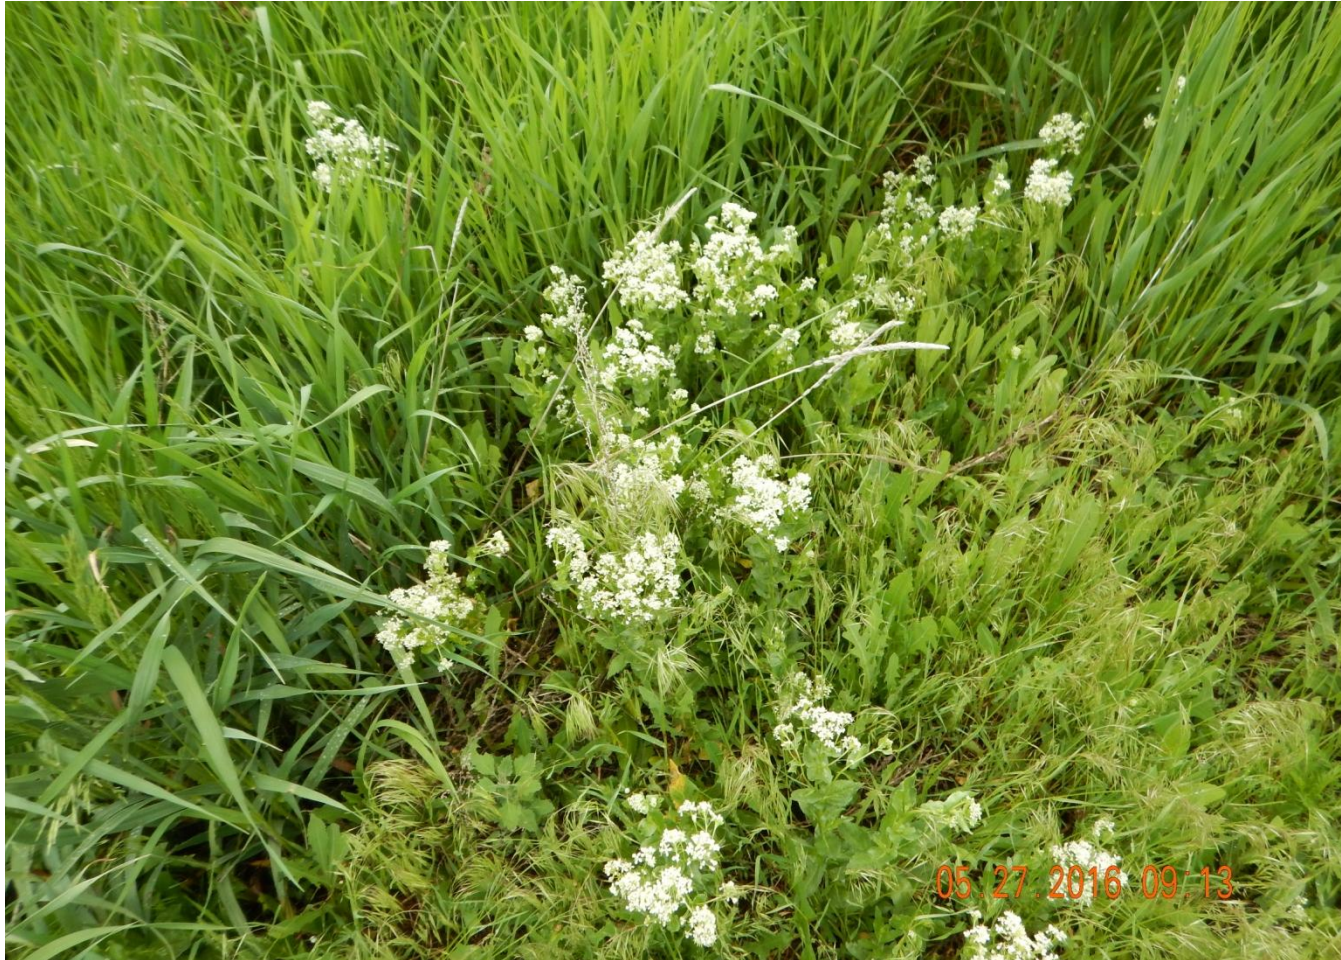
Photo 8. Photo taken of a List B Colorado Noxious weed species, Hoary cress (*Cardaria draba*)

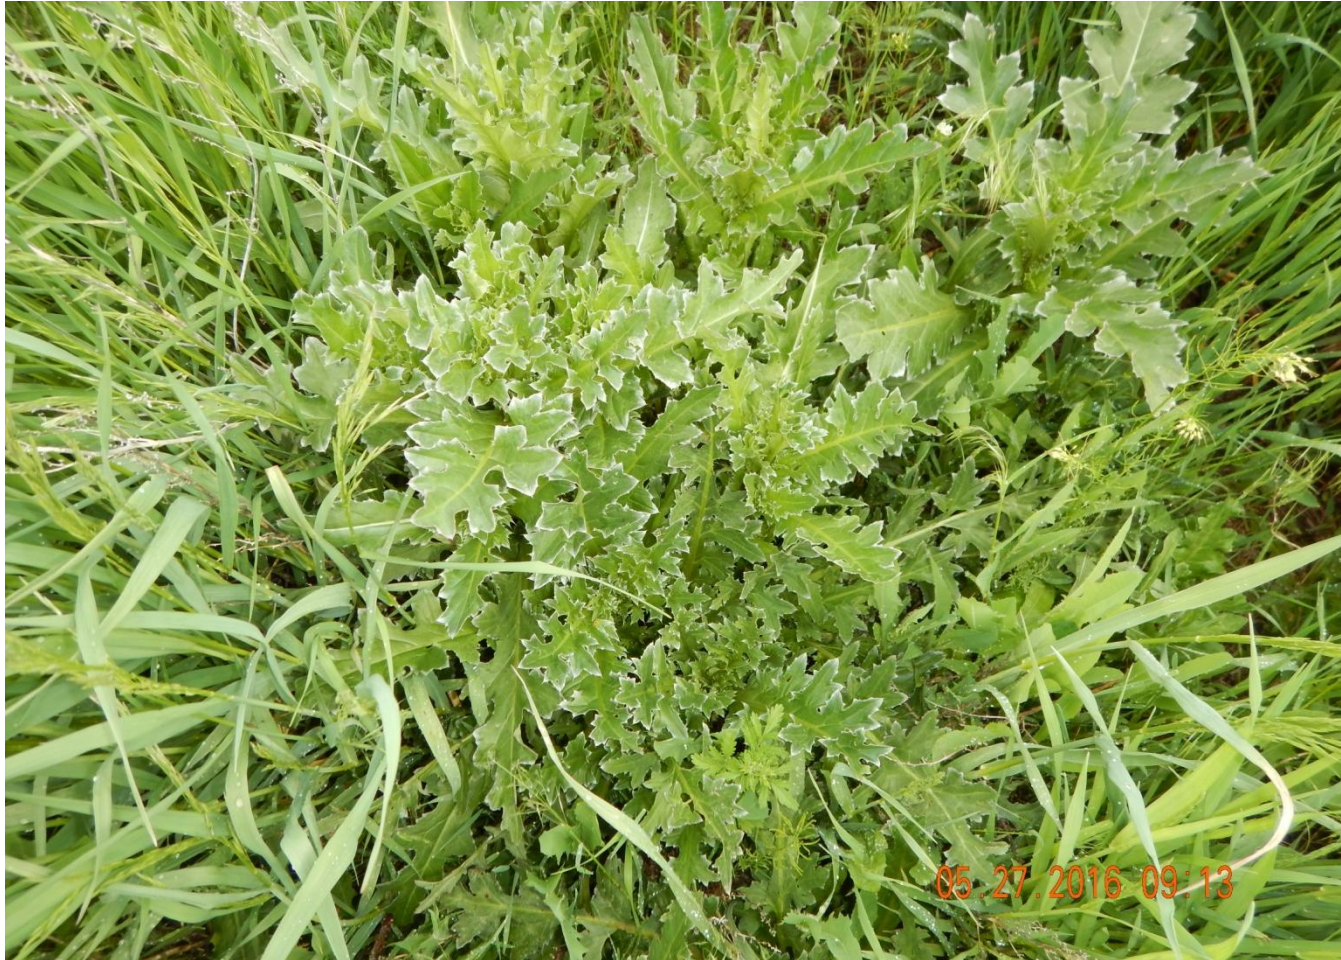
Photo 9. Photo taken of a List B Colorado Noxious weed species, Musk thistle (*Carduus nutans*).
