Final Reclamation Inspection

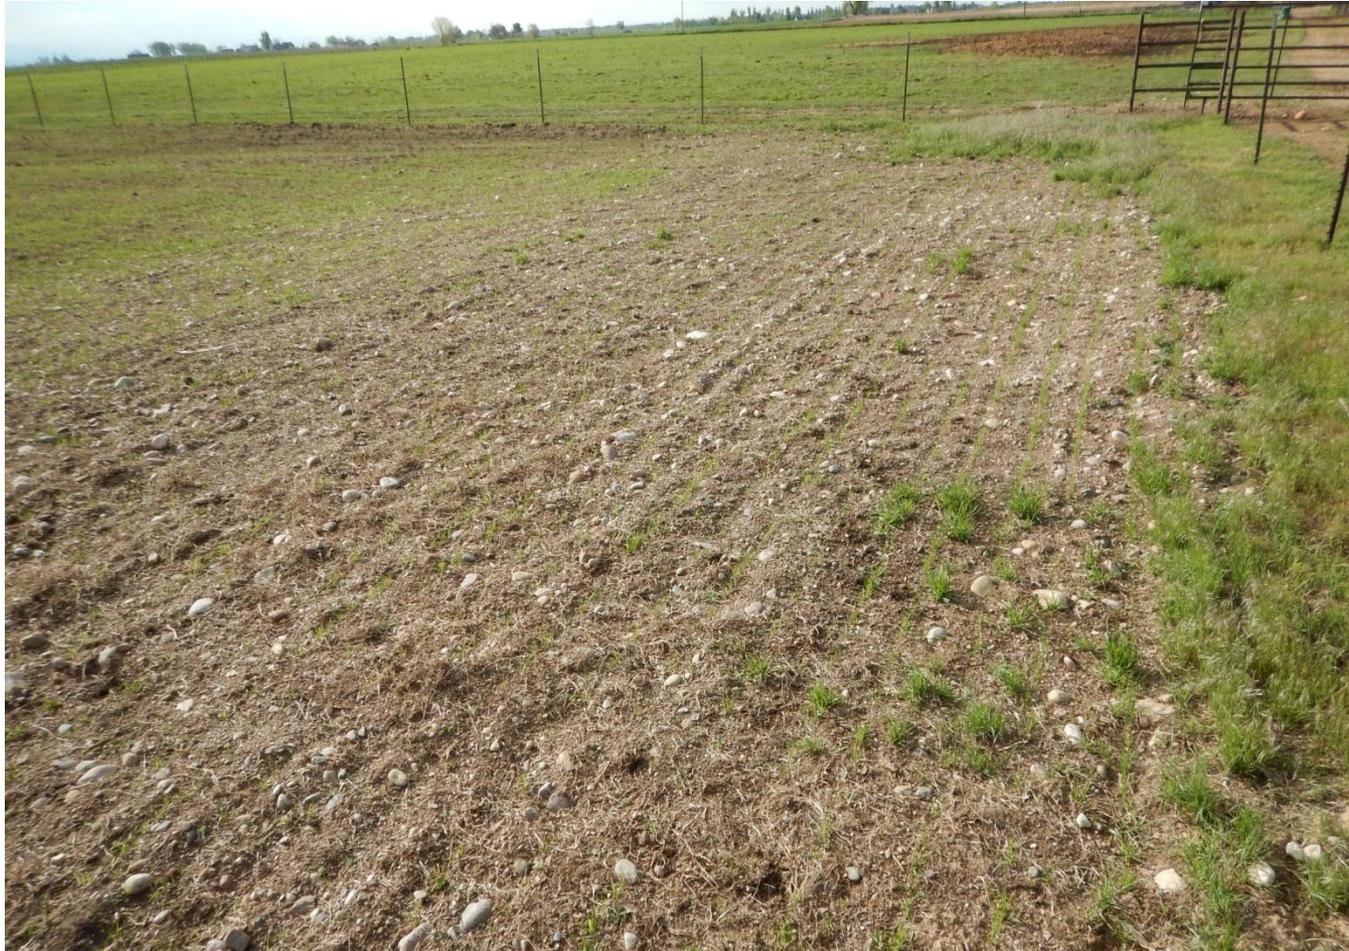
Photo 1. Photo taken from center of the location, facing Northwest. Gravel was not removed per Rule 1004, which is negatively affecting plant growth.

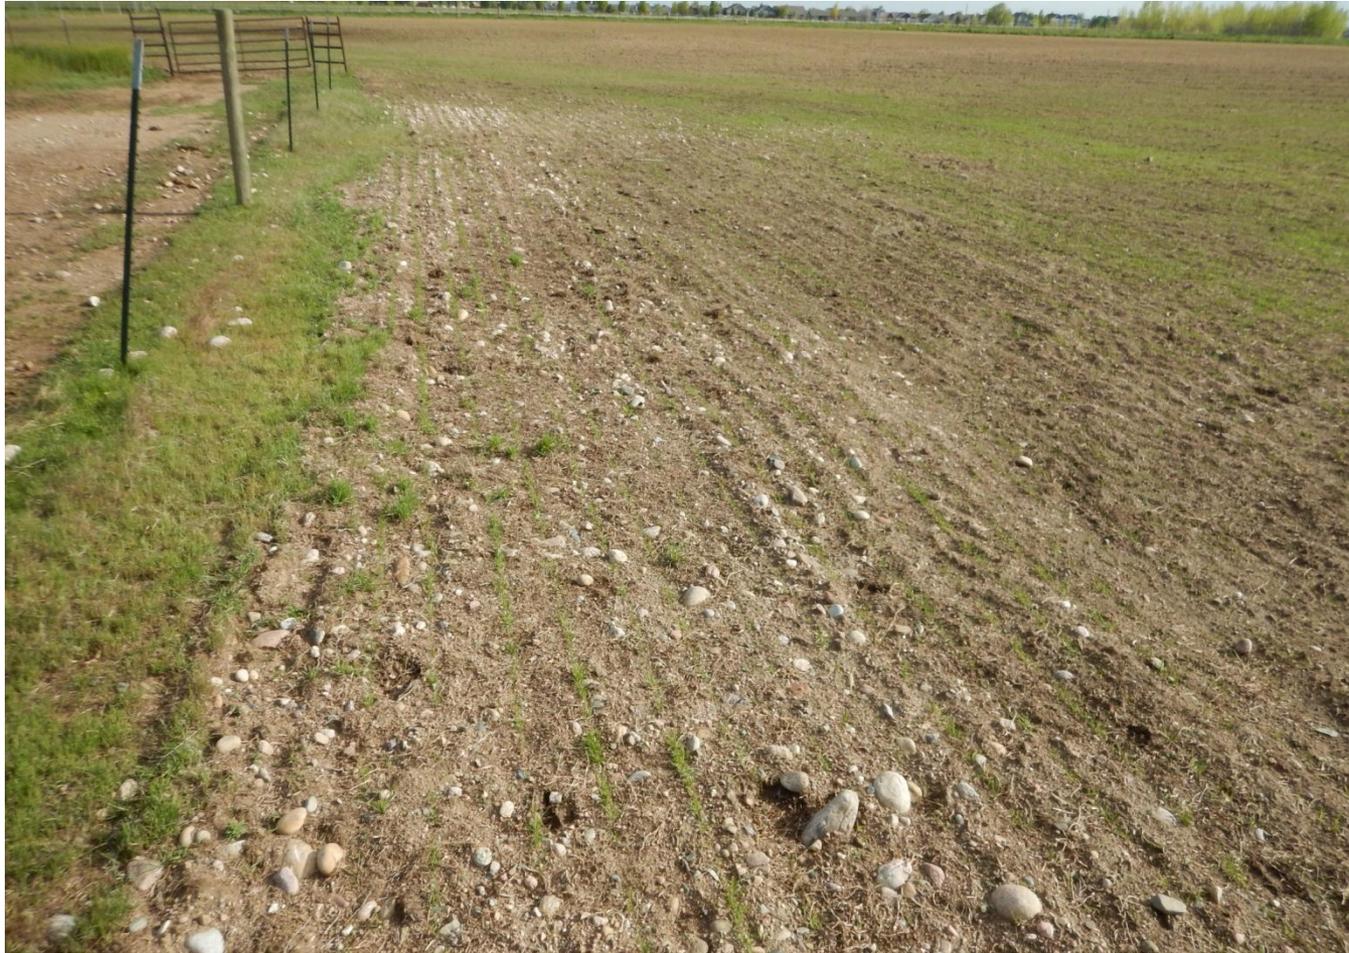
Photo 2. Photo taken from center of the location, facing Southwest. Gravel was not removed per Rule 1004, which is negatively affecting plant growth.

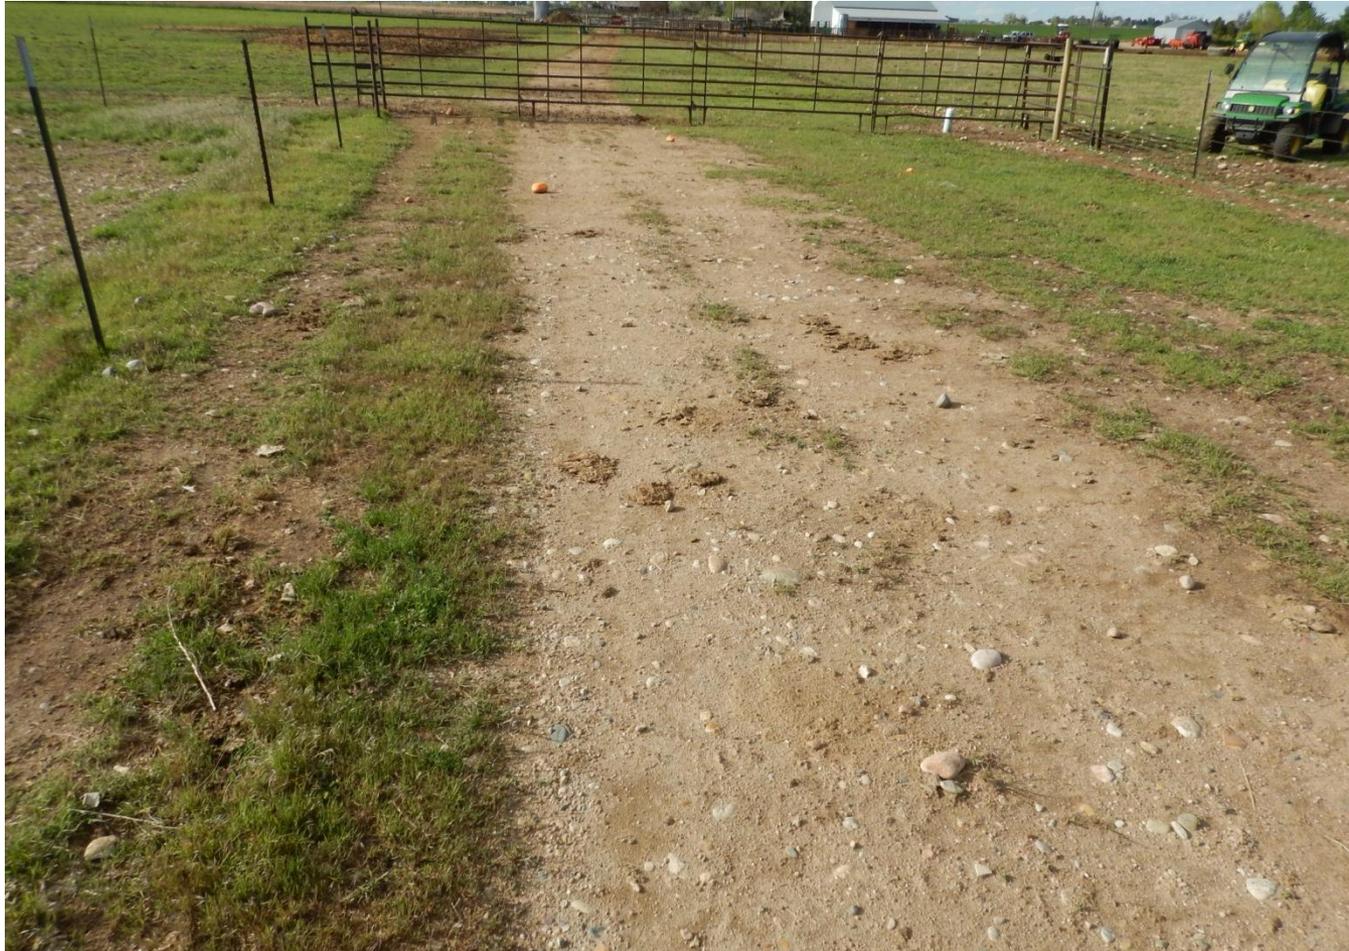
Photo 3. Photo taken from center of the location, facing North. Gravel was not removed per Rule 1004.

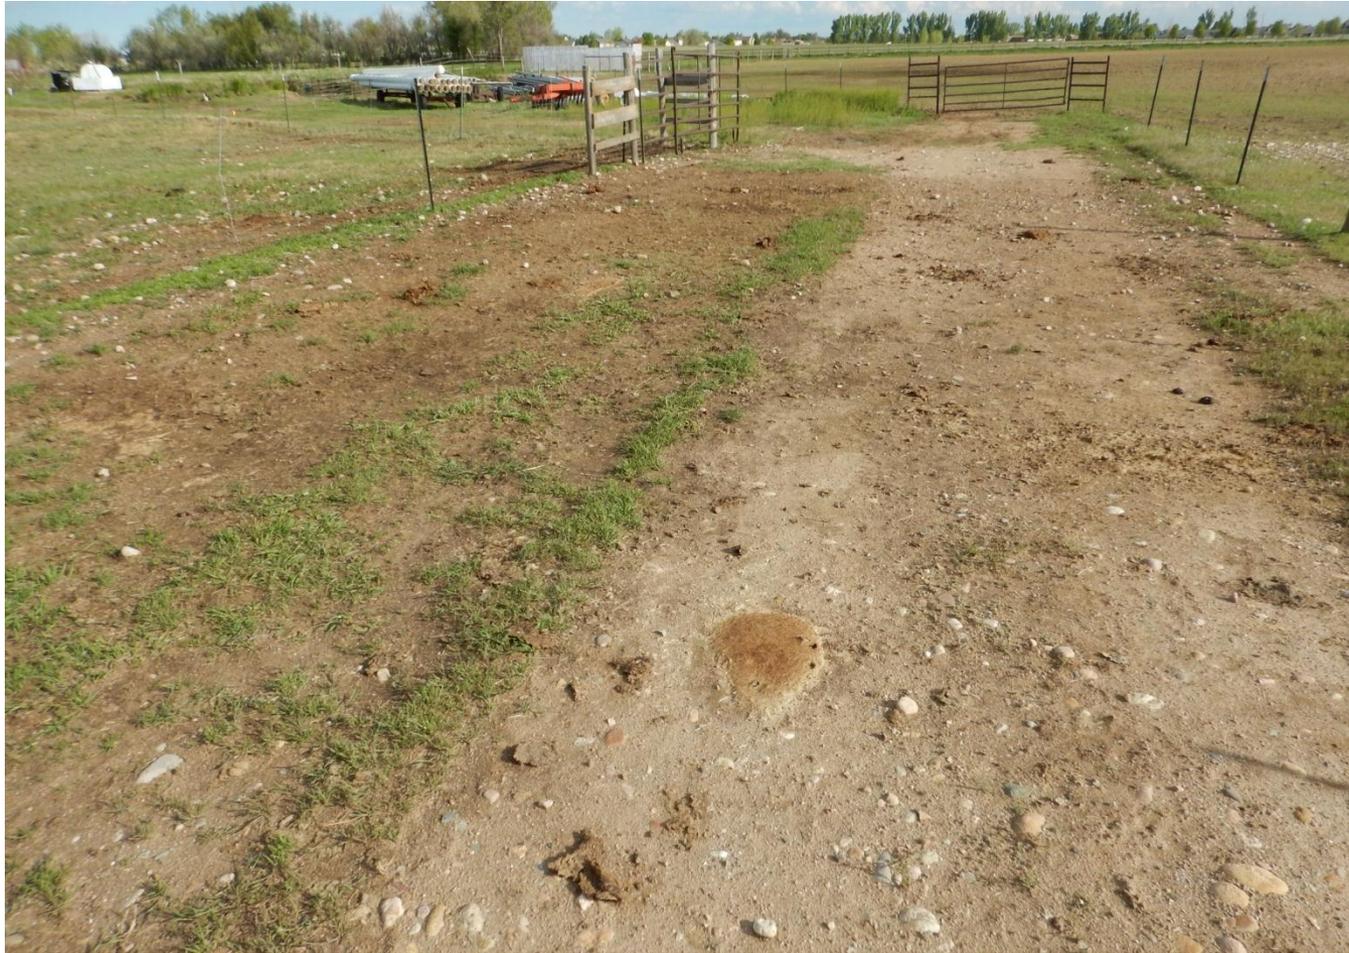
Photo 4. Photo taken from center of the location, facing South. Gravel was not removed per Rule 1004.
