**Re: Sump Replacement Summary Letter Report
HSR-Cannon-62N66W3NESE (HSR Cannon 9-3A)
API: 05-123-20134
Facility ID: 331088
Legal: NESE Sec 3-T2N-R66W
Remediation Project #8961**

Kerr-McGee Oil and Gas Onshore, LP
HSR-Cannon-62N66W3NESE (HSR Cannon 9-3A)
NESE, Section 3, Township 2 North, Range 66 West
Weld County, Colorado

Sample Location
Map

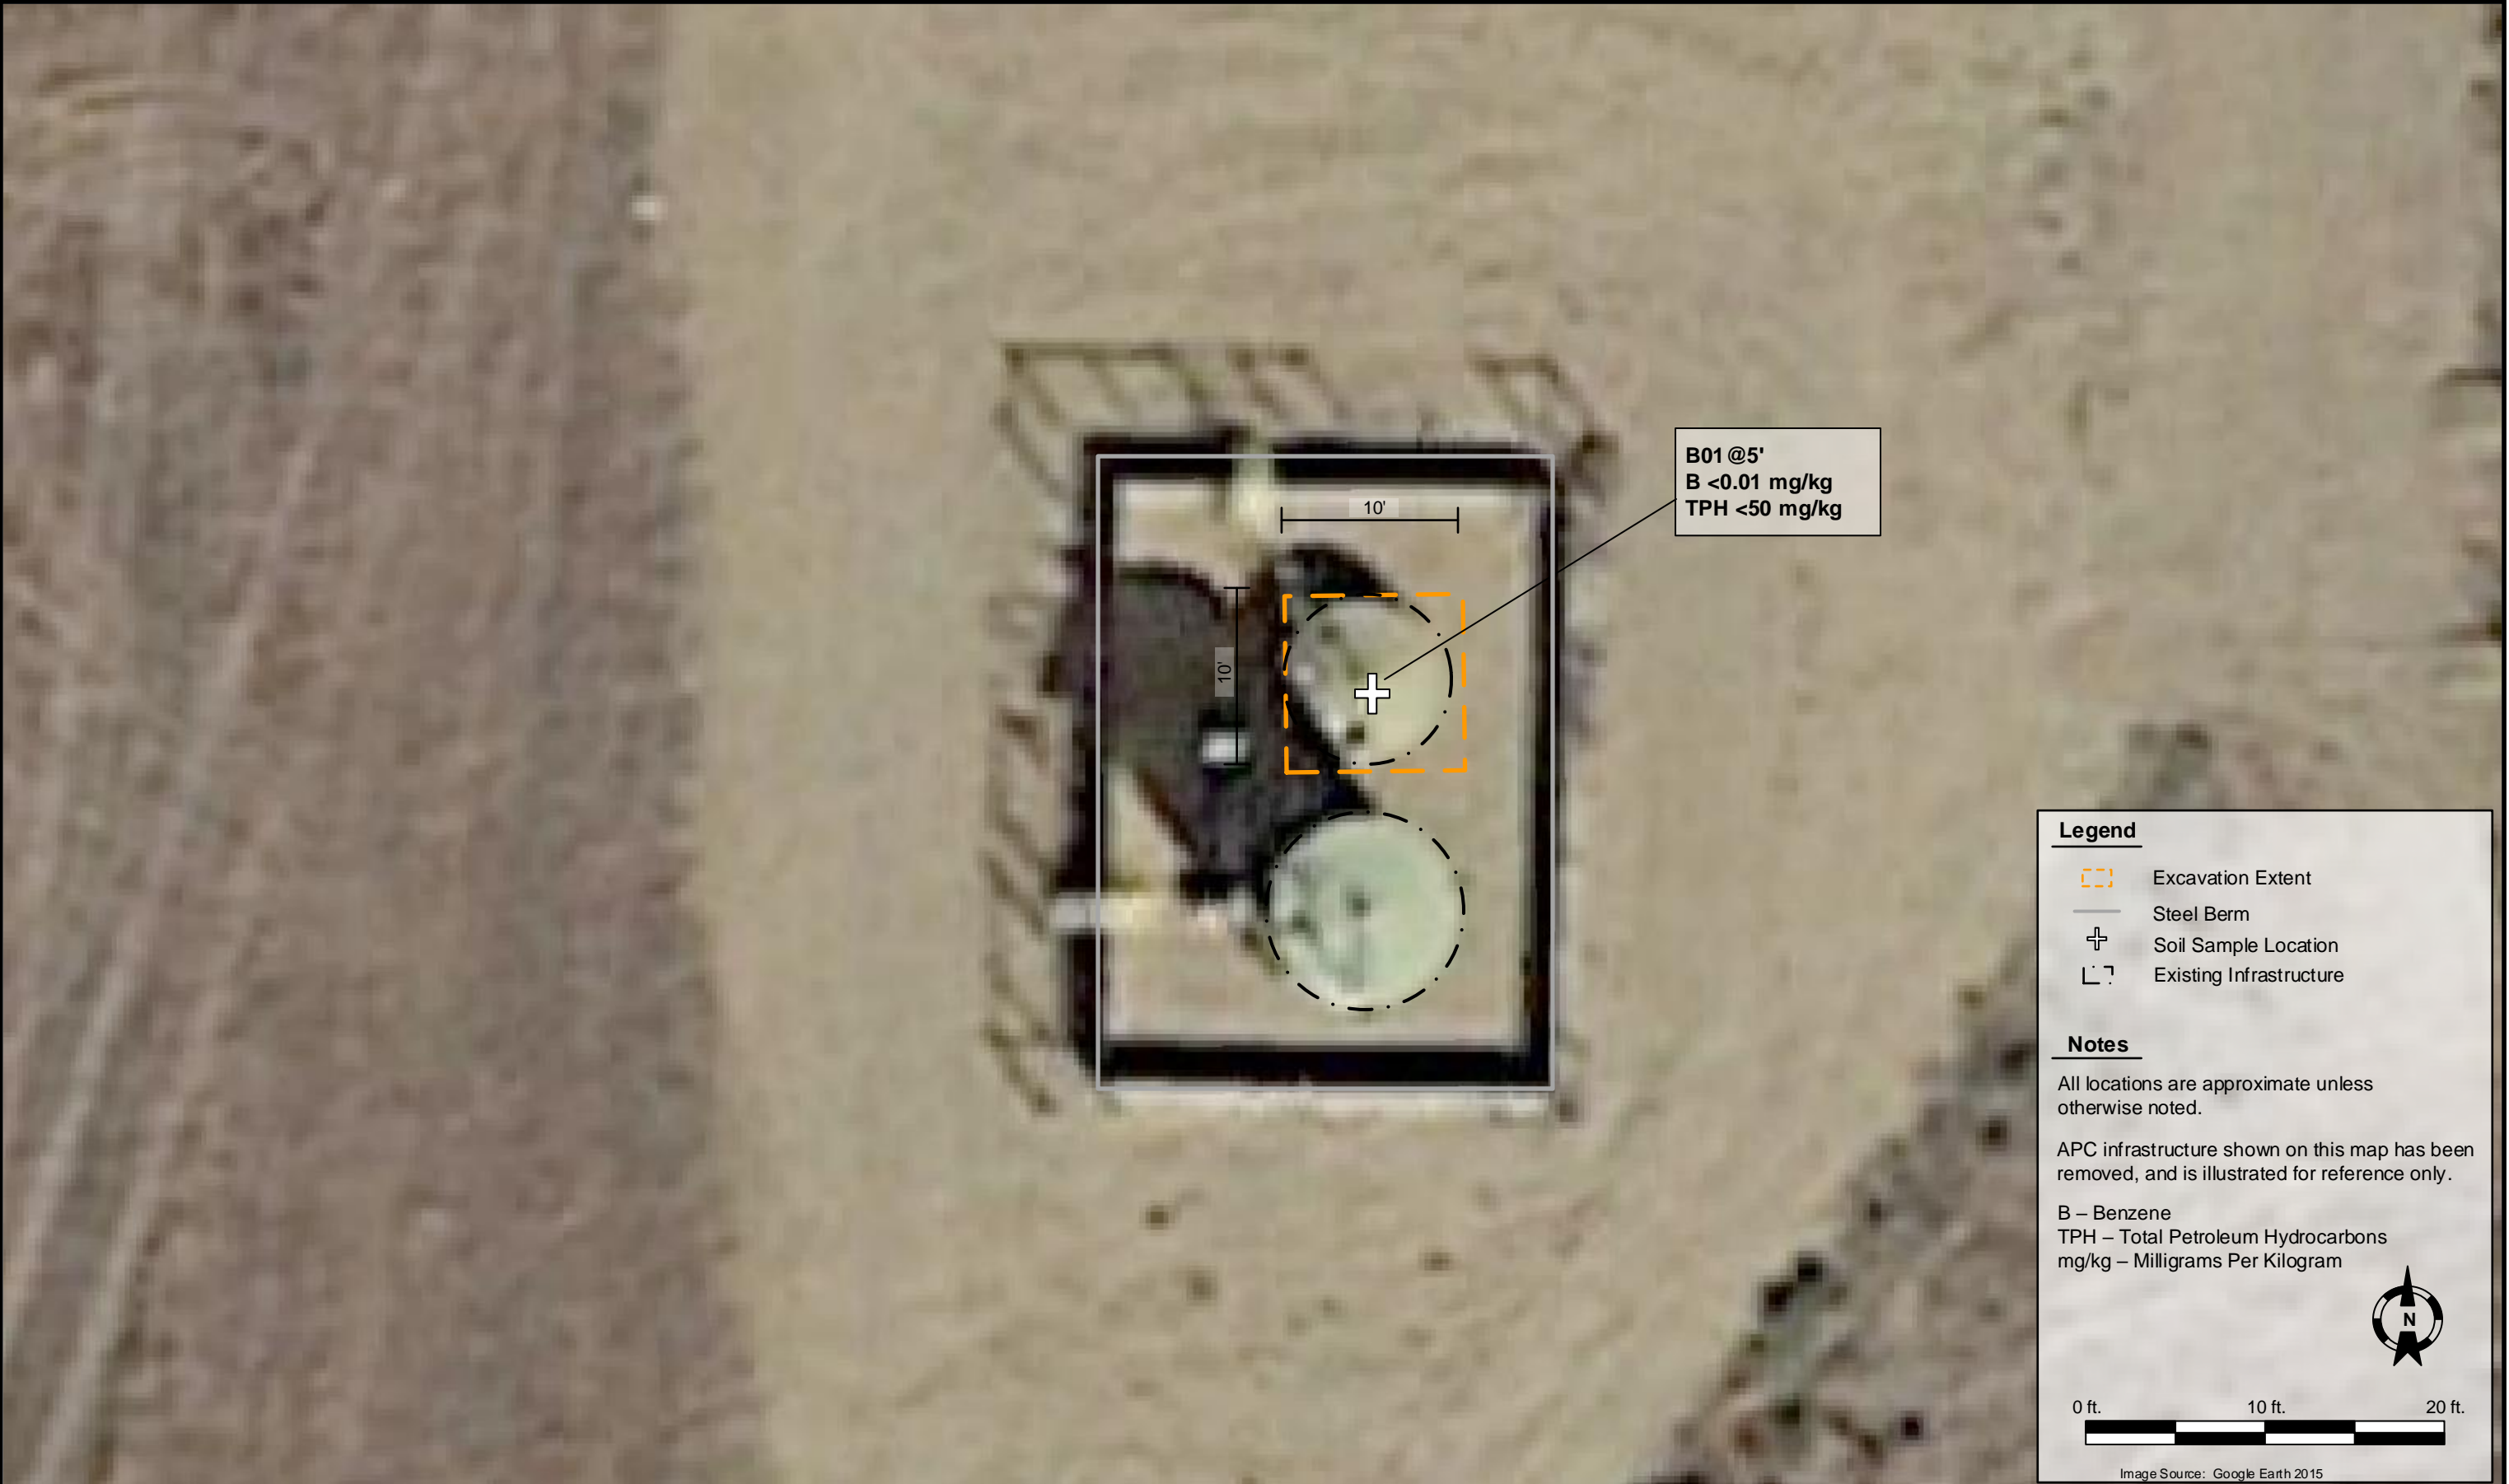
FIGURE
1

The field activities described herein were performed with the purpose of assessing potential hydrocarbon impacts at the site related to the replacement of the produced water sump on June 30, 2014. Soil sampling activities, laboratory analytical results, and conclusions are presented below. The general site layout and sample locations are provided in the attached site map (Attachment A).

The final extent of the excavation measured approximately 10 feet by 10 feet with an approximate depth of 5 feet below ground surface (bgs). No impacted material was removed during the replacement of the produced water sump at this location. A liner was not present at the location and groundwater was not encountered in the excavation.

Confirmation soil samples were collected from the base and sidewalls of the excavation area at approximately 5 feet and 3 feet bgs, respectively. Soil samples were field screened for volatile organic compound (VOC) concentrations using a photoionization detector (PID). The confirmation soil sample collected from the base of the excavation area was submitted to eAnalytics Laboratory in Loveland, Colorado, for analysis of benzene, toluene, ethylbenzene, total xylenes (BTEX), total petroleum hydrocarbons (TPH) – gasoline range organics (GRO) by

Analytical results described herein confirm BTEX and TPH impacts are not present at concentrations above applicable regulatory standards in the former sump location. Consequently, no further site assessment or remedial activity is recommended at this time. Following site assessment activities, the produced water sump was replaced and the excavation area was backfilled and contoured to match pre-existing site conditions. The production facility remains operational.
