Final Reclamation Inspection

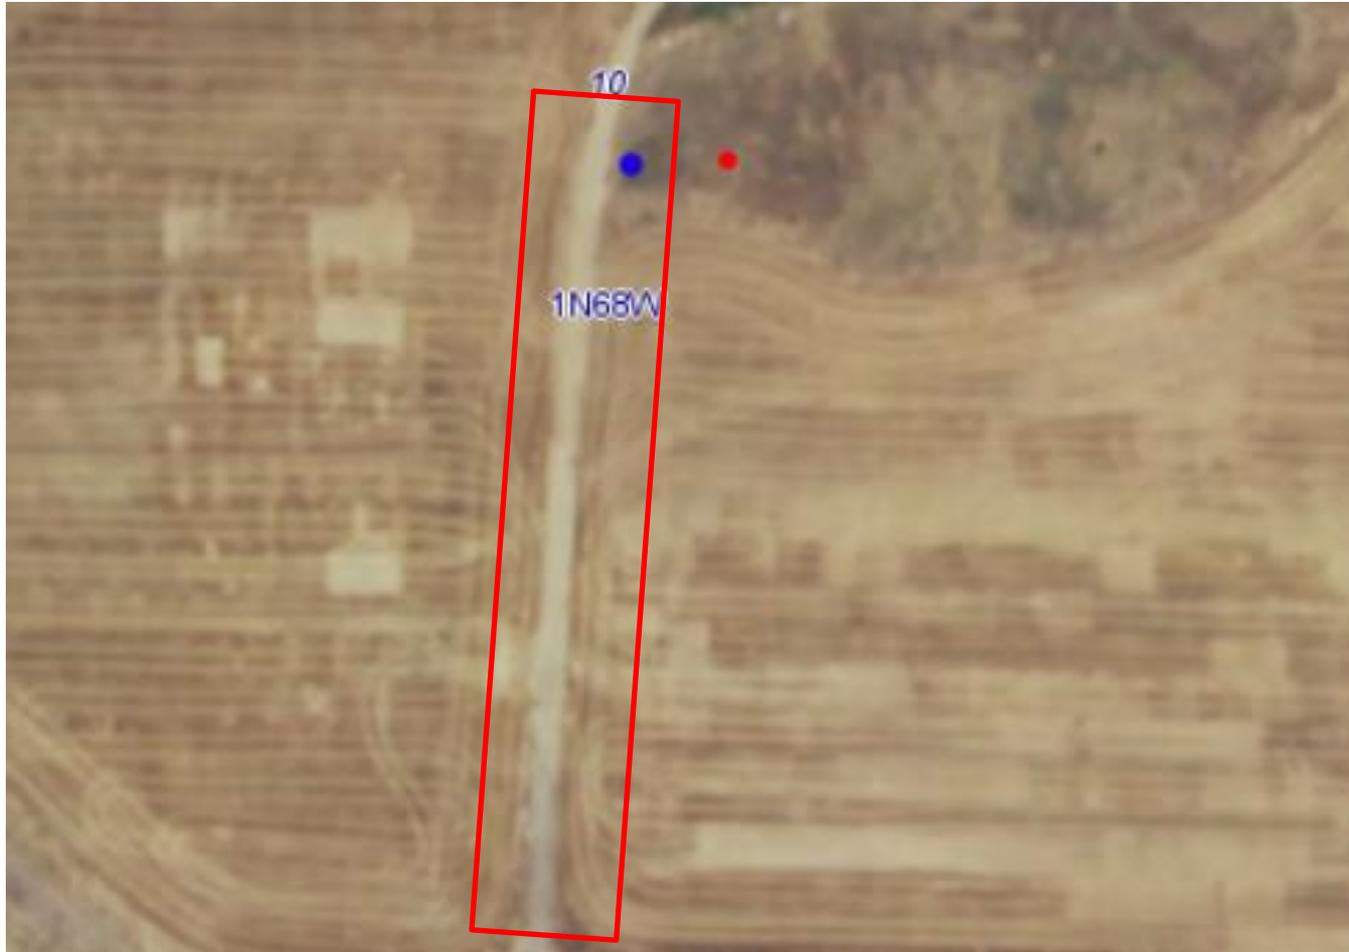
Photo 1. Aerial imagery from 2015 using COGCC GISOnline. Access road still remains after a corrective action inspection from 2013 was issued.

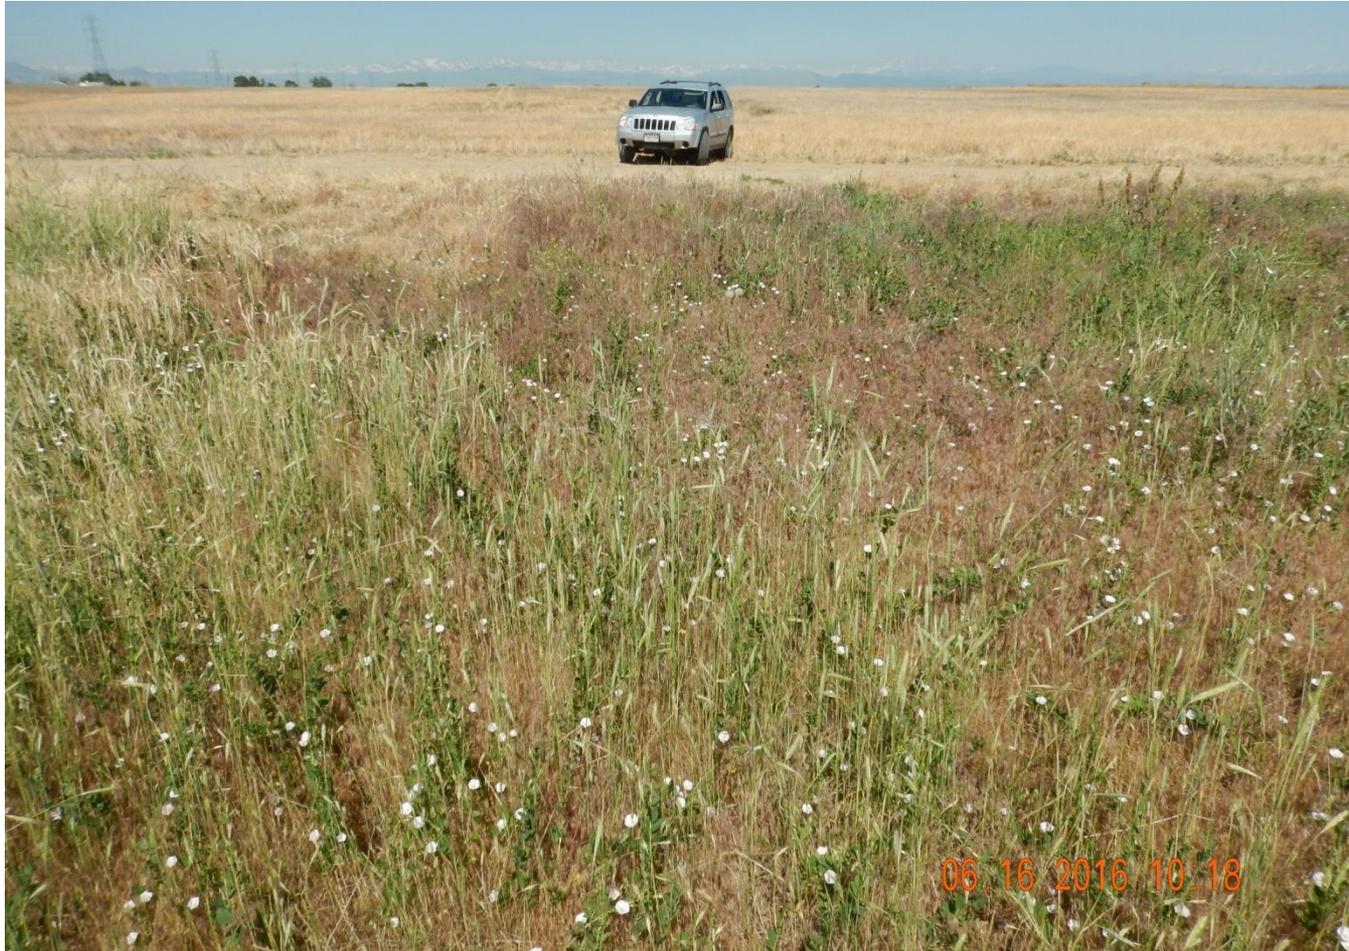
Photo 2. Photo taken from center of location, facing West. Location is IN PROCESS. List C Colorado Noxious weeds (Cheatgrass and Field bindweed) are competing with desirable plant species at this current time.

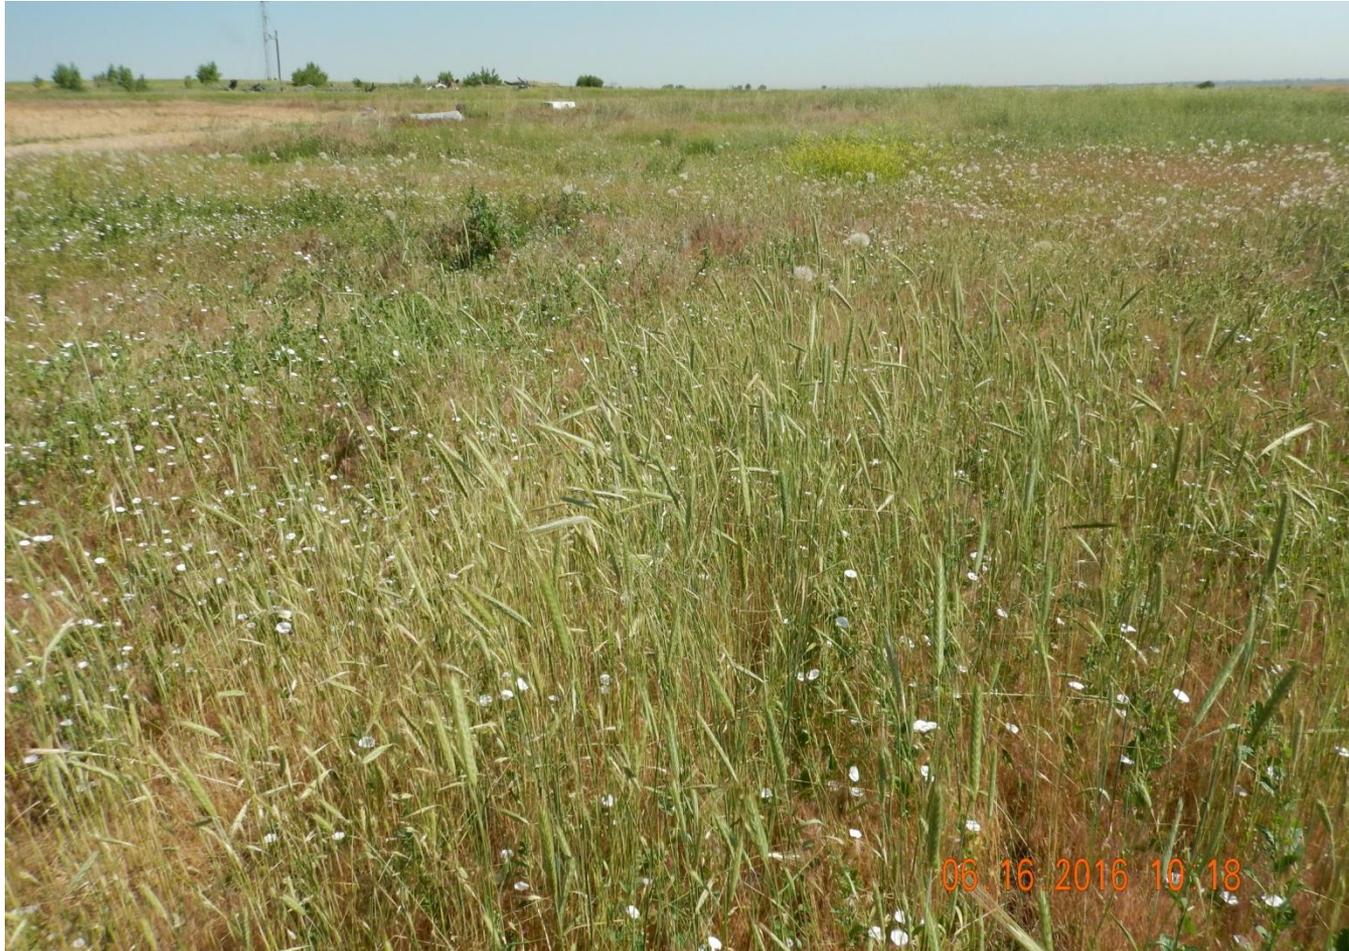
Photo 3. Photo taken from center of location, facing North. Location is IN PROCESS. List C Colorado Noxious weeds (Cheatgrass and Field bindweed) are competing with desirable plant species at this current time.

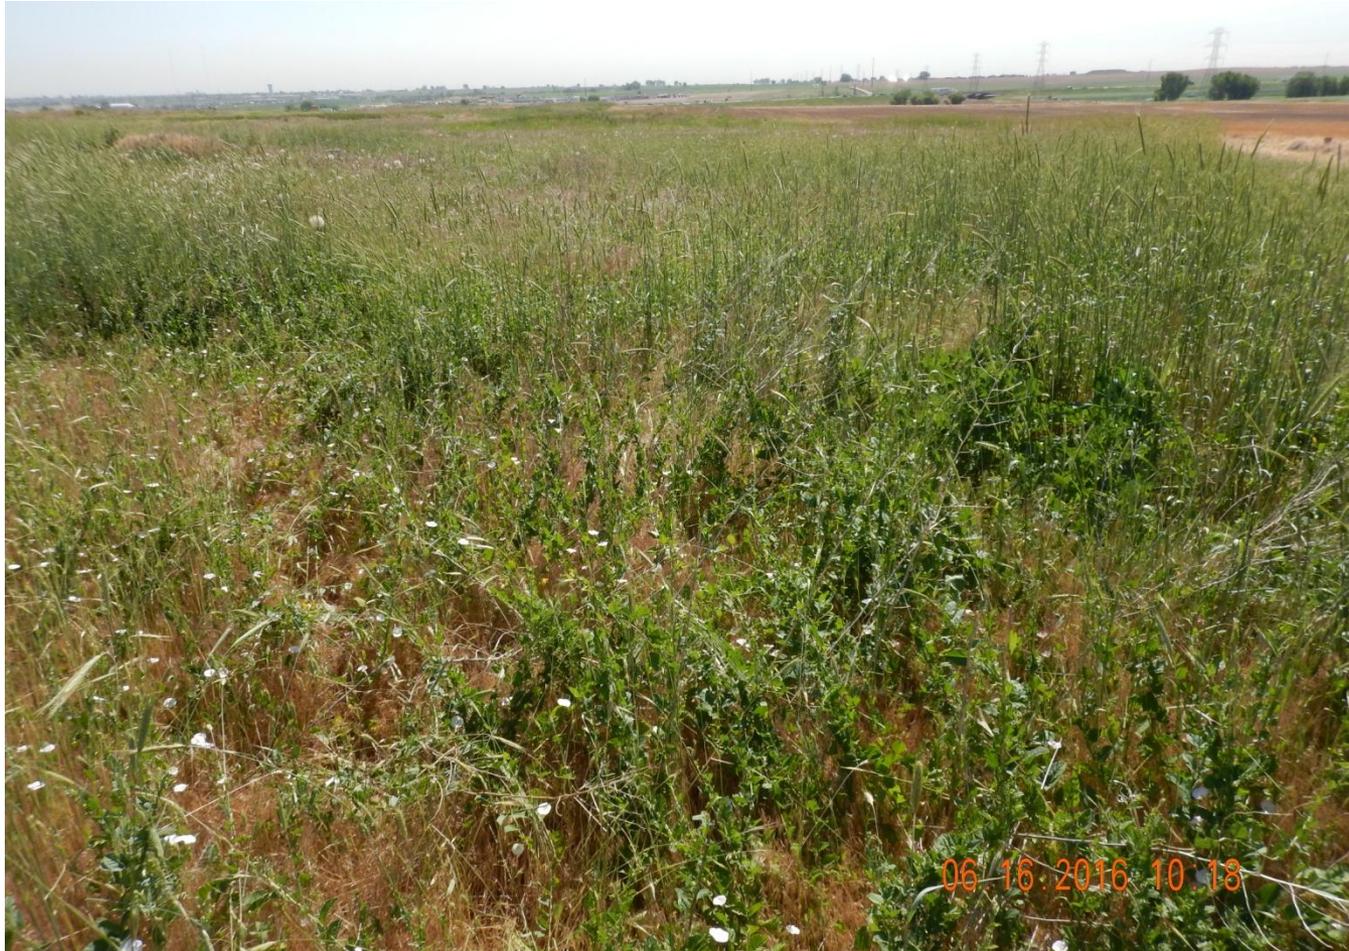
Photo 4. Photo taken from center of location, facing East. Location is IN PROCESS. List C Colorado Noxious weeds (Cheatgrass and Field bindweed) are competing with desirable plant species at this current time.

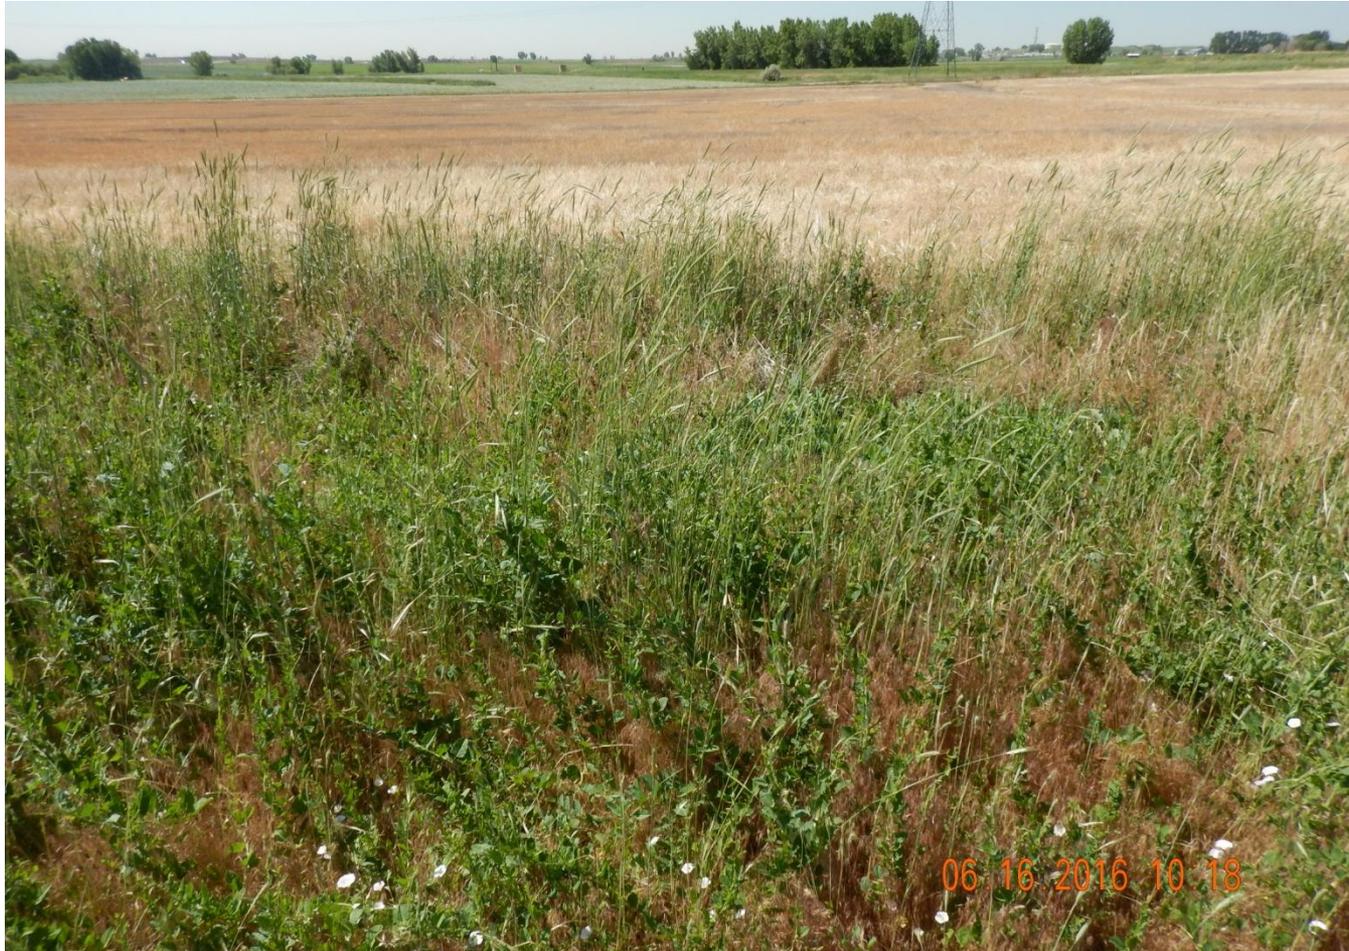
Photo 5. Photo taken from center of location, facing South. Location is IN PROCESS. List C Colorado Noxious weeds (Cheatgrass and Field bindweed) are competing with desirable plant species at this current time.

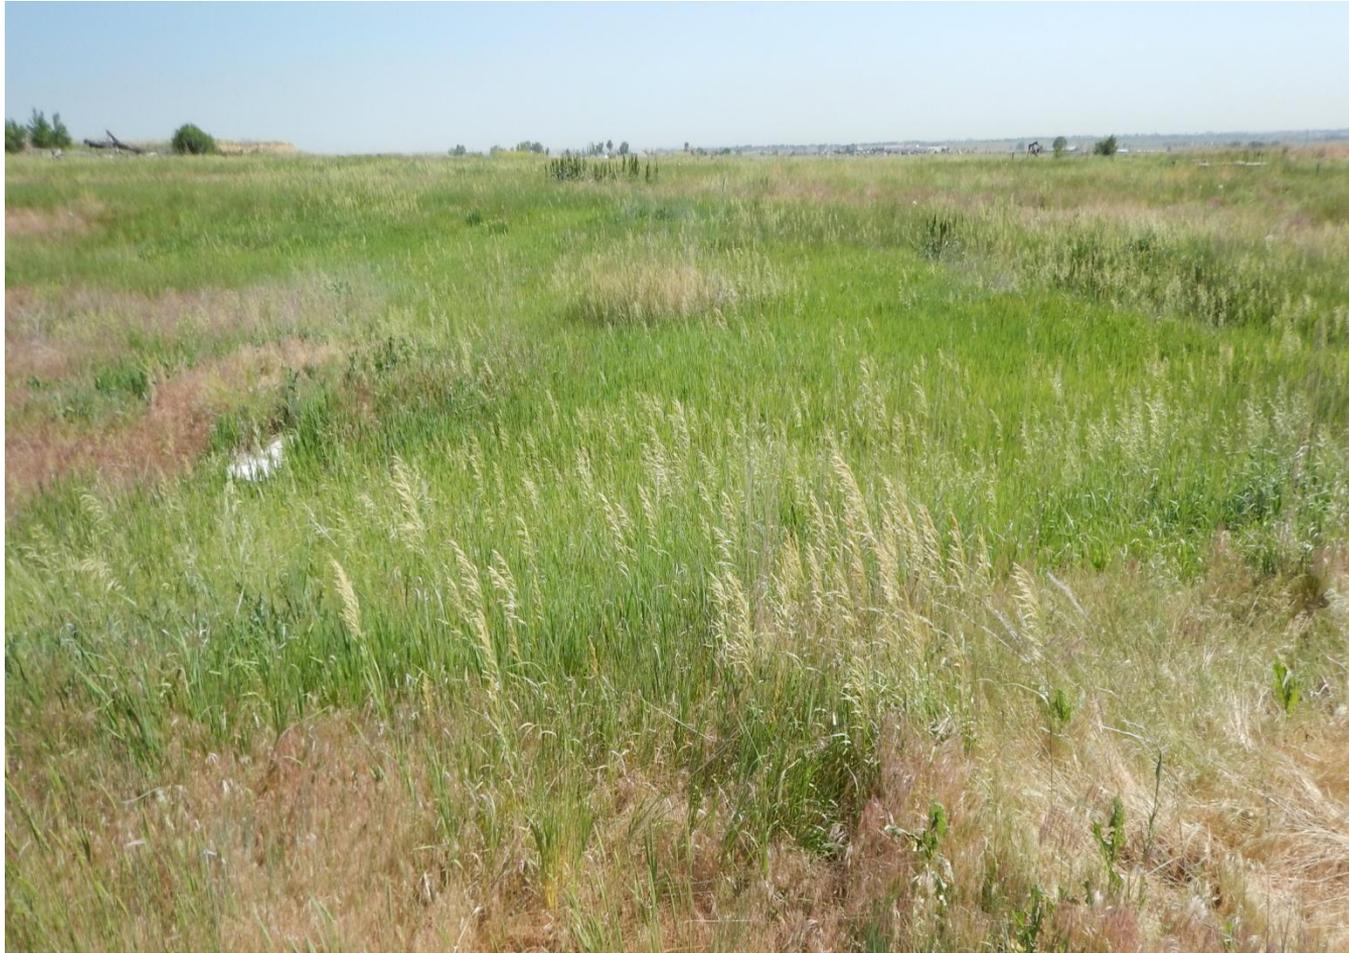
Photo 6. Reference photo taken from north of location, facing North. Although cheatgrass is present in the reference area its dominance is being outcompeted by other desirable plant species.
