Interim Reclamation Inspection

Photo 12. Photo taken of cropland datasheet used to evaluate the western Gee interim reclamation area.

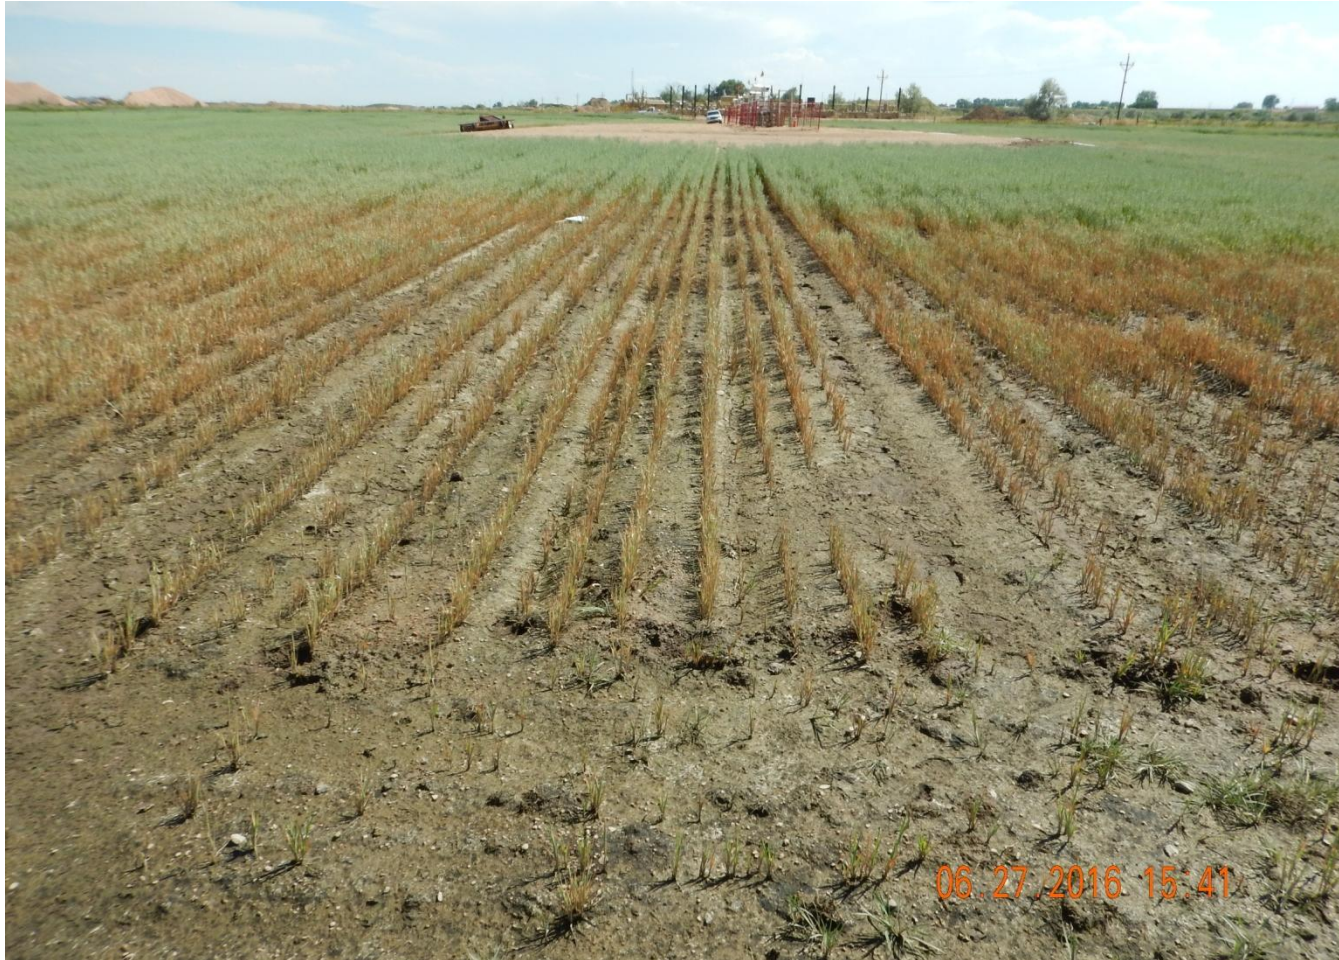
Photo 1. Photo taken from northern location, facing South. The northern region saturates the crop because contouring was not properly completed, crop growth is stunted and even killing the crop, and crop density is diminished or not growing which is not reflective of reference areas.

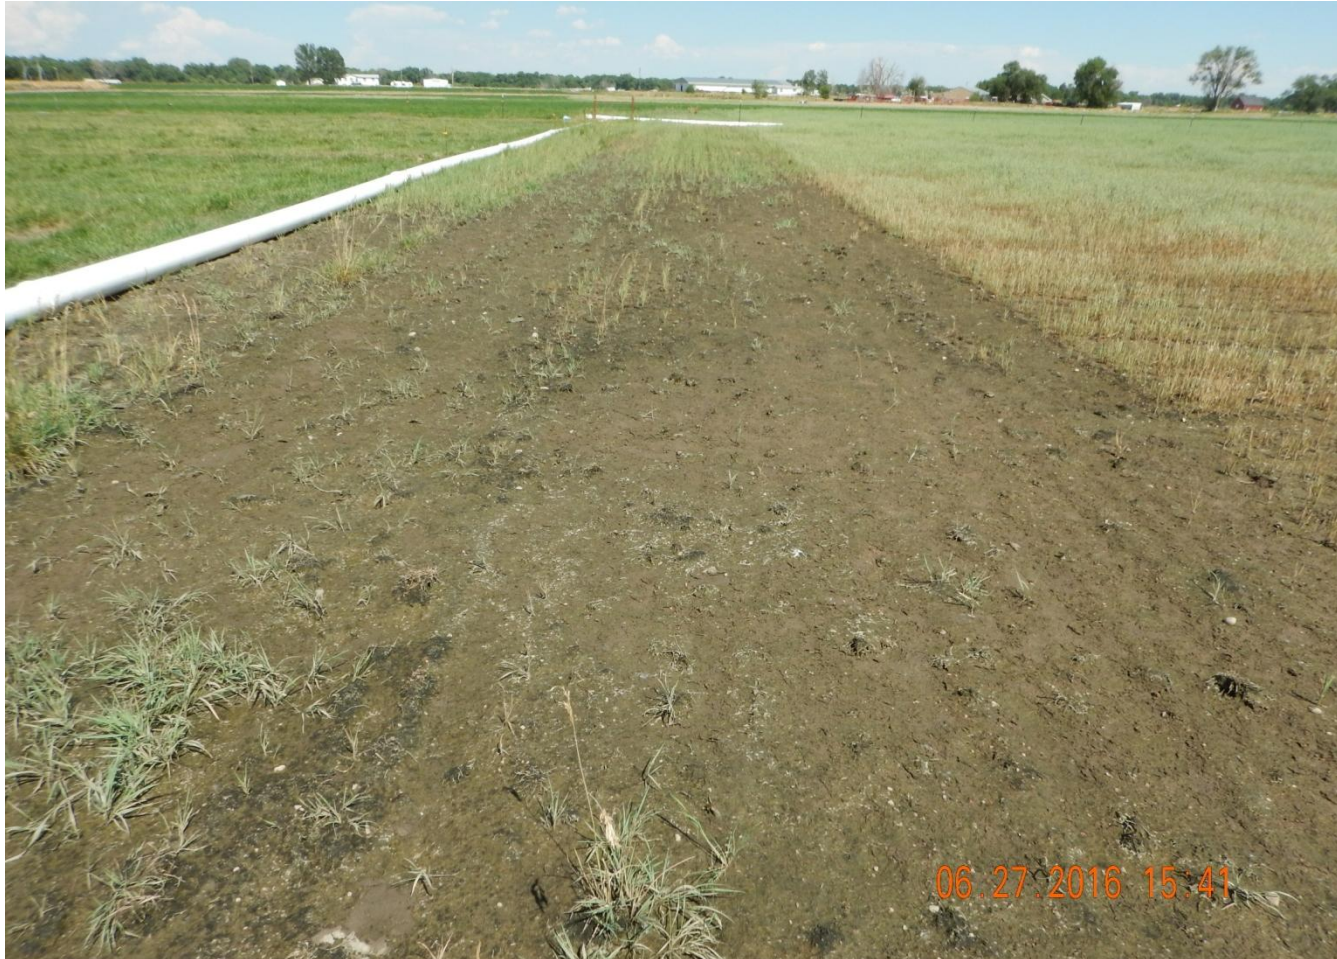
Photo 2. Photo taken from northern location, facing East. The northern region saturates the crop because contouring was not properly completed, crop growth is stunted and even killing the crop, and crop density is diminished or not growing which is not reflective of reference areas.

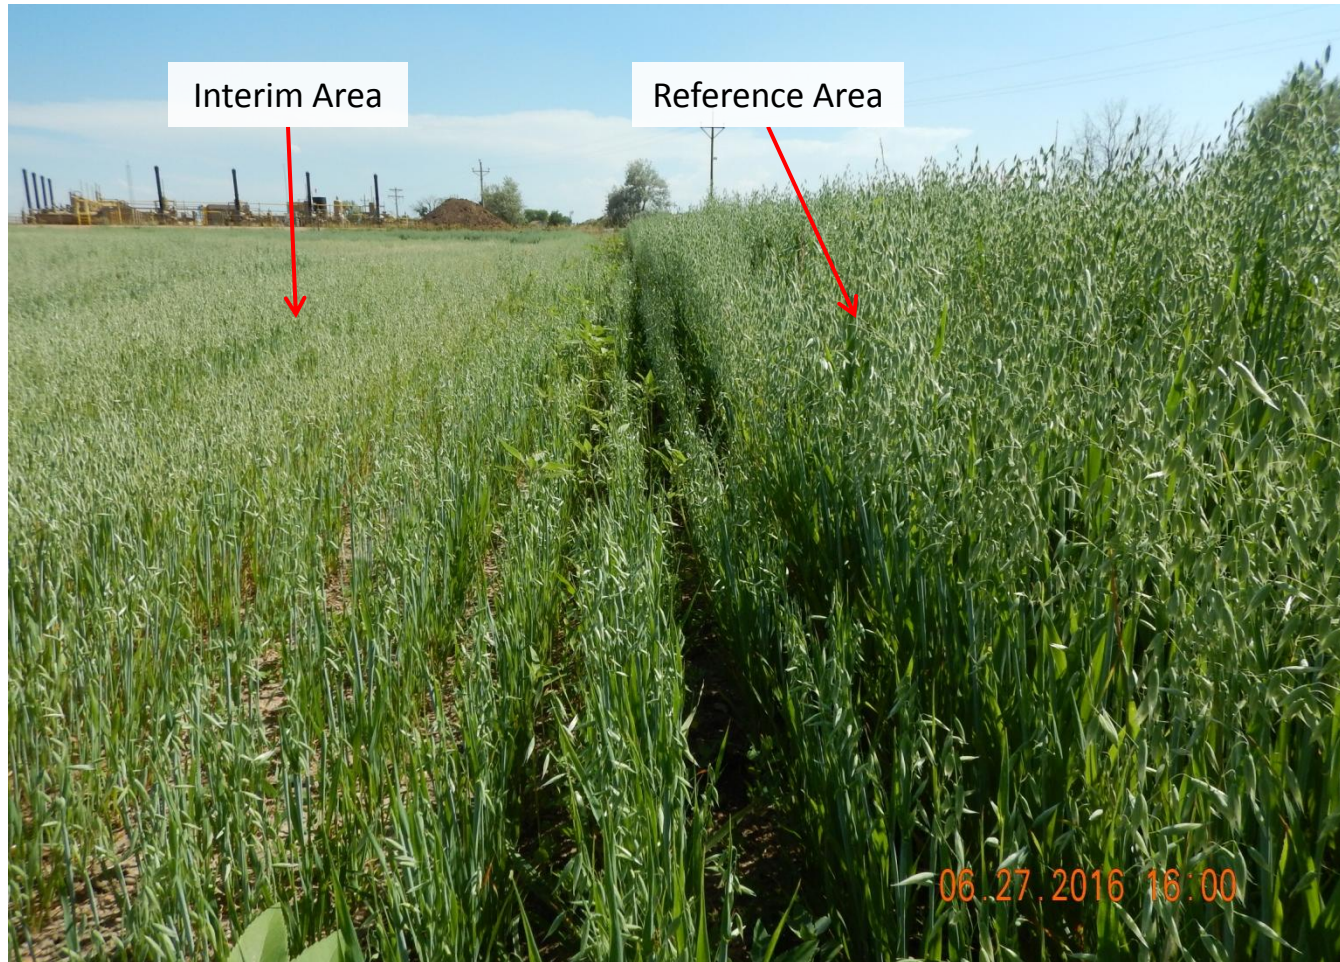
Photo 3. Photo taken from western location, facing South, illustrating discrepancy between reference and interim areas. Interim area density and height not representative of reference area.

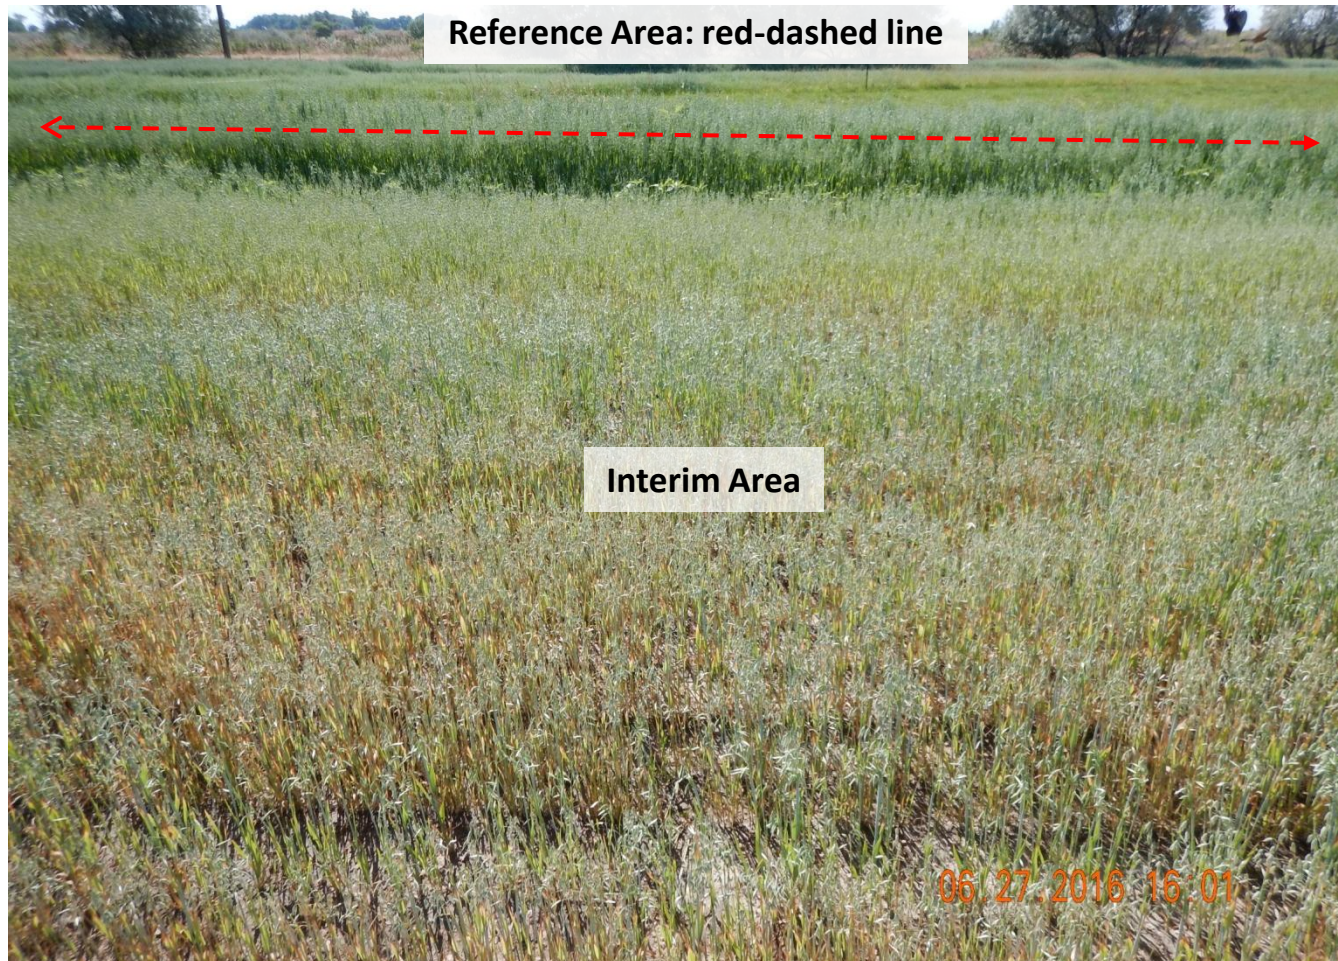
Photo 4. Photo taken from western location, facing West, illustrating discrepancy between reference and interim areas. Interim area density and height not representative of reference area.

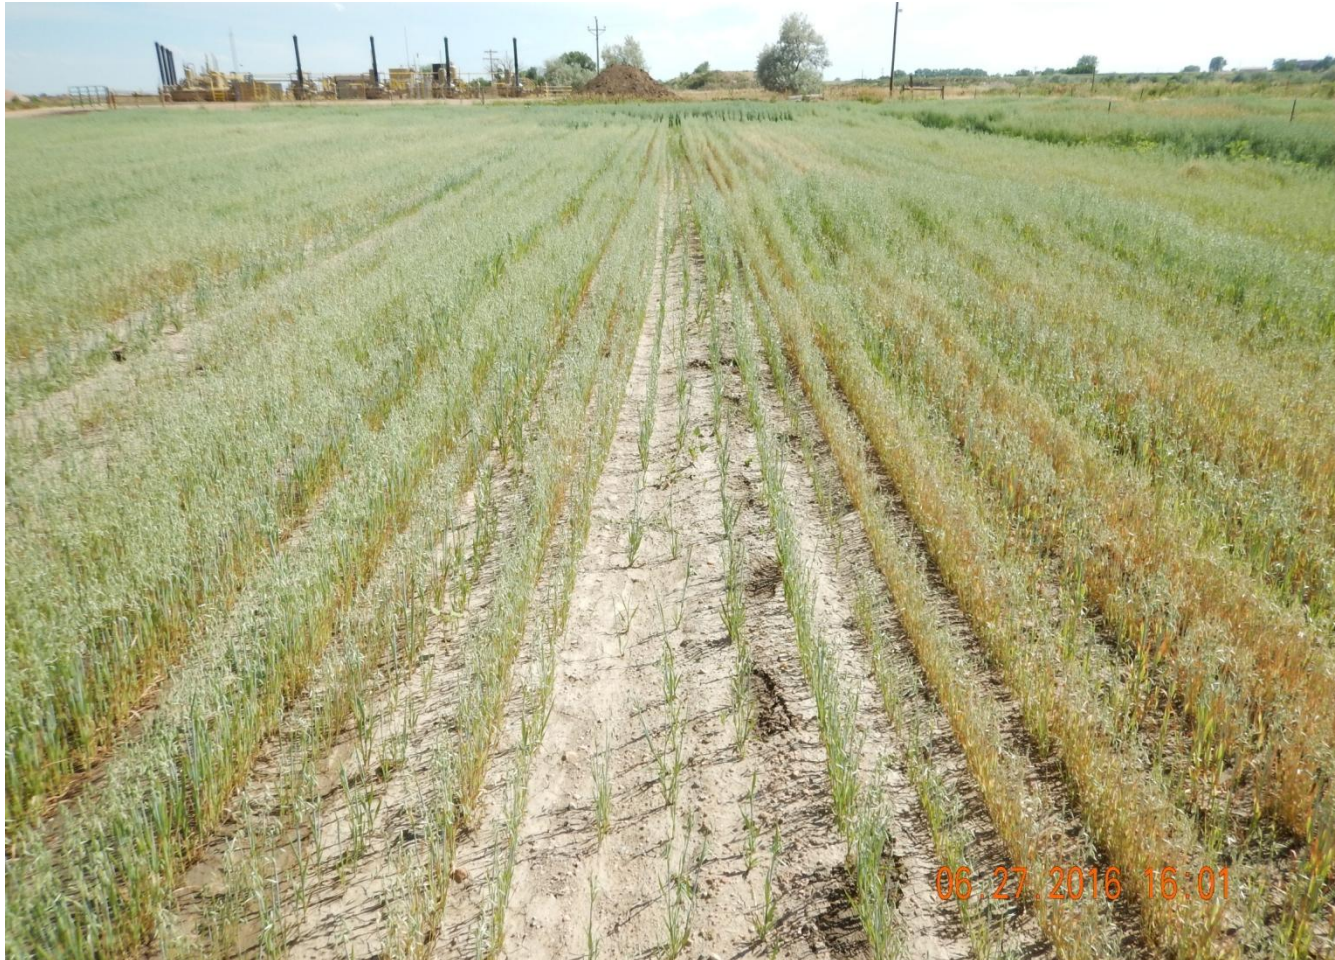
Photo 5. Photo taken from the previous Photo 4 western location, facing South, illustrating discrepancy between reference and interim areas. Interim area density and height not representative of reference area. Bare soil and inconsistent crop growth are apparent throughout interim areas.

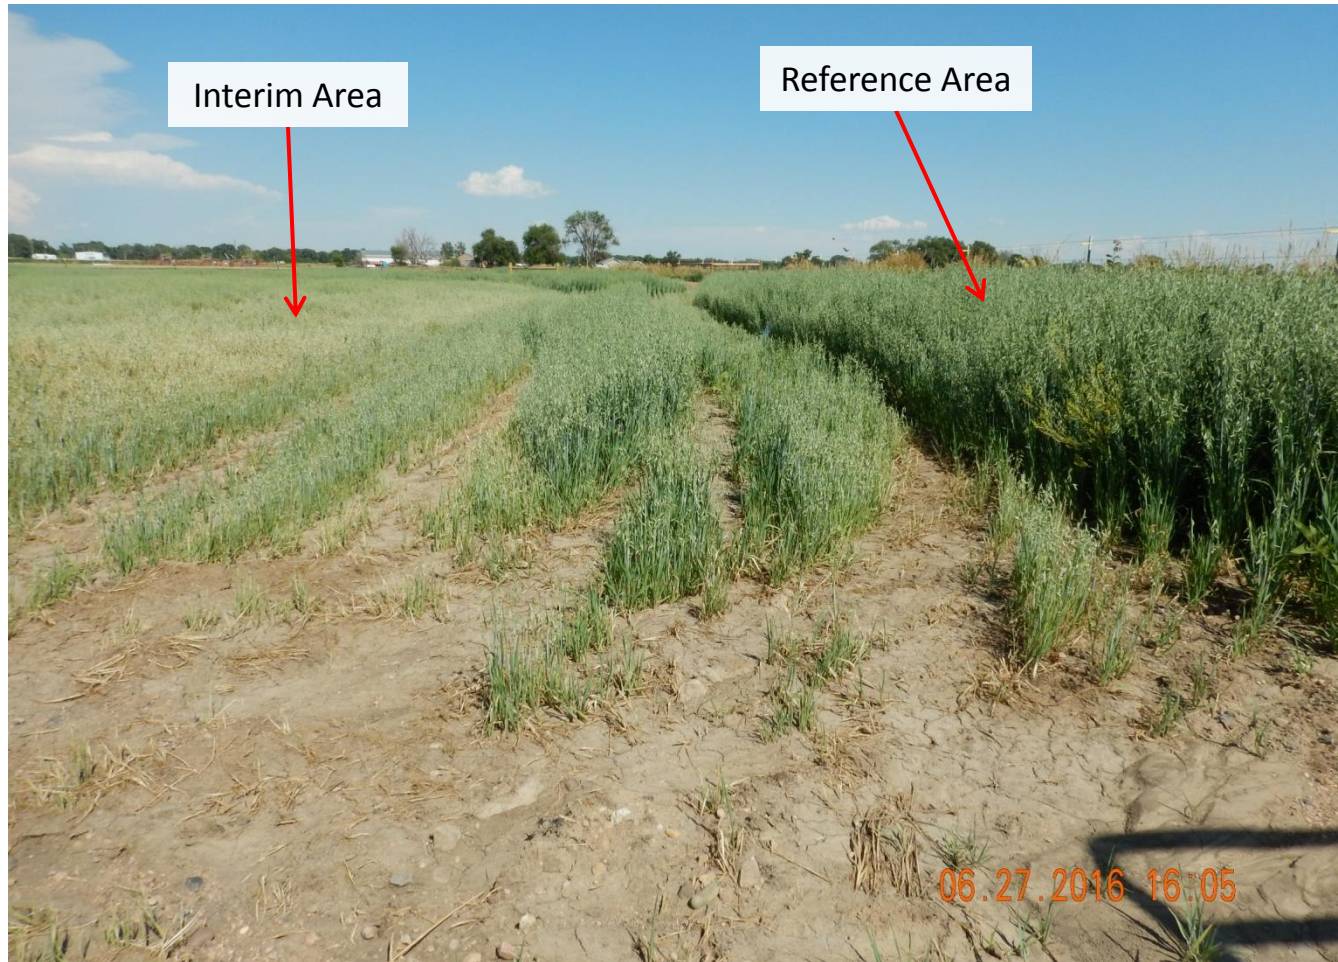
Photo 6. Photo taken from southeast location, facing East, illustrating discrepancy between reference and interim areas. Interim area density and height not representative of reference area.

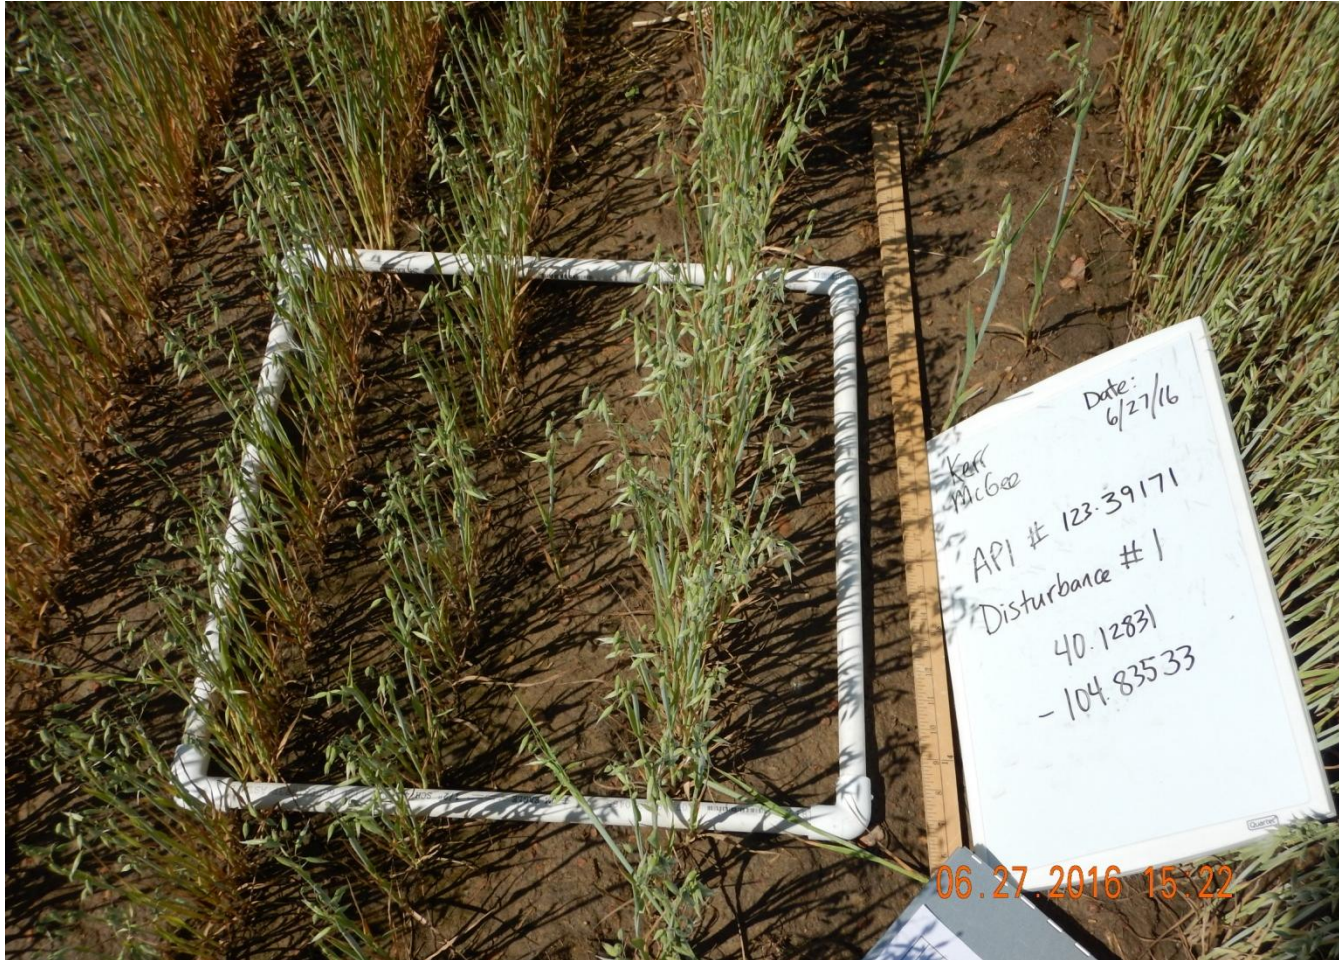
Photo 7. Photo taken 6/27/16 from Disturbance #1 cropland quadrat. Refer to datasheet for total vegetative composition.

| Cropland Vegetation Report | | | | |
|---|---|---|---|---|
| 1 | Sideoats | 15" | 164 | |
| | | 57+50+57=164 | | |

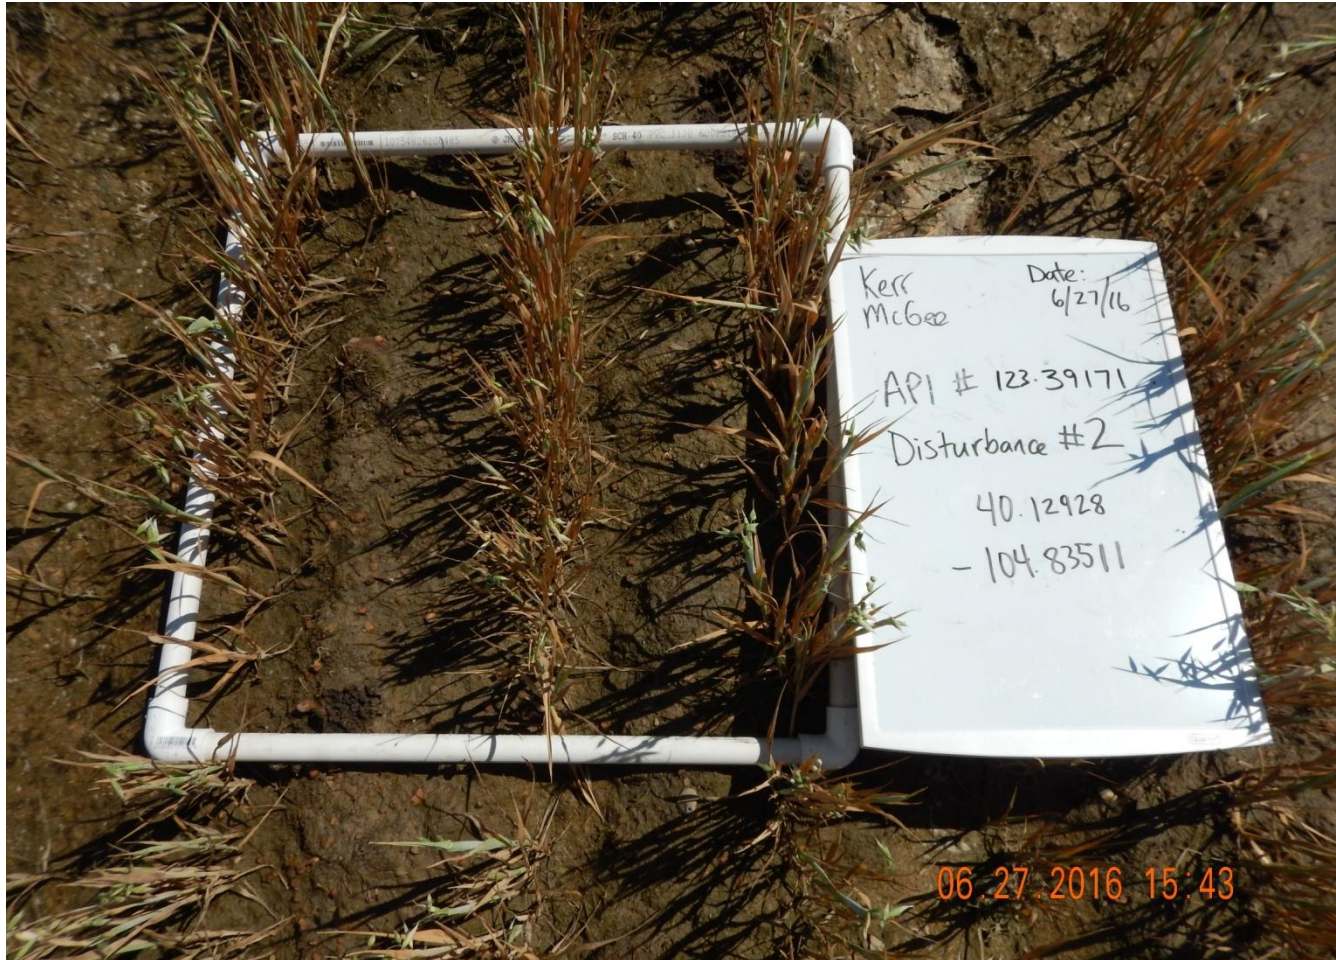
Photo 8. Photo taken 6/27/16 from Disturbance #2 cropland quadrat. Refer to datasheet for total vegetative composition.

| Cropland Vegetation Report | | | | |
|---|---|---|---|---|
| 2 | | 11" | 122 | |
| | | 52+54+36=122 | | |

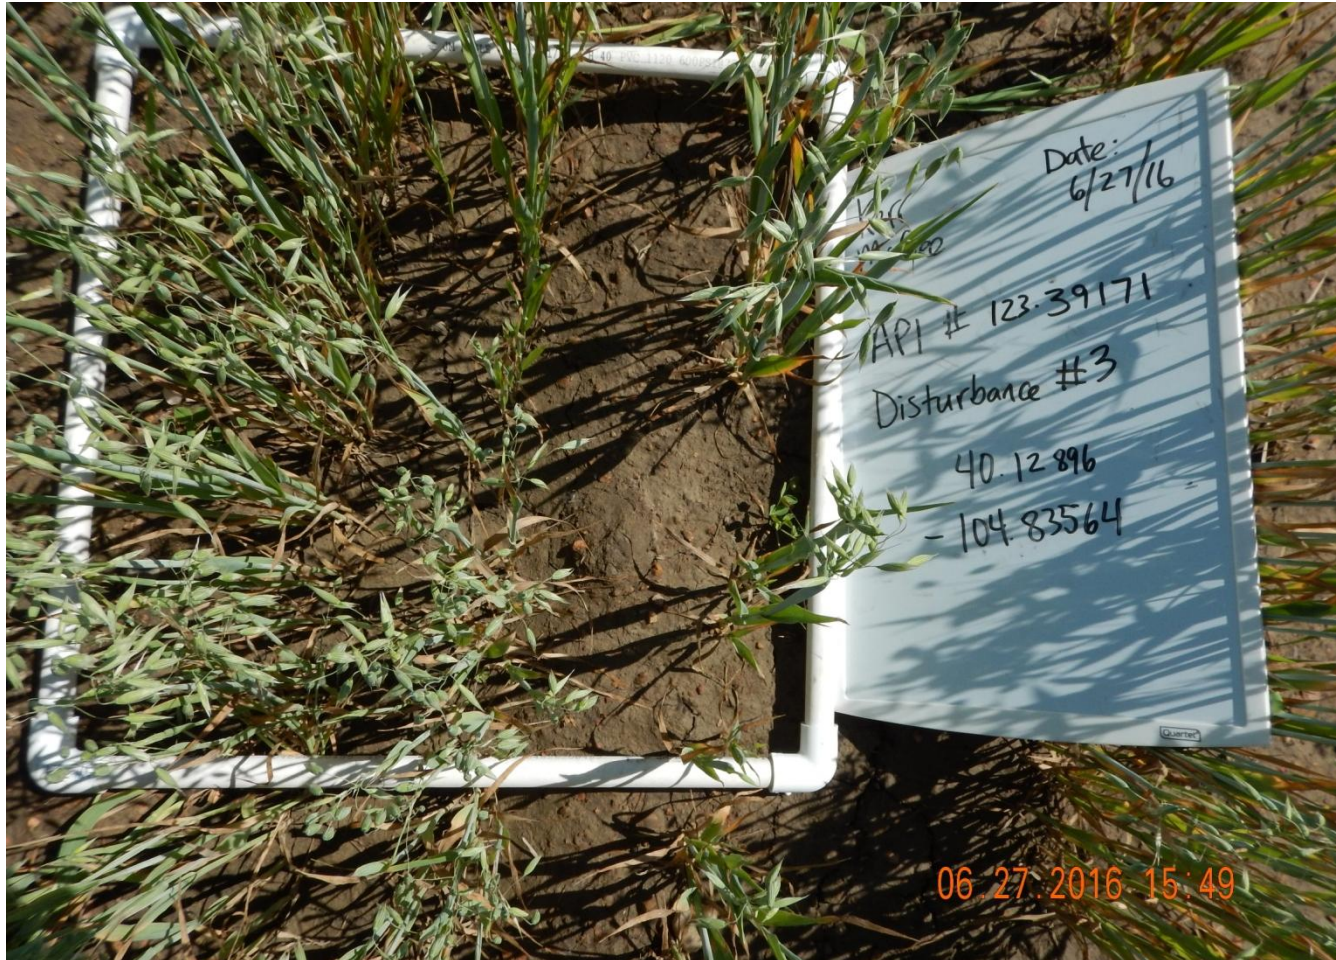
Photo 9. Photo taken 6/27/16 from Disturbance #3 cropland quadrat. Refer to datasheet for total vegetative composition.

| Cropland Vegetation Report | | | | |
|---|---|---|---|---|
| 3 | | 19" | 118 | |
| | | 19+33+66=118 | | |

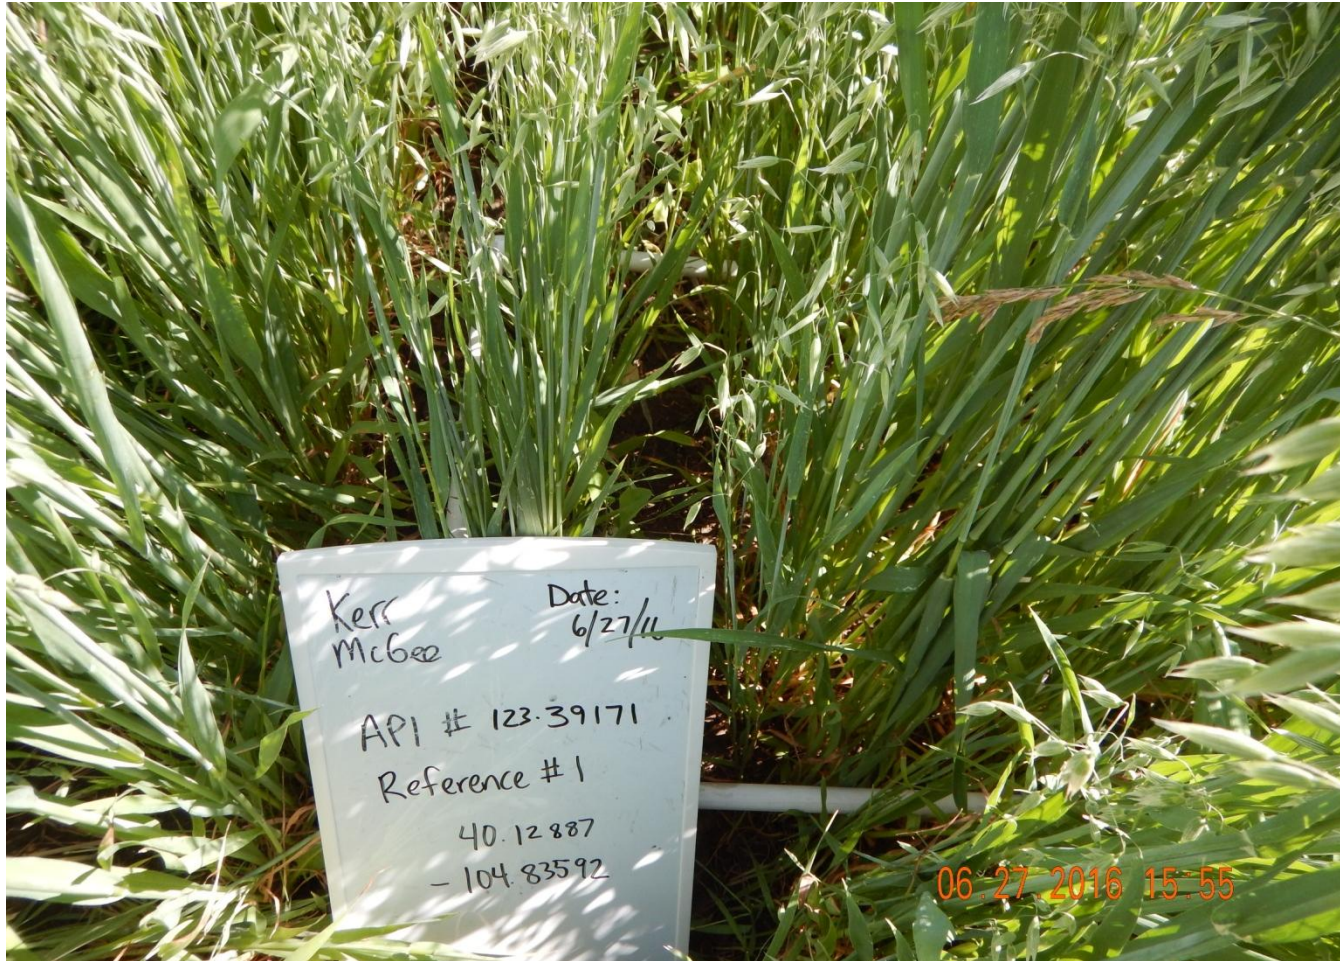
Photo 10. Photo taken 6/27/16 from Reference #1 cropland quadrat. Refer to datasheet for total vegetative composition.

| Cropland Vegetation Report | | | | |
|---|---|---|---|---|
| 4 | | 34" | 189 | |
| | | 60+87+42=189 | | |

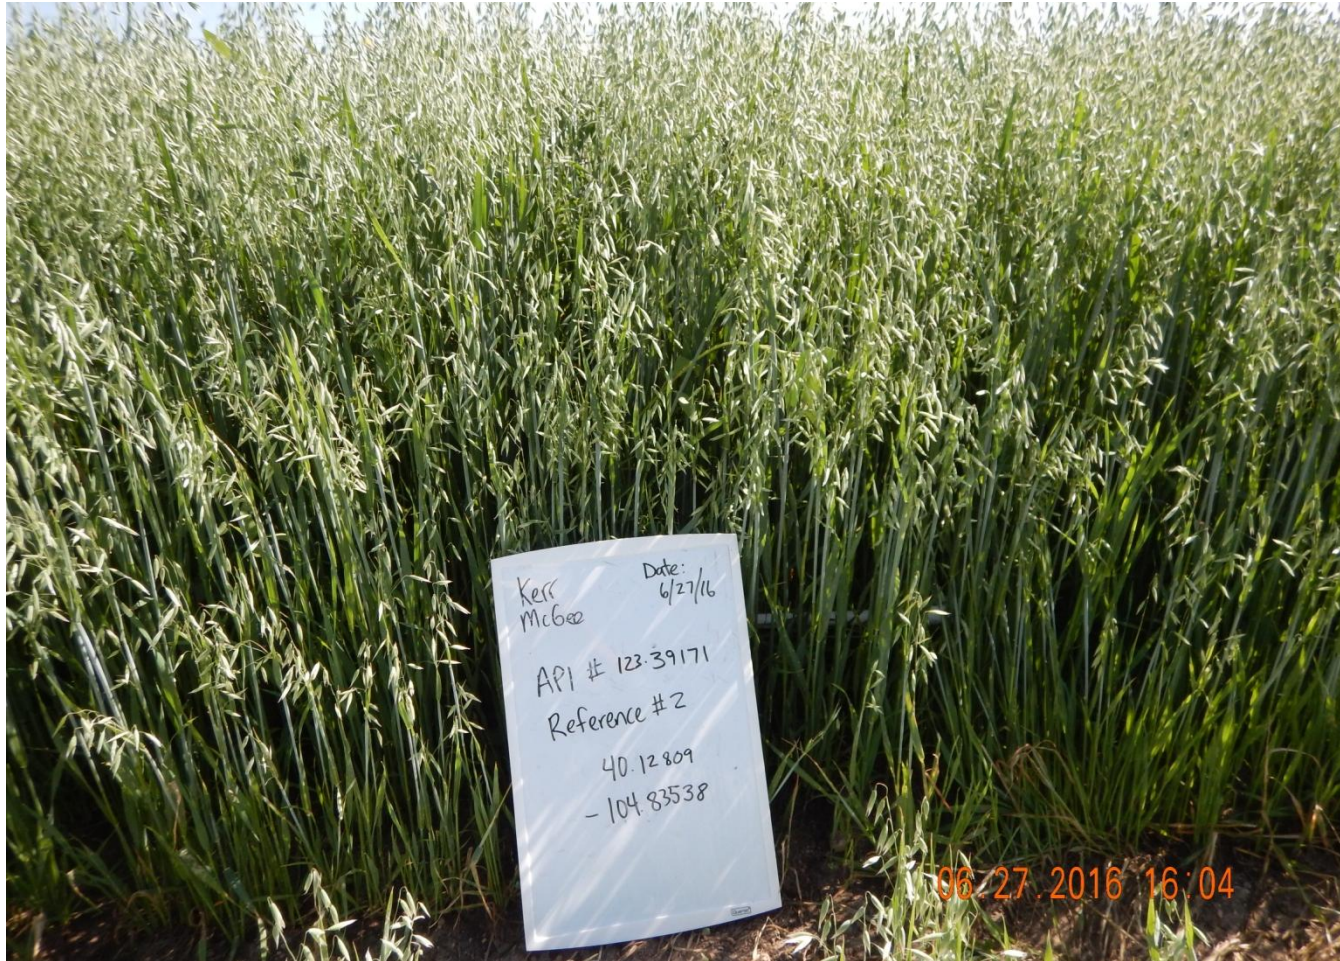
Photo 11. Photo taken 6/27/16 from Reference #2 cropland quadrat. Refer to datasheet for total vegetative composition.

| Cropland Vegetation Report | | | | |
|---|---|---|---|---|
| 5 | | 38" | 244 | |
| | | 131+113=244 | | |
