Final Reclamation Inspection- McDonald Farm Beneficial Reuse Area

COLORADO
Oil & Gas Conservation
Commission
Department of Natural Resources

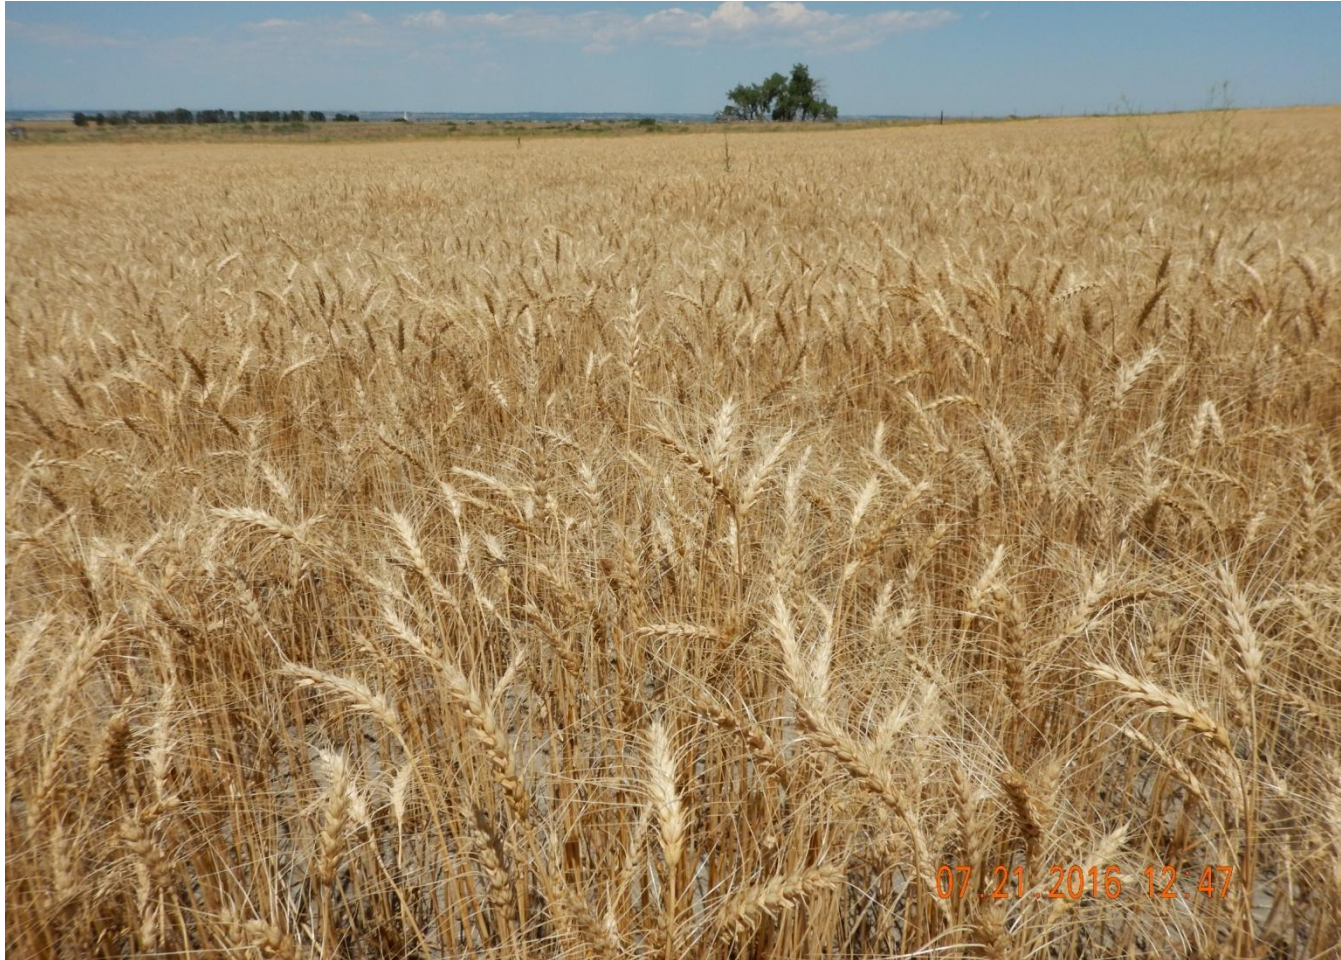
Photo 2. Photo taken from Land Application Area #1 cropland quadrat, facing North. Appears to have uniform vegetative crop growth throughout location. Cropland quadrat results indicated crop height averaged 33" and stem density count of 127.

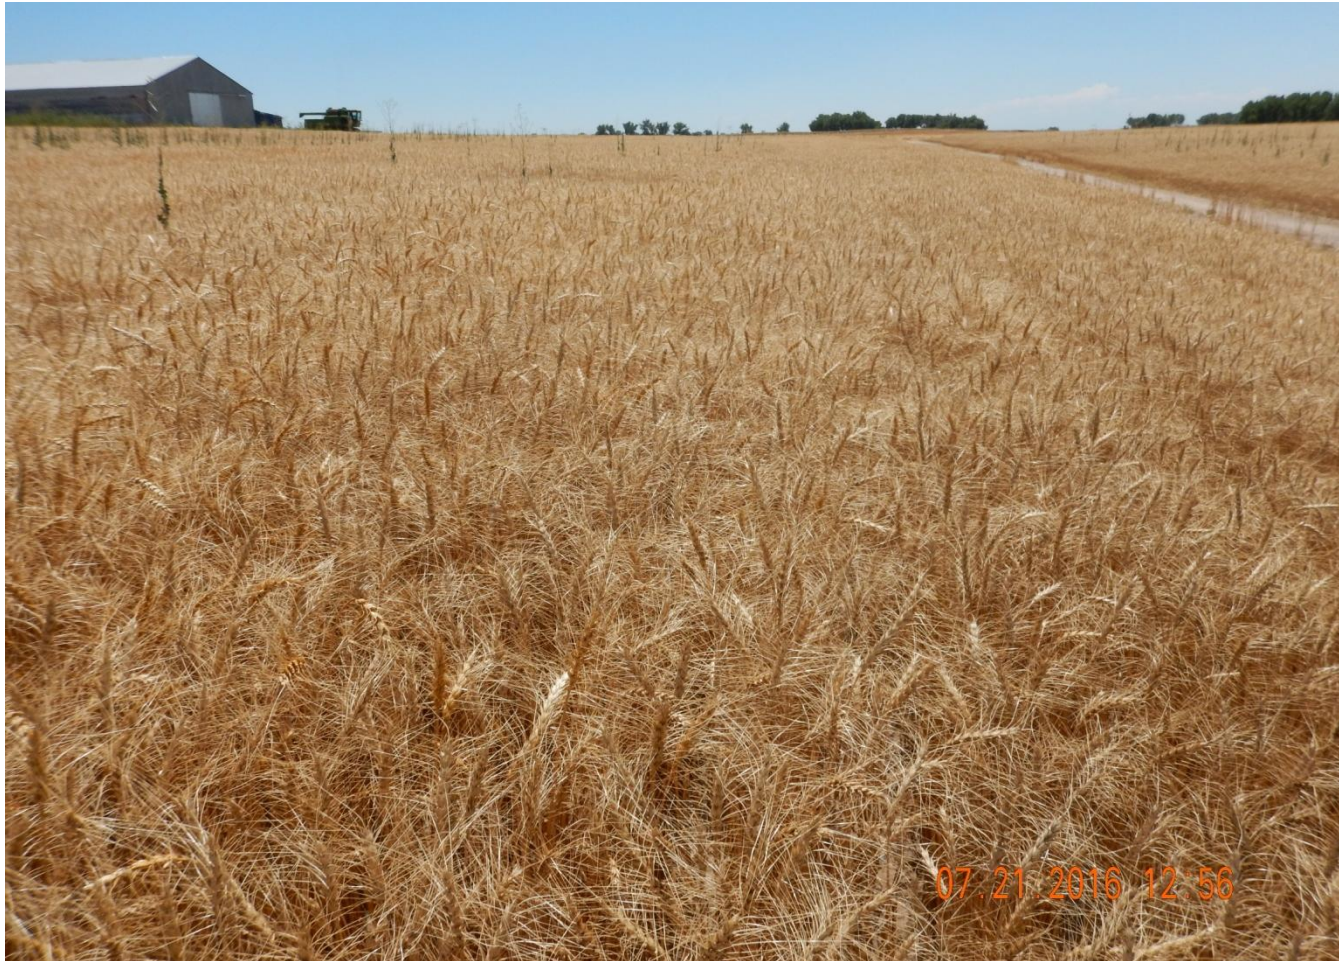
Photo 4. Photo taken from Land Application Area #2 cropland quadrat, facing South. Appears to have uniform vegetative crop growth throughout location. Cropland quadrat results indicated crop height averaged 32" and stem density count of 168.

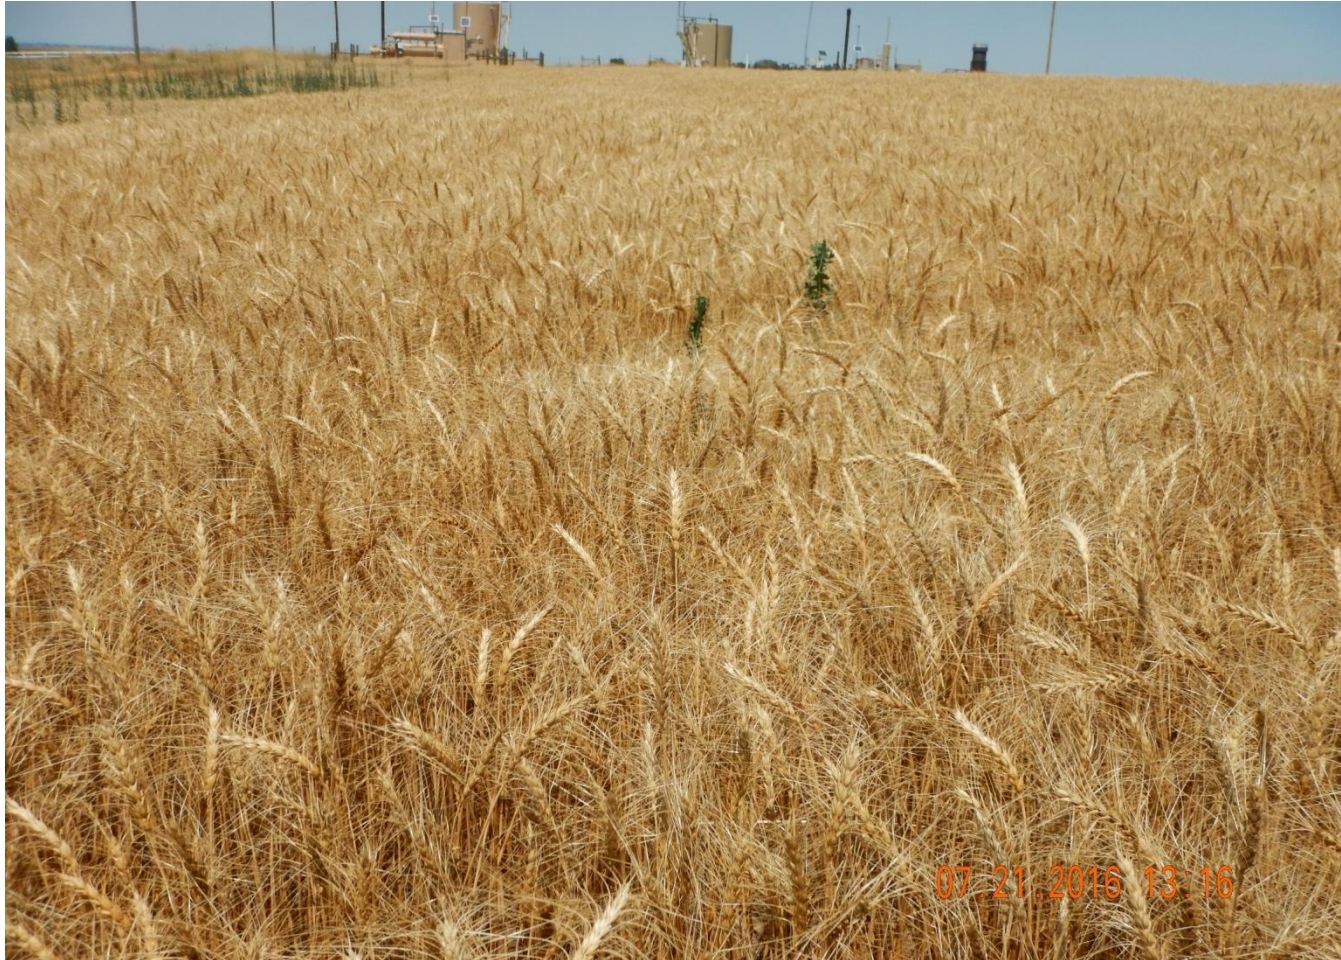
Photo 6. Photo taken from Reference Area #1 cropland quadrat, facing North. Land Application areas appear to be reflective of reference areas. Cropland quadrat results indicated crop height averaged 30" and stem density count of 202.

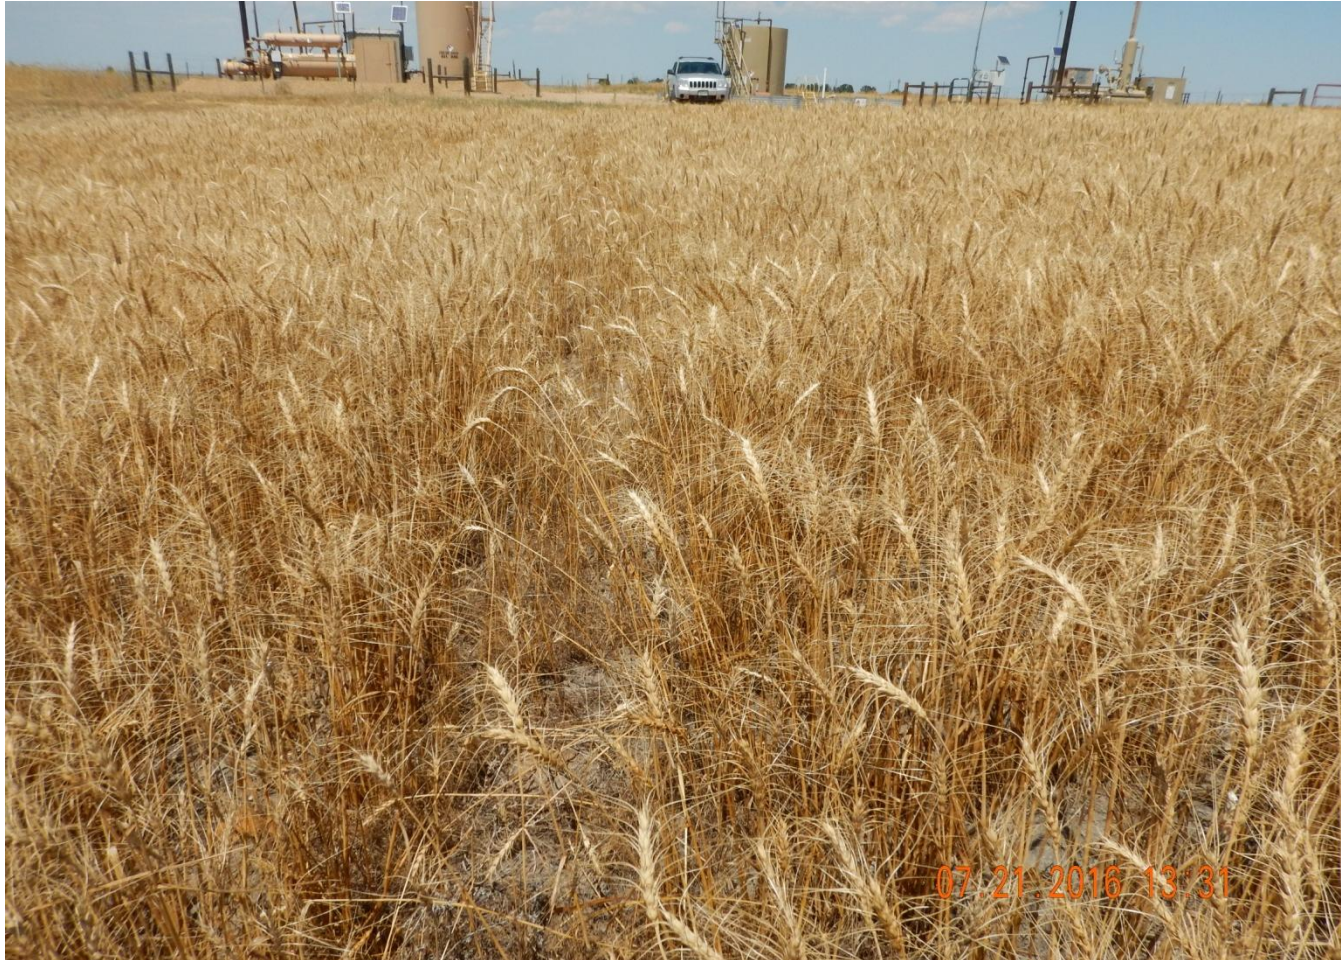
Photo 8. Photo taken from Reference Area #2 cropland quadrat, facing North. Land Application areas appear to be reflective of reference areas. Cropland quadrat results indicated crop height averaged 27" and stem density count of 166.
