Final Reclamation Inspection

Operator: Petro-Canada

Location ID: 311698

Adams County, CO

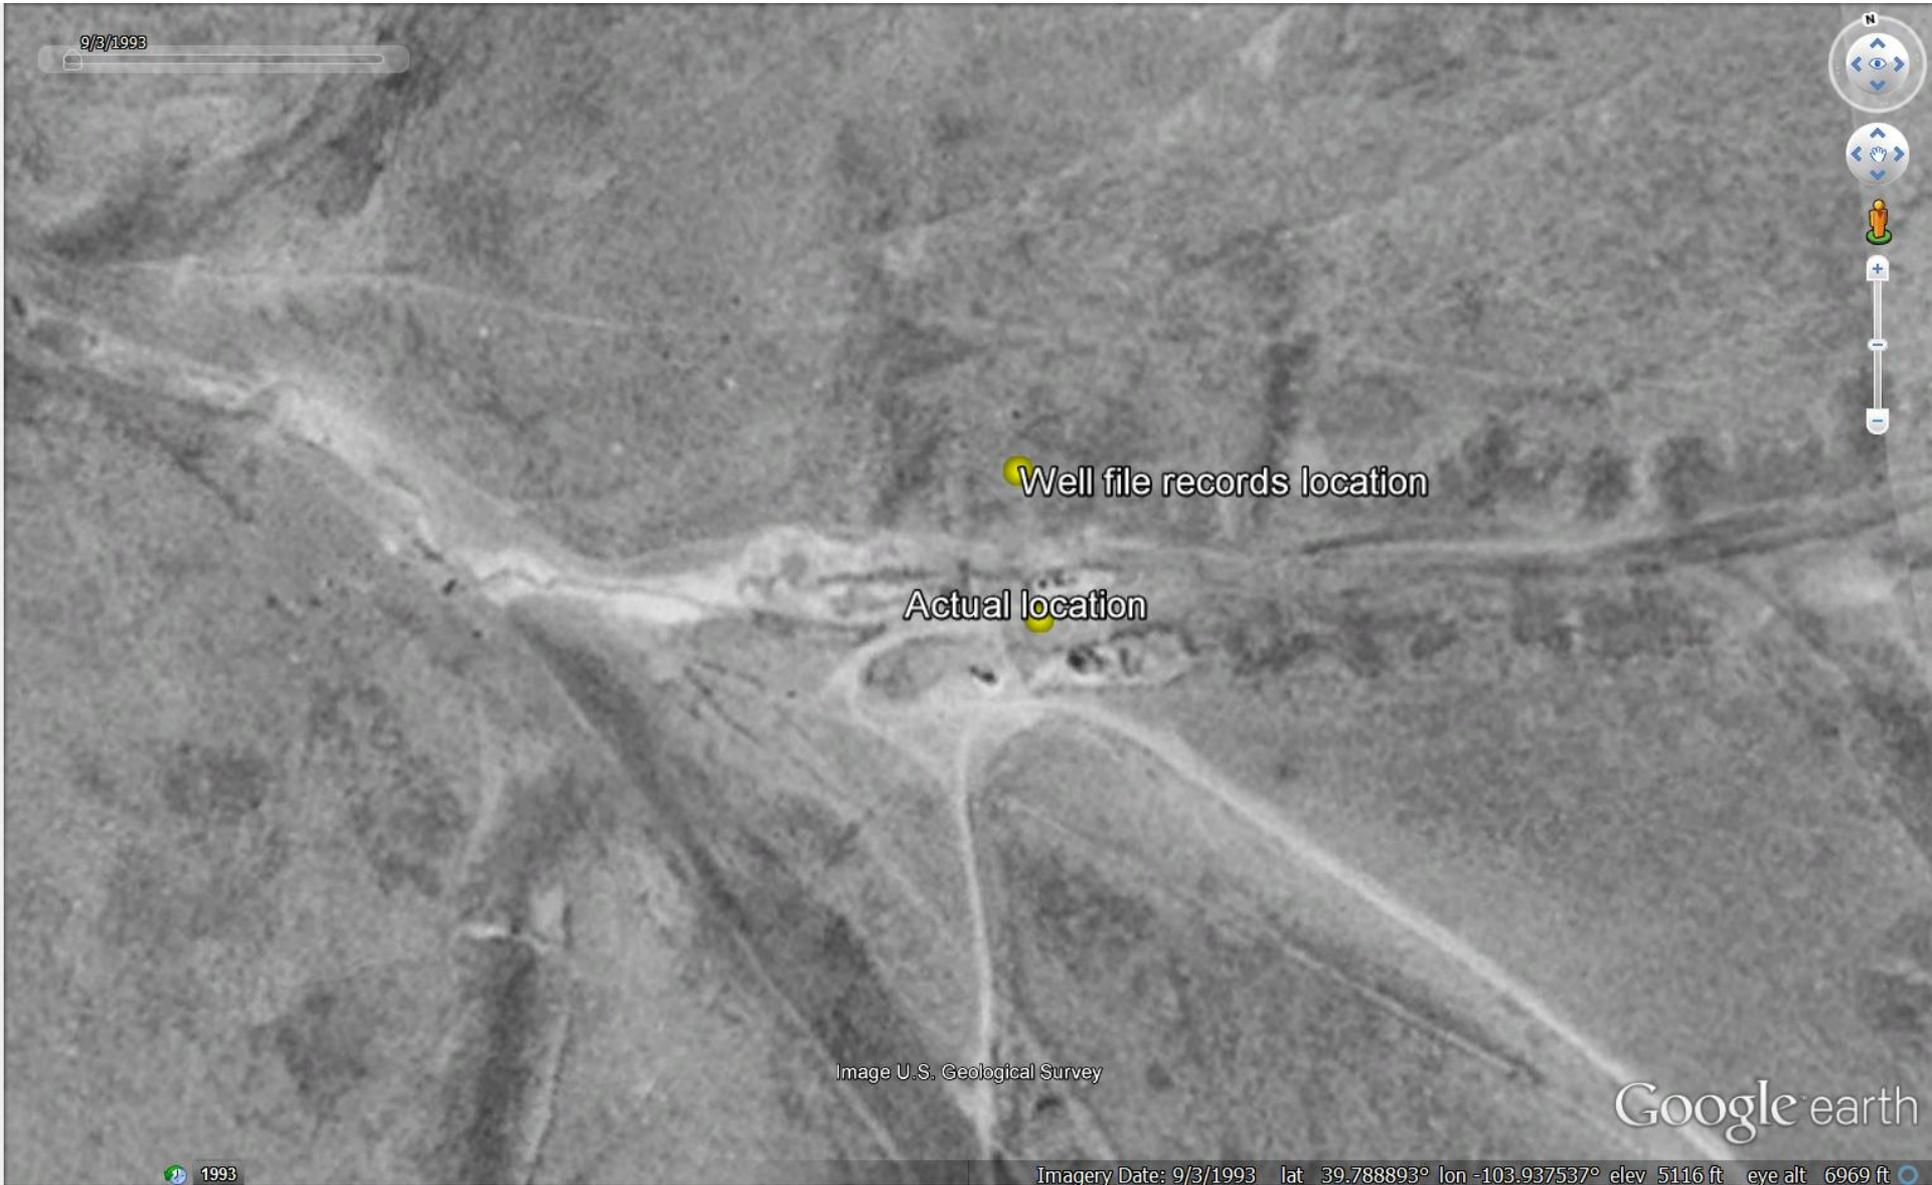
Figure 1: 1993 aerial imagery showing where location exists vs. scout card records.

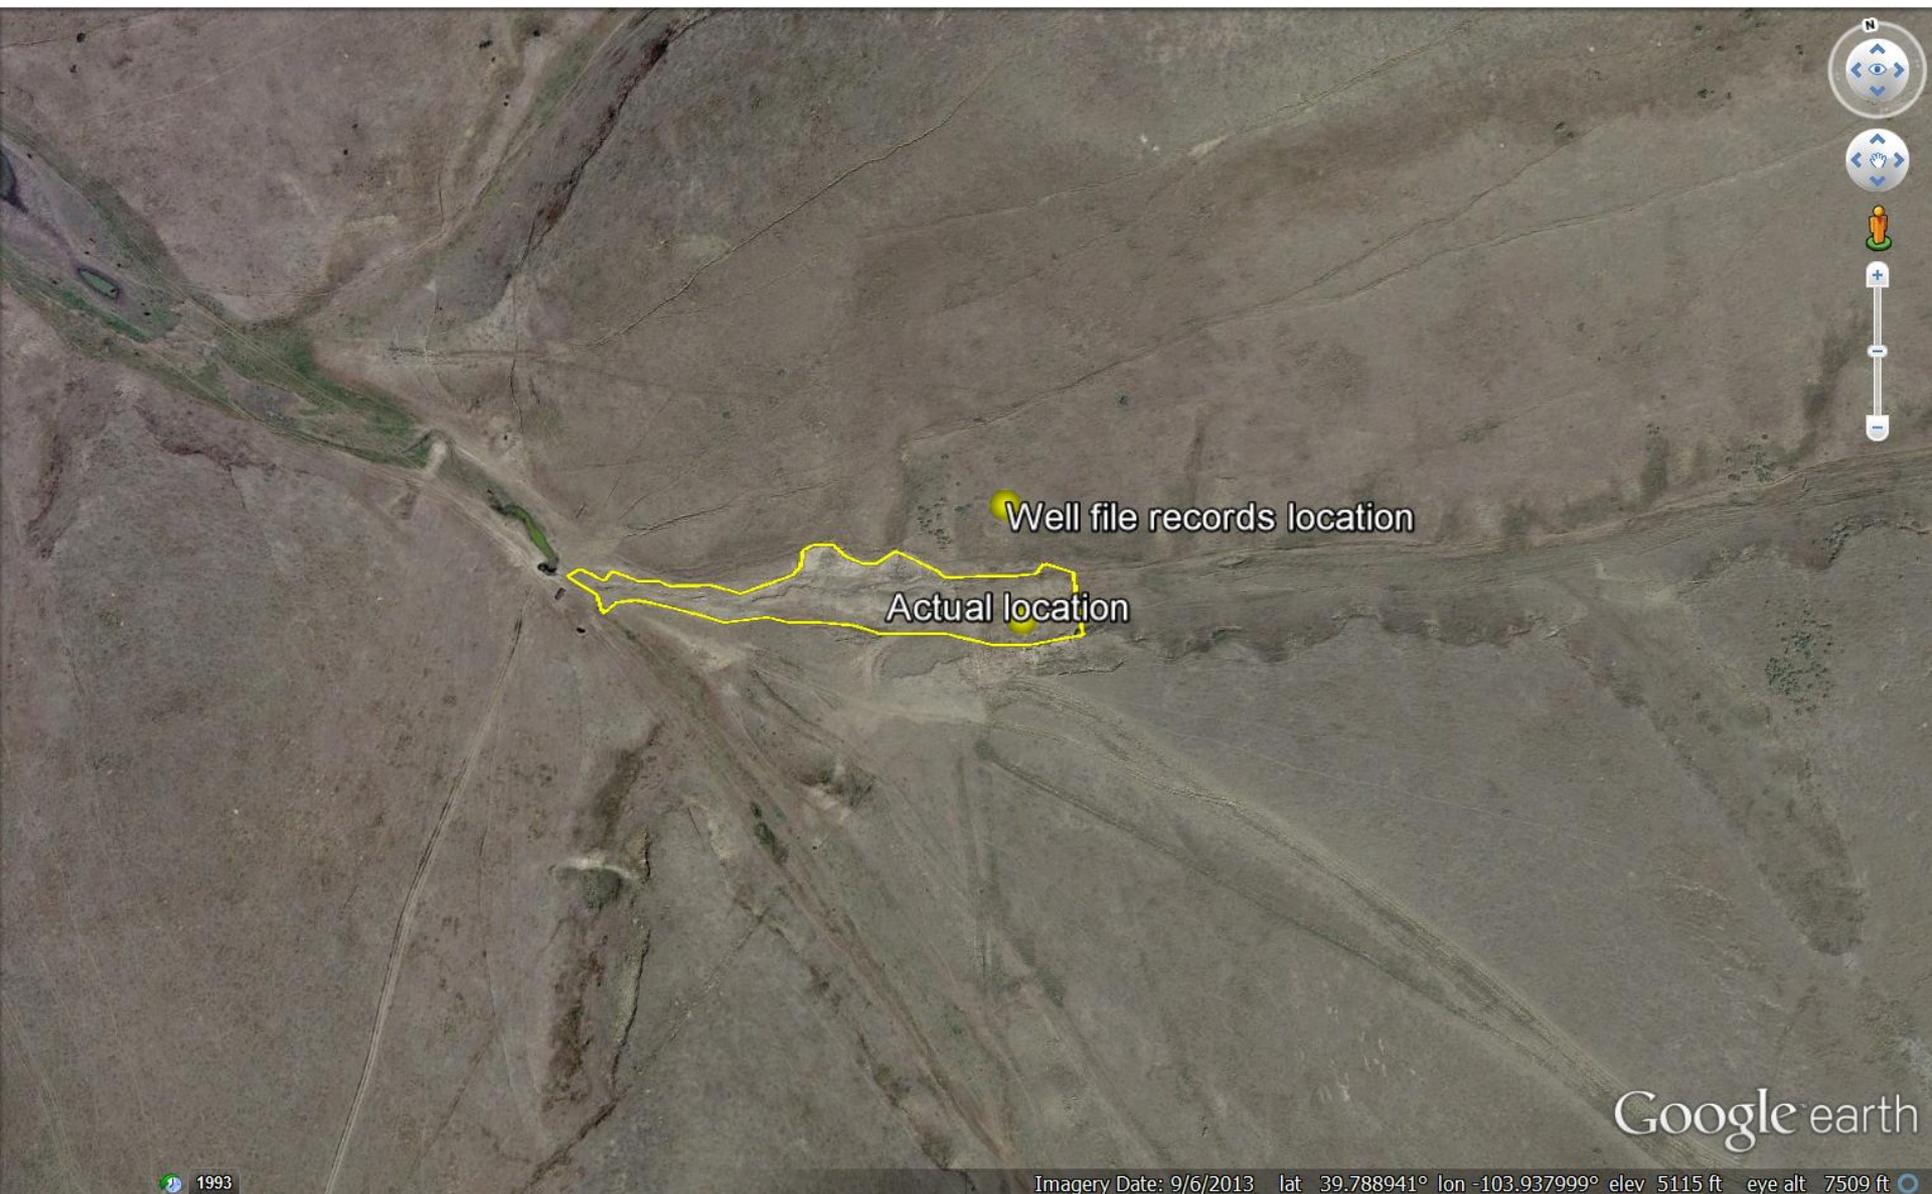
Figure 2: Most recent aerial imagery (2013) shows approximate outline of degradation within drainage. Approximate area of degradation is 1.3 acres.

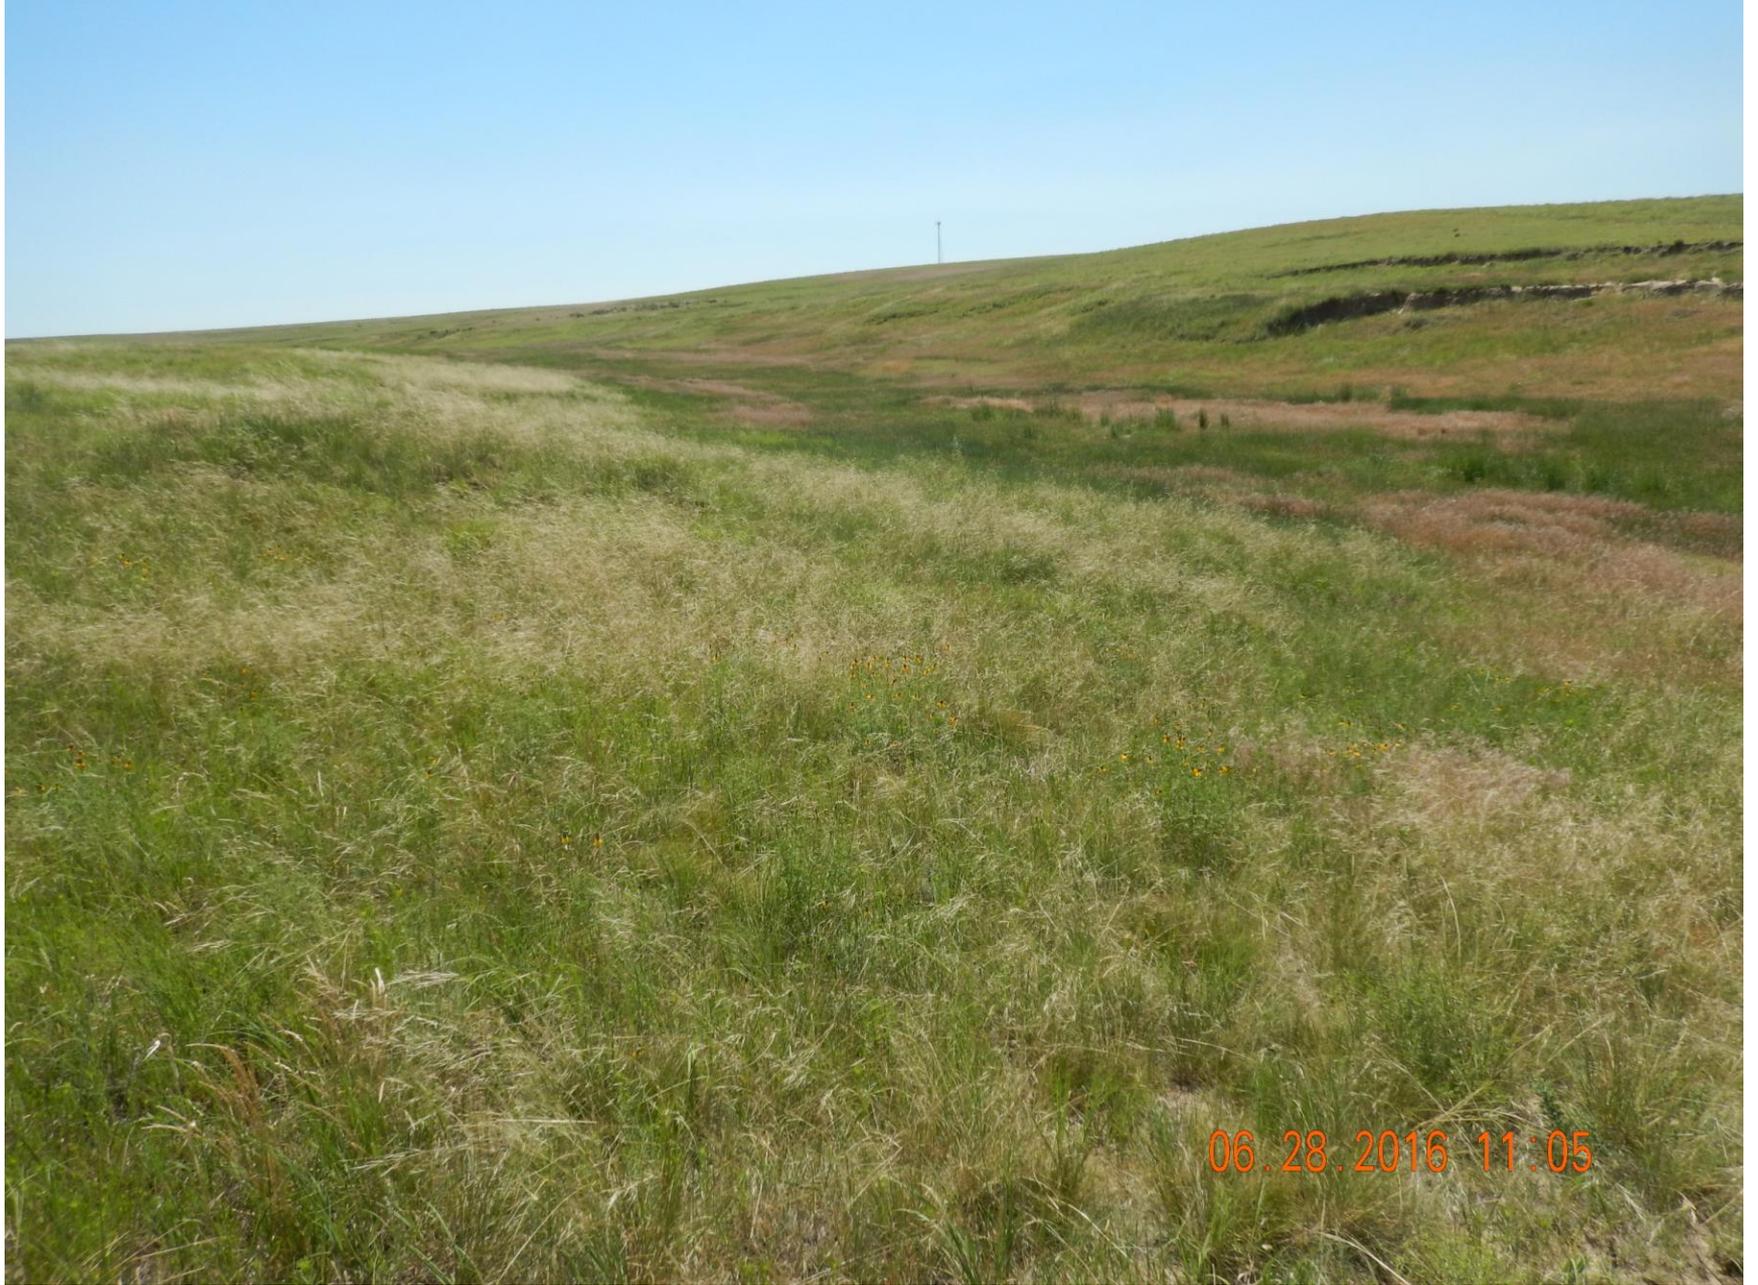
Figure 3: Photo taken from the north side of the intermittent stream, facing east. Photo shows vegetation within the drainage upstream of location.

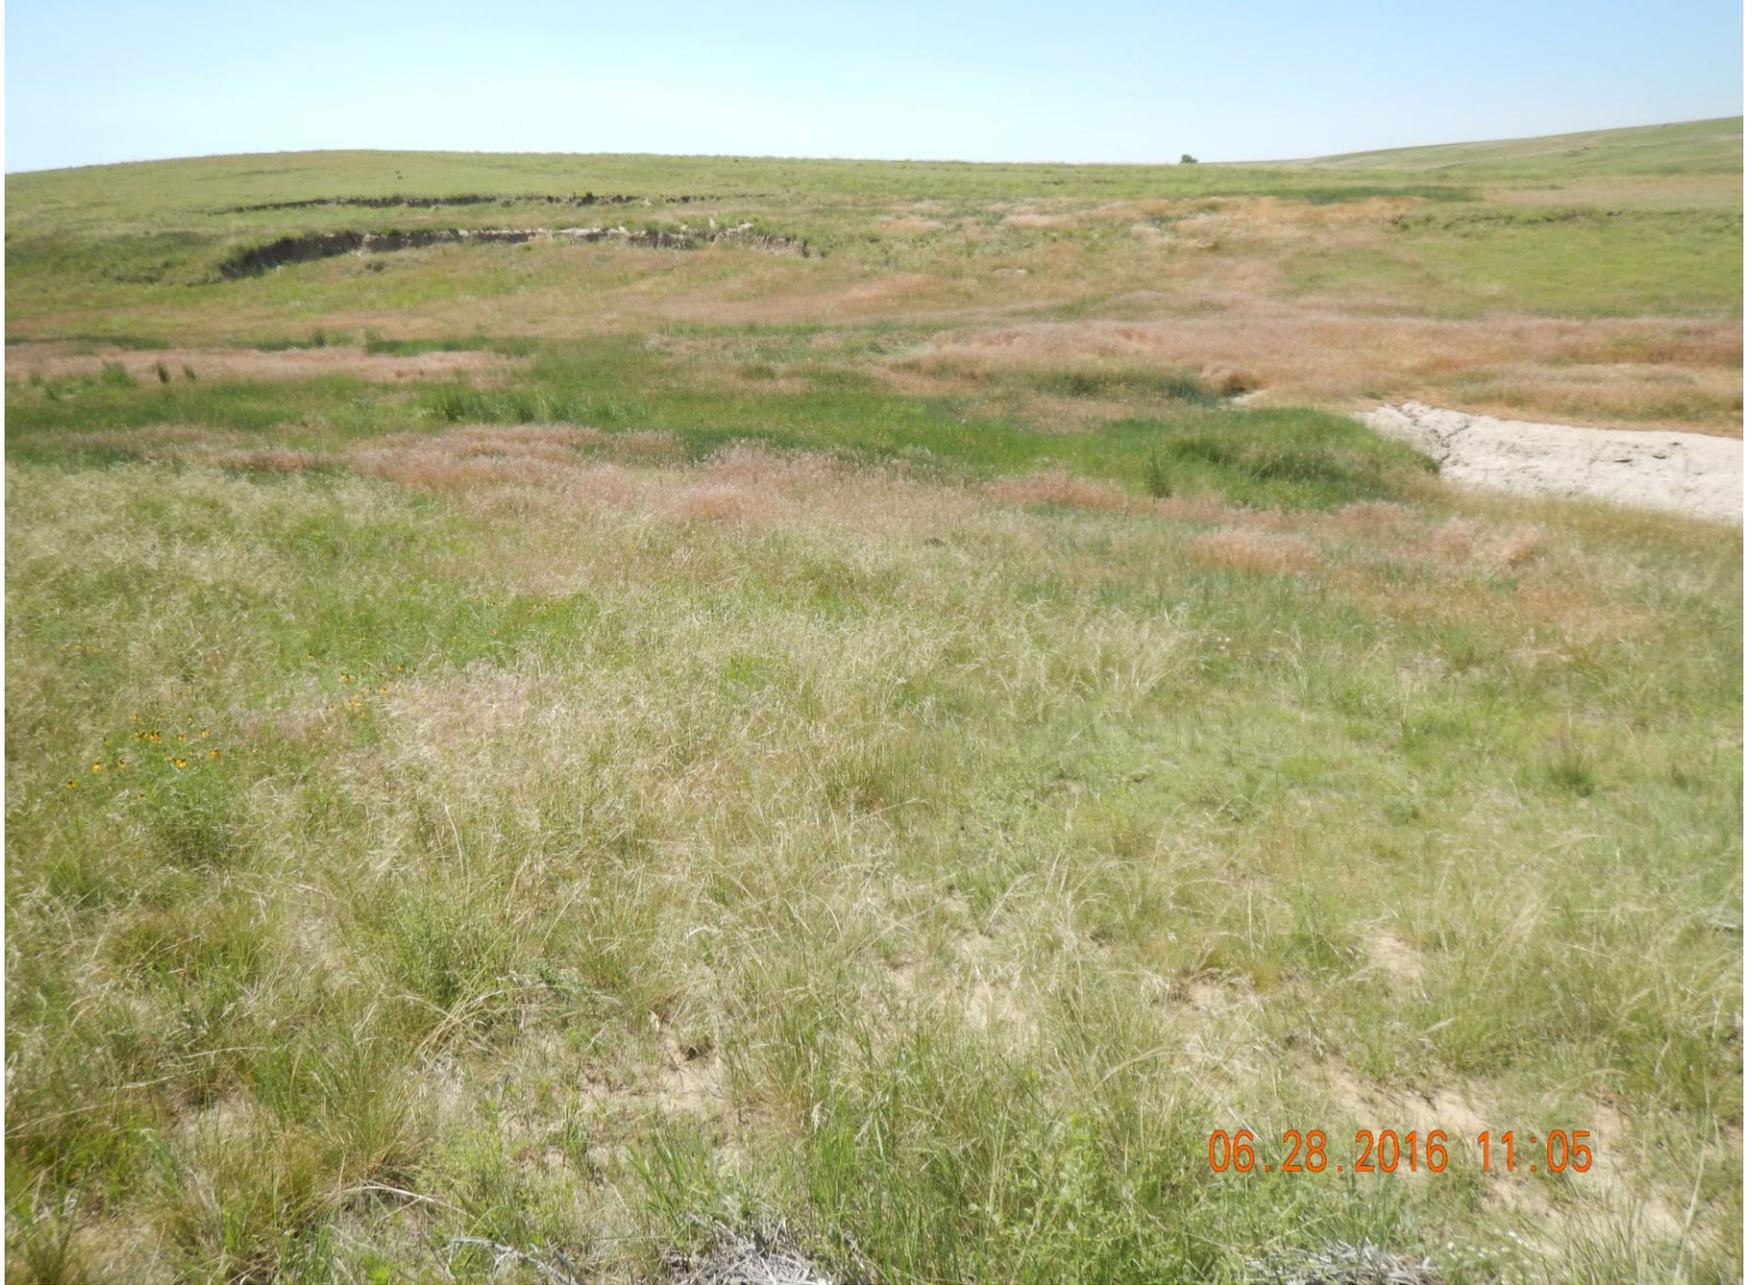
Figure 4: Photo taken from the north side of the intermittent stream, facing southeast towards the location (south side of stream). Photo shows vegetation within the drainage. Note degradation within drainage becomes evident.

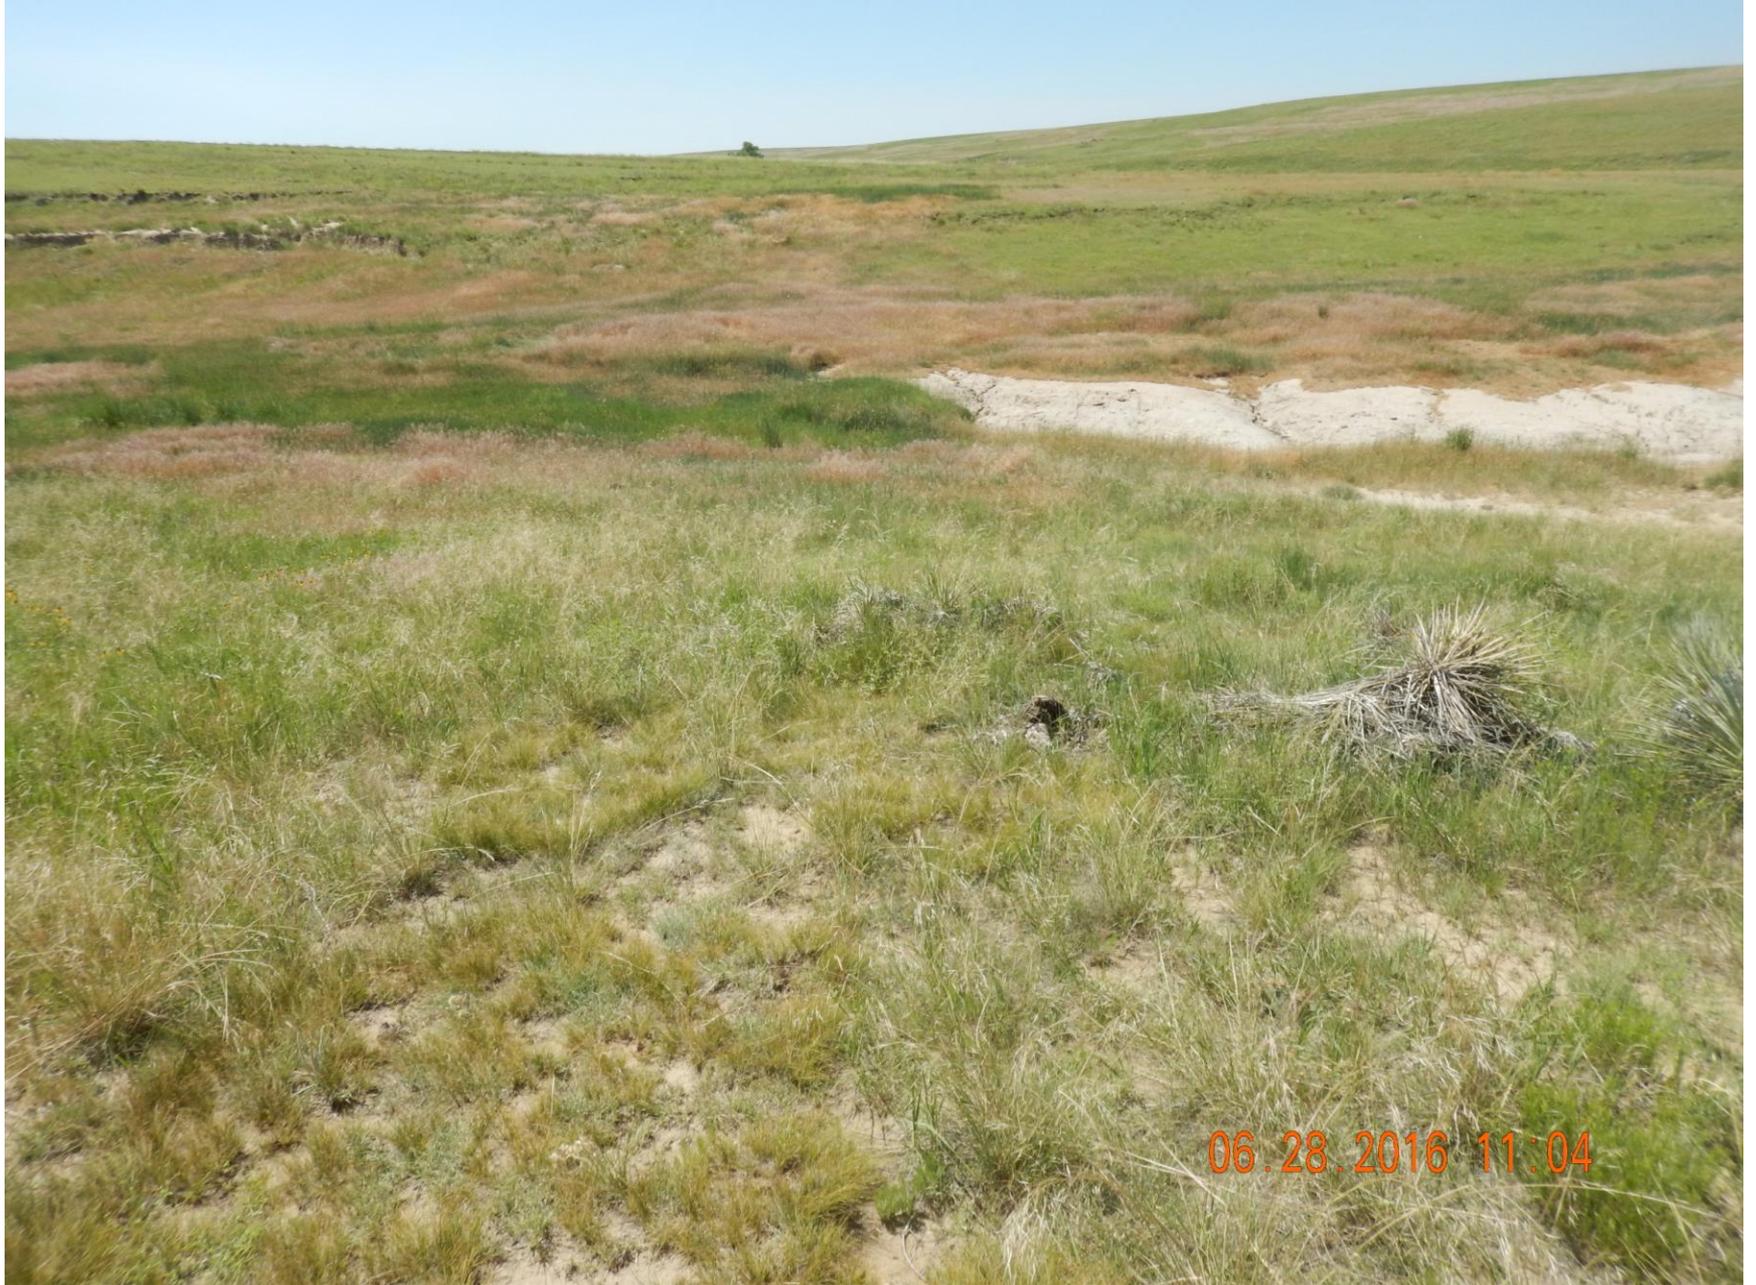
Figure 5: Photo taken from the north side of the intermittent stream, facing south towards the location (south side of stream). Photo shows vegetation within the drainage. Note degradation within drainage becomes evident.

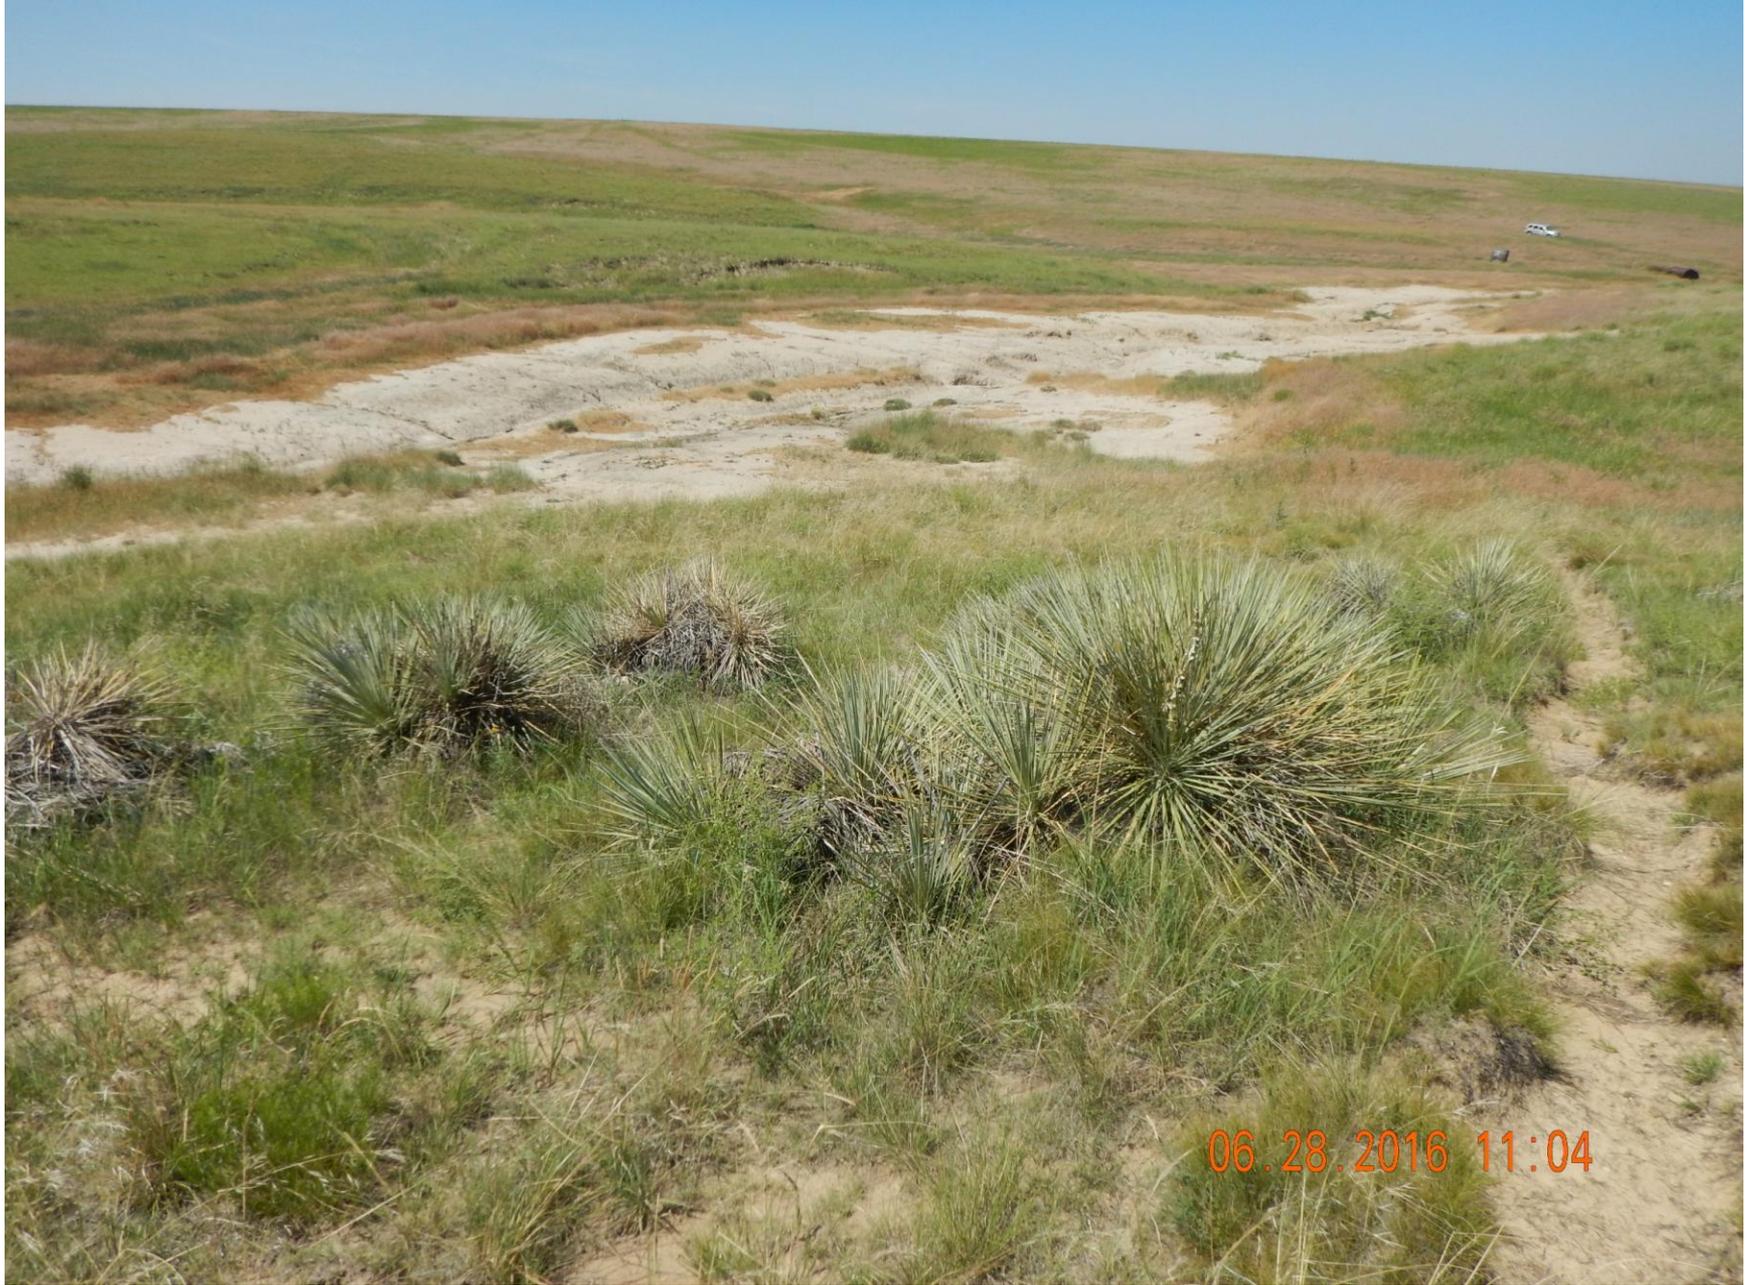
Figure 6: Photo taken from the north side of the intermittent stream, facing southwest. Photo shows (lack of) vegetation within the drainage downstream of location.

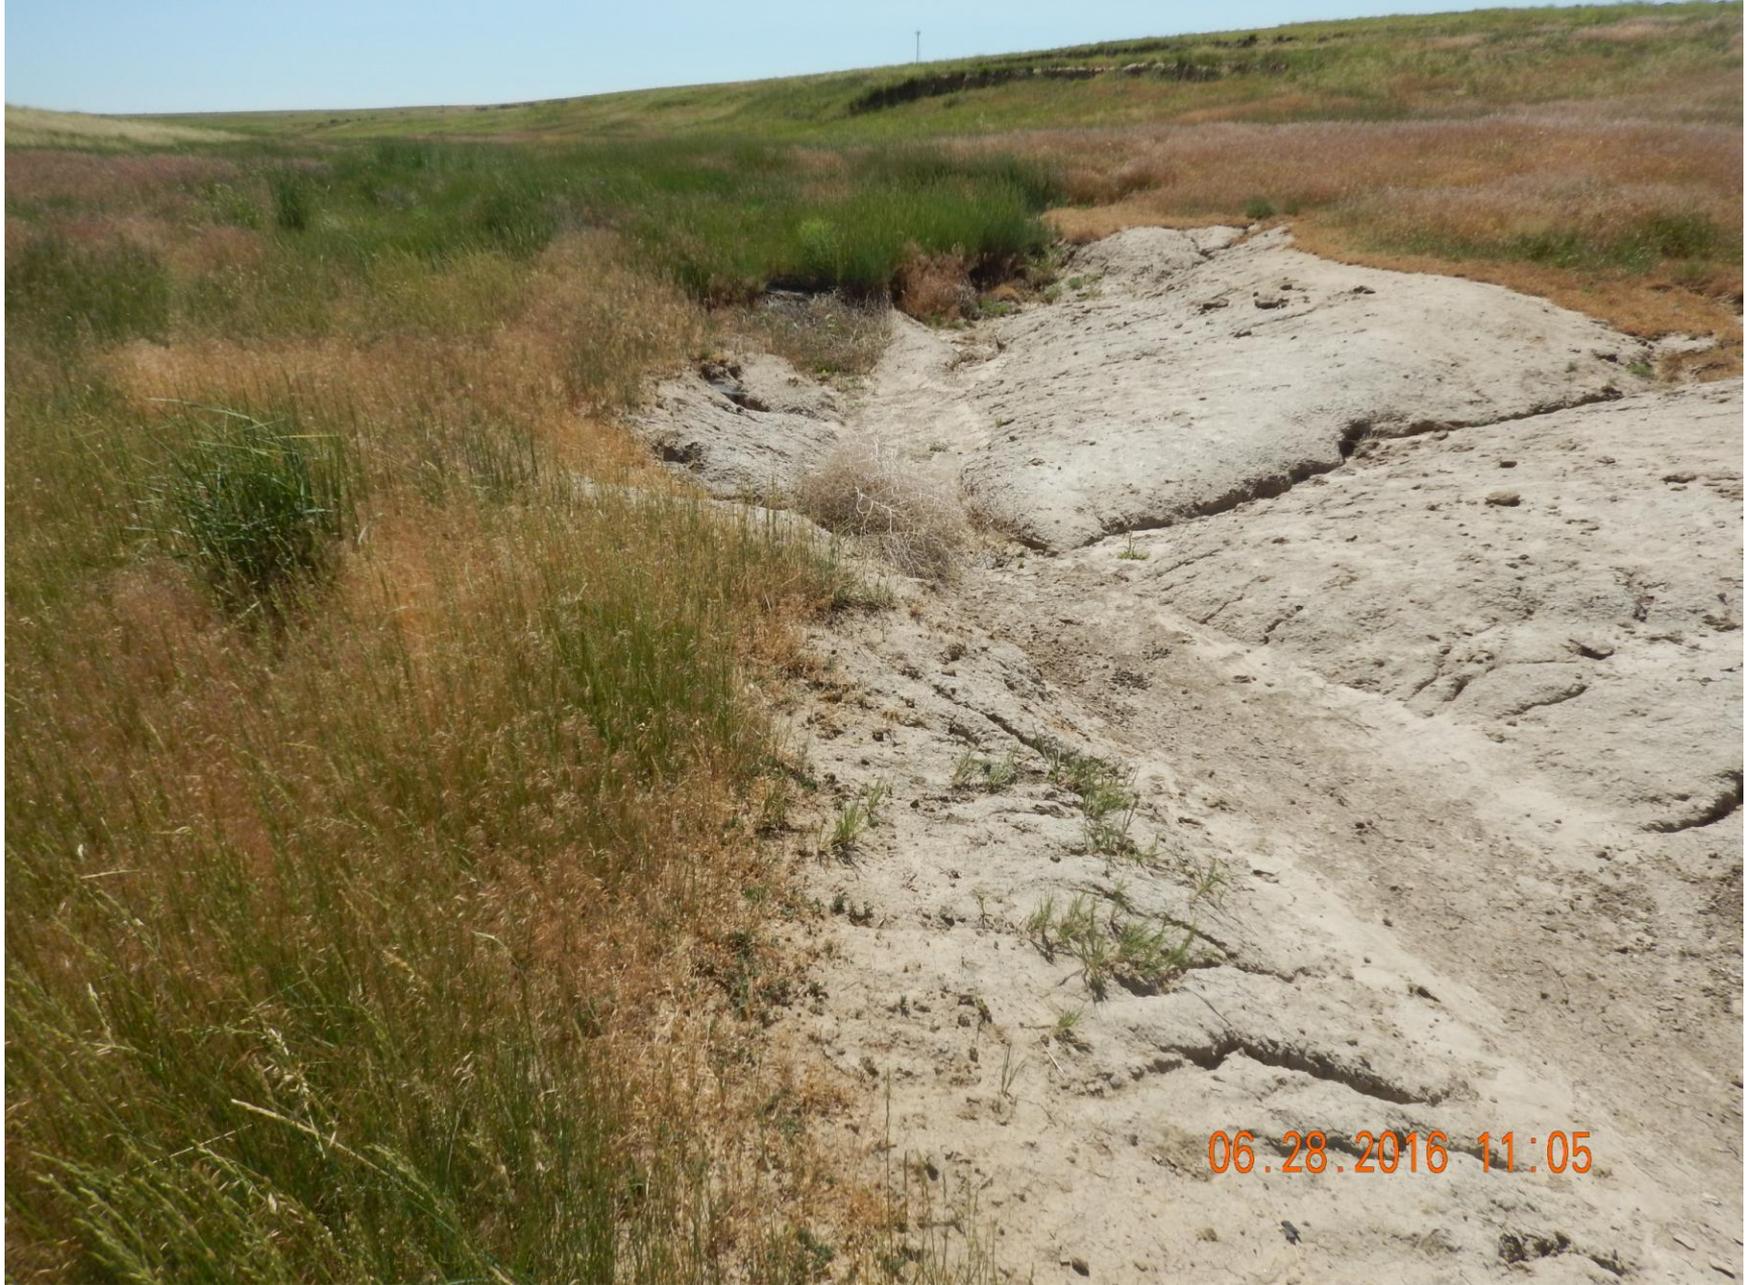
Figure 7: Photo taken within drainage, adjacent to the pit location, facing east. Photo shows areas of degradation.

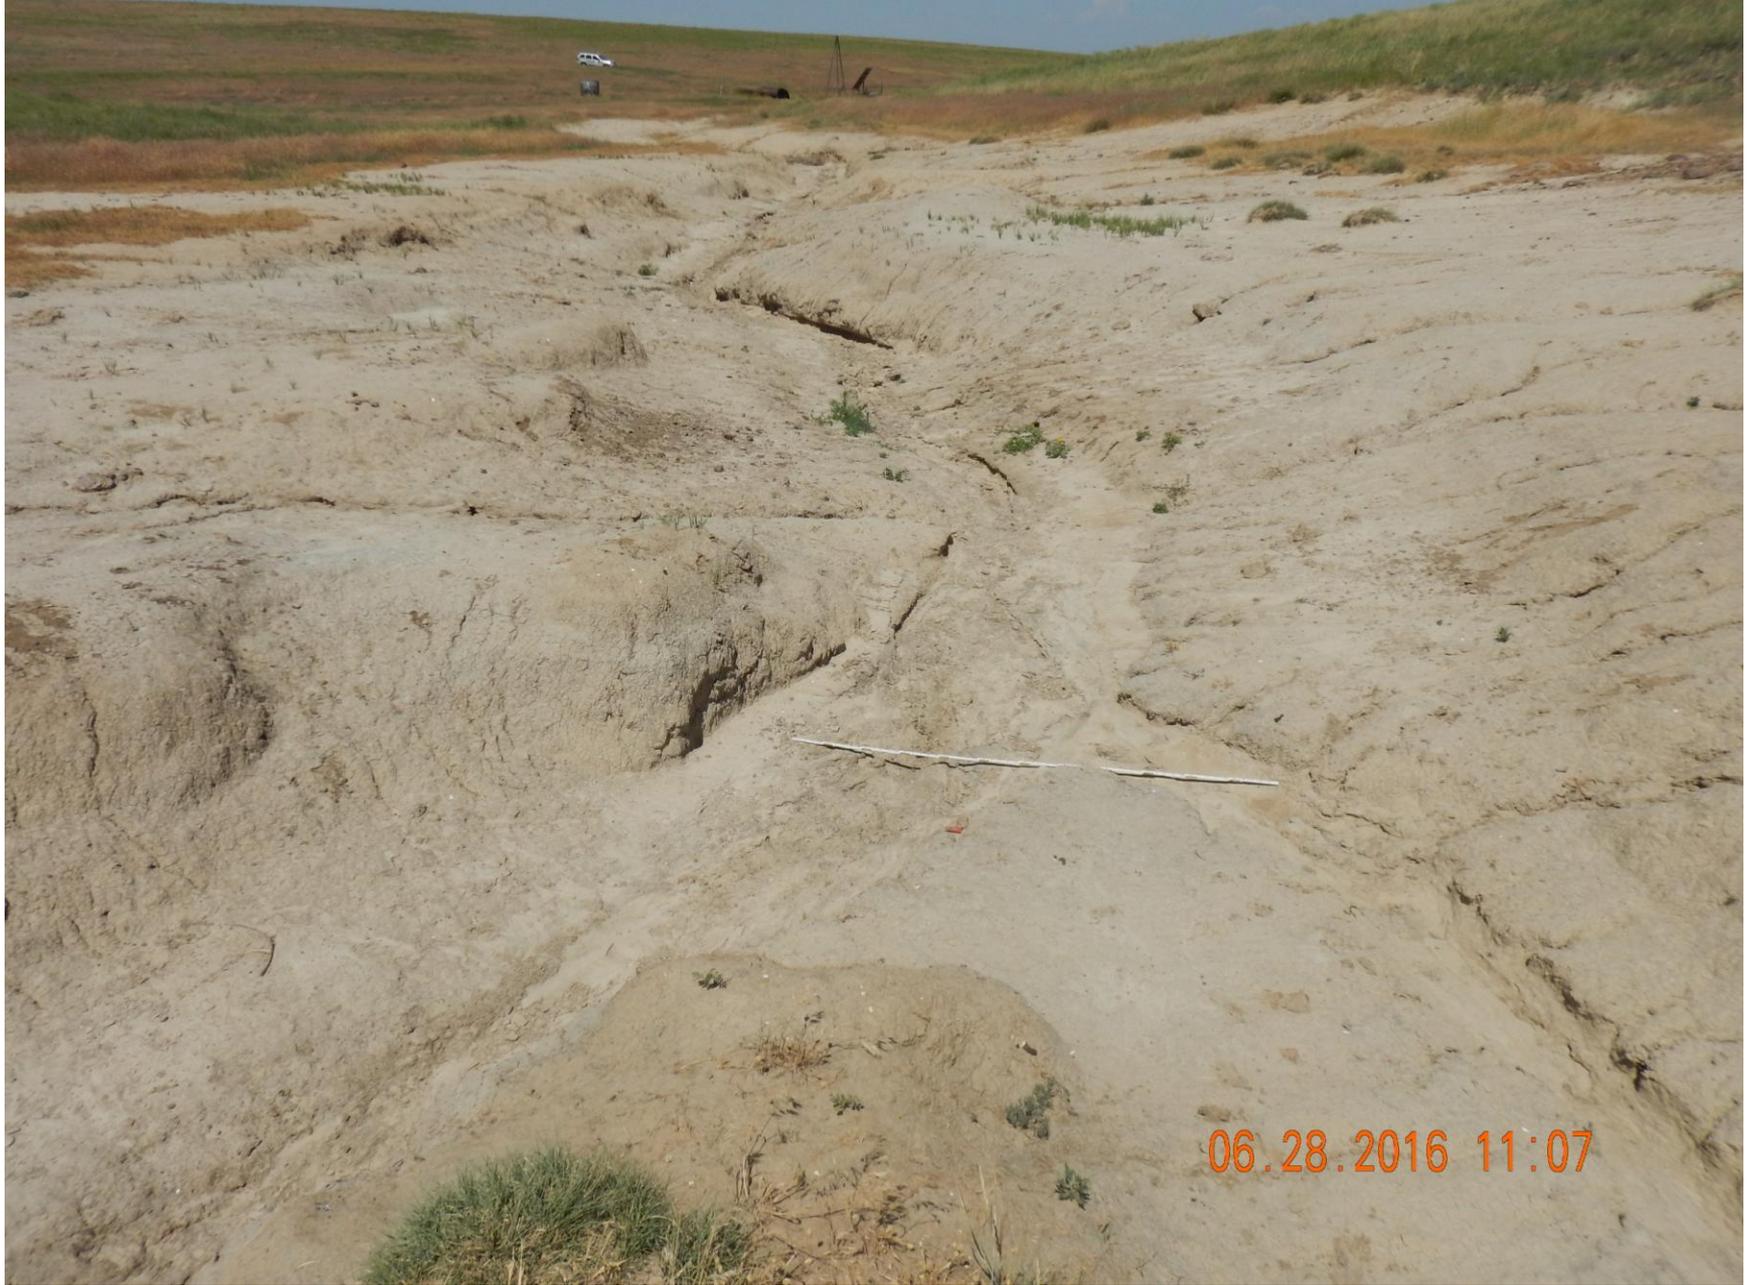
Figure 8: Photo taken within intermittent stream, facing west. Photo shows degradation within stream. 6' measuring stick in photo used for reference.
