Interim Reclamation Inspection

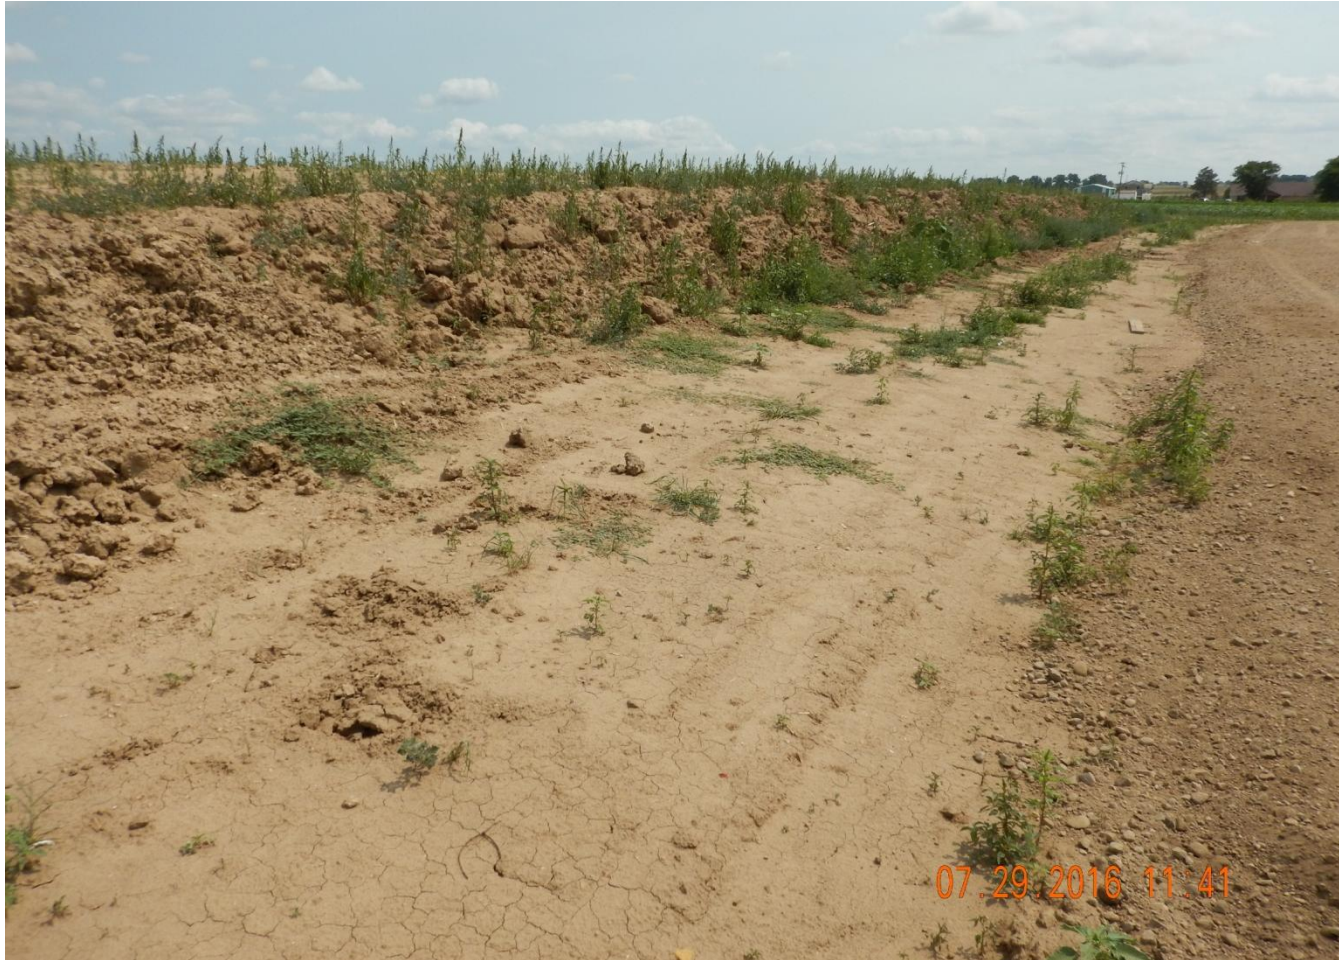
Photo 1. Photo taken from northern location, facing East, towards the south-facing topsoil stockpile. Per Rule 1002.c., best management practices to prevent weed establishment shall be implemented. Undesirable, weedy plant species dominates topsoil stockpile that is not protective of the topsoil stockpile.

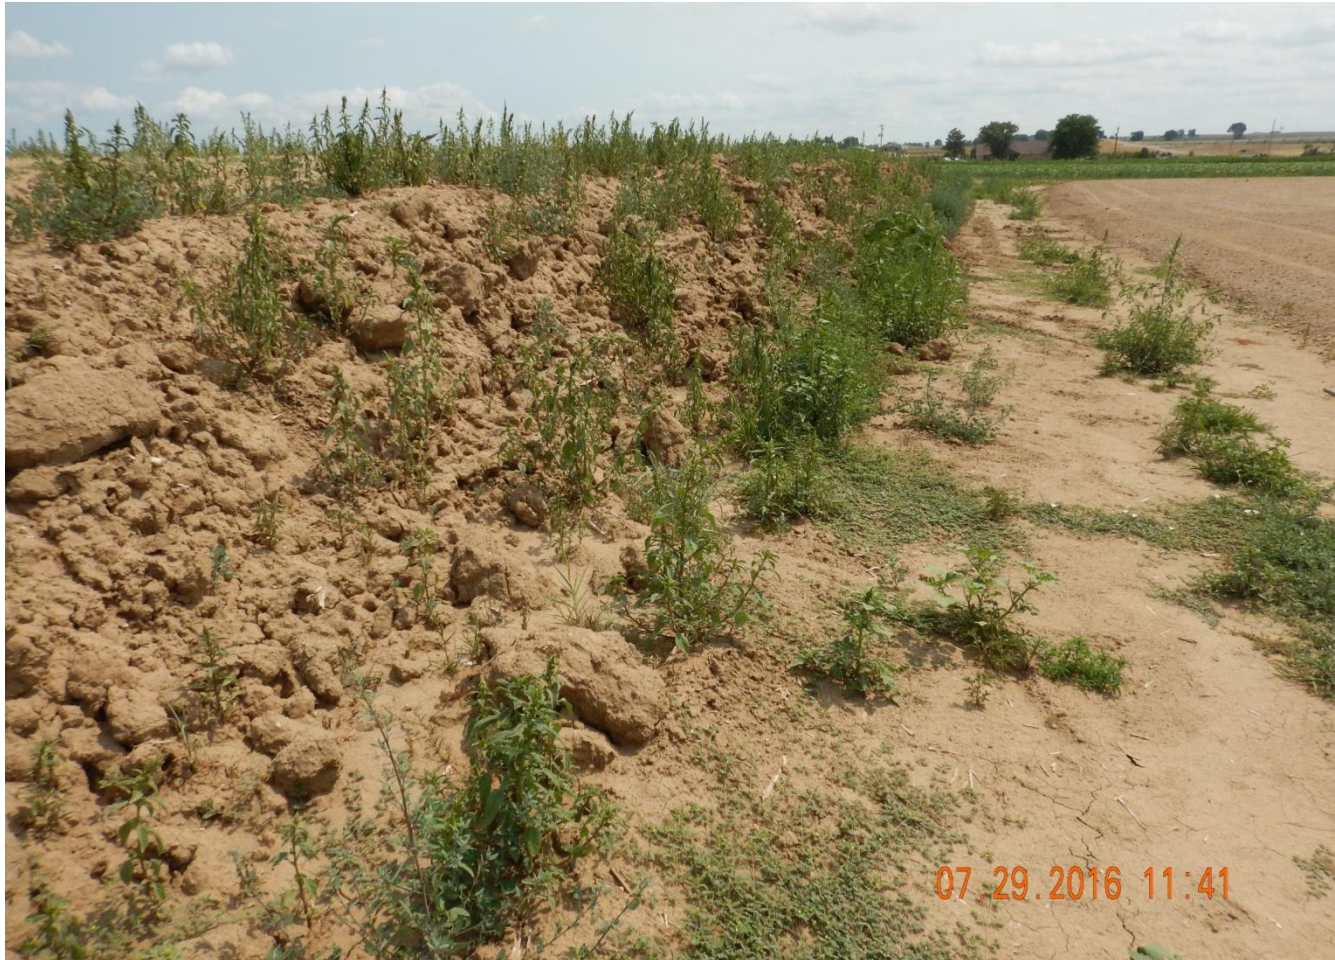
Photo 2. Photo taken from northern location, facing East, towards the south-facing topsoil stockpile. Per Rule 1002.c., best management practices to prevent weed establishment shall be implemented. Undesirable, weedy plant species dominates topsoil stockpile that is not protective of the topsoil stockpile.

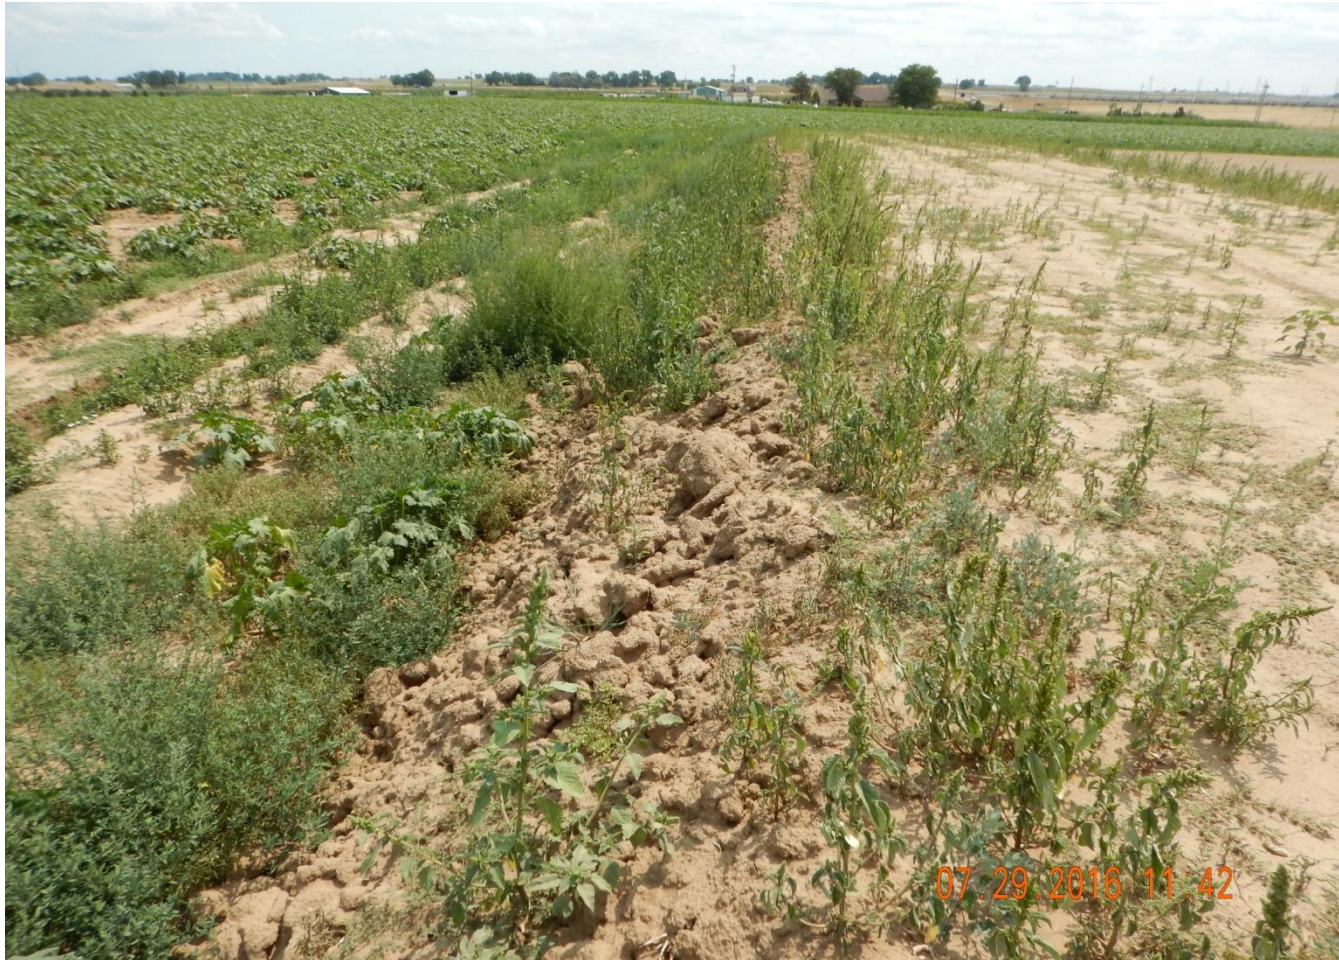
Photo 3. Photo taken from northern location, facing East, towards the north-facing topsoil stockpile. Per Rule 1002.c., best management practices to prevent weed establishment shall be implemented. Undesirable, weedy plant species dominates topsoil stockpile that is not protective of the topsoil stockpile.

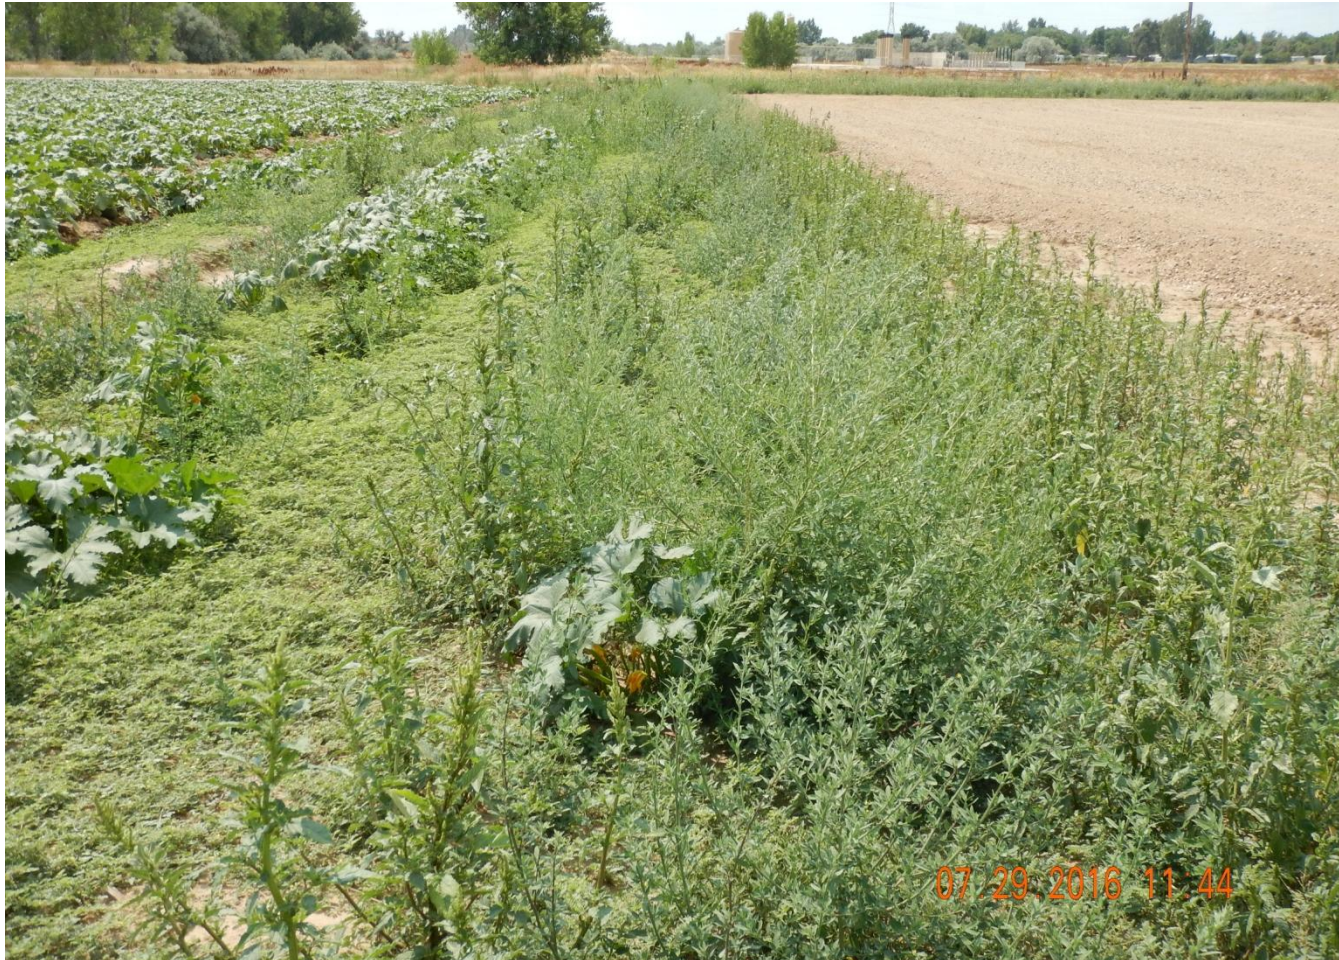
Photo 4. Photo taken from eastern location, facing South. Per Rule 1003.e., the area shall be treated if necessary and practicable to prevent invasion of undesirable species and noxious weeds on crop lands. Perimeter of location is dominated by undesirable plant species.

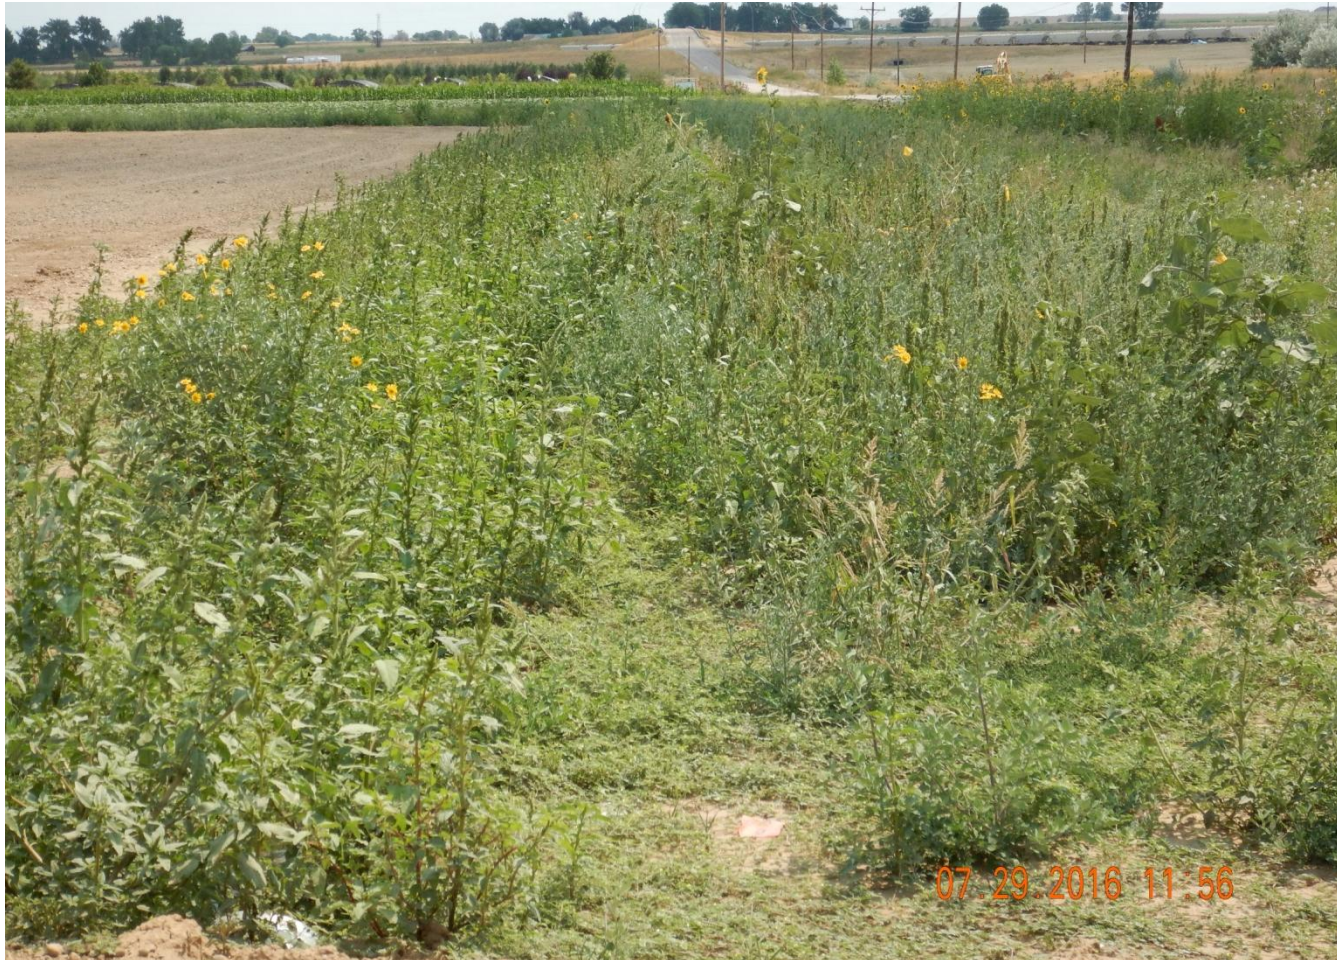
Photo 5. Photo taken from western location, facing South. Per Rule 1003.e., the area shall be treated if necessary and practicable to prevent invasion of undesirable species and noxious weeds on crop lands. Perimeter of location is dominated by undesirable plant species.
