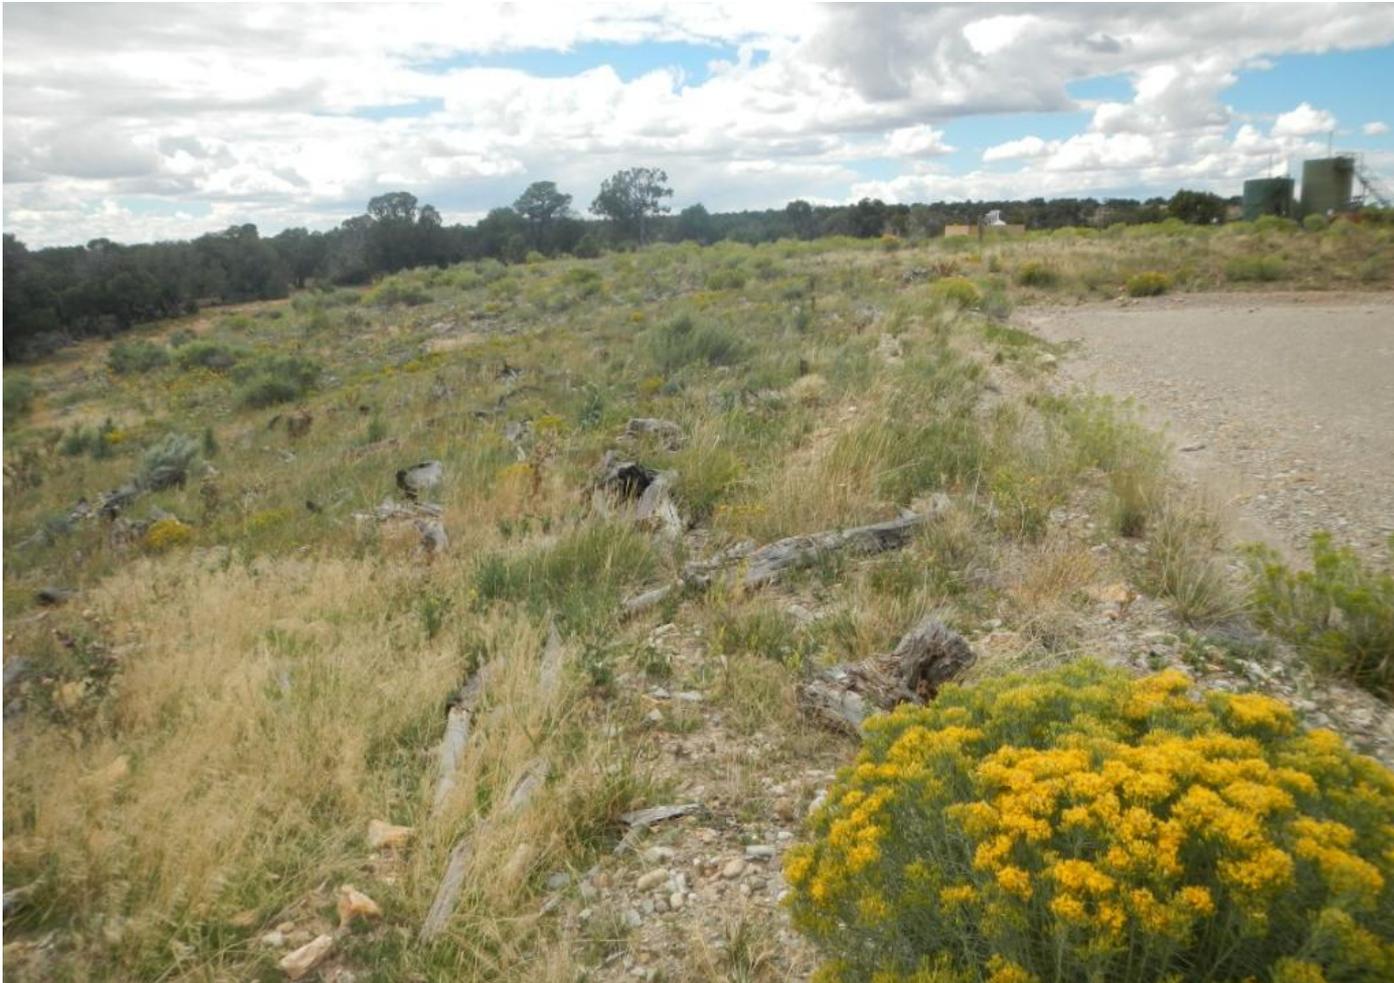
Photo 2. View of the southern portion of the project area from the southeastern corner facing westward. Revegetation is progressing and with desirable and weedy species such as western wheatgrass (*Pascopyrum smithii*), rubber rabbitbrush (*Chrysothamnus nauseosus*), and cheatgrass (*Bromus tectorum*).

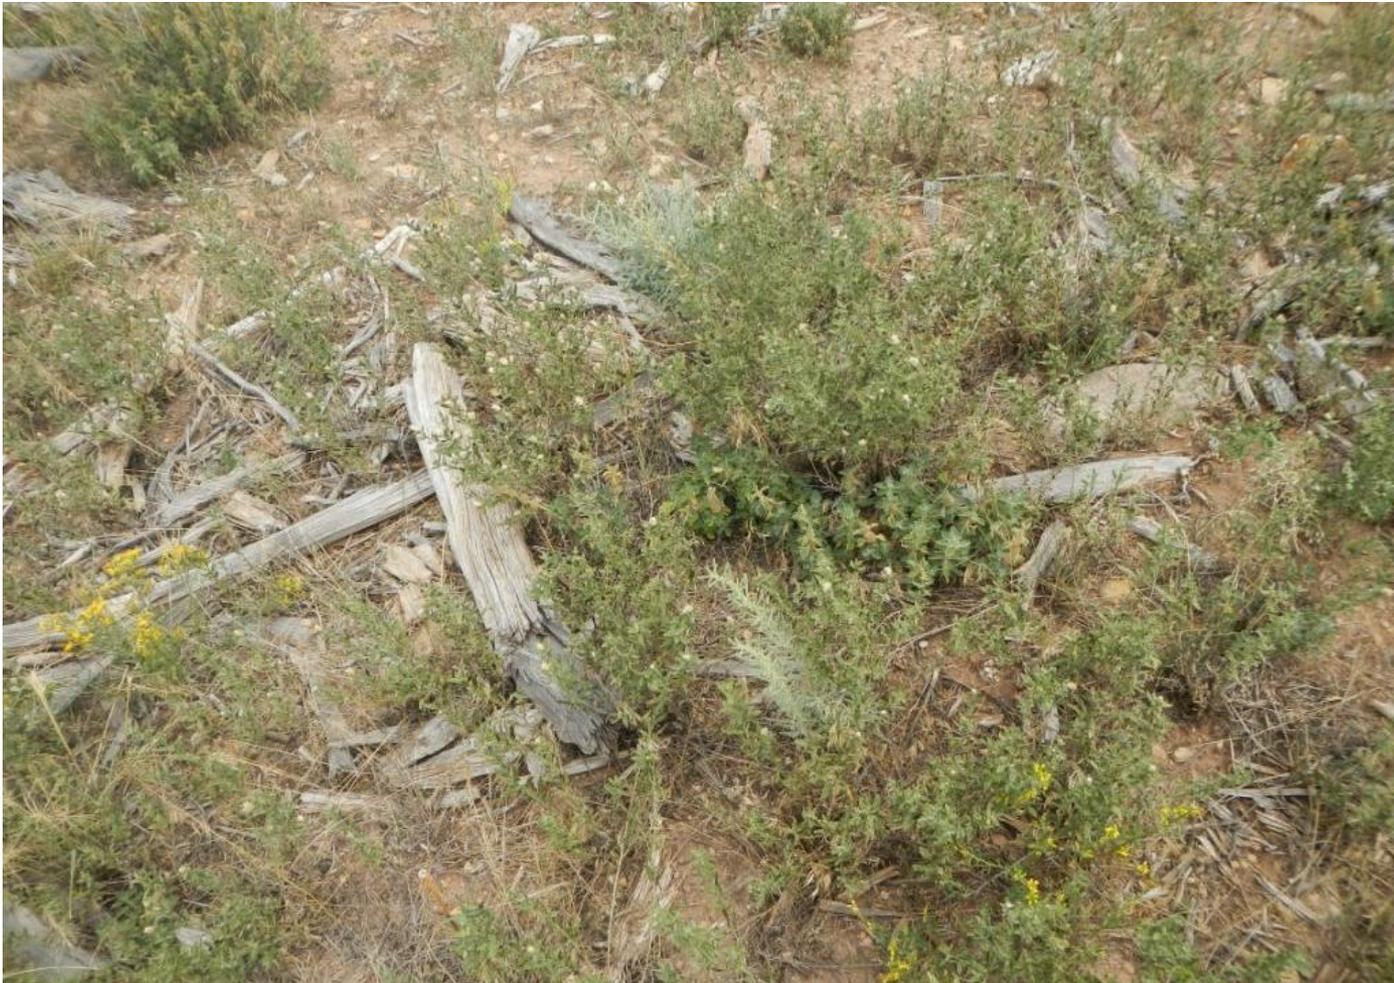
Photo 3. View of the Russian knapweed (*Acroptilon repens*) in the eastern portion of the project area. Approximately 200 plants were observed.

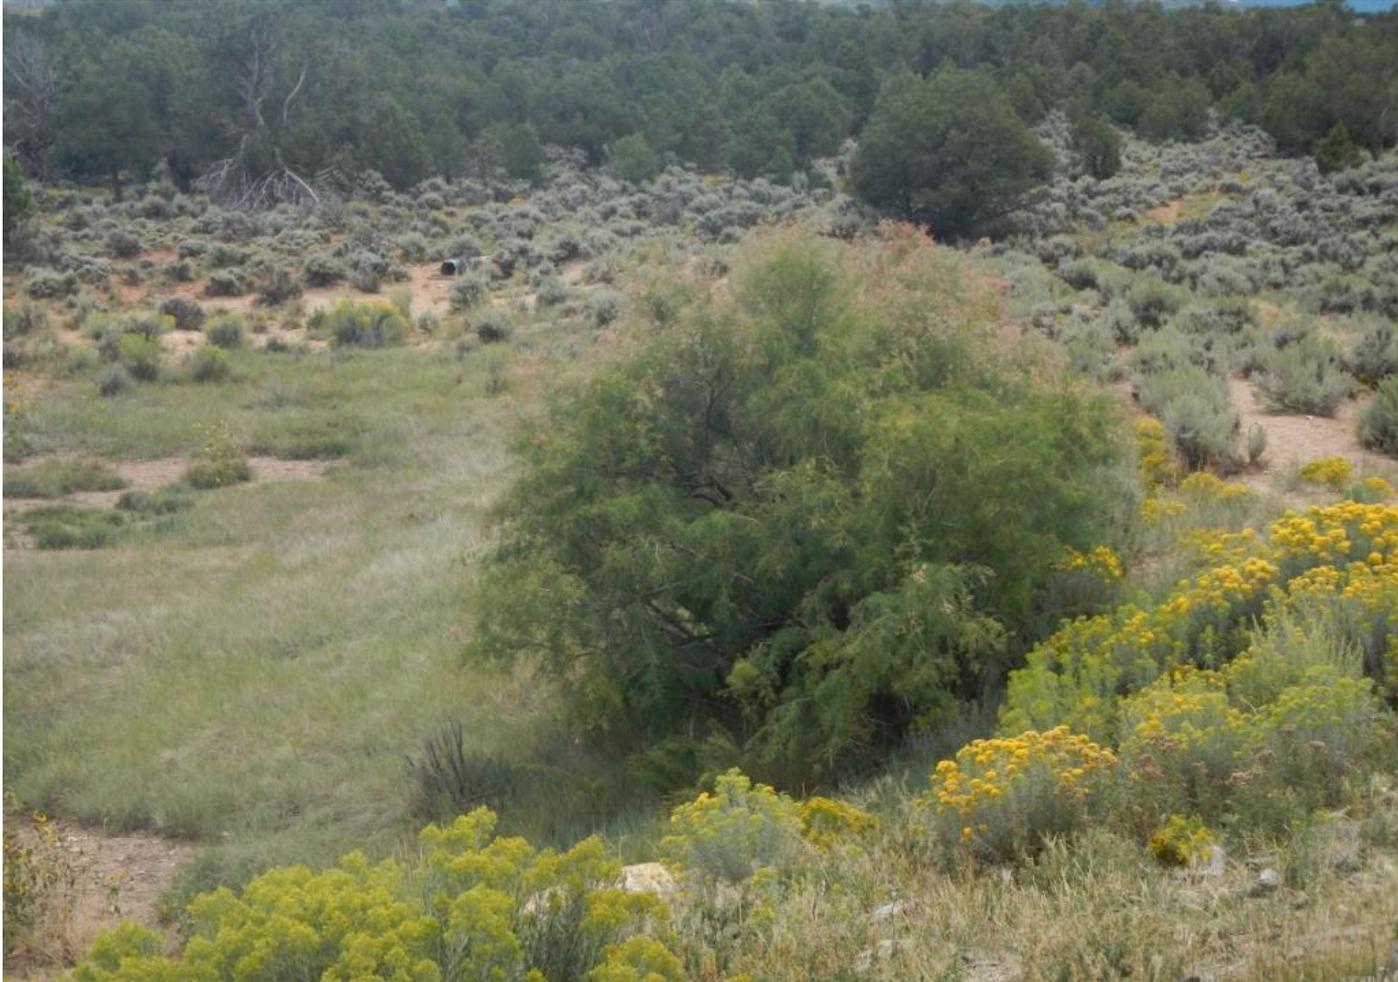
Photo 3. View of salt cedar (*Tamarix* sp.) growing in silt trap in southeastern portion of the project area.

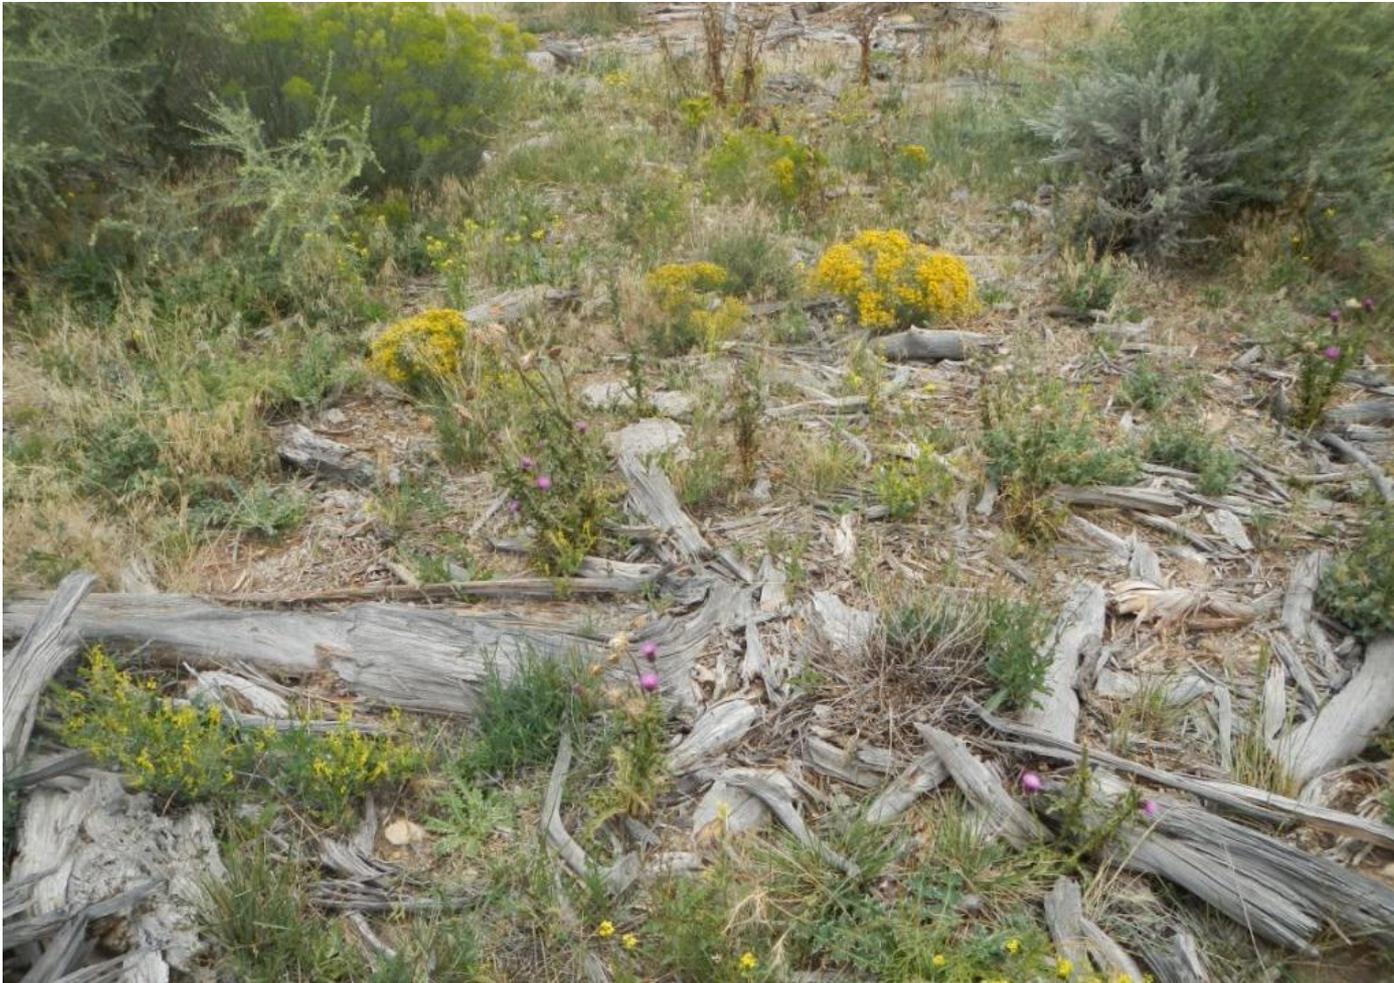
Photo 3. View of musk thistles (*Carduus nutans*) growing within the southern portion of the interim reclamation area. At least 1000 musk thistles are growing throughout the reclamation areas.
