## **COGCC Remediation Project #9425 Update**

### **September 29, 2016**

# Nelson water well

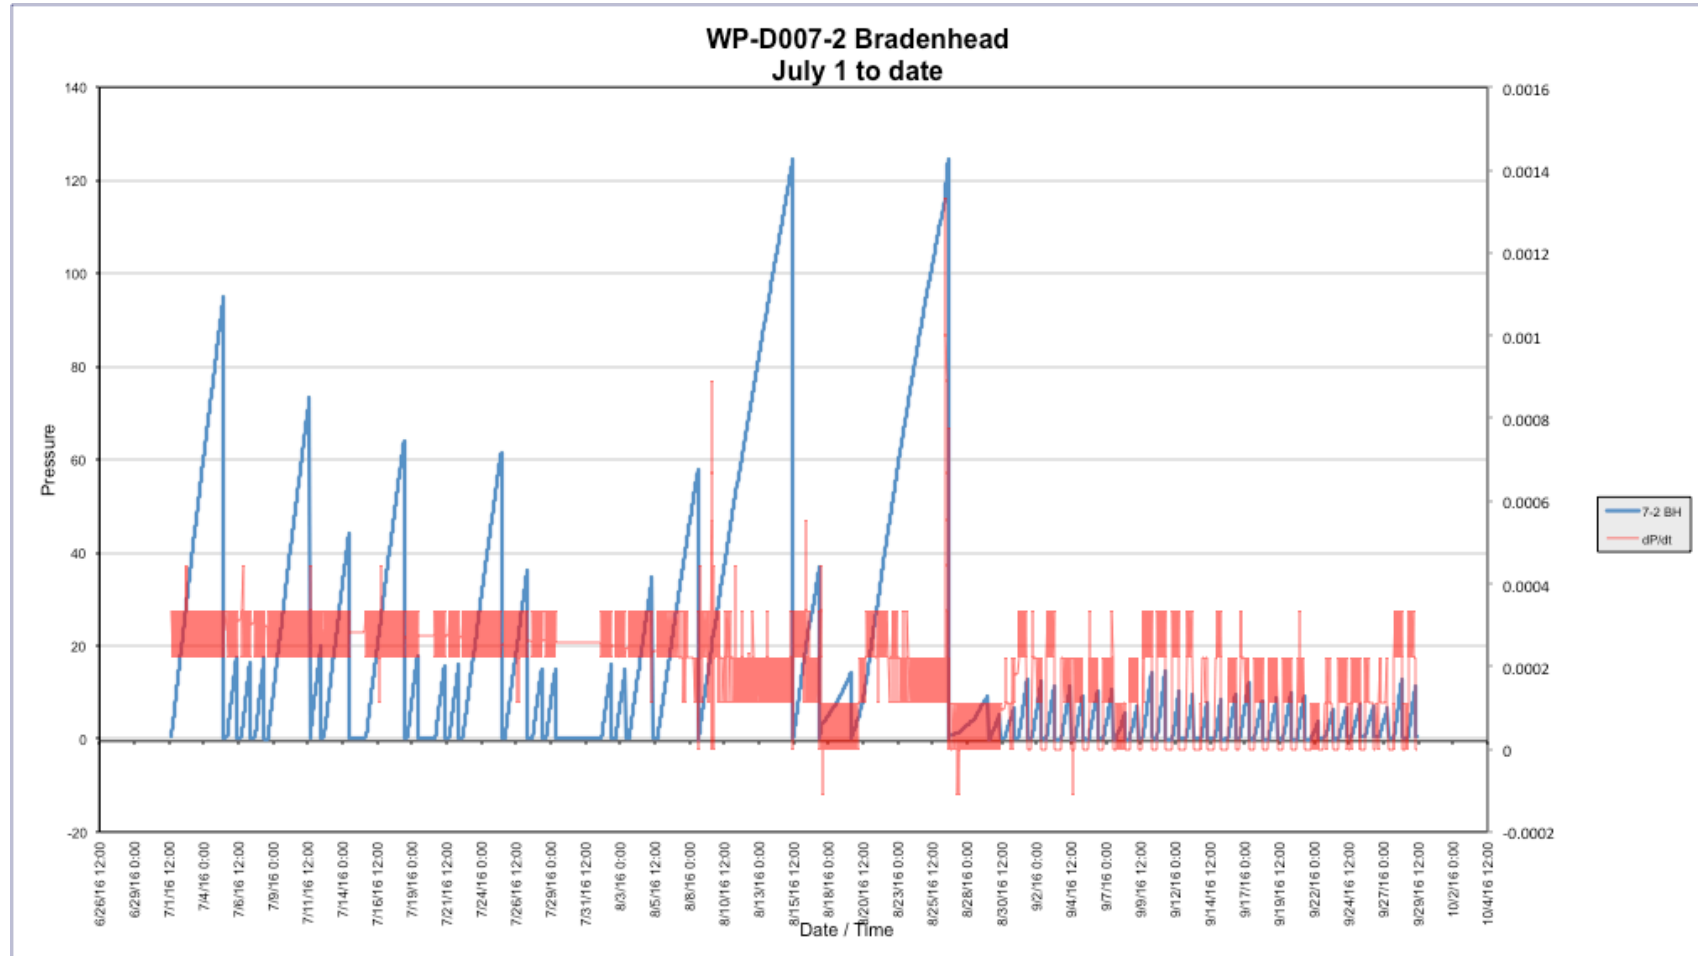
## WP-D007-2 post-remediation bradenhead pressure monitoring

Initial Pressure 790 psig

- Remediation work complete
  - Perforated and squeezed at 5142' and 3040'
  - Performed acid job on well to improve performance after contaminating near well bore with squeeze cement

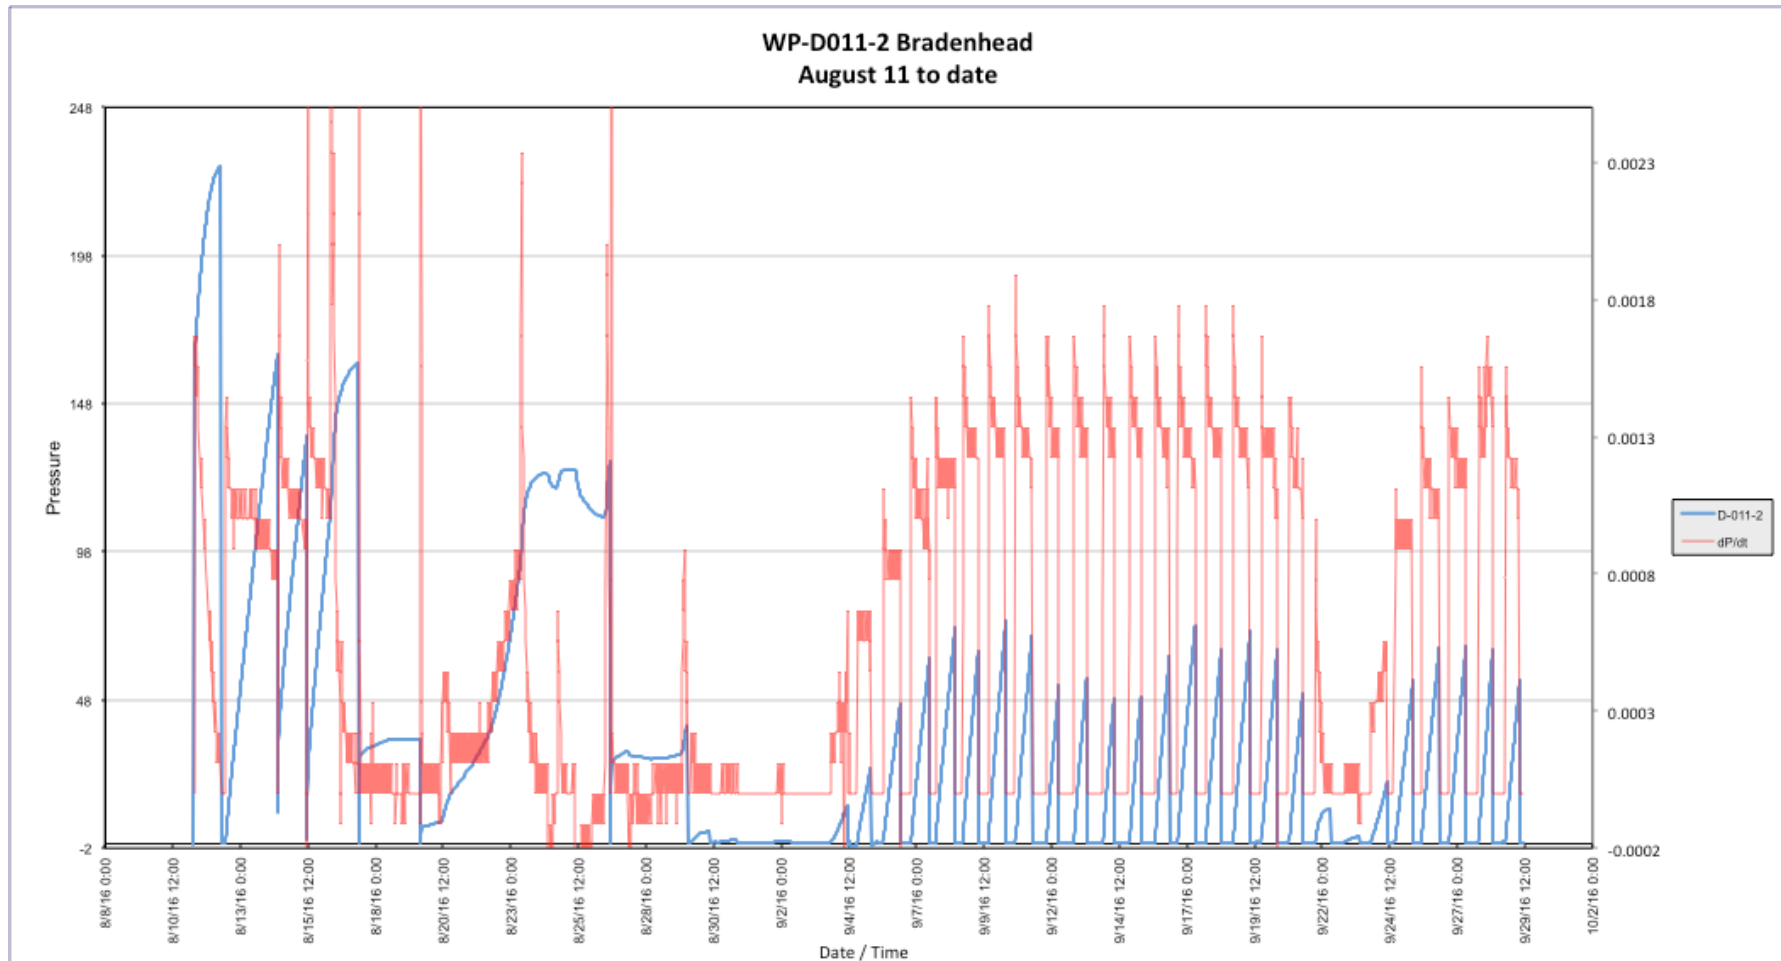
## WP-D011-2 post-remediation bradenhead pressure monitoring

Initial Pressure 390 psig

- Remediation work complete
  - Perforated at 1,850' and performed squeeze.
  - Performed second squeeze at 1,770.
  - Performed subsequent squeeze jobs with WellLock due to perfs leaking.

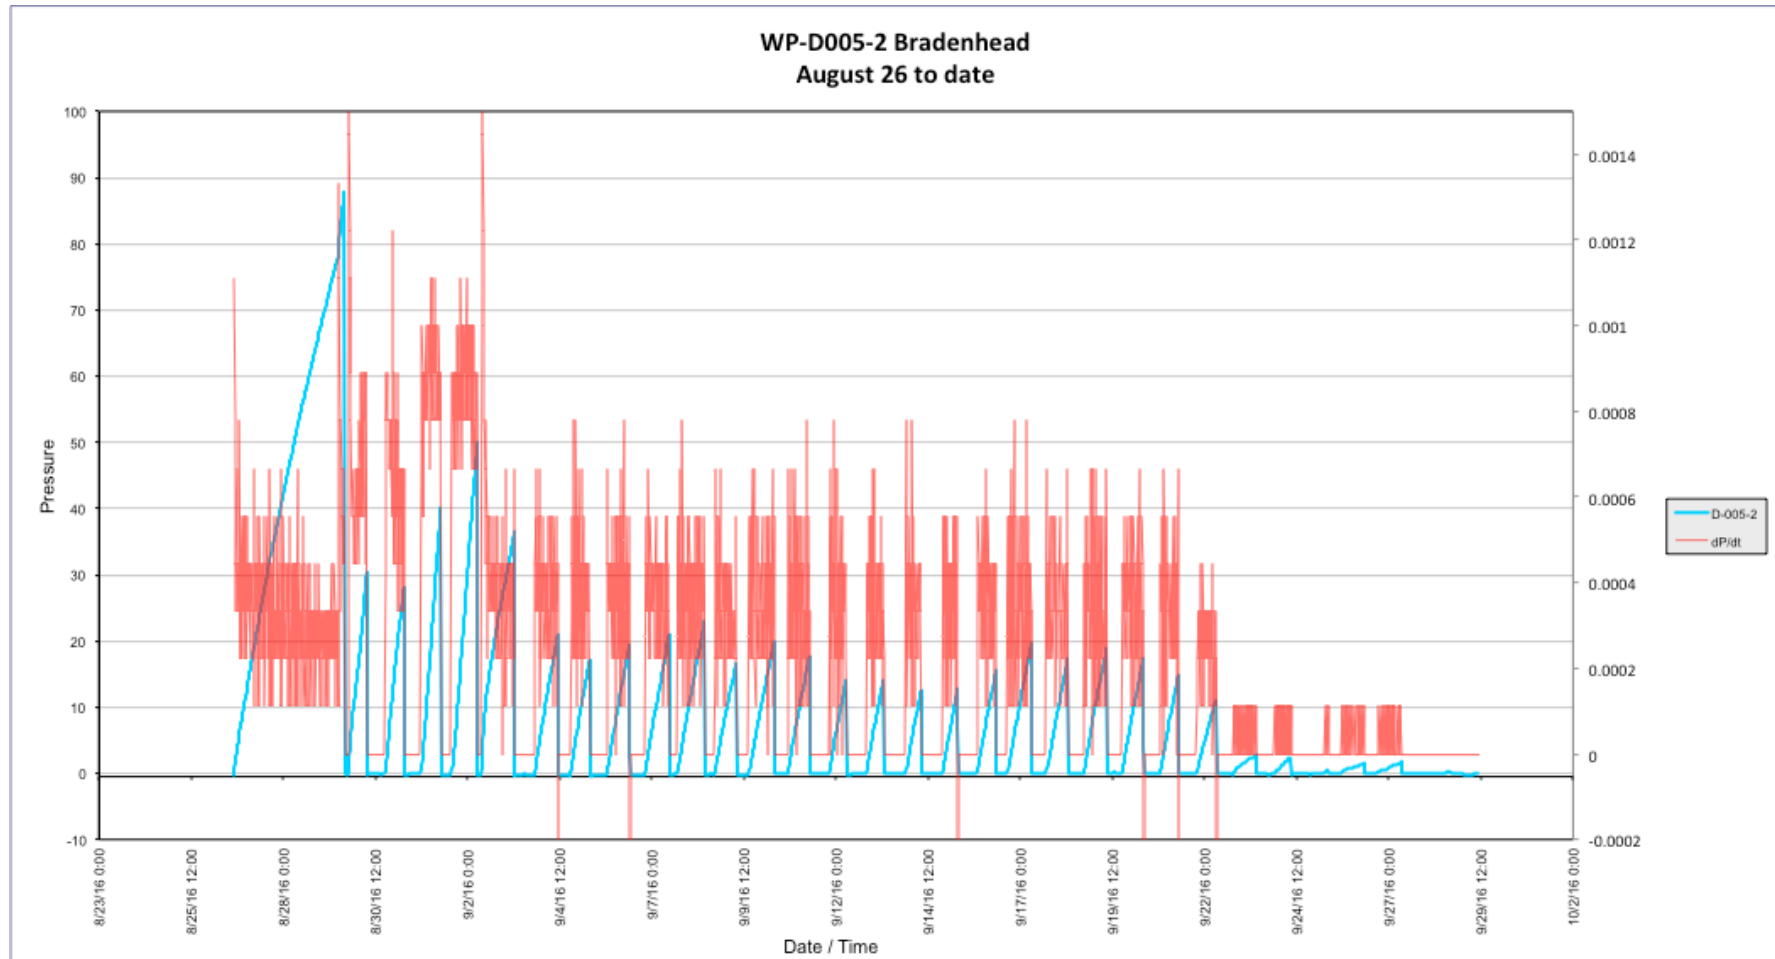
## WP-D005-2 post-remediation bradenhead pressure monitoring

Initial Pressure 724 psig

- Remediation work complete
  - Perforated at 5,070' and performed block squeeze.

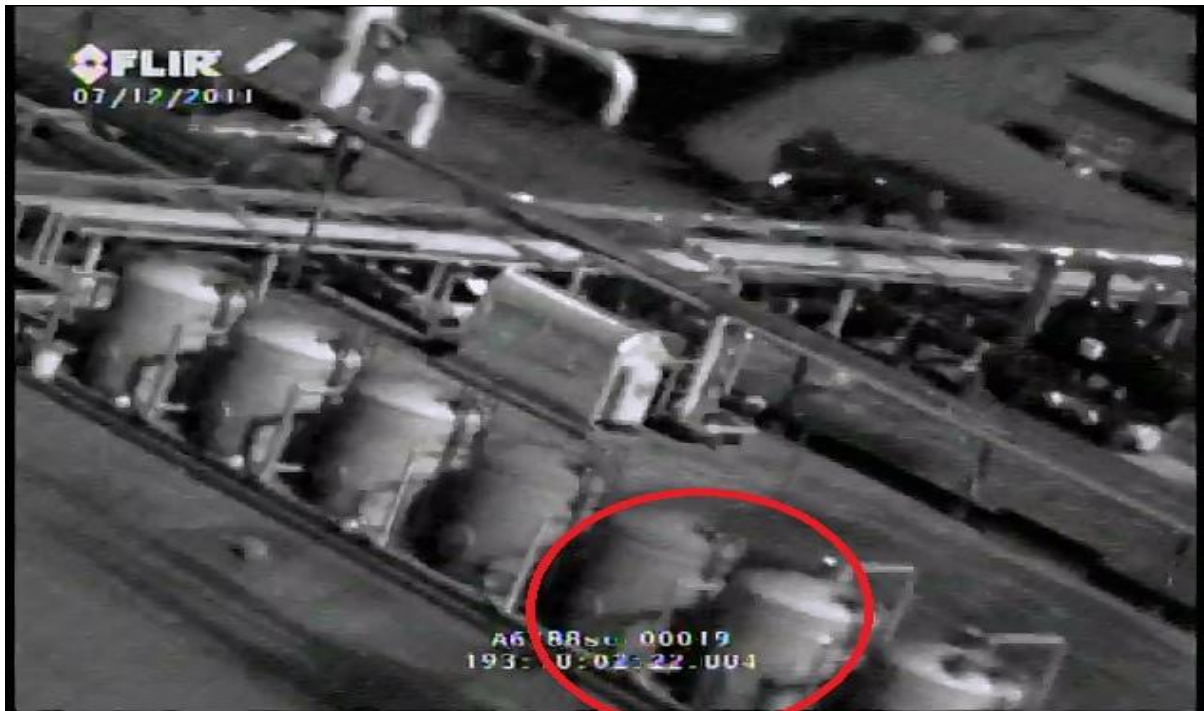
Optical Gas Imaging View of the emission source.

The pictures above are of the possible emission source taken in post-process from the Mid-Wave Infrared Camera (MWIR) with Grayscale filter applied and Color Camera. The videos as well as all of the associated metadata acquired during survey are accessible via the secured server provided by Red Hen Systems, LLC, the access credentials to the server are provided below:

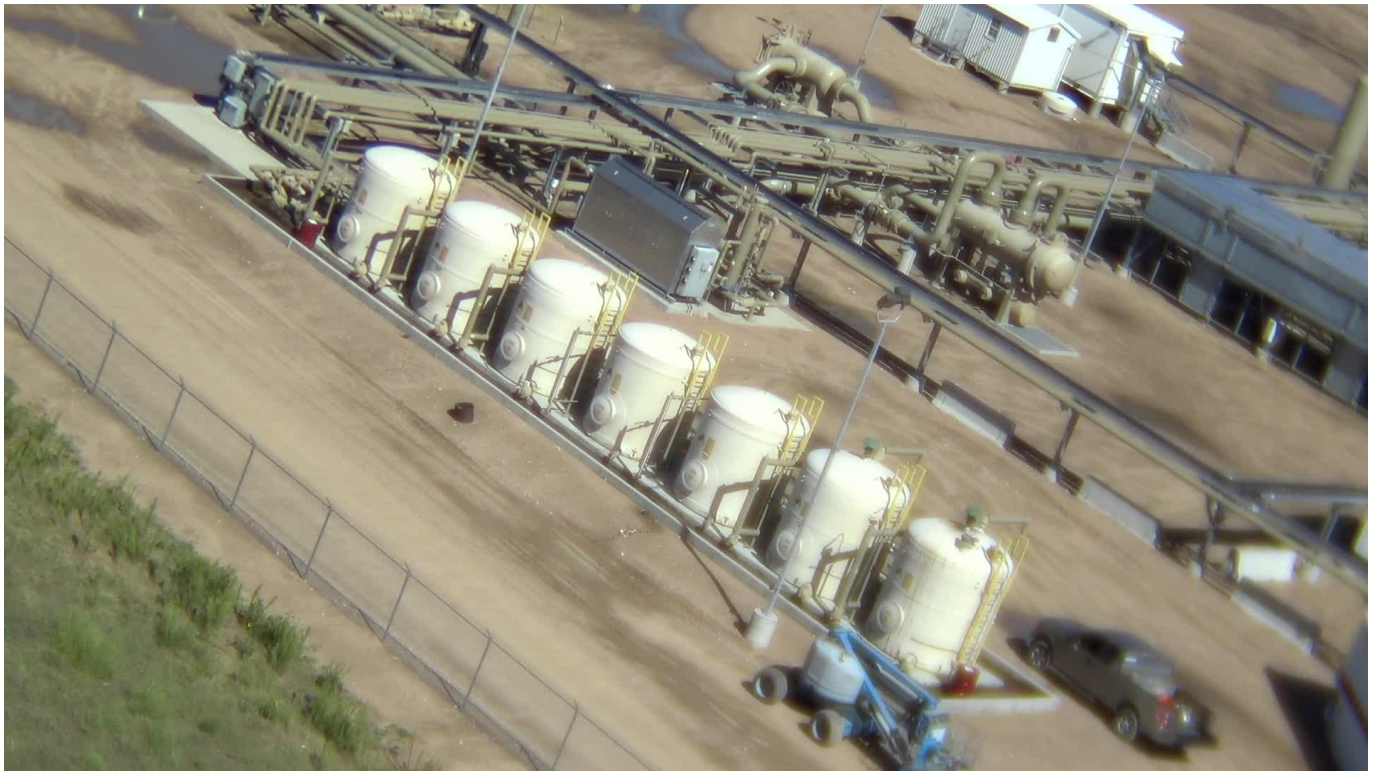
Color Camera View of the emission source.
