Final Reclamation & Stormwater Inspection

Operator: Kaiser-Francis Oil Co # 45898

Location ID: 376749

Adams County, CO

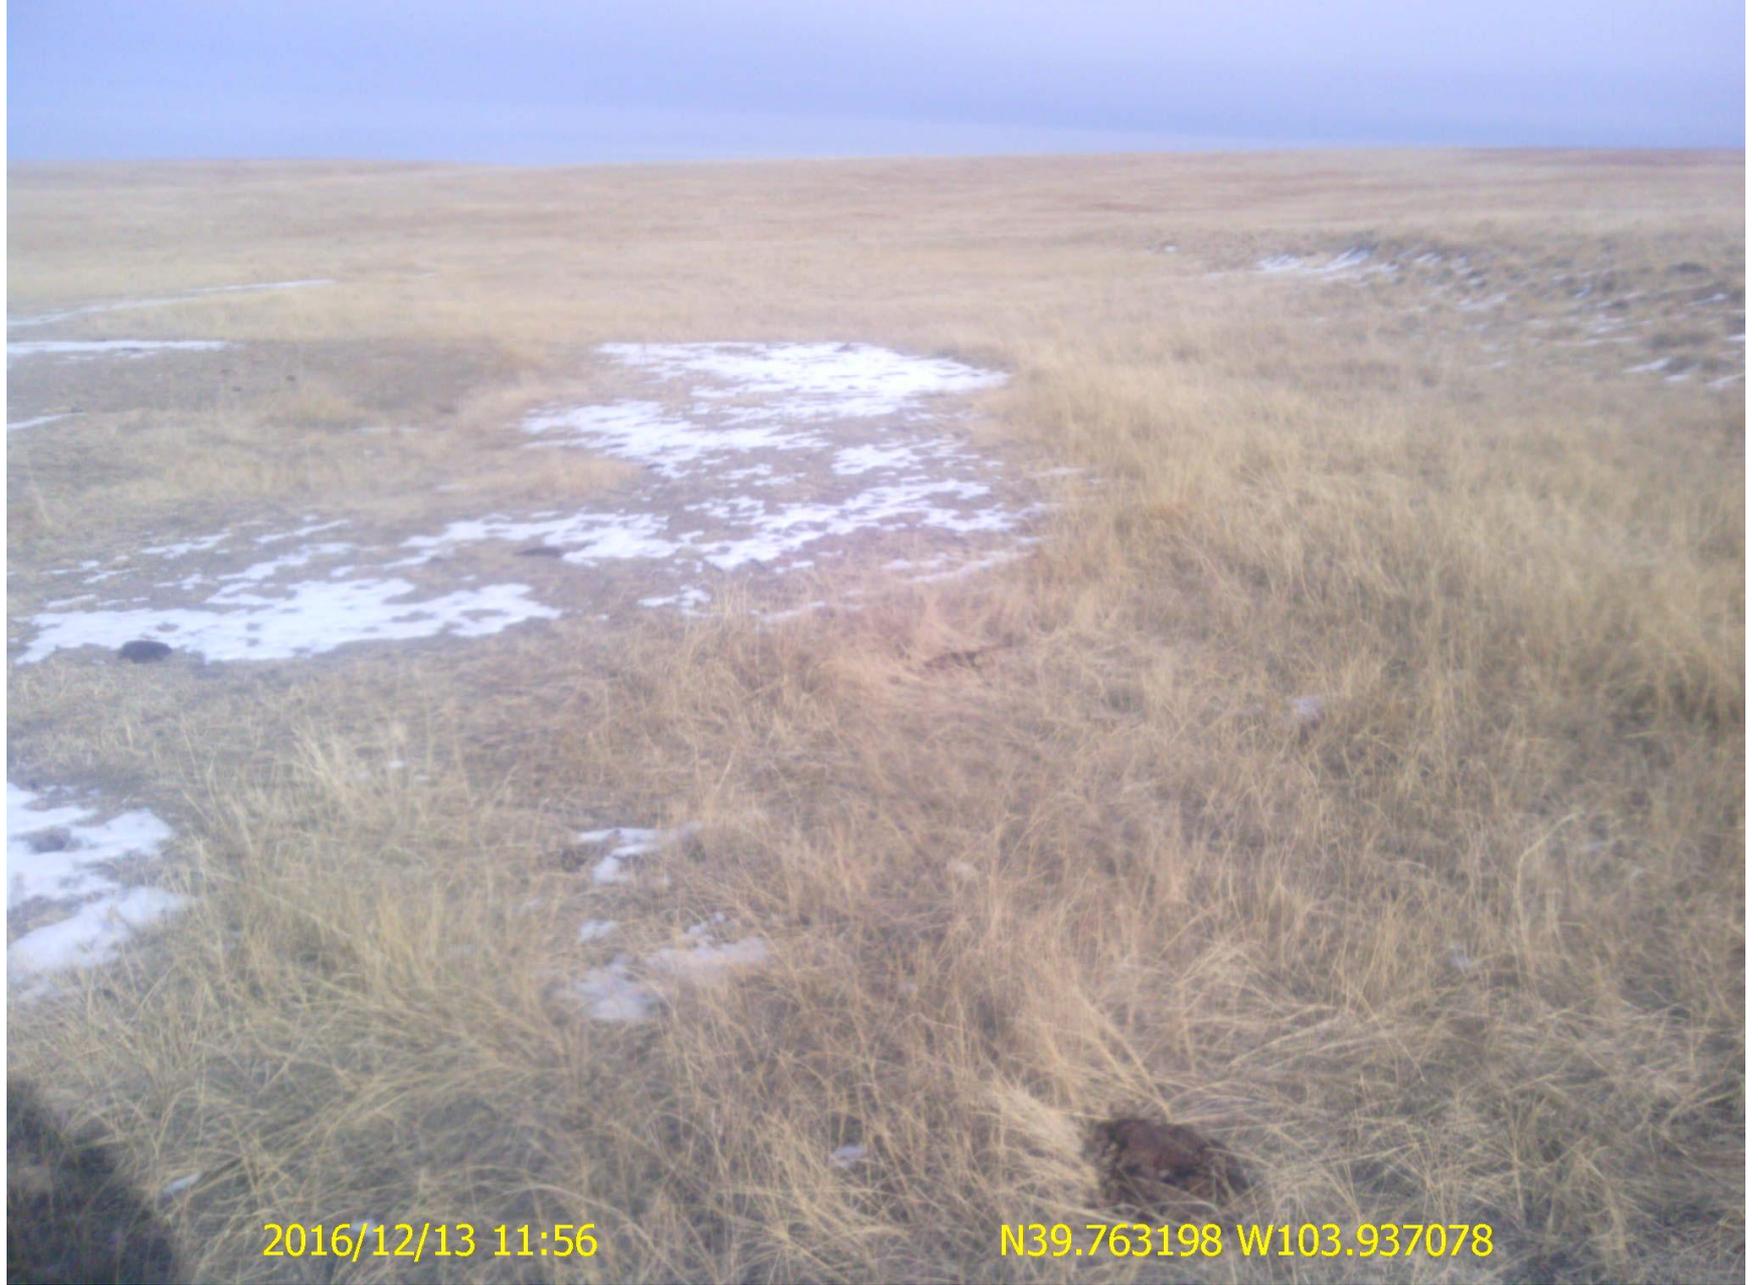
Figure 2: Photo taken from the south end of the location, facing northeast. Photo shows location has not achieved uniform vegetative cover.

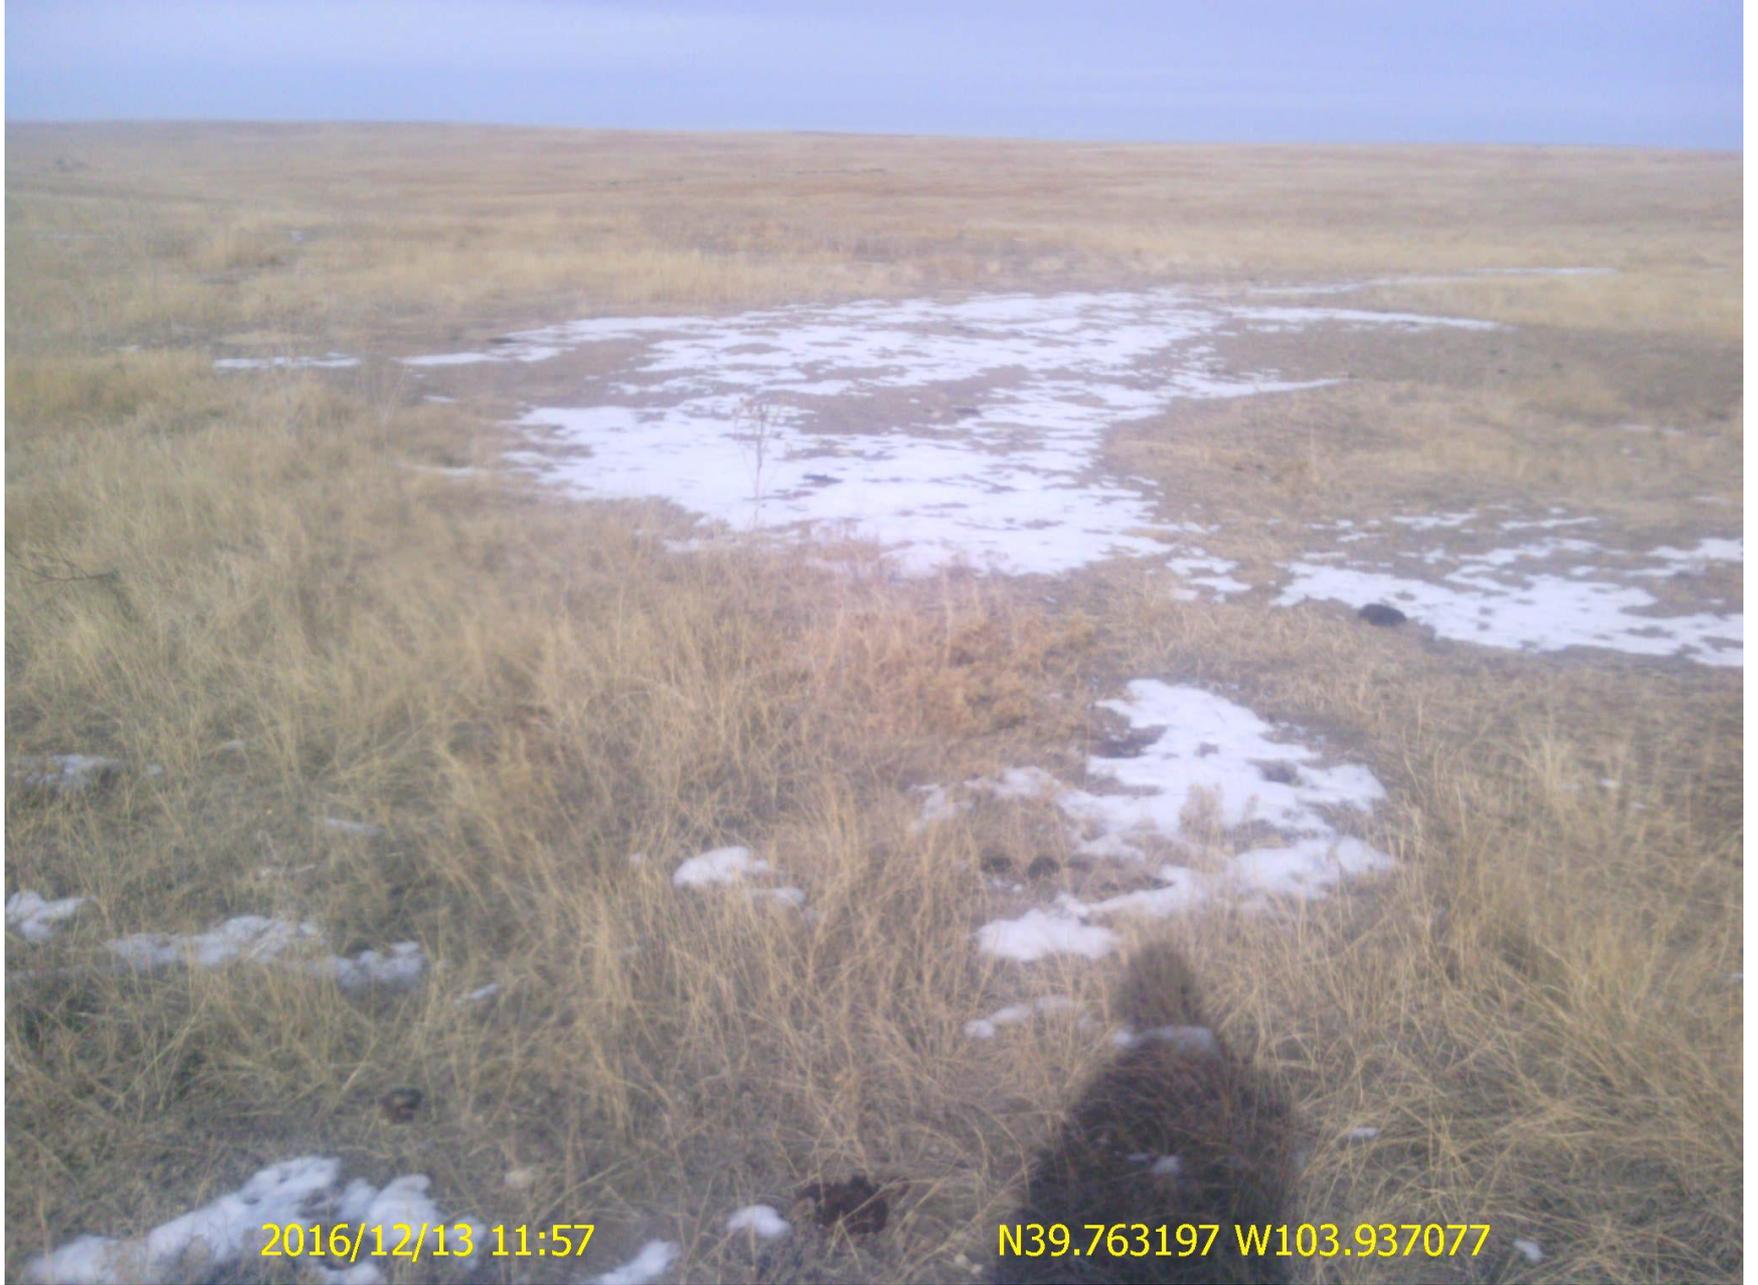
Figure 3: Photo taken from the south end of the location, facing north. Photo shows location has not achieved uniform vegetative cover.

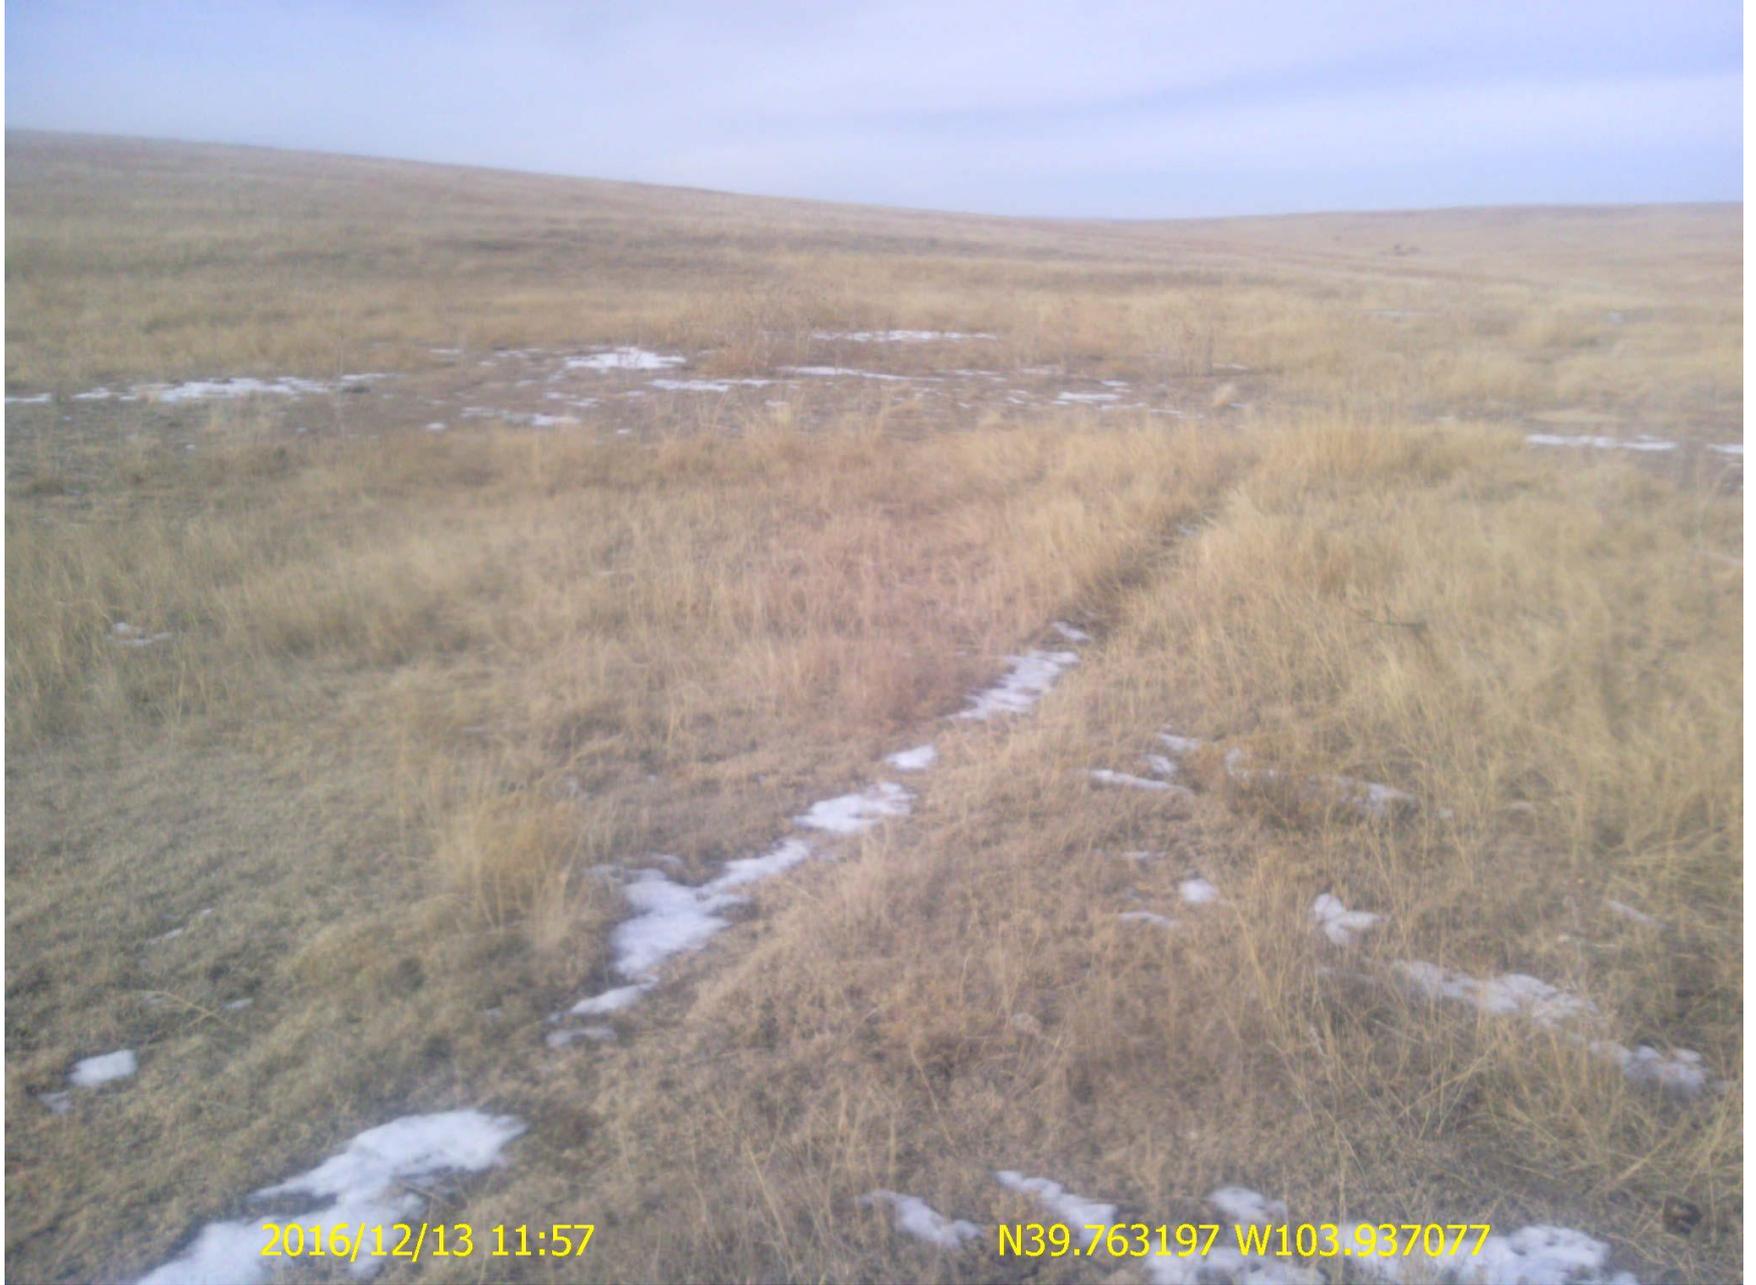
Figure 4: Photo taken from the south end of the location, facing northwest. Photo shows location has not achieved uniform vegetative cover.

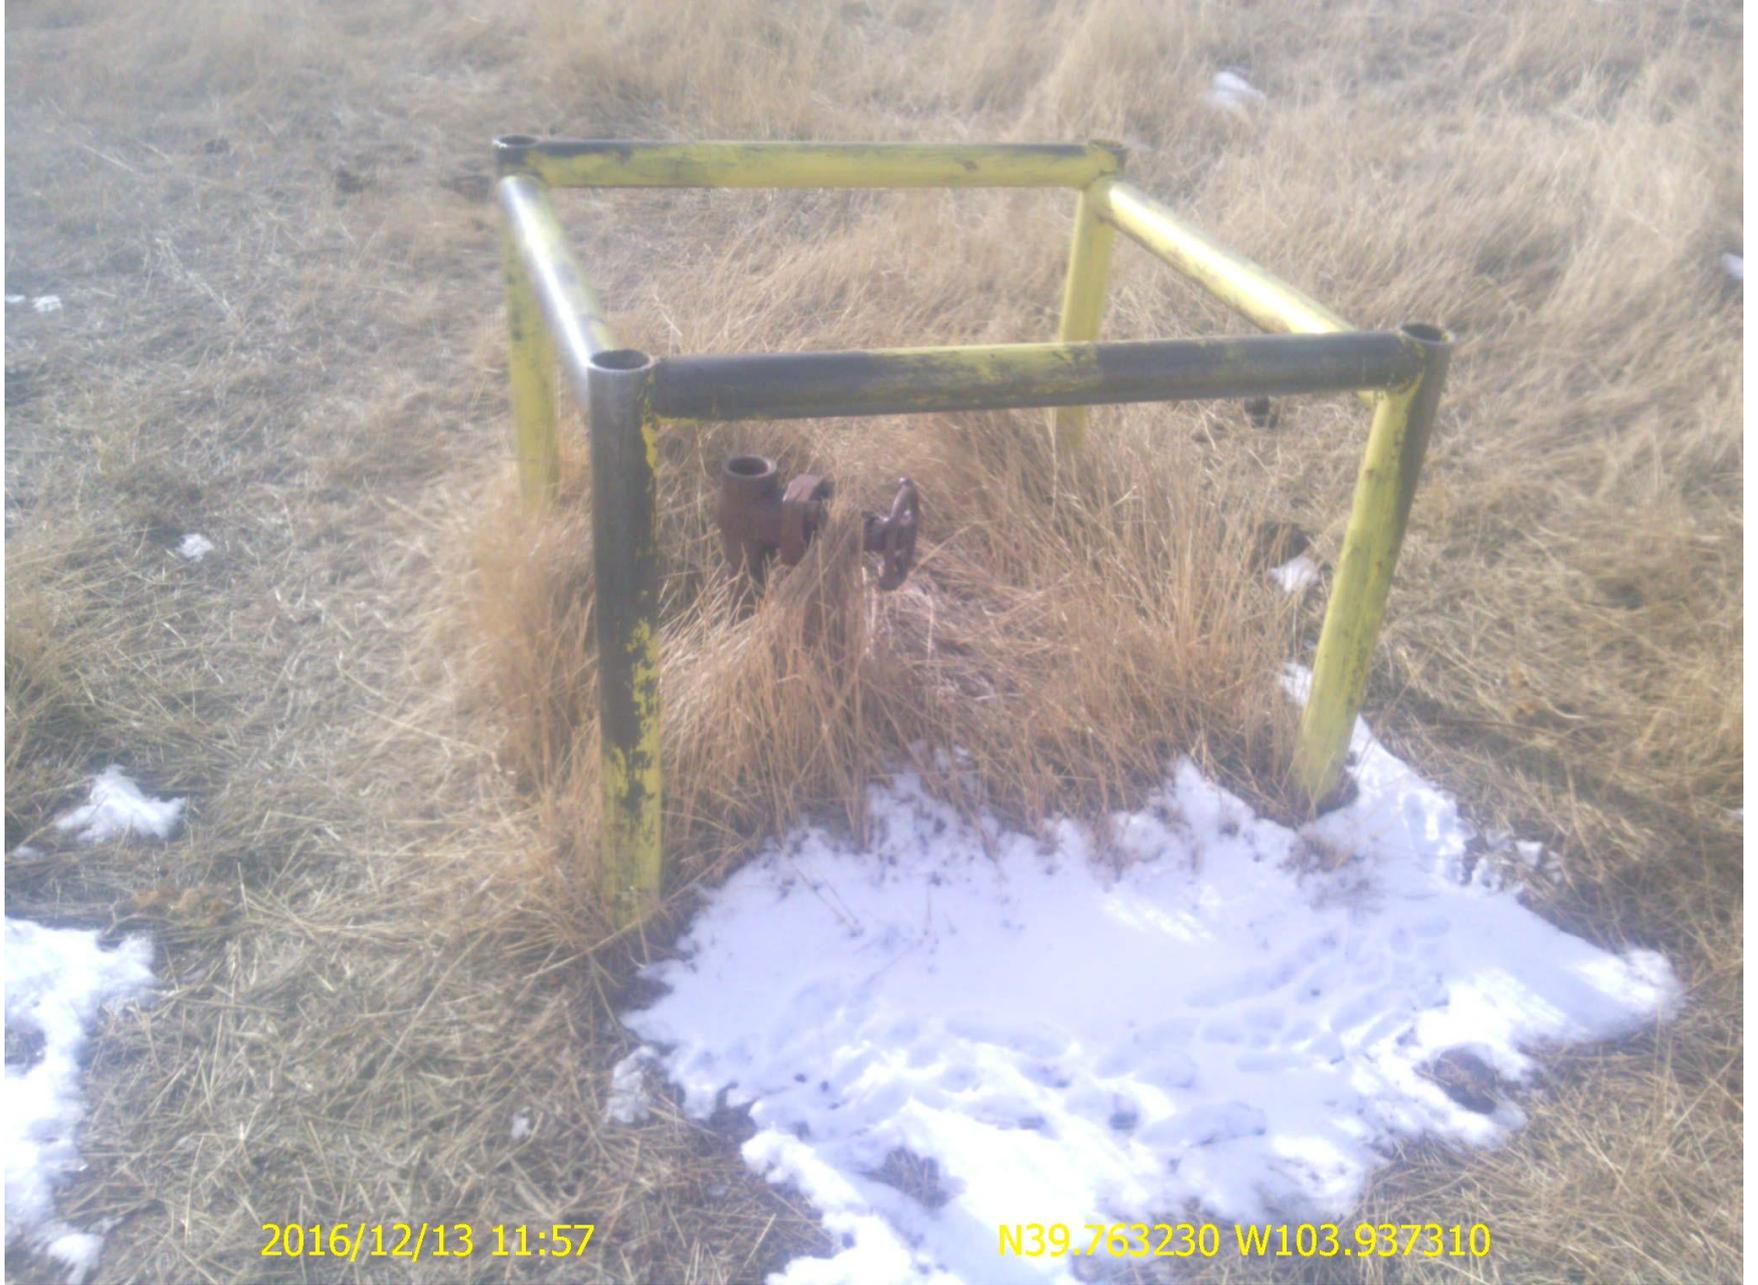
Figure 5: Photo taken from the west end of the location. Photo shows equipment remaining on the location.

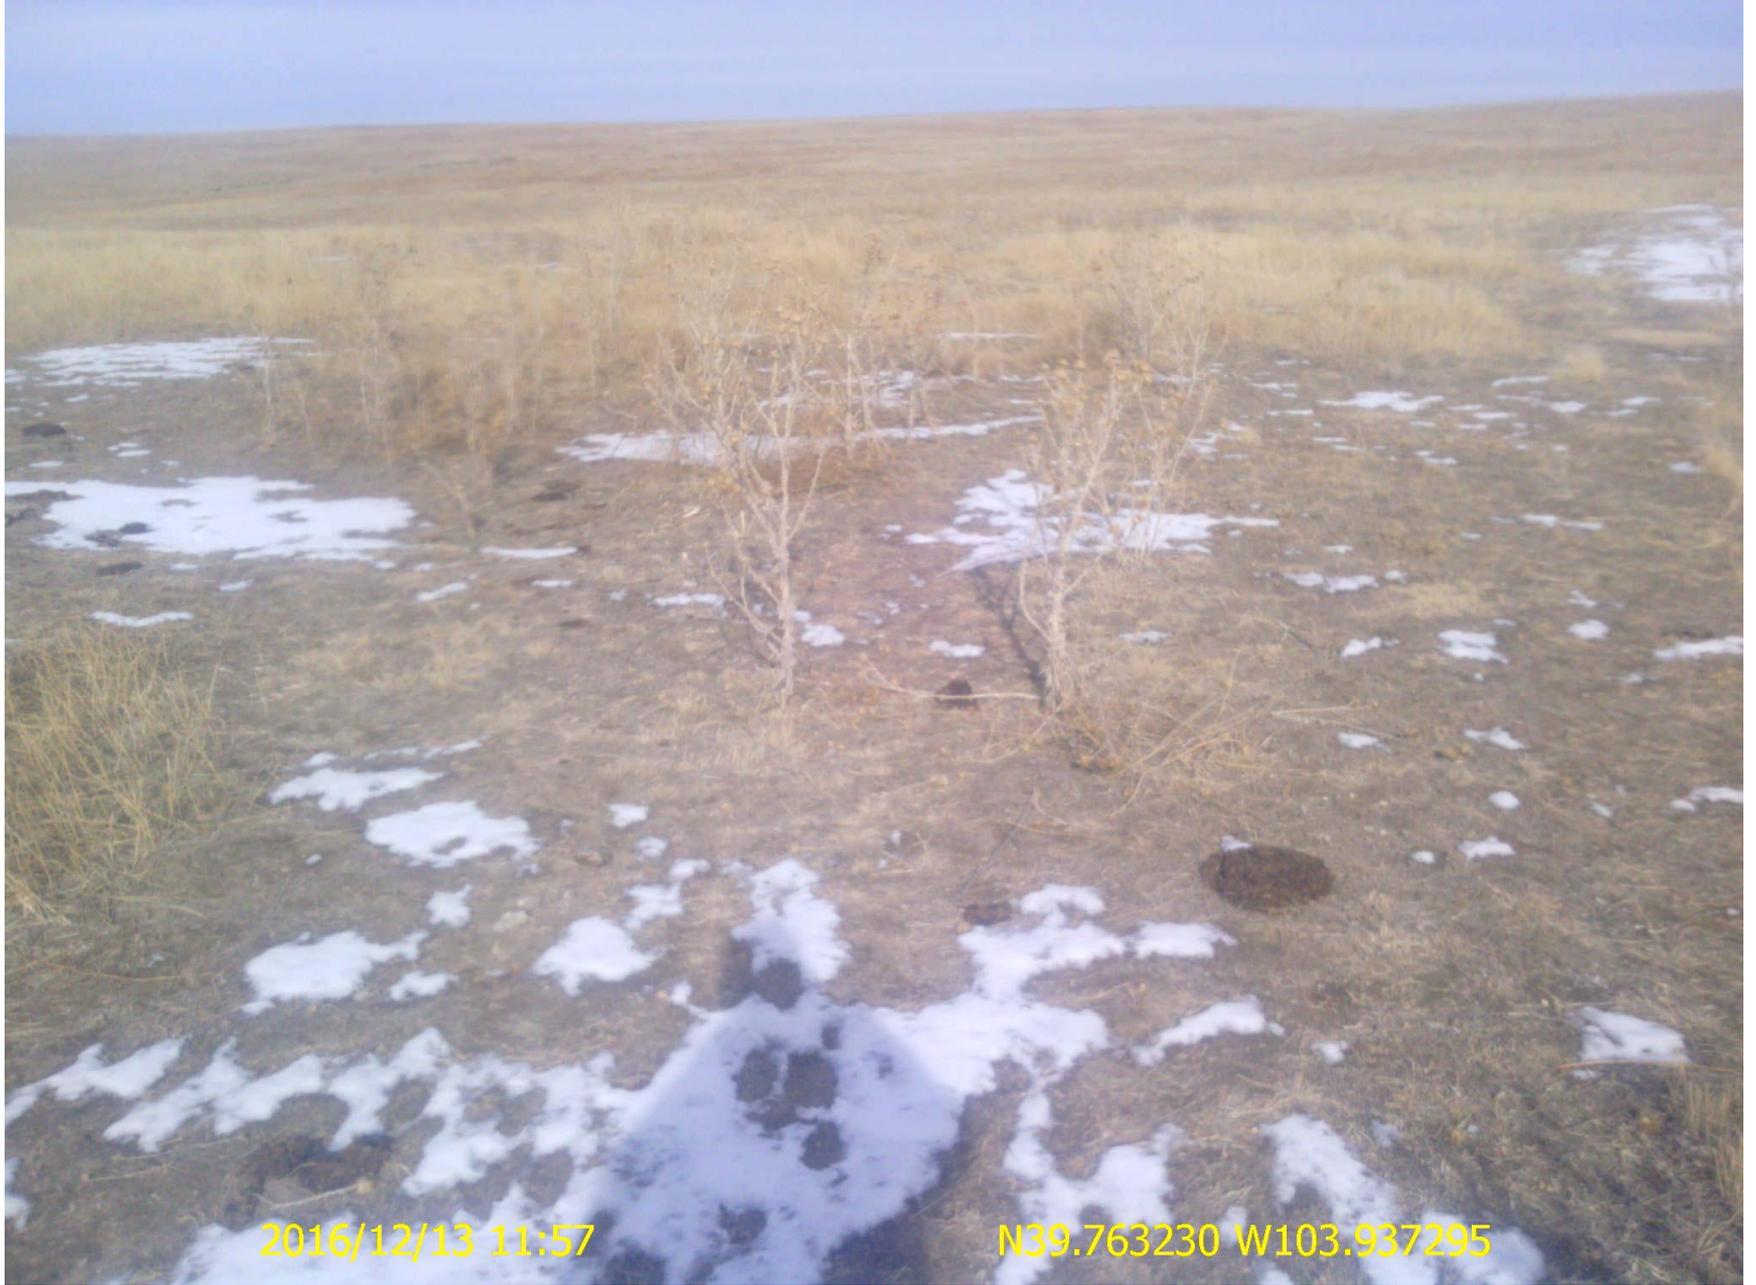
Figure 6: Photo taken from the location, facing north. Photo shows scotch thistle stalks from this years growth on location. This is a Colorado State, and Adams County noxious weed and needs to be managed and removed.

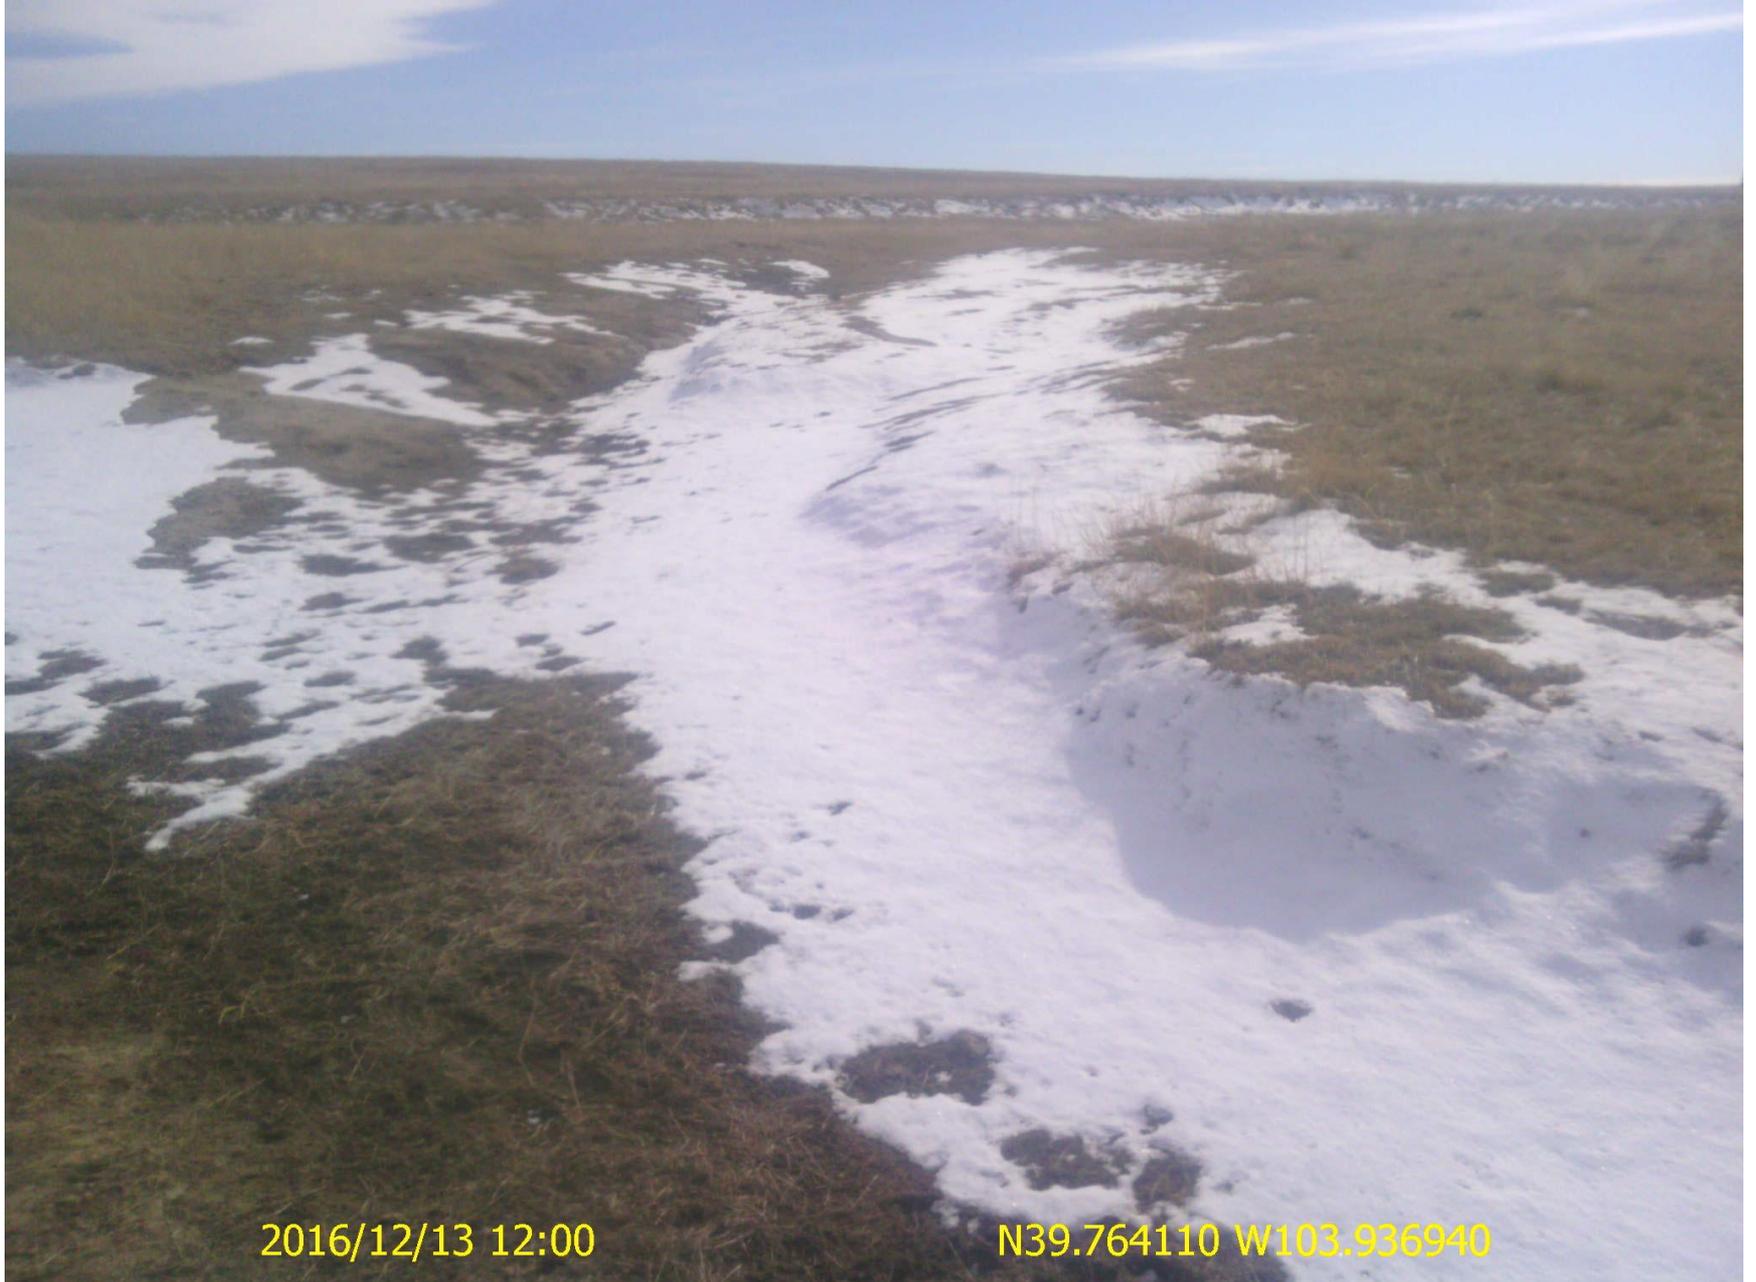
Figure 7: Photo taken from the northeast end of the location, facing south. Photo shows erosion leading off of the well location.

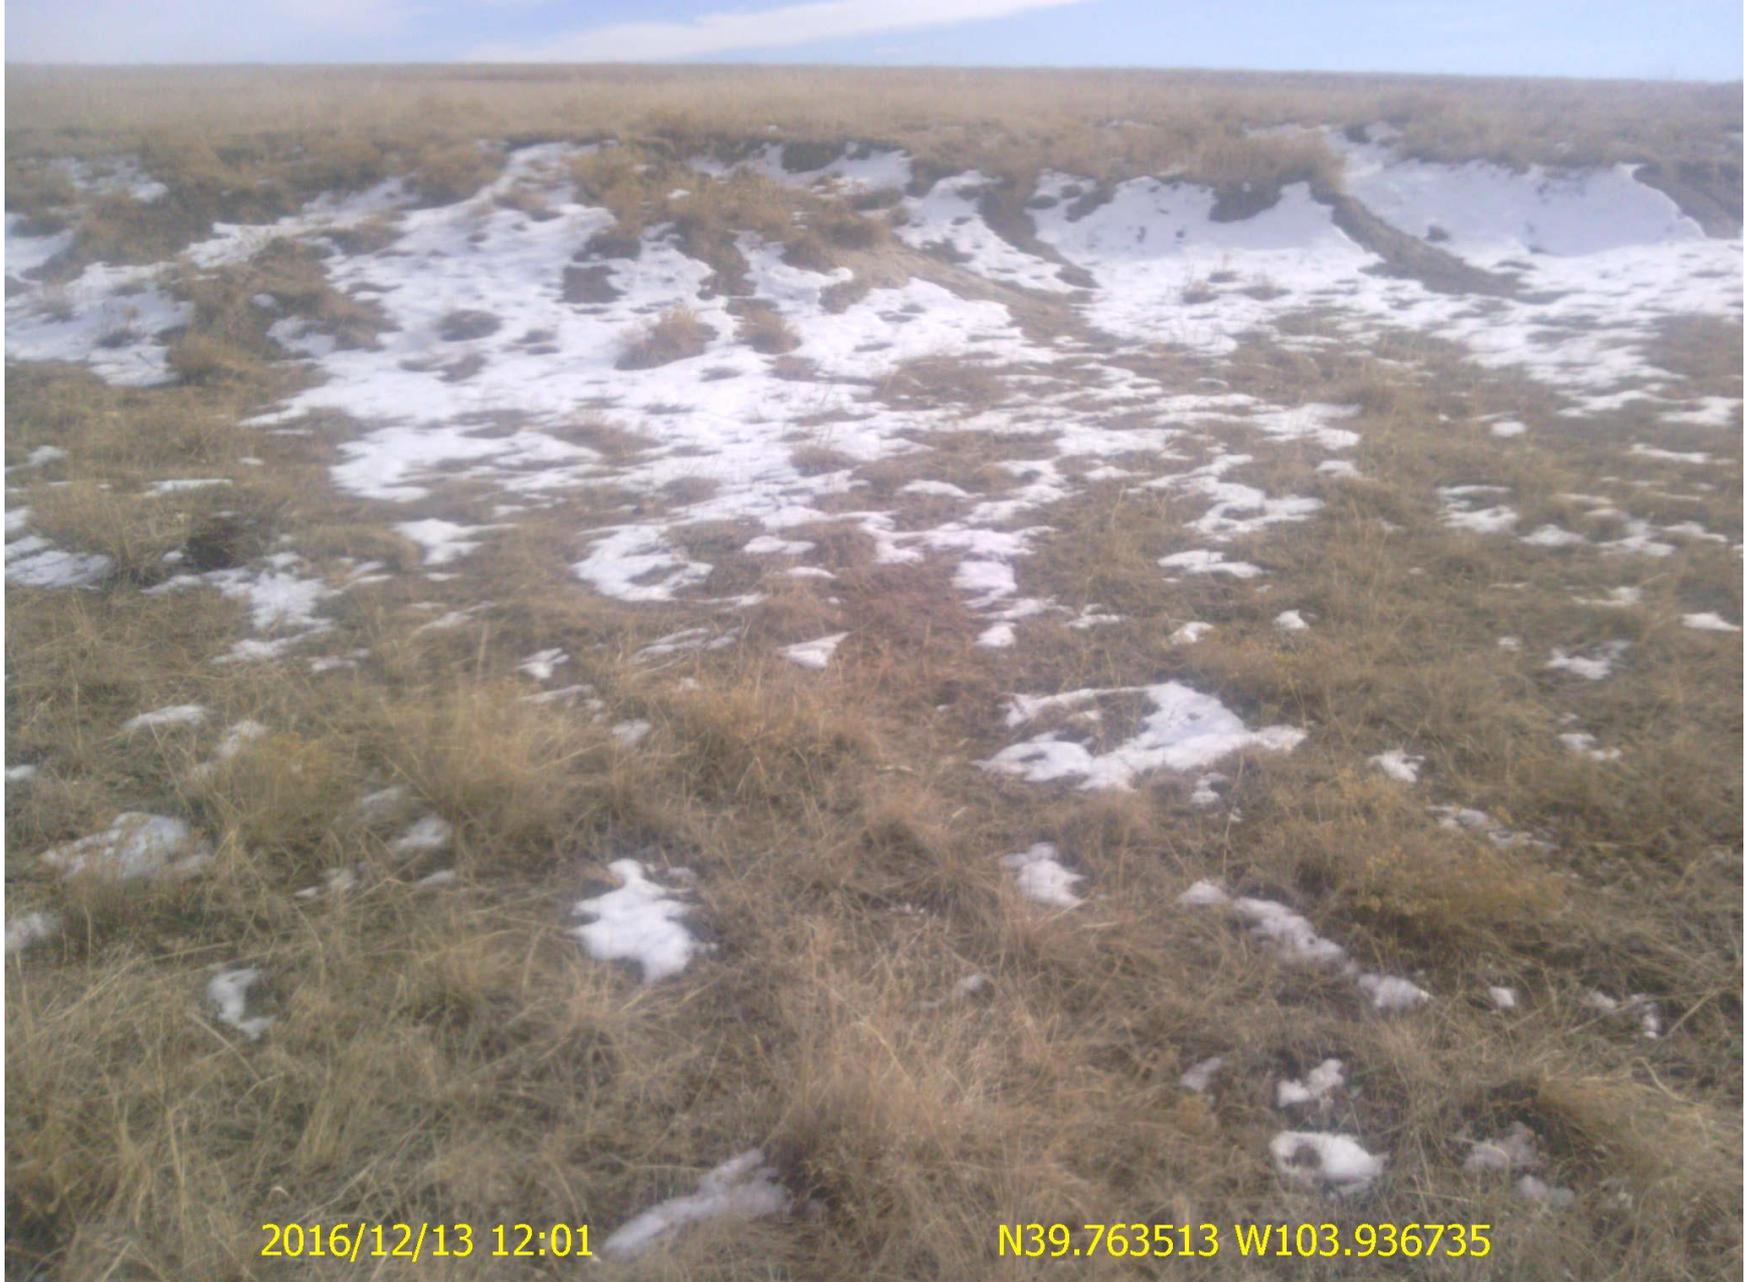
Figure 8: Photo taken from the southeast end of the well location, facing southeast. Photo shows location has not been adequately recontoured and is experiencing degradation due to stormwater erosion.

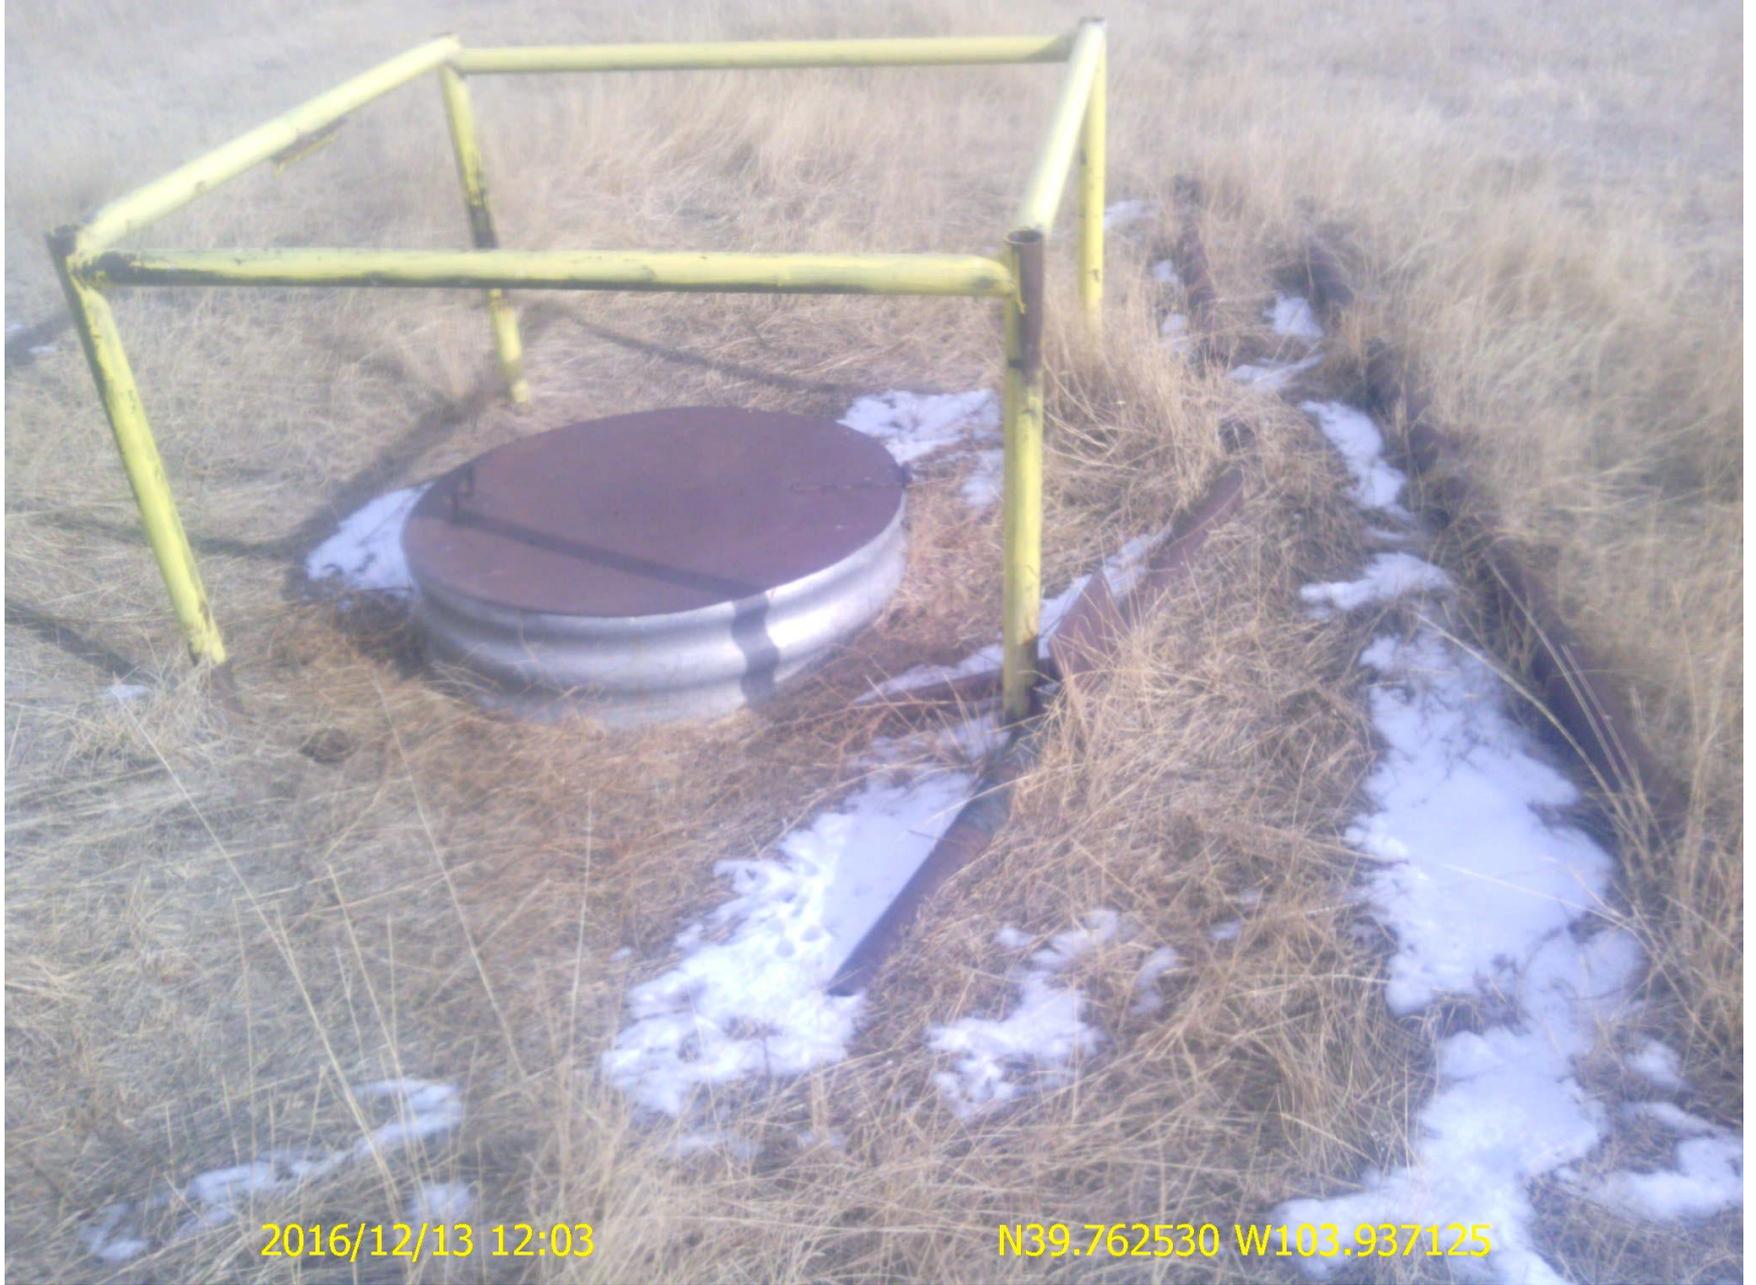
Figure 9: Photo taken from the access road, on the south end of the location. Photo shows equipment remaining.
