**ENVIRONMENTAL SITE ASSESSMENT OF PETRO-CANADA RESOURCES  
SCHROEDER #23-33 WELL SITE, WELD COUNTY, COLORADO,  
TOWNSHIP 6 NORTH, RANGE 64 WEST, SECTION 23**

Western Project #07149

December 11, 2007

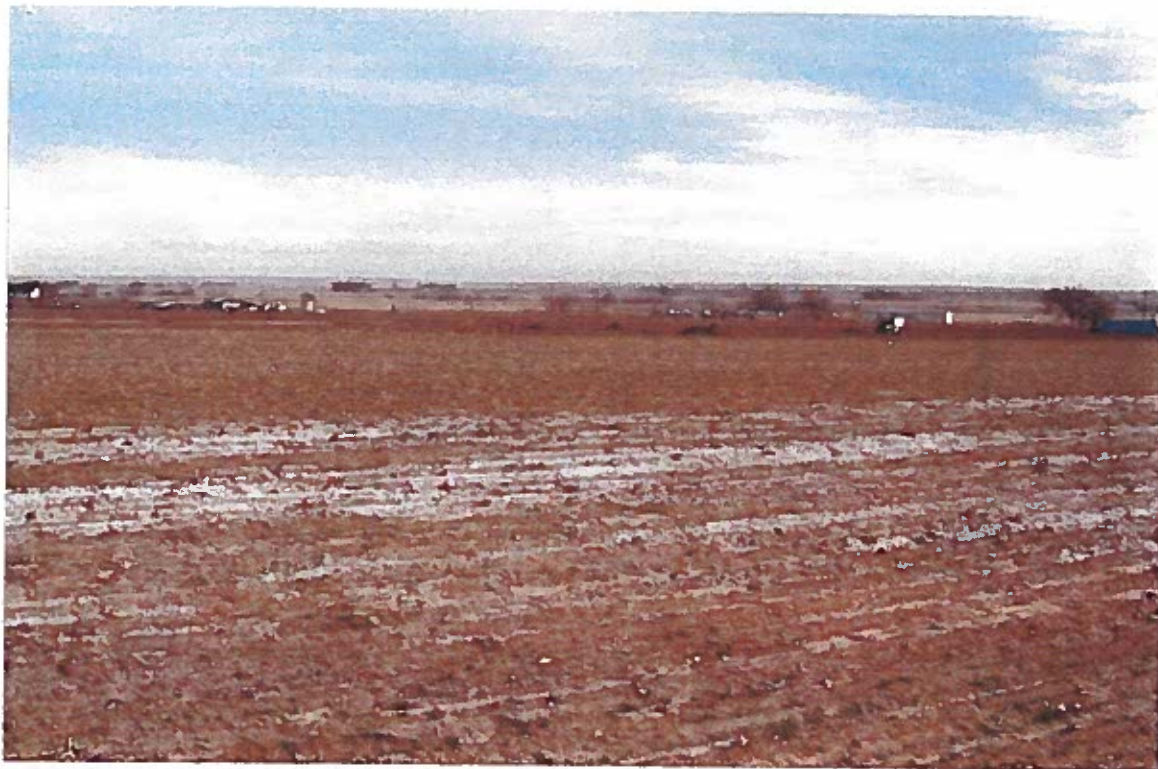
**Photo 1 - View of Schroeder lease facing to the east. Schroeder well head is in middle of field.**

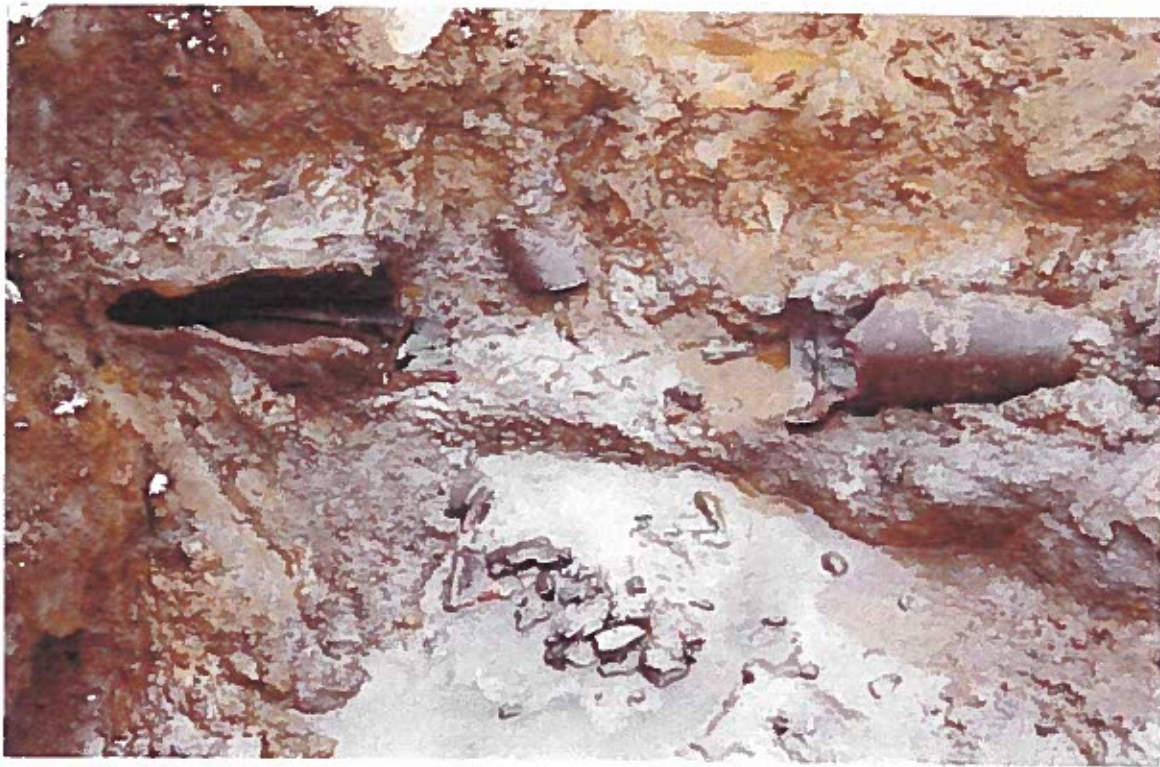
Petro-Canada personnel mobilized equipment to uncover and determine where a clog or obstruction in the system might exist. A backhoe was used to dig test excavations on the property. The excavations were to uncover the drainage system to allow repairs. During initial test excavations on December 5, 2007 a tile drainage pipe was accidentally broken. Water flowing through the pipe was observed to have a sheen.

**Photo 2 - Photograph of broken field drainage tile. The drainage system is buried 6 feet below grade.**

The source area of the detected hydrocarbons in site samples is thought to be near the Schroeder #23-33 drilling location. Repairs have been completed to the farm field drainage system. Clay sediment and solid debris were removed from the farm field tile pipes. The drainage system now appears to be functioning properly. No further actions or assessments are planned for the location. Please contact us with any questions which you may have.

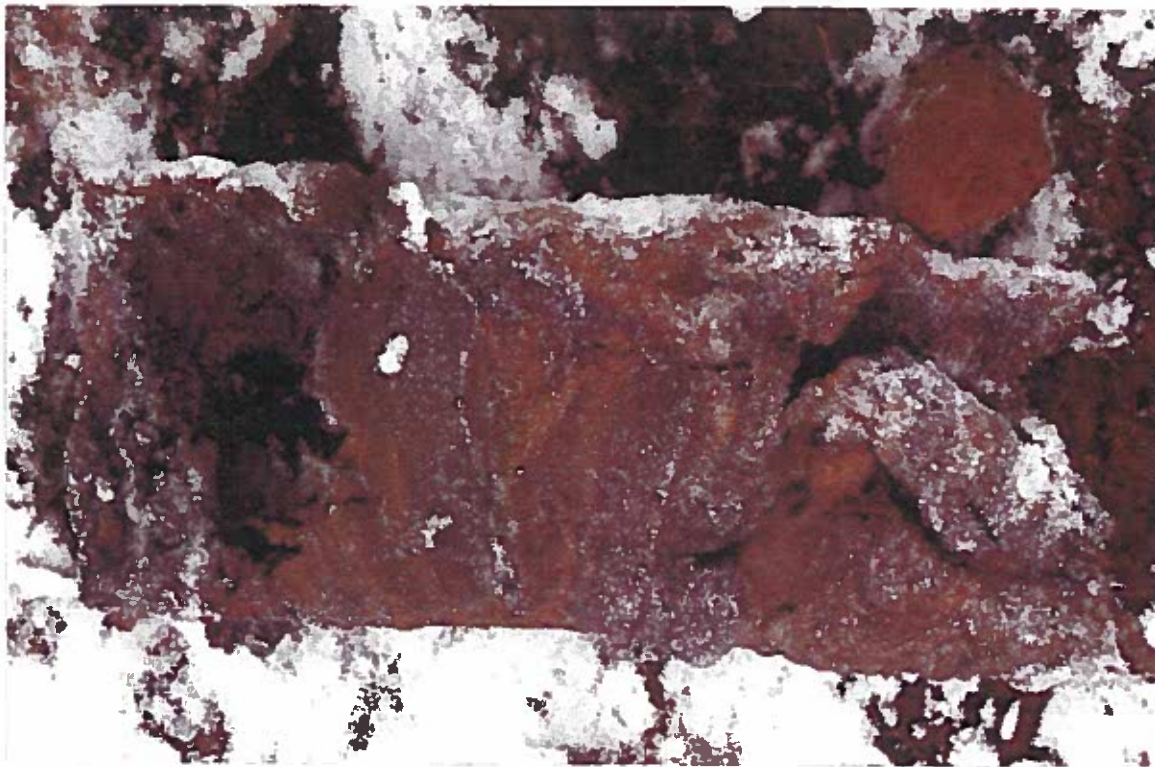
**Photo 3 -** View of section of removed drainage tile pipe. The pipe was clogged with clay.

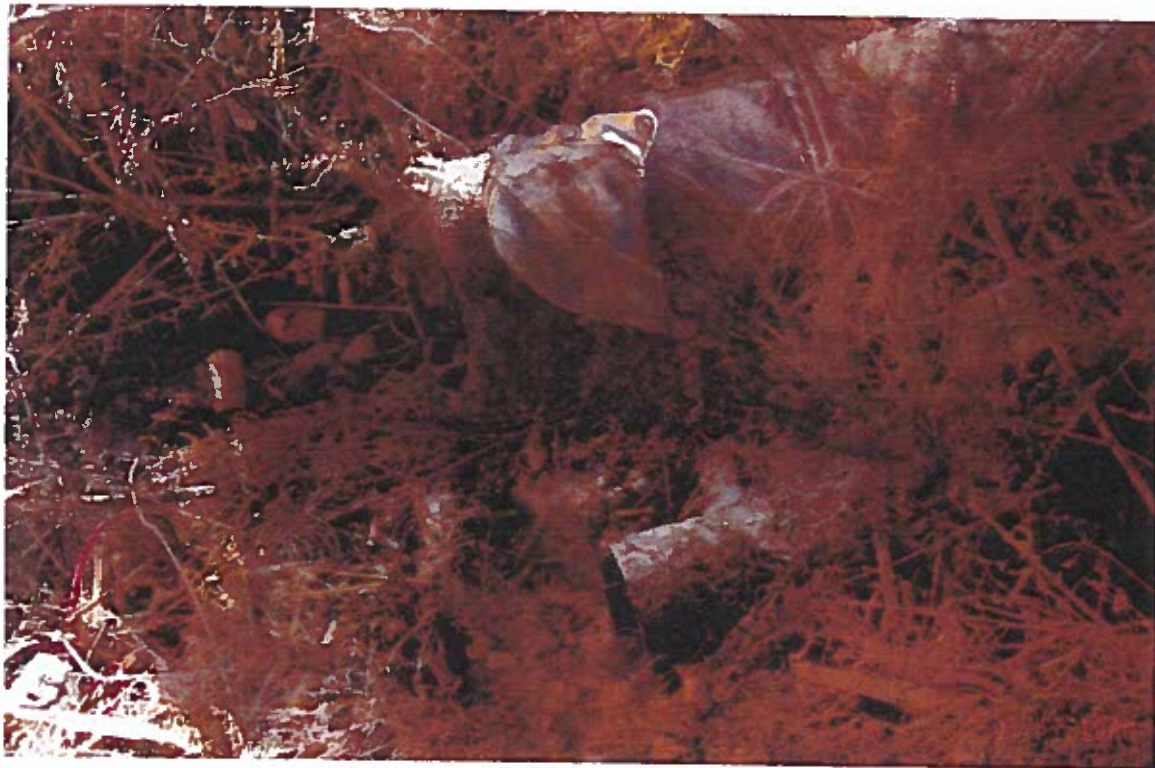
Western personnel also obtained a water sample from the drainage discharge culvert to determine if any hydrocarbons were reaching the nearby irrigation ditch. A ground water sample was also obtained from the frac tanks used to store the pumped ground water. The locations of the samples obtained from the assessment are indicated on an attached site map.

**Photo 4 -** Photo of field drainage water discharge. The culvert is buried beneath the access road.

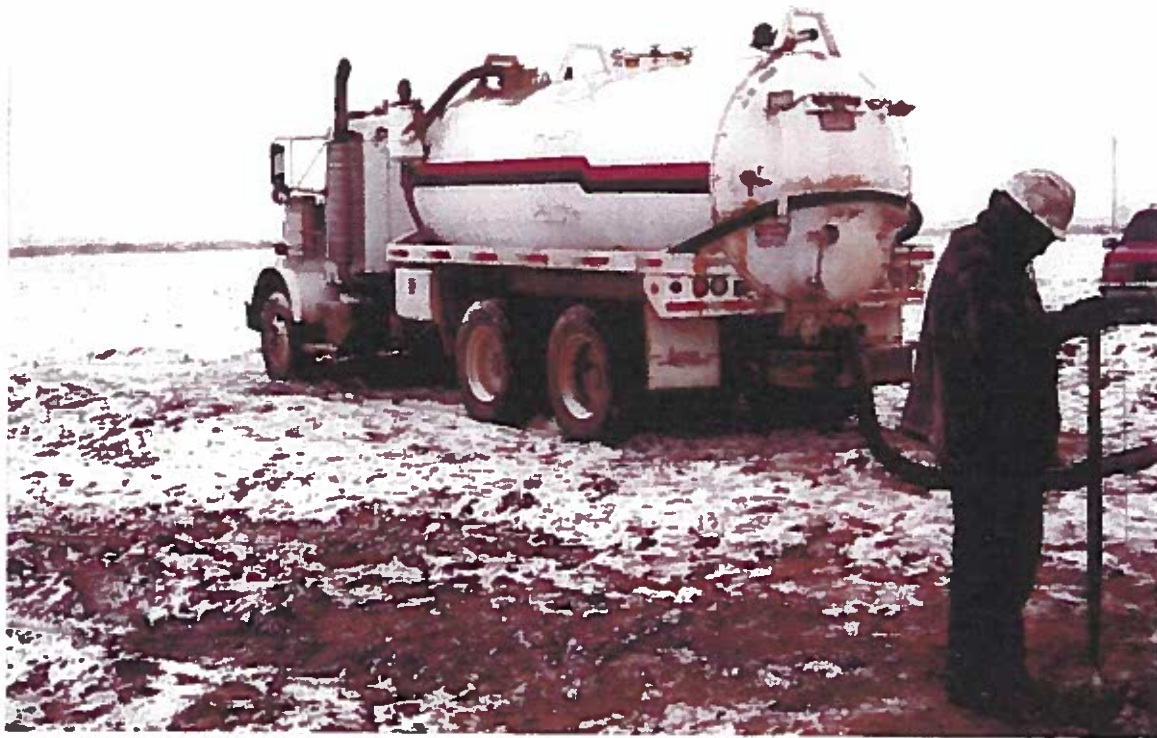
**Photo 5** - A vacuum truck recovers ground water from a test excavation.

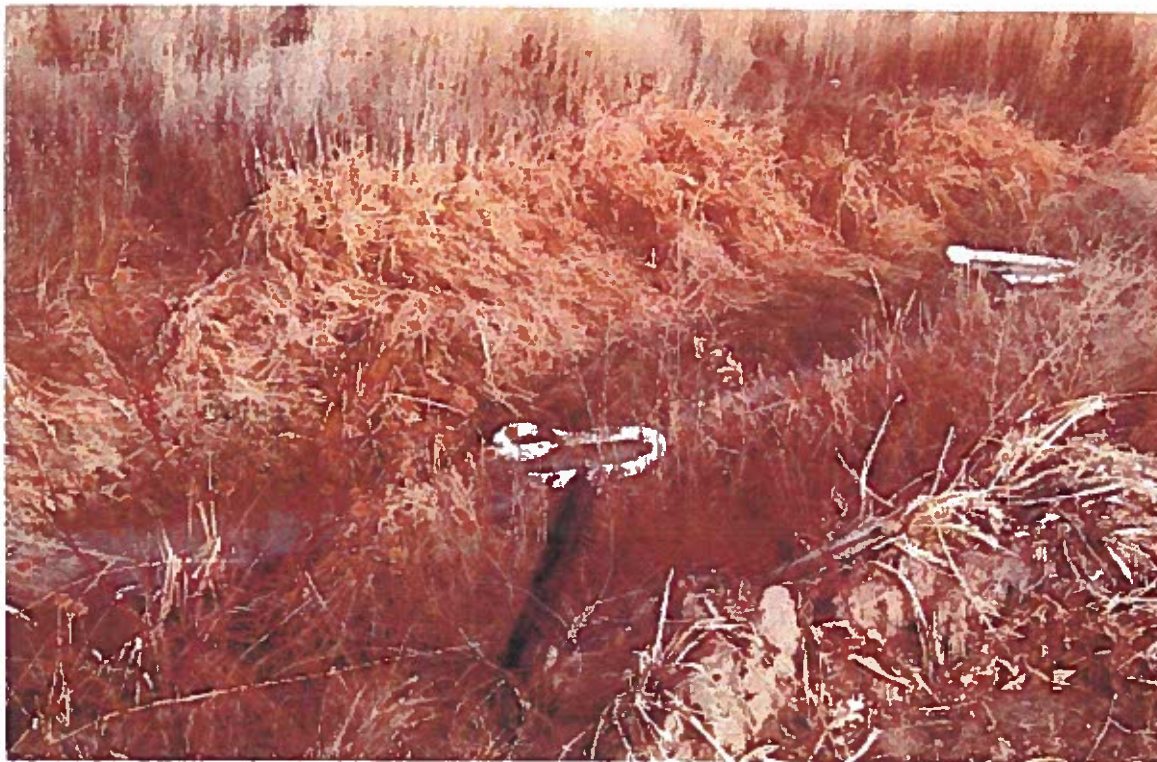
**Photo 6** - Oil sorbent booms were placed into a nearby irrigation ditch.

Petro-Canada personnel then mobilized more equipment and materials to the project site. Oil booms were immediately placed into the irrigation ditch. A large excavation was dug to capture water flowing from the broken field drainage system pipe. Oil booms and bales of straw were placed into the pit. A large capacity water pump trailer moved recovered ground water from the pit into frac tanks. Ground water generated at the site could then be prevented from discharging into the nearby irrigation ditch.

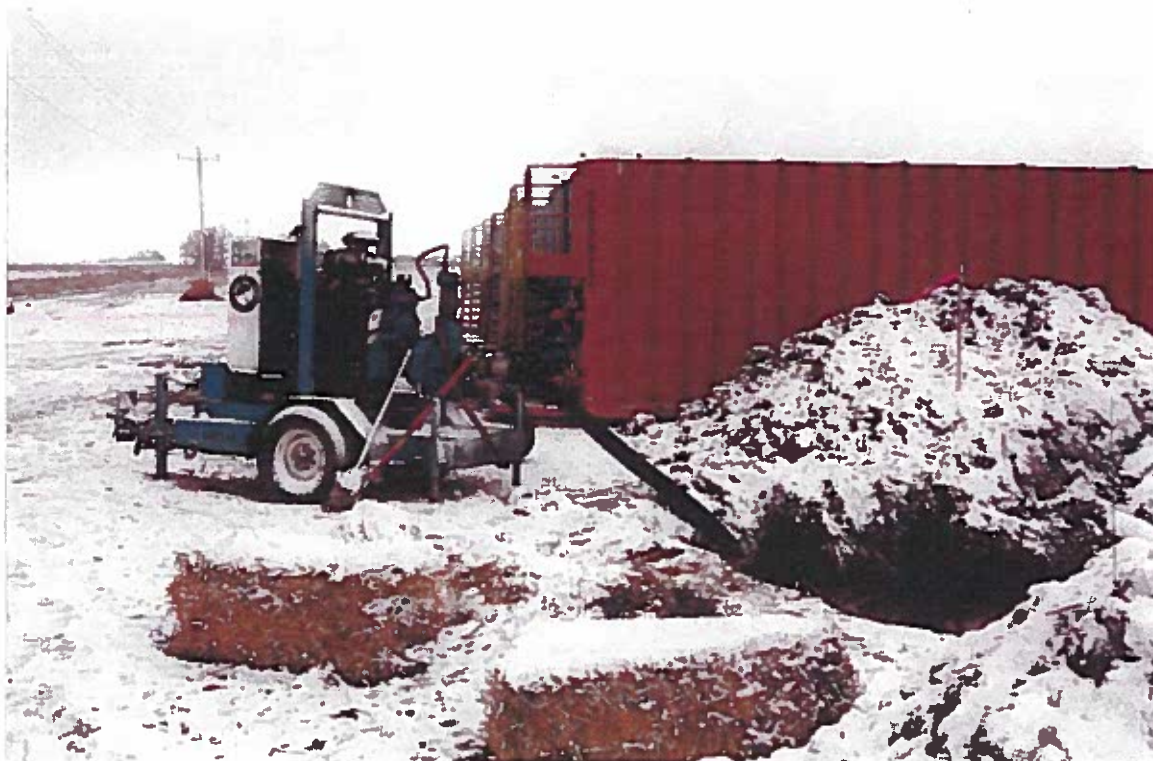
**Photo 7** - Petro-Canada dug and excavation to recover water draining from the farm field drainage system. A large capacity pump moved recovered waste liquids into frac tanks.

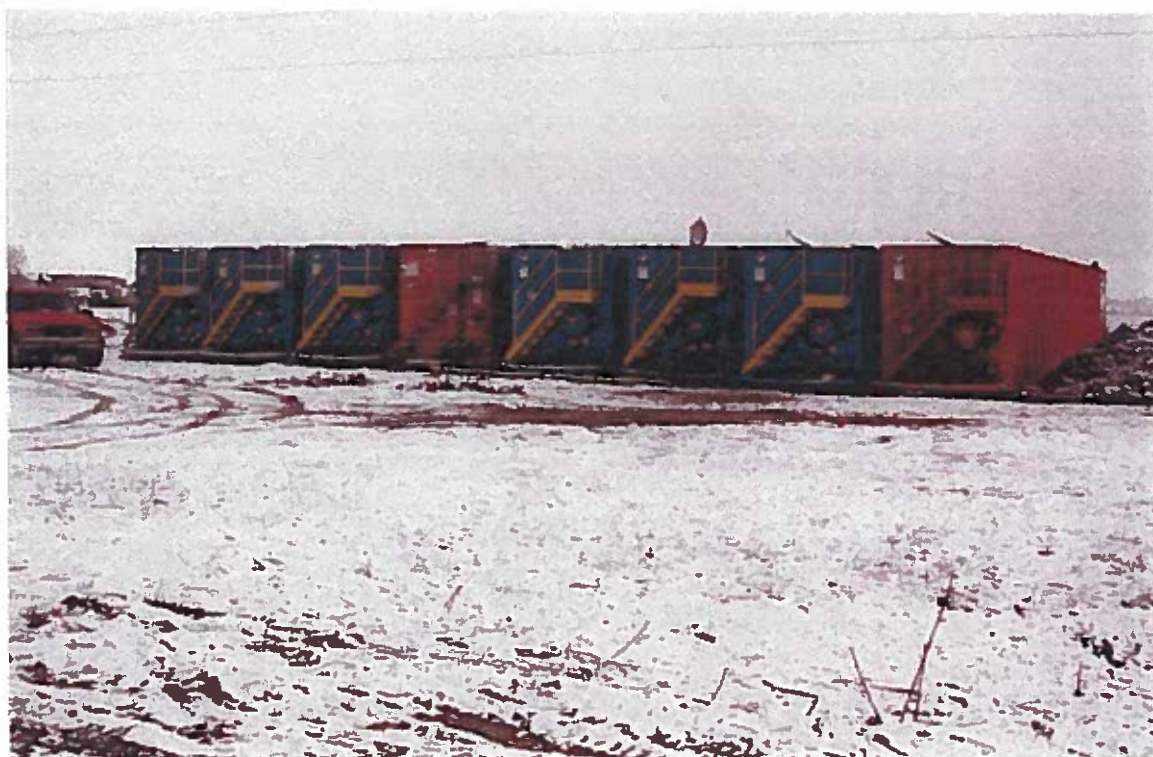
**Photo 8** - A view of frac tanks mobilized to the site to store recovered liquids.
