# Inspection Photos

Operator: Lilis Energy Inc #10495

Location ID: 322206

Inspection Doc. Number: 682501919

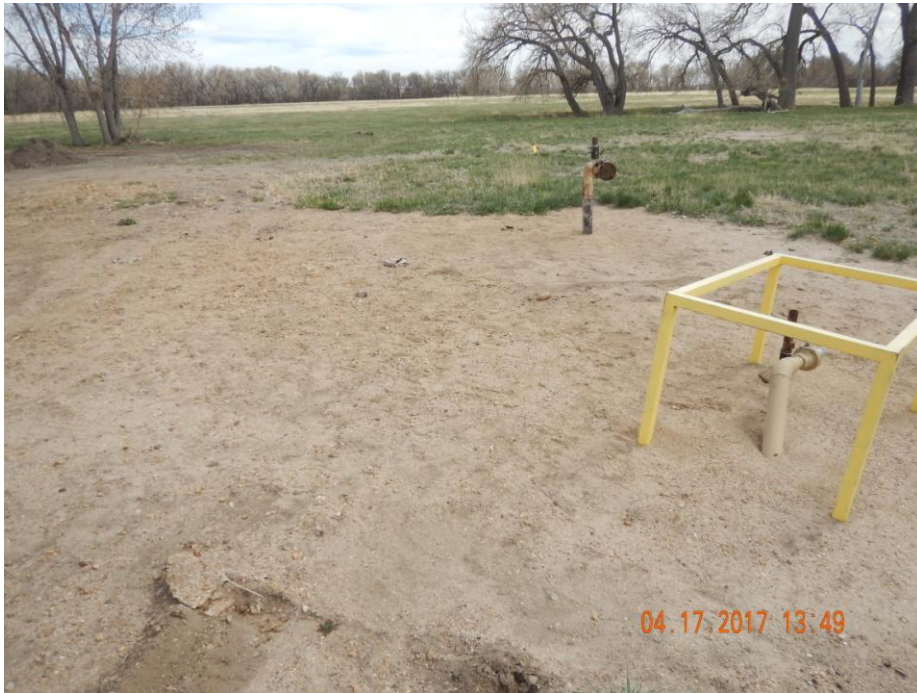
**Photo 2:** Photo taken from the west end of the location, facing south. Photo shows riser from flow/gathering system. Mr. Murphey from Lilis stated that Anadarko would be removing the lines on Wed. April 19<sup>th</sup>

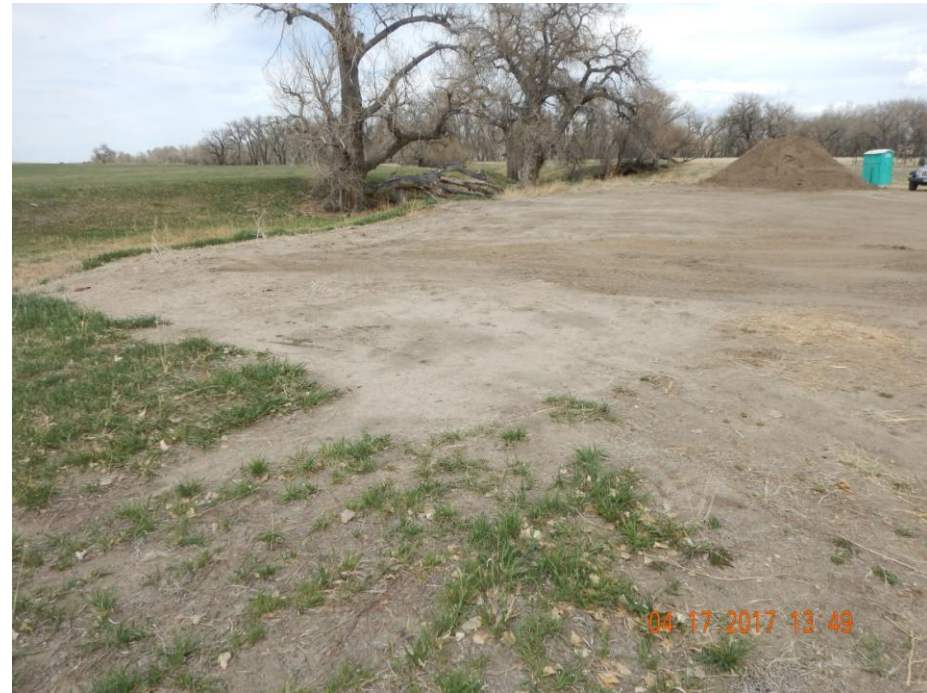
**Photo 3:** Photo taken from the west end of the location, facing northeast. Photo shows related O&G facilities have been removed from the location. Reclamation in process.

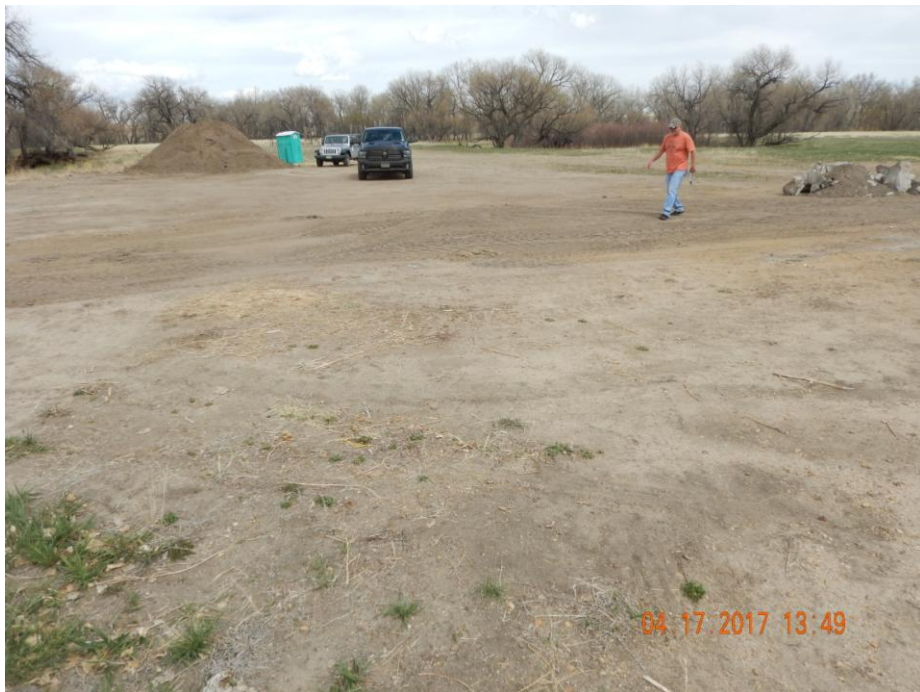
**Photo 4:** Photo taken from the west end of the location, facing east. Photo shows related O&G facilities have been removed from the location. Reclamation in process.

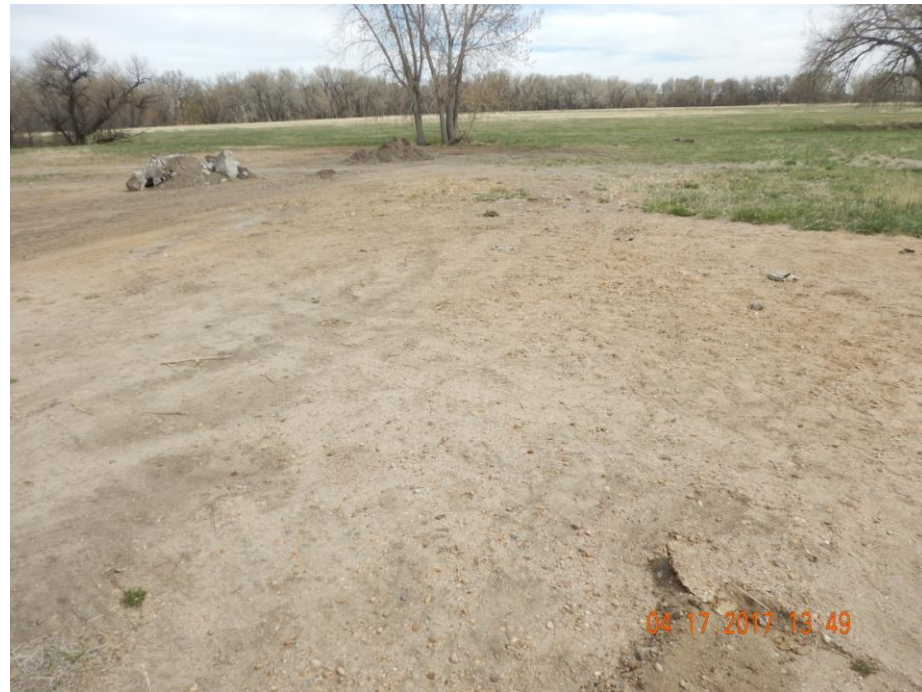
**Photo 5:** Photo taken from the west end of the location, facing southeast. Photo shows related O&G facilities have been removed from the location. Reclamation in process.

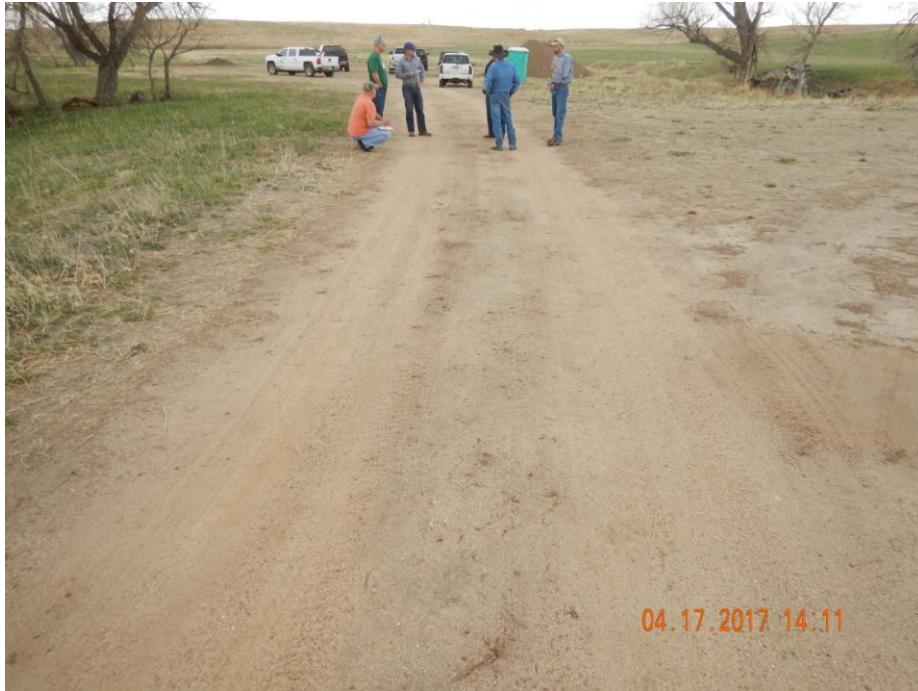
**Photo 6:** Photo taken from the access road east of the location, facing west. Surface owner had stated interest in leaving a portion of this road. A 502.b variance to not perform reclamation on portions of the road desired by the surface owner will need to be submitted and approved.

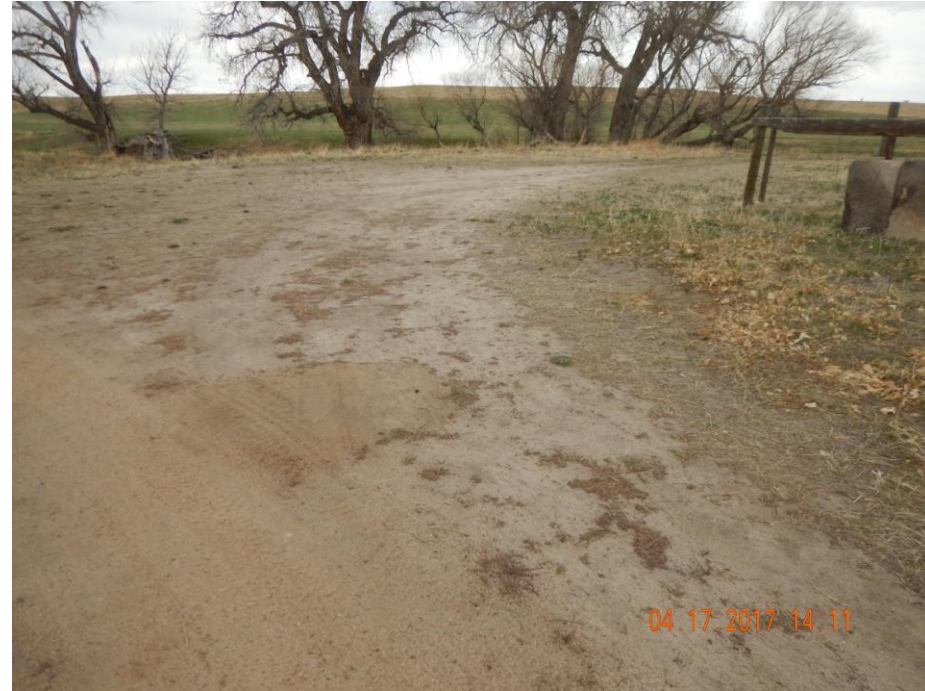
**Photo 7:** Photo taken from the access road east of the location, facing southwest. Surface owner had stated interest in leaving a portion of this road. A 502.b variance to not perform reclamation on portions of the road desired by the surface owner will need to be submitted and approved.
