Inspection Photos

Operator: Diversified Operating Corp #24461

Location ID: 408223

Inspection Doc. Number: 682501949

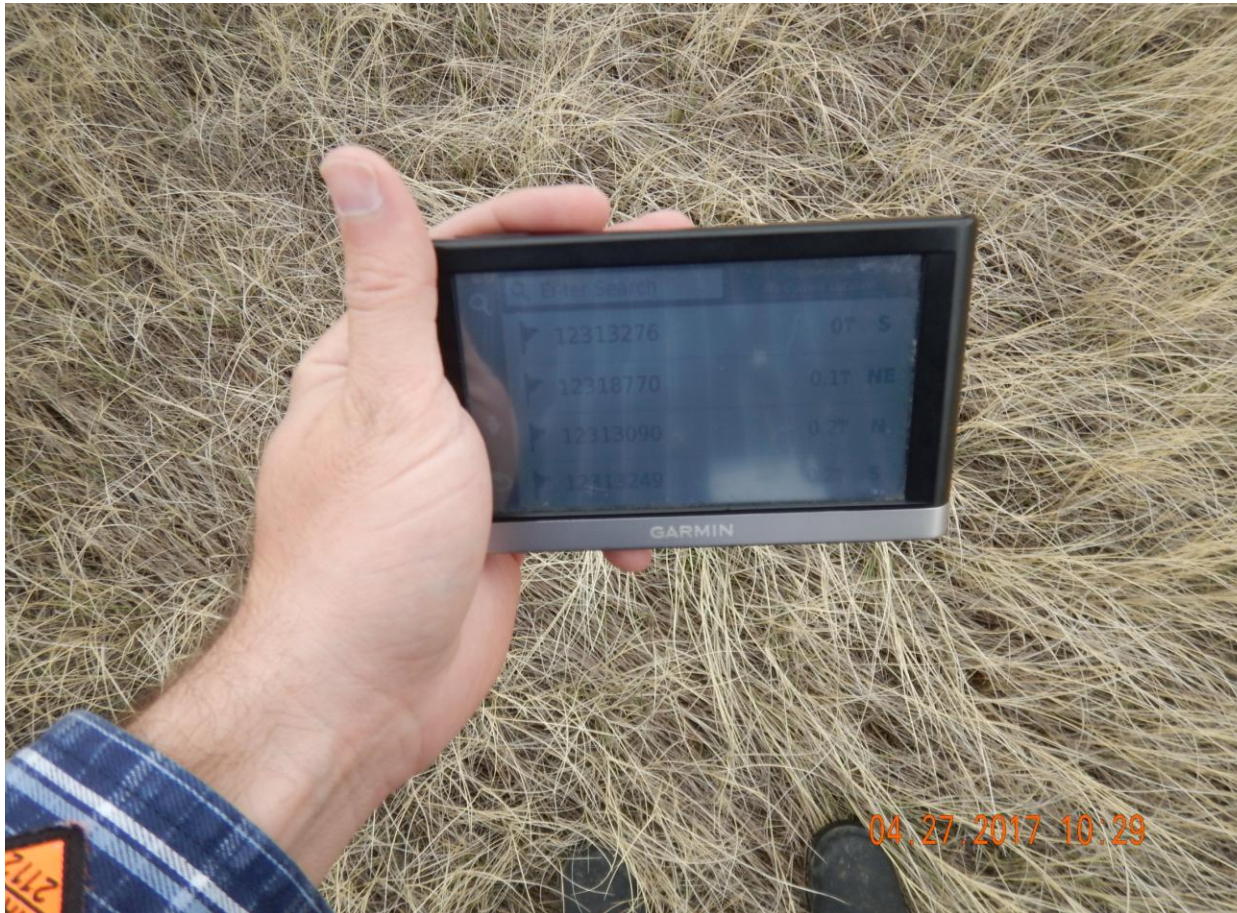
Photo 1: Photo of GPS verifying location.

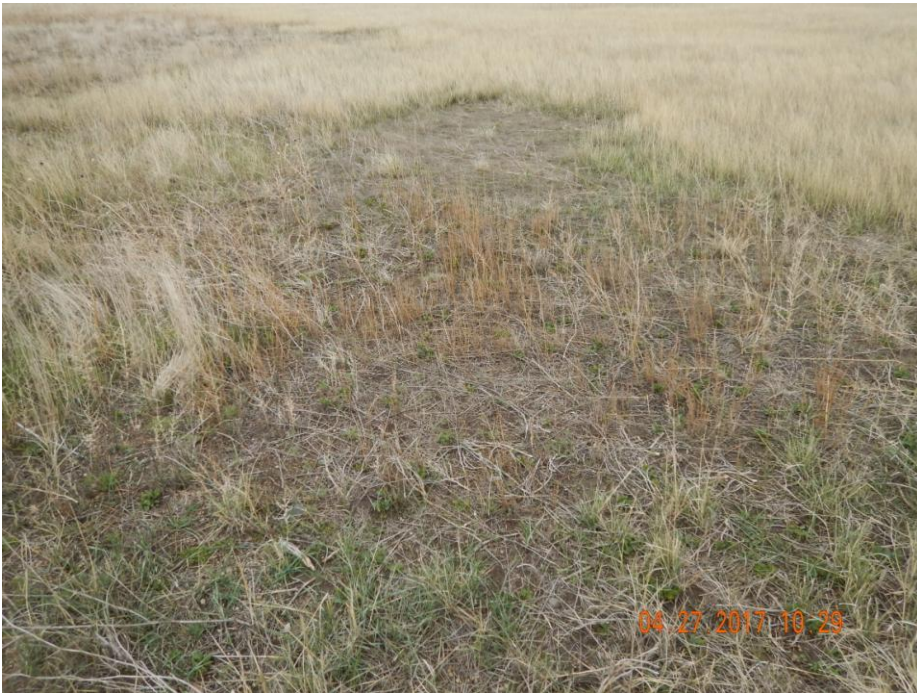
Photo 3: Photo taken from the location. Photo shows areas of the location that have not achieved total perennial, non-invasive uniform plant cover of at least eighty (80) percent of pre-disturbance or reference area levels. Unable to find evidence that additional reclamation activities have occurred.

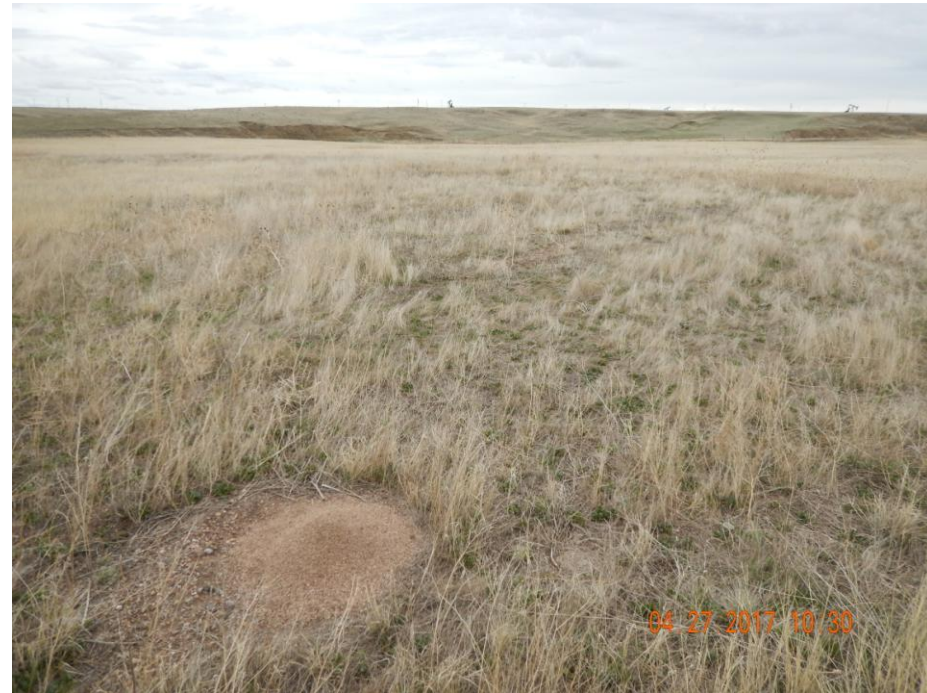
Photo 4: Photo taken from the location. Photo shows areas of the location that have not achieved total perennial, non-invasive uniform plant cover of at least eighty (80) percent of pre-disturbance or reference area levels. Unable to find evidence that additional reclamation activities have occurred.

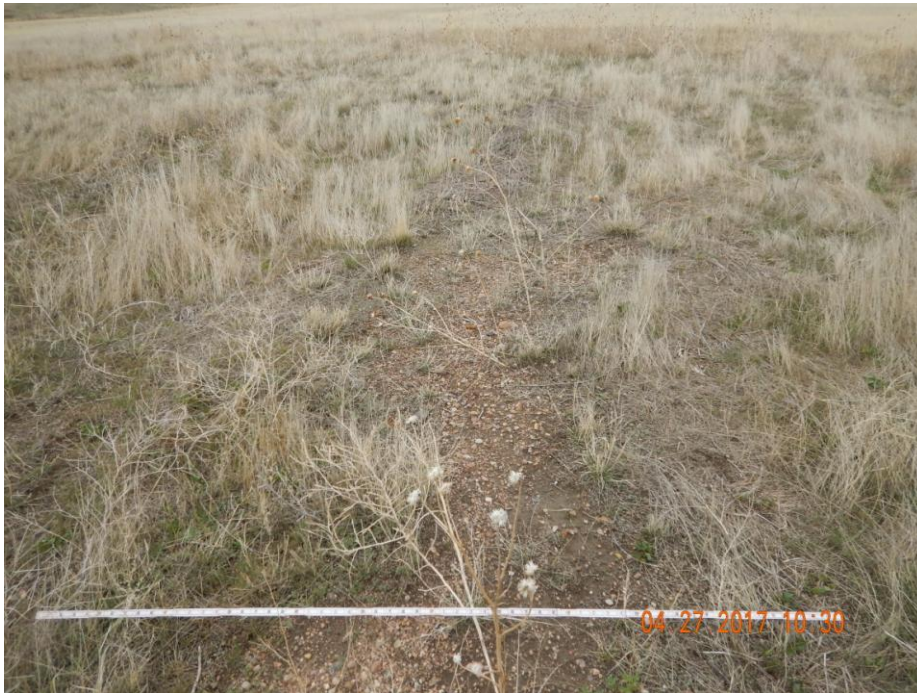
Photo 4: Photo taken from the location. Photo shows areas of the location that have not achieved total perennial, non-invasive uniform plant cover of at least eighty (80) percent of pre-disturbance or reference area levels. Unable to find evidence that additional reclamation activities have occurred. 6 foot measuring stick for reference.

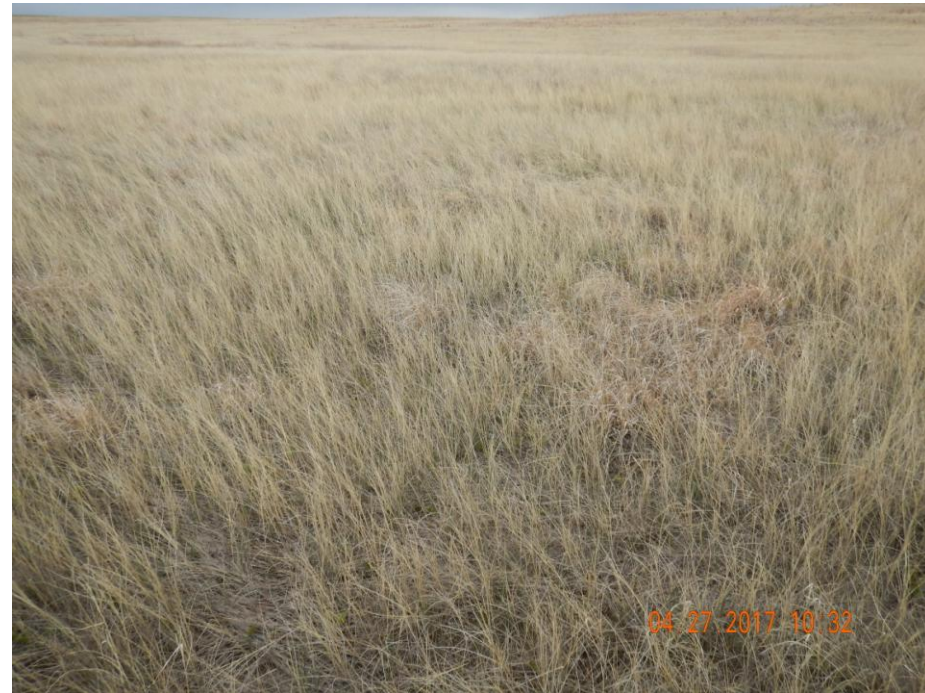
Photo 5: Photo taken from the adjacent reference area. Photo shows vegetation over the reference area to visually compare to vegetation over reclamation area. Vegetations in reference area appears to be predominantly western wheat.
