# Construction and Stormwater Inspection

Operator: KERR MCGEE OIL & GAS ONSHORE LP- #47120

Location ID: 443598

Inspection Photos  
Location Name: GABEL /37N-8HZ  
Location ID: 443598

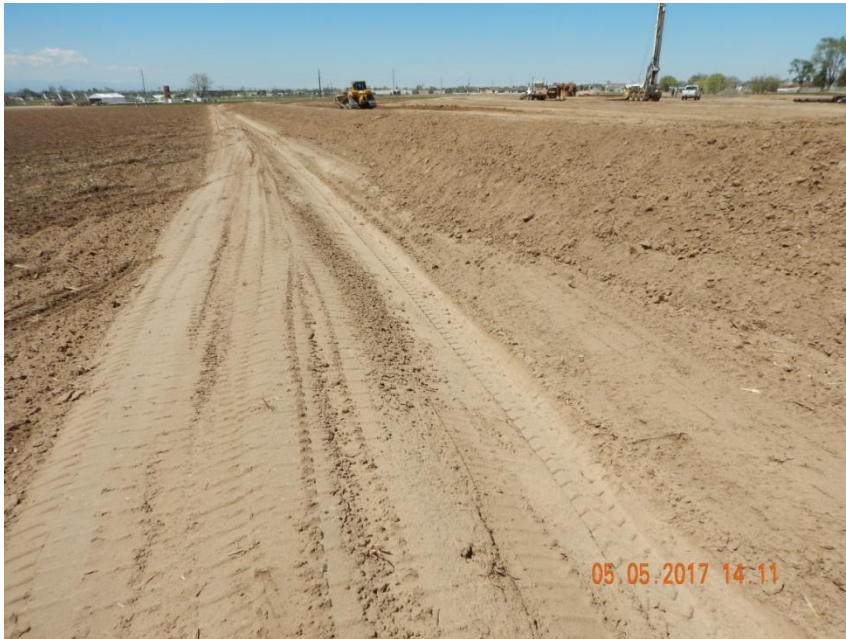
**Photo 1.** Photo taken from the southwestern location, facing North. A ditch and berm BMP has been installed around the perimeter of the location.

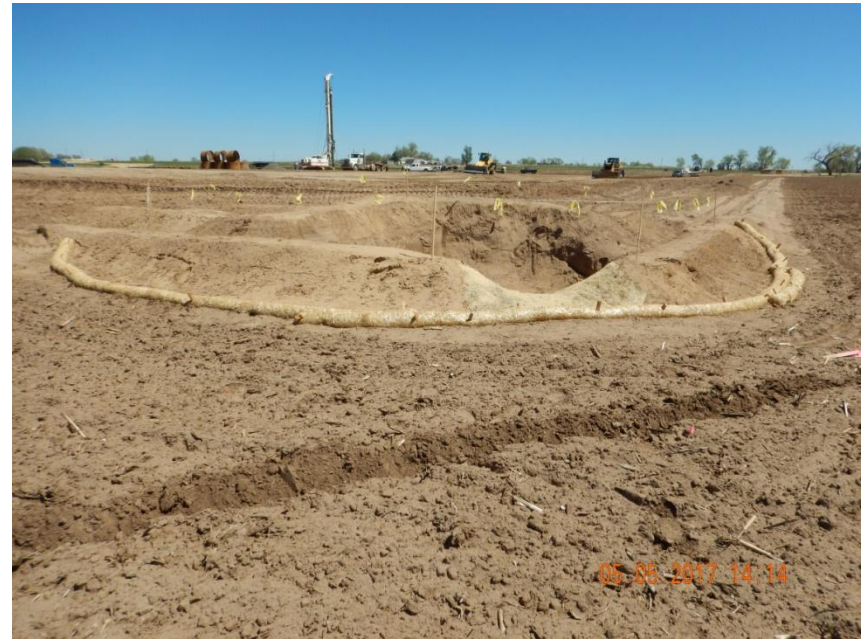
**Photo 2.** Photo taken from the northwest location, facing Southeast. A sediment trap has been installed with outlet protection devices.

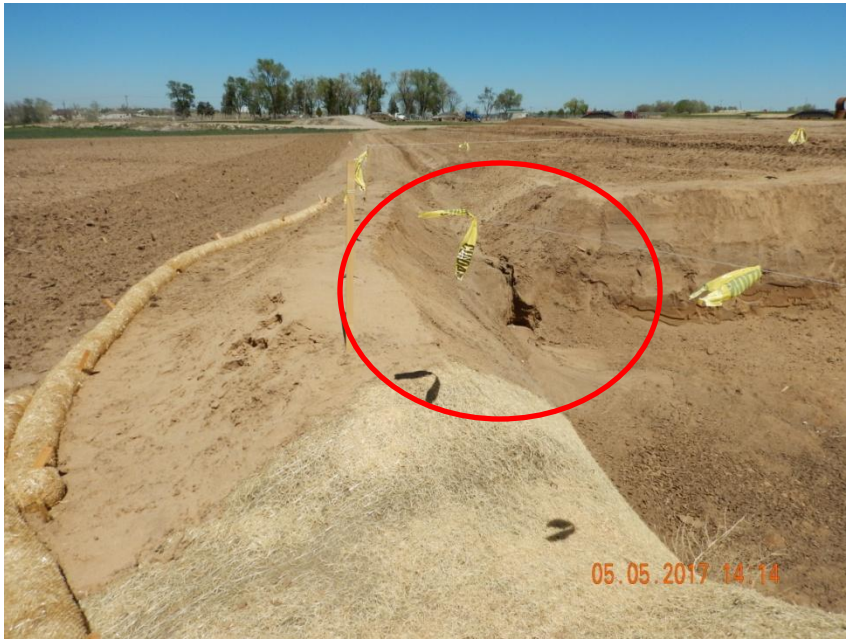
**Photo 3.** Photo taken from the sediment trap, facing East. Erosion is occurring at the inlet of the sediment trap because there is no inlet protection. May need to install inlet protection and monitor to ensure erosion does not progress further.

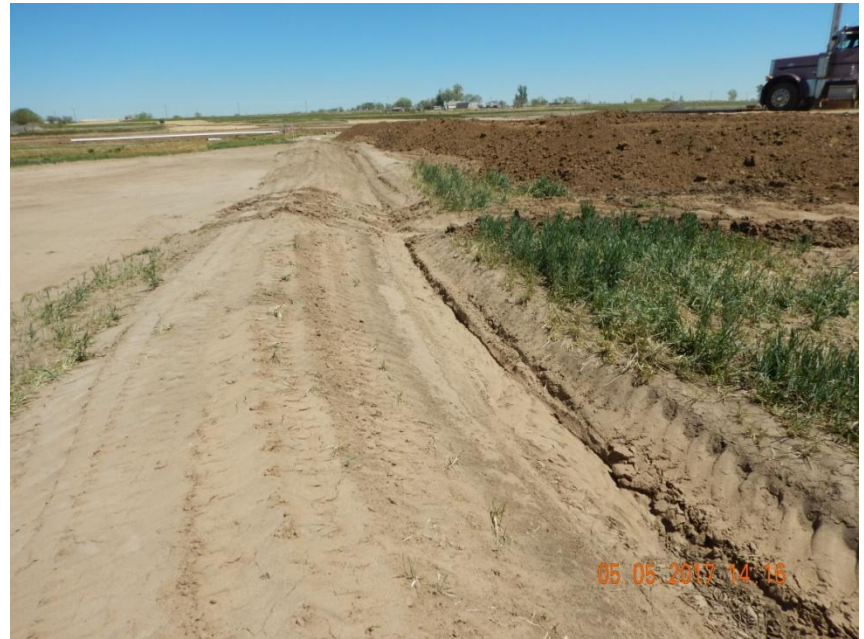
**Photo 4.** Photo taken from the northern location, facing East. A ditch and berm BMP has been installed around the perimeter of the location.

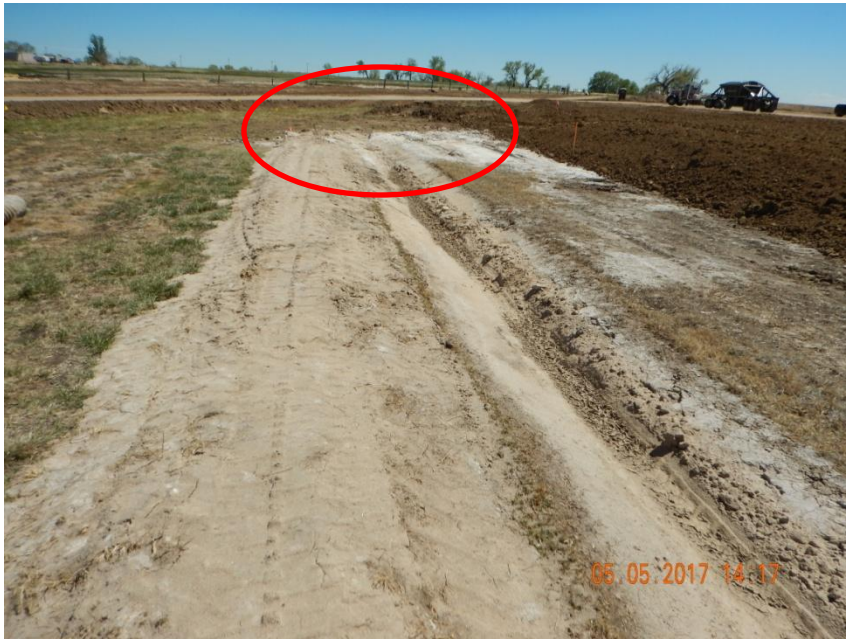
**Photo 5.** Photo taken from the northeastern location, facing Southeast. A ditch and berm BMP has been installed around the perimeter of the location but stops short along the northeastern location.
